MINERALS PROGRAM INSPECTION REPORT
PHONE: (303) 866-3567

MINE NAME: Moon Pit No 2	MINE/PROSPECTING ID#: M-1977-443	MINERAL: Sand and gravel	COUNTY: Moffat
INSPECTION TYPE: Monitoring	INSPECTOR(S): Zach Trujillo	INSP. DATE: July 27, 2022	INSP. TIME: 10:00
OPERATOR: Northwest Aggregates, Inc.	OPERATOR REPRESENTATIVE:	TYPE OF OPERATION: 110c - Construction Limited Impact	
REASON FOR INSPECTION: Normal I&E Program	BOND CALCULATION TYPE: Complete Bond	BOND AMOUNT: \$23,704.51	
DATE OF COMPLAINT: NA	POST INSP. CONTACTS: None	JOINT INSP. AGENCY: None	
WEATHER: Clear	INSPECTOR'S SIGNATURE:

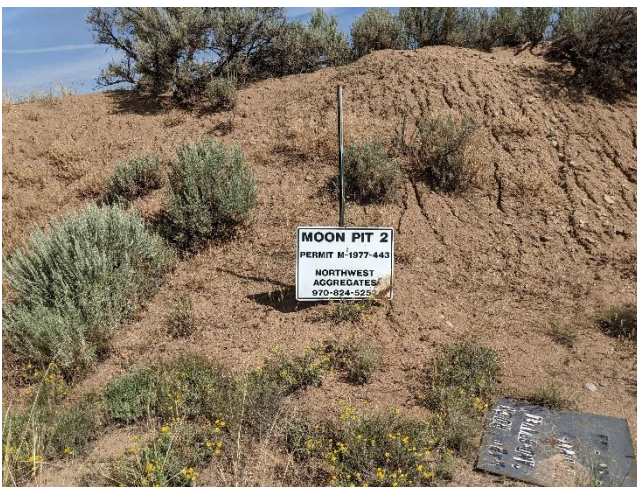
The mine identification sign and affected area boundary markers are in place and in compliance with Rule 3.1.12. High winds appeared to have shifted the sign but was fixed during the inspection to ensure it was visible.

Mine ID sign.

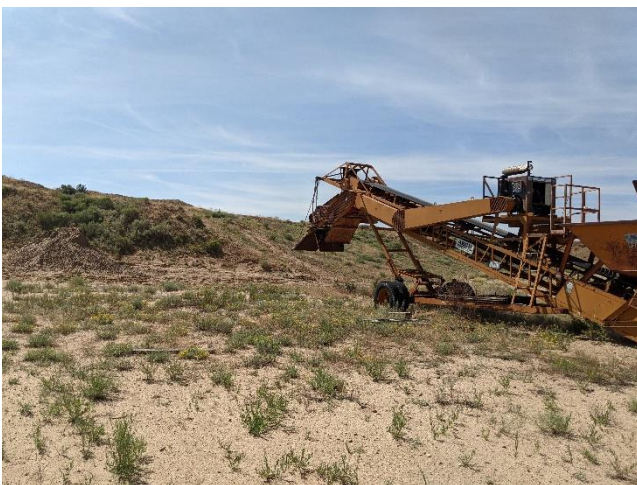
This site was inactive at the time of the inspection. A lone rock crusher was the only equipment on site and a couple of small stockpiles were located along the south eastern side of the pit. No fuel, buildings or other equipment were on site. Native vegetation has begun to establish itself along the pit floor due to inactivity.

Rock crusher.

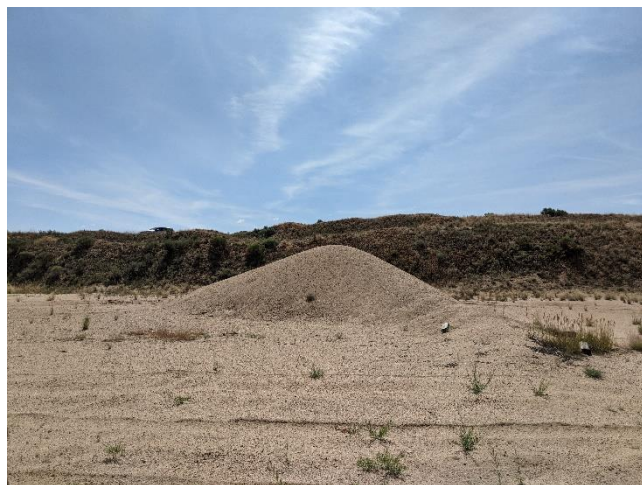
Material stockpile.

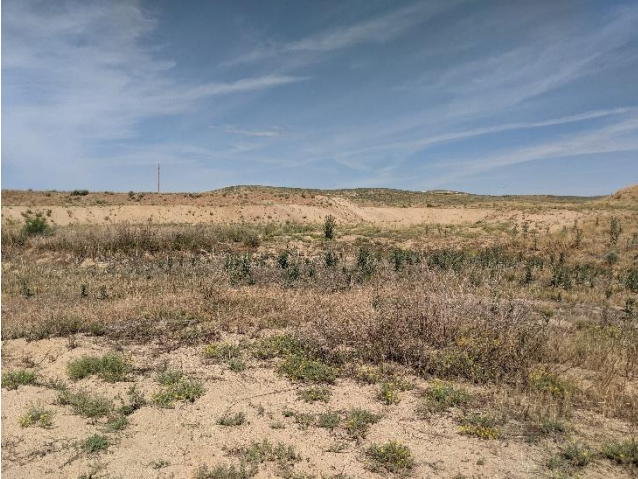
Scattered patches of thistle was observed along the eastern embankment along the site entrance as well as along the central floor of the pit. These areas should be treated as needed to prevent further infestation.

Thistle patch.
