MINERALS PROGRAM INSPECTION REPORT
PHONE: (303) 866-3567

MINE NAME: Sheehan Pit	MINE/PROSPECTING ID#: M-2007-058	MINERAL: Sand and gravel	COUNTY: Moffat
INSPECTION TYPE: Monitoring	INSPECTOR(S): Zach Trujillo	INSP. DATE: July 27, 2022	INSP. TIME: 15:00
OPERATOR: C&B Sand and Gravel Inc.	OPERATOR REPRESENTATIVE: None	TYPE OF OPERATION: 110c - Construction Limited Impact	
REASON FOR INSPECTION: Normal I&E Program	BOND CALCULATION TYPE: Complete Bond	BOND AMOUNT: \$51,470.00	
DATE OF COMPLAINT: NA	POST INSP. CONTACTS: None	JOINT INSP. AGENCY: None	
WEATHER: Clear	INSPECTOR'S SIGNATURE:

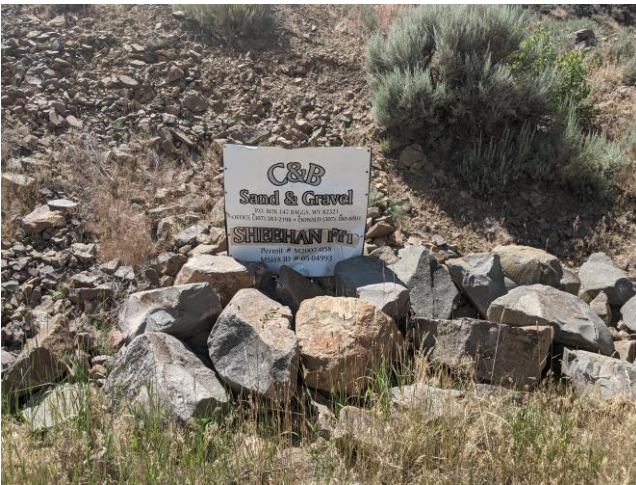
The mine identification sign and affected area boundary markers are in place and in compliance with Rule 3.1.12. A sign is posted off of the county road 1 just the south of the site.

Mine ID sign

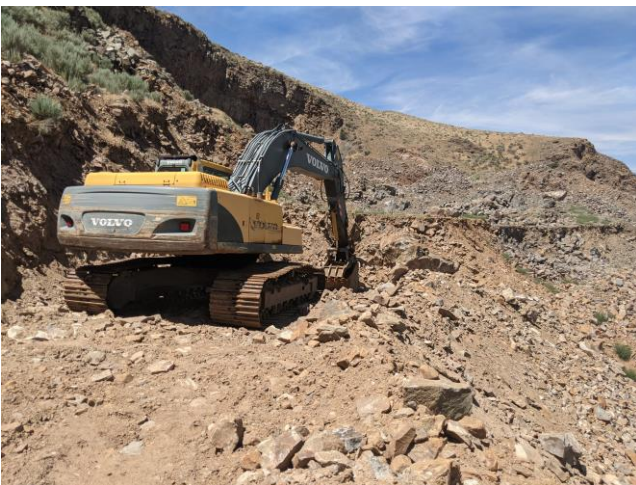
No fuel or buildings were on site at the time of the inspection. One excavator and dozer were parked along the access road to the upper section of the site. Access to the upper benches were limited due to the latest excavation and loose material along the steep slope.

Current excavation area.

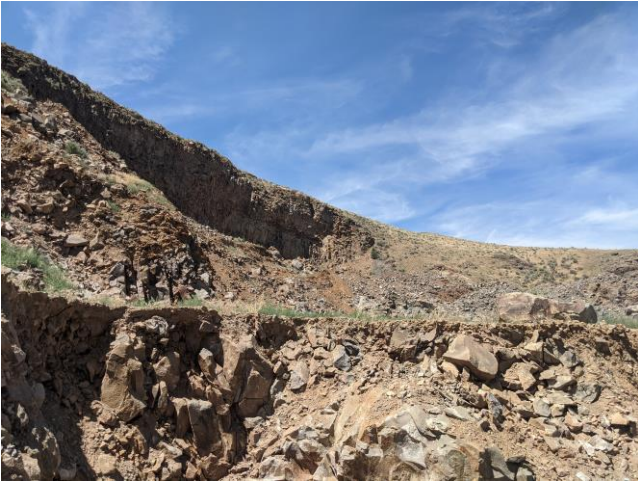
The upper excavated bench was observed from below near the noted excavator. The extent of the permit boundary was walked using GPS and ArcGIS Collector with preloaded maps. The site was visually inspected

and compared to from GPS to ensure mining was within the approved boundaries. No issues were observed.

Upper bench from current excavation.

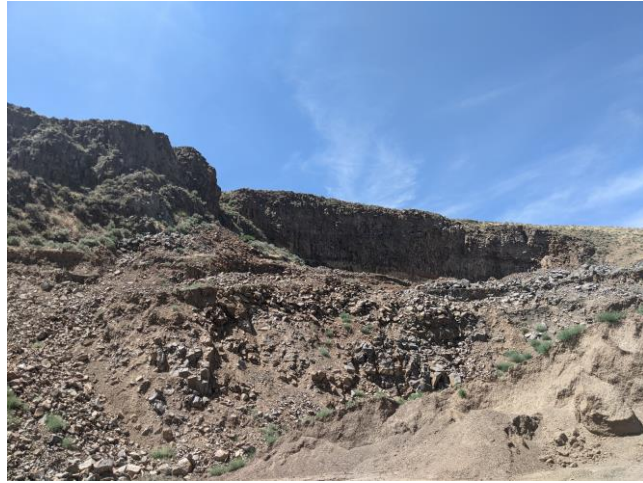
Site from below near county road 1.

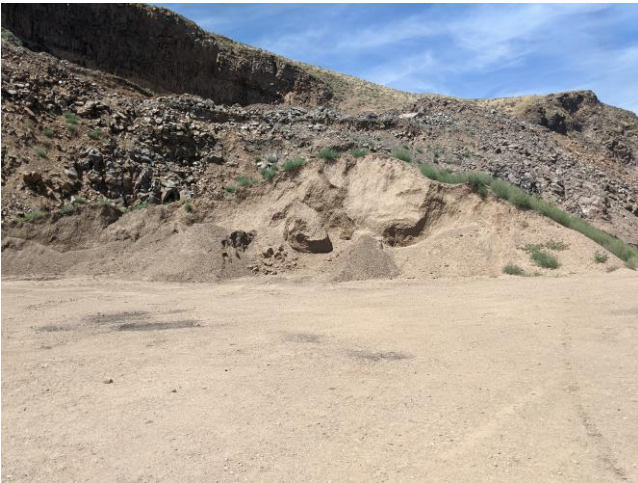
Material has been stockpiled adjacent to the county road. Some material has been pulled from the pile but it is unclear to how long ago. Vegetation has begun to establish itself on the stockpile. This area is adjacent to the permit boundary but remains inside.

Material stockpile.
