**MINERALS PROGRAM INSPECTION REPORT**  
**PHONE: (303) 866-3567**

<b>MINE NAME:</b> Lamar East Pit	<b>MINE/PROSPECTING ID#:</b> M-1977-572	<b>MINERAL:</b> Sand and gravel	<b>COUNTY:</b> Prowers
<b>INSPECTION TYPE:</b> Monitoring	<b>INSPECTOR(S):</b> Amy Eschberger	<b>INSP. DATE:</b> July 12, 2022	<b>INSP. TIME:</b> 10:45
<b>OPERATOR:</b> City of Lamar	<b>OPERATOR REPRESENTATIVE:</b> Rick Akers, Mike Machone	<b>TYPE OF OPERATION:</b> 112c - Construction Regular Operation

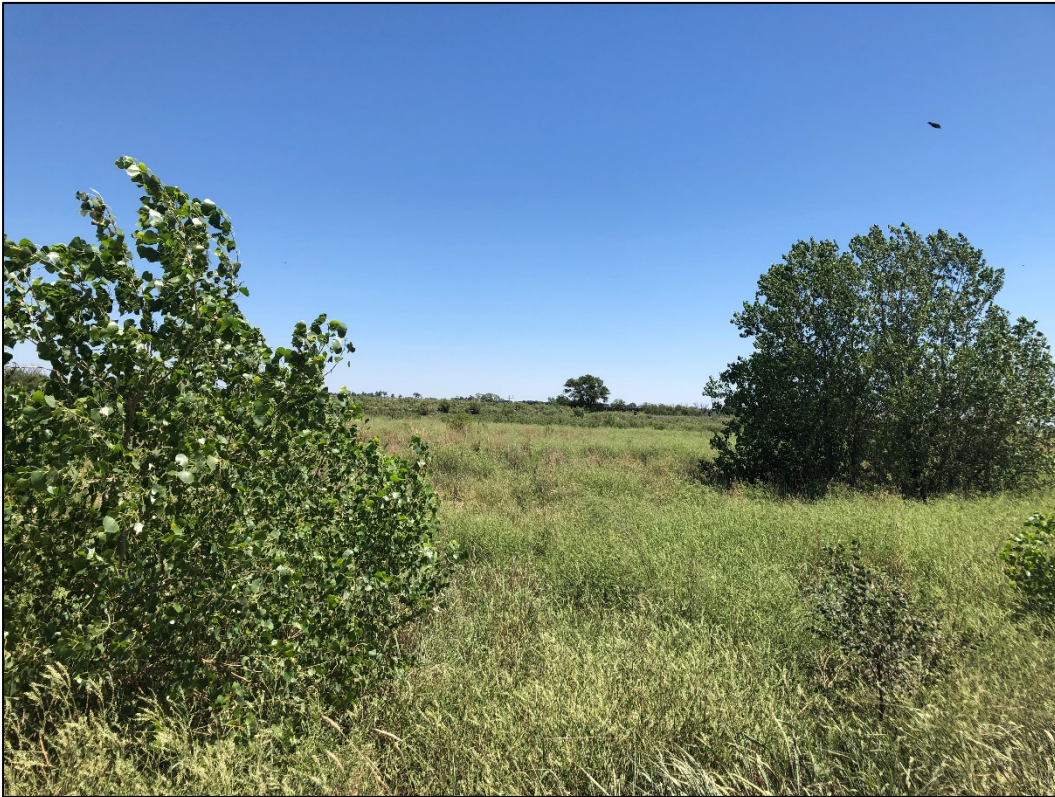
**Photo 1.** View looking north across backfilled pond area which has been reclaimed for many years.

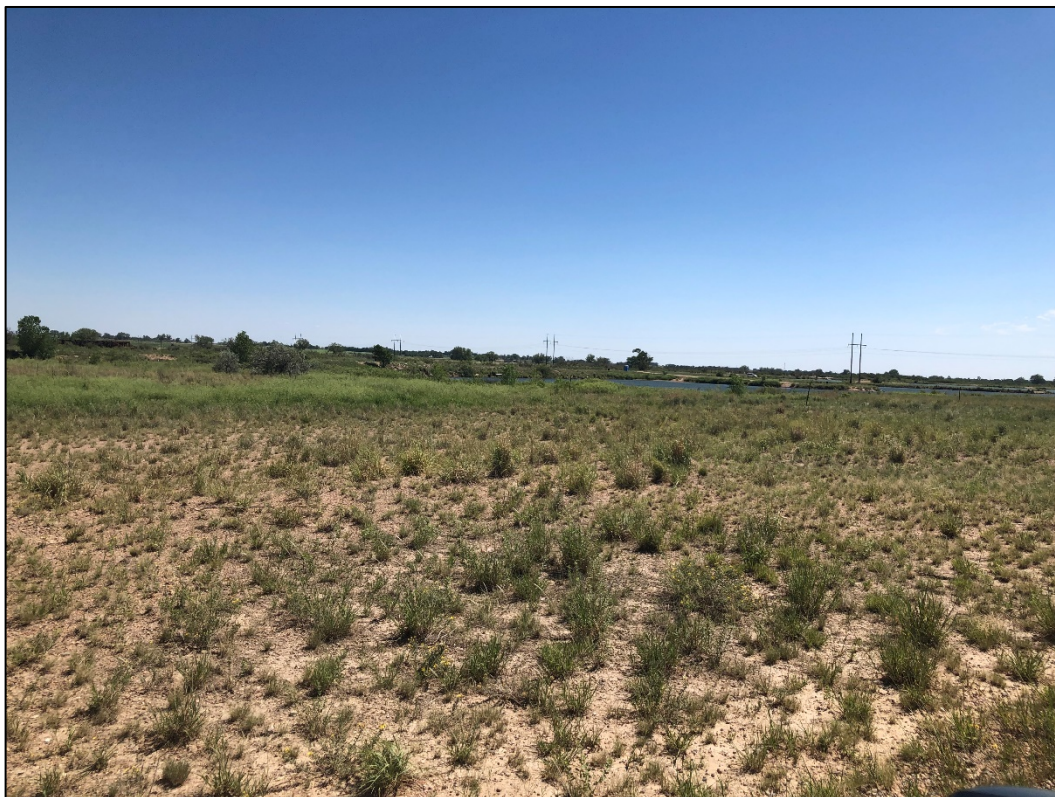
**Photo 2.** View looking north across area located southwest of middle pond, showing grasses establishing in this area.

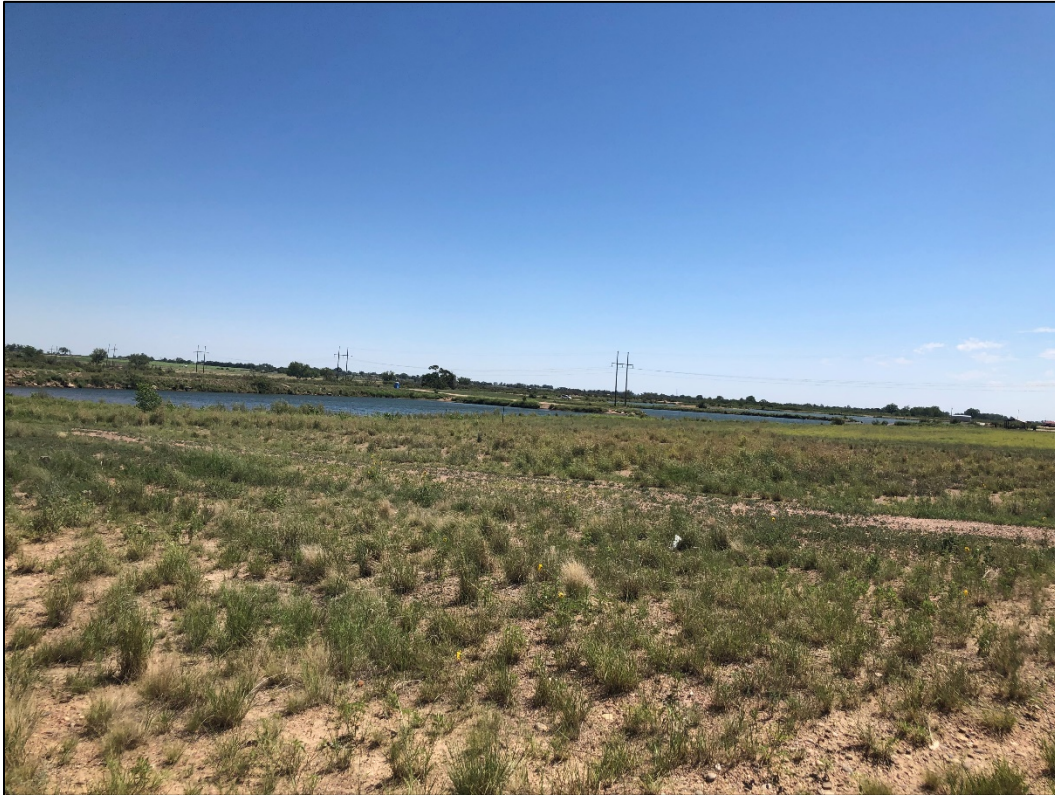
**Photo 3.** View looking northeast across area located southwest of middle pond, showing grasses establishing in this area.

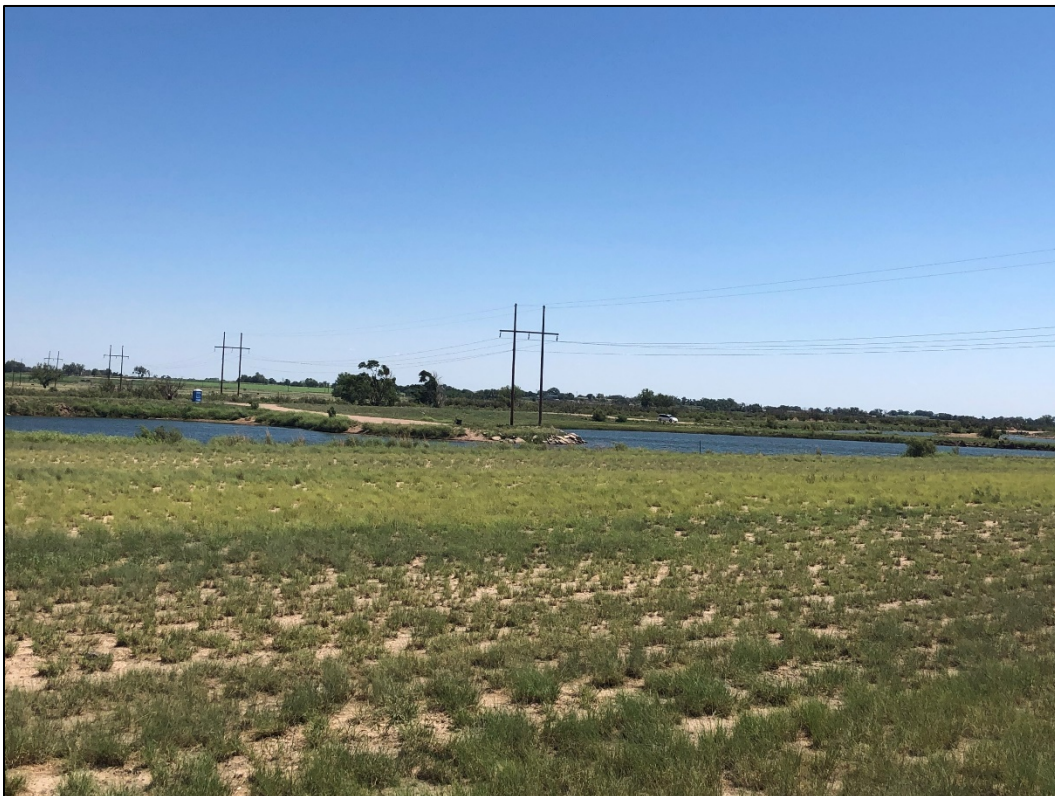
**Photo 4.** View looking northeast across area located south of middle pond, showing grasses establishing in this area.

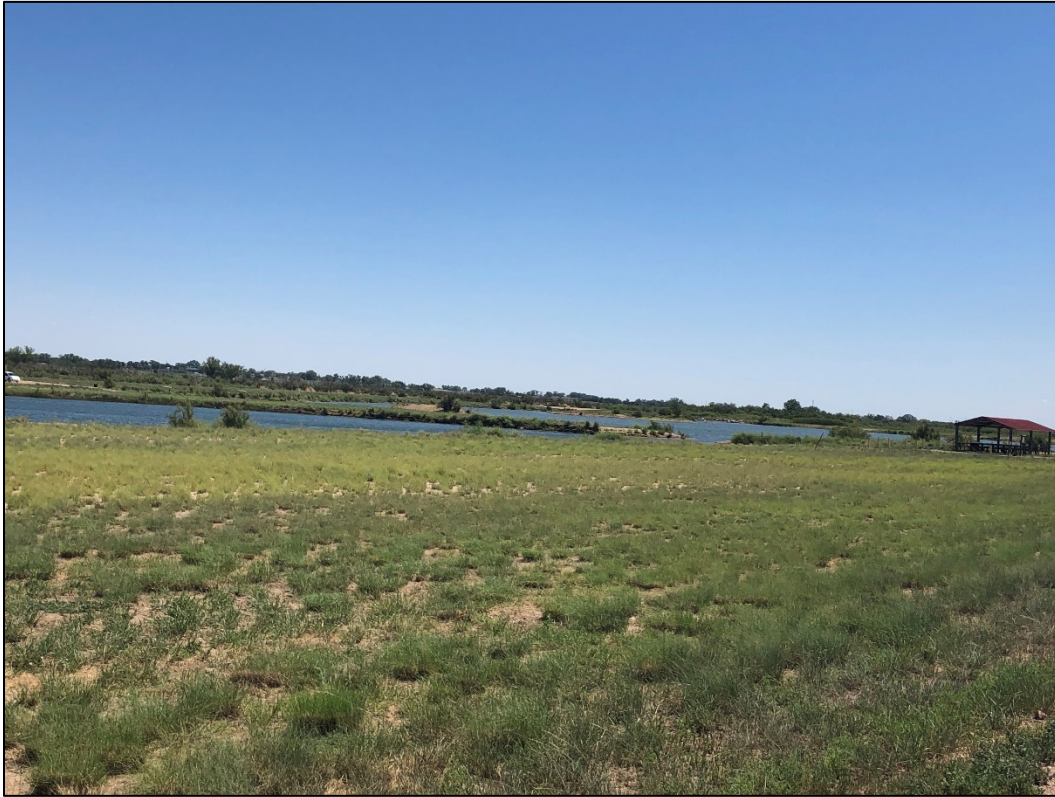
**Photo 5.** View looking northeast across area located south of middle pond, showing grasses establishing in this area.

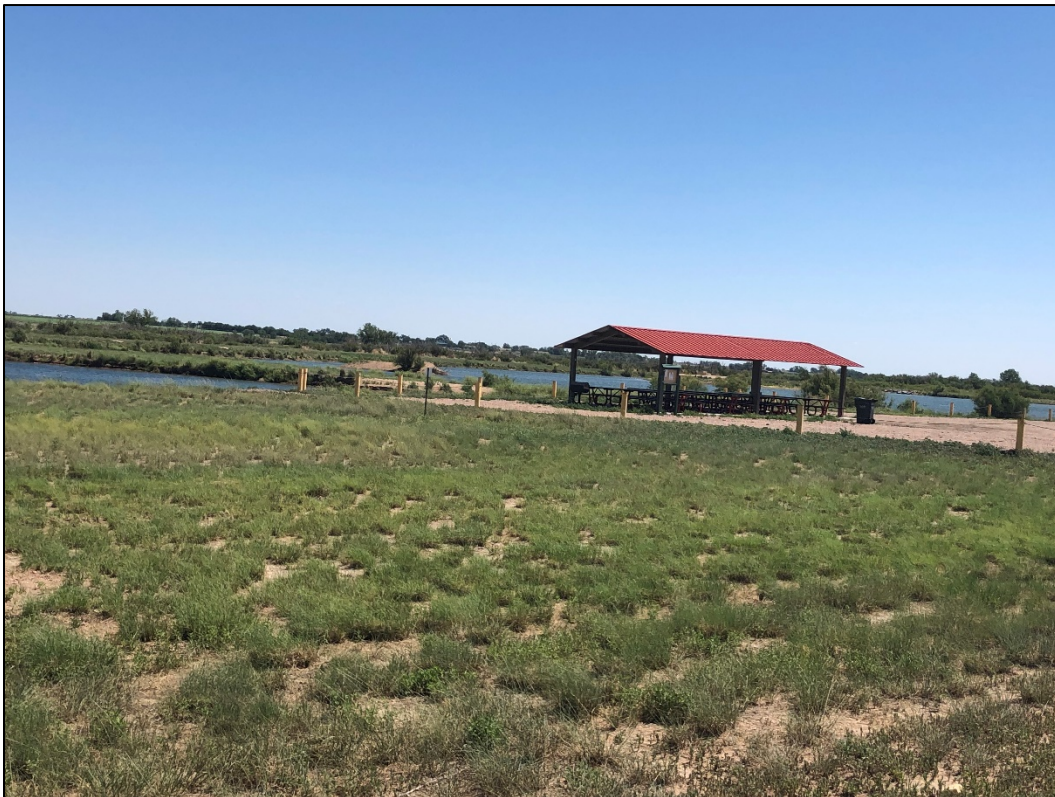
**Photo 6.** View looking northeast across area located southeast of middle pond, showing grasses establishing in this area. Note picnic/shade structure installed in this area for park use.

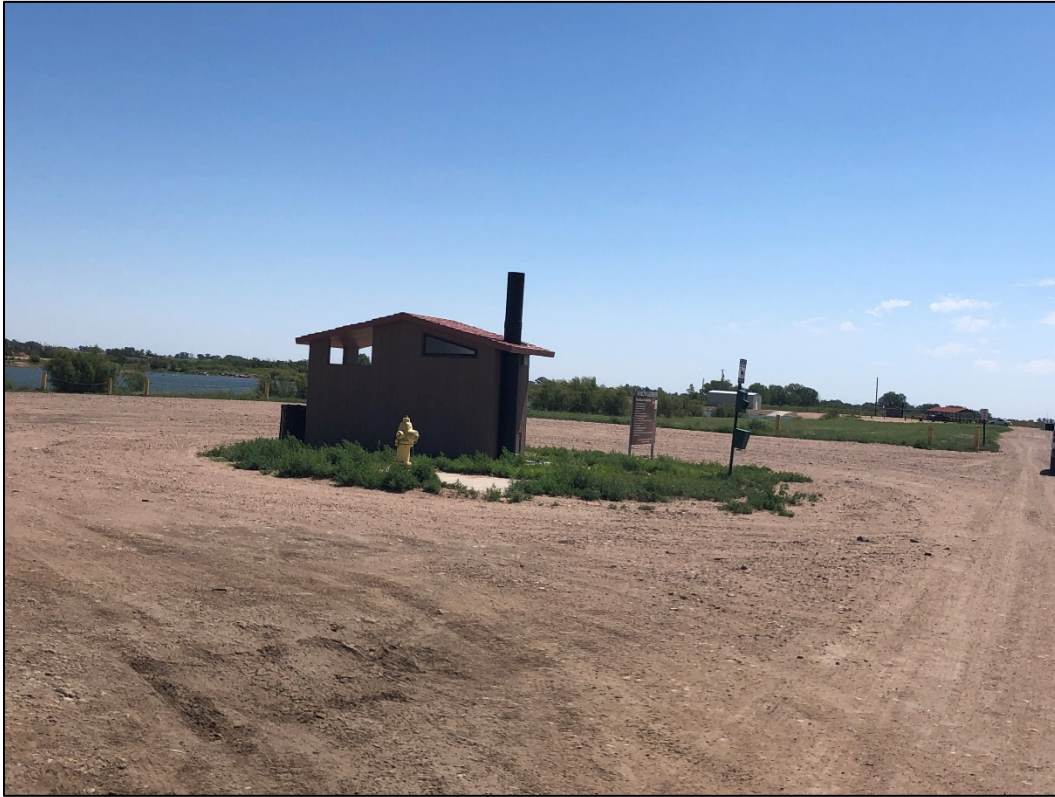
**Photo 7.** View looking northeast across small parking area located south of (and in between) eastern ponds, showing restroom facility installed in this area for park use.

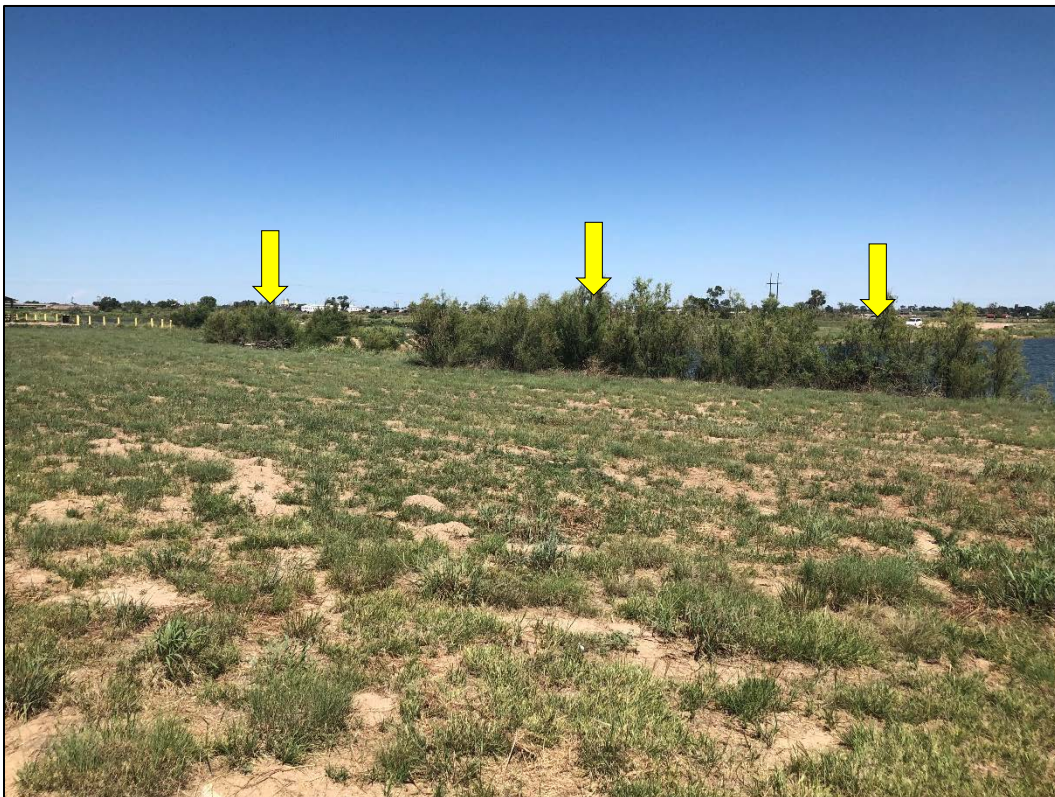
**PROBLEM:** There are state-listed noxious weeds present on site, particularly Tamarisk (Salt Cedar). This is a problem for failure to employ weed control methods for state listed noxious weed species within the permitted area, and to reduce the spread of weeds to nearby areas as required by Rule 3.1.10(6).

**Photo 8.** View looking northwest across area located southwest of easternmost pond, showing grasses establishing in this area. Note Tamarisk trees (indicated) growing along shoreline.

**CORRECTIVE ACTIONS:** The operator shall implement the approved weed control plan for the site to address the Tamarisk, and provide proof to the Division that this has been done by the corrective action date. If a weed control plan is not already in place, the operator shall develop a weed control and management plan for the site. This plan should be developed in consultation with the county extension agency or weed control district office, and should include specific control measures to be applied, a schedule for when control measures will be applied, and a post-treatment monitoring plan. This weed control plan shall be submitted to the Division as a Technical Revision, with the appropriate fee of \$216.00, by the corrective action date.

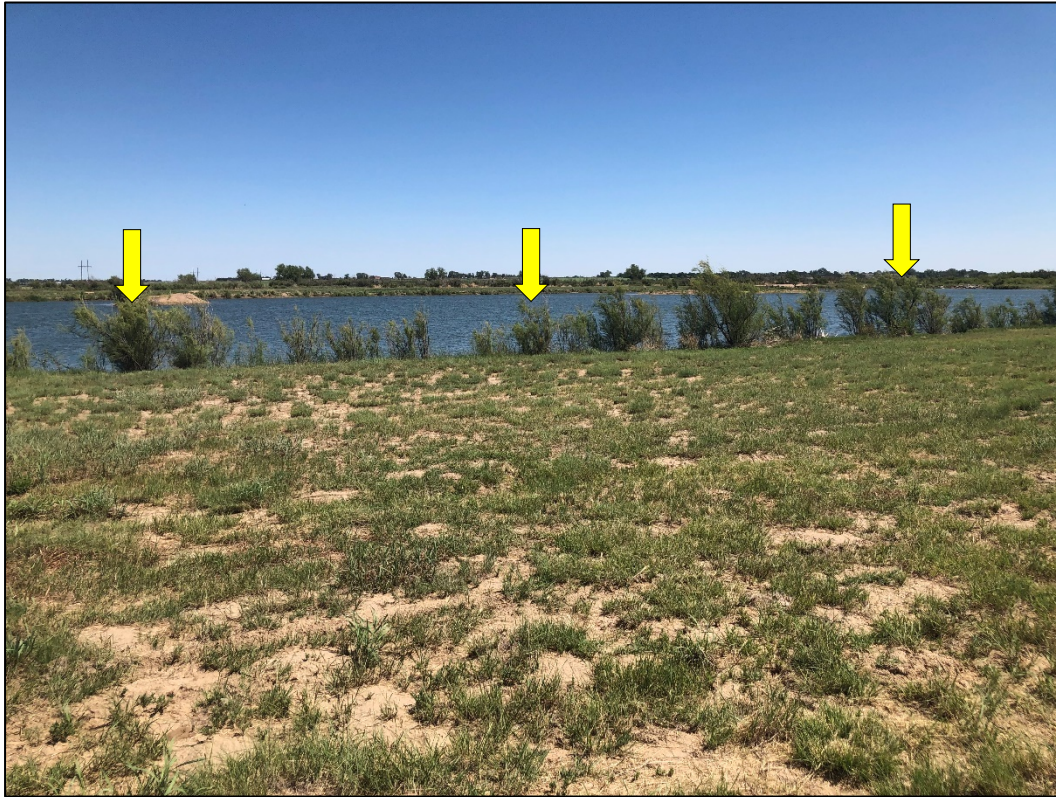
**Photo 9.** View looking north across area located southwest of easternmost pond, showing grasses establishing in this area. Note Tamarisk trees (indicated) growing along shoreline.

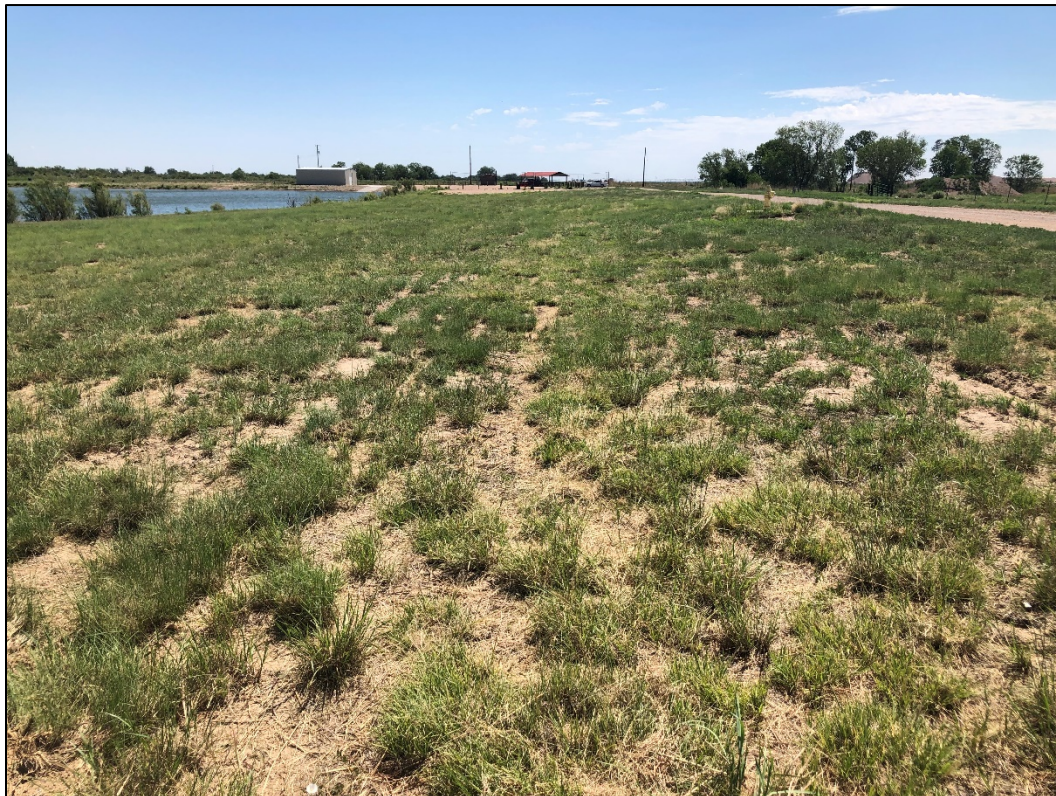
**Photo 10.** View looking east across area located south of easternmost pond, showing grasses establishing in this area.

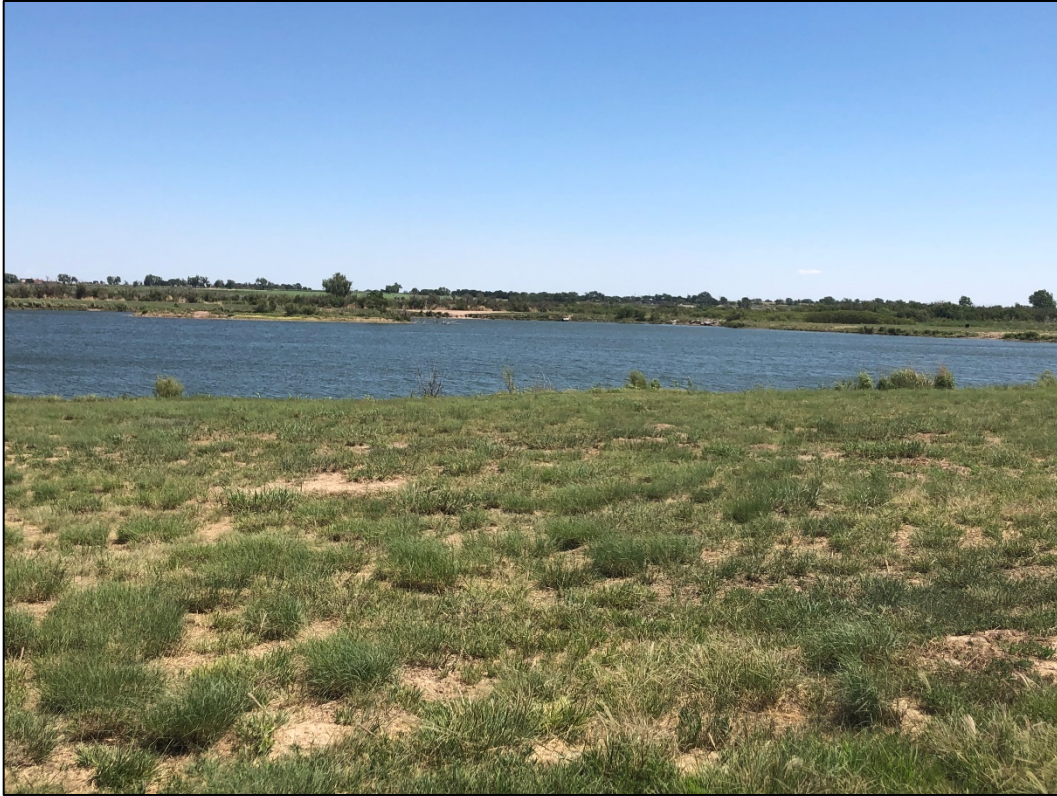
**Photo 11.** View looking northeast across area located south of easternmost pond, showing grasses establishing in this area.

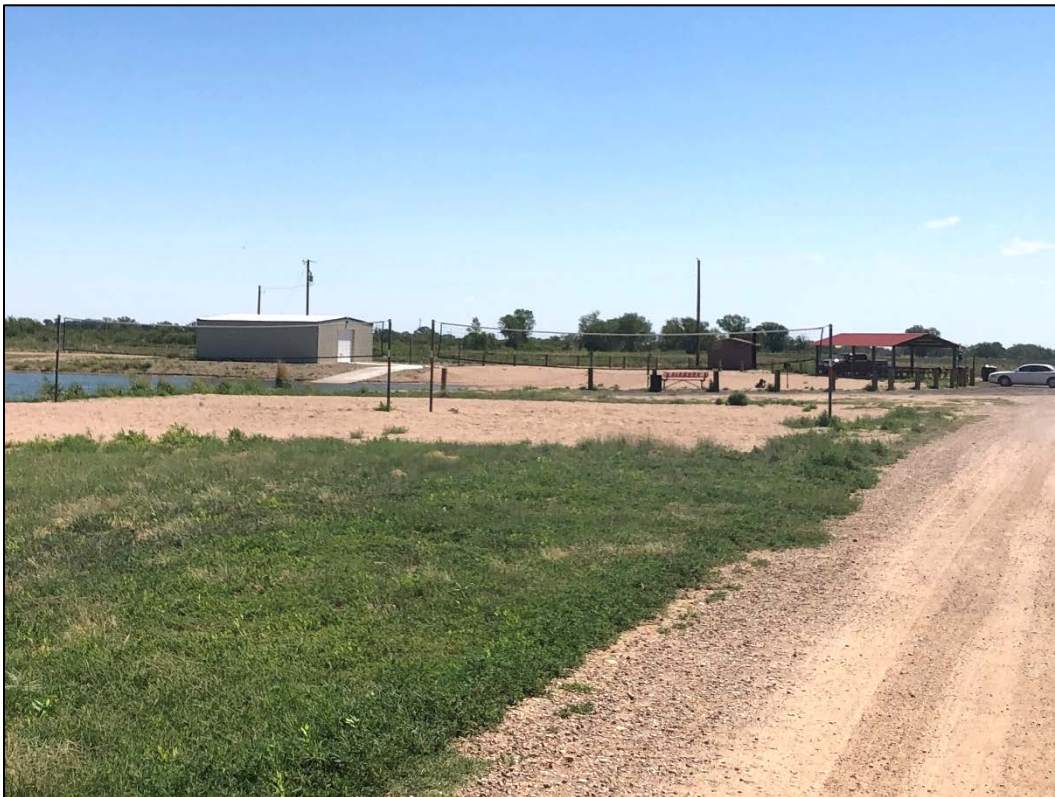
**Photo 12.** View looking east across area located southeast of easternmost pond, showing volleyball area, picnic/shade structure, restroom facility, and storage building installed in this area for park use.

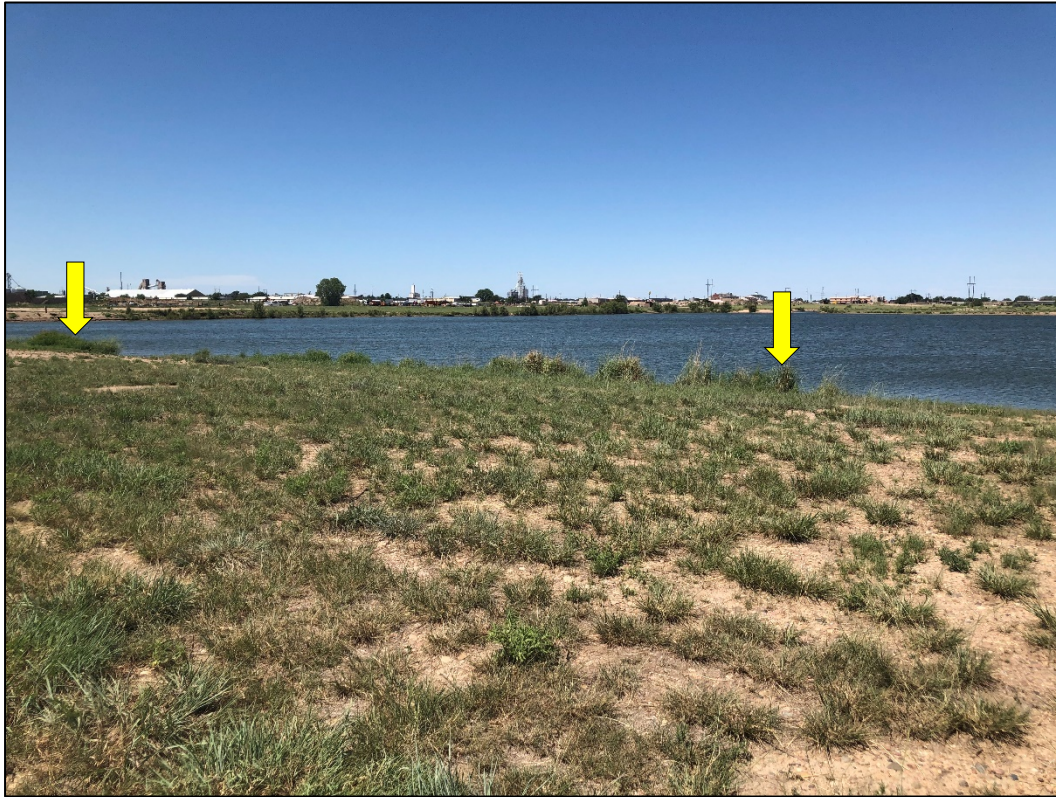
**Photo 13.** View looking southwest across area located east of easternmost pond, showing grasses establishing in this area. Note small Tamarisk trees (indicated) growing along shoreline.

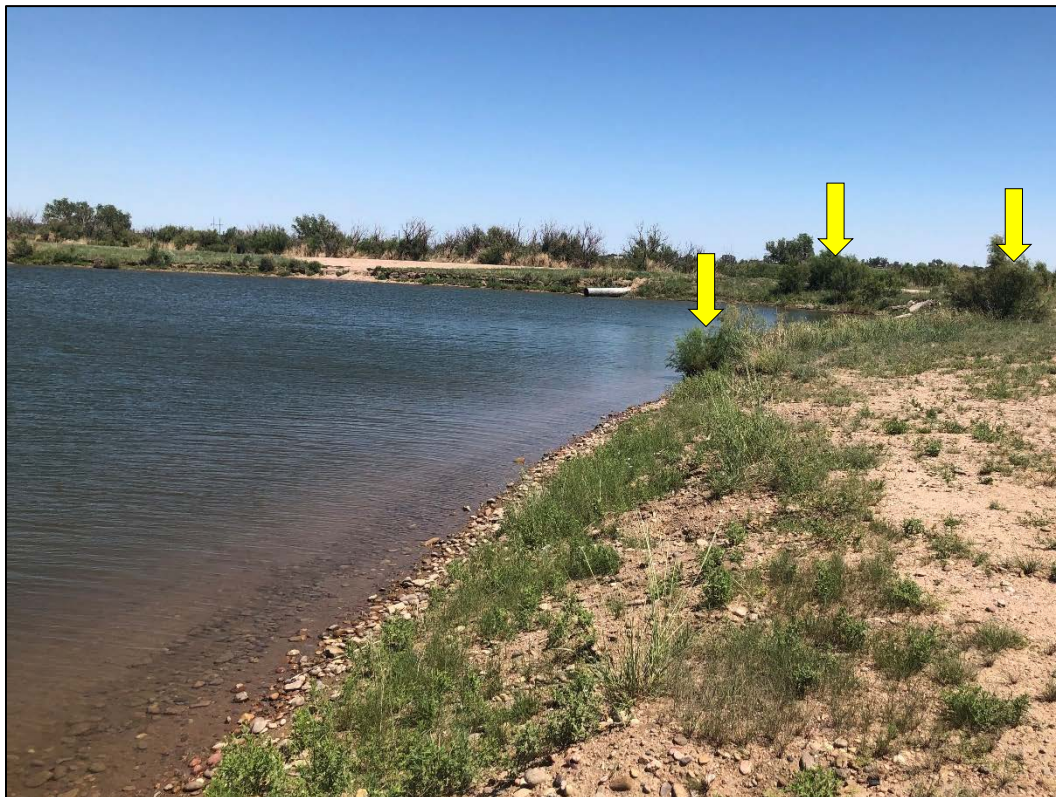
**Photo 14.** View looking north across eastern shoreline of easternmost pond, showing slopes graded flatter than 3H:1V. Note Tamarisk trees (indicated) growing along shoreline.

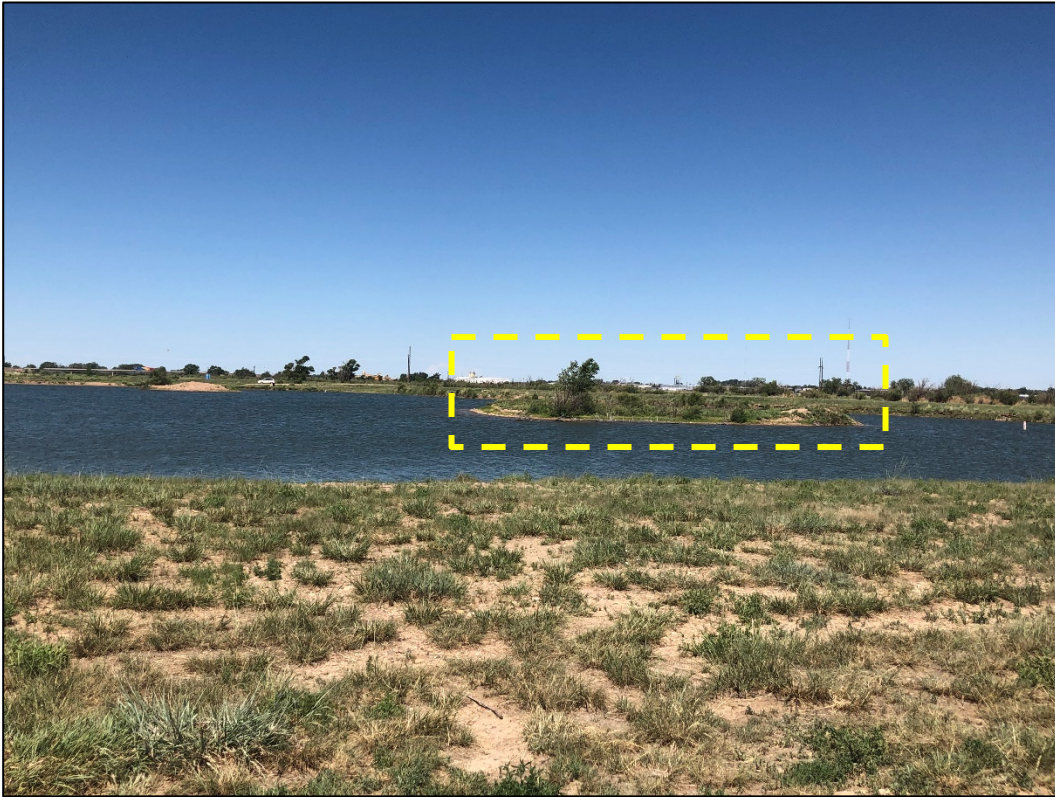
**Photo 15.** View looking south across area located north of easternmost pond, showing good vegetative cover in this area. Note one of two islands present in easternmost pond (indicated).

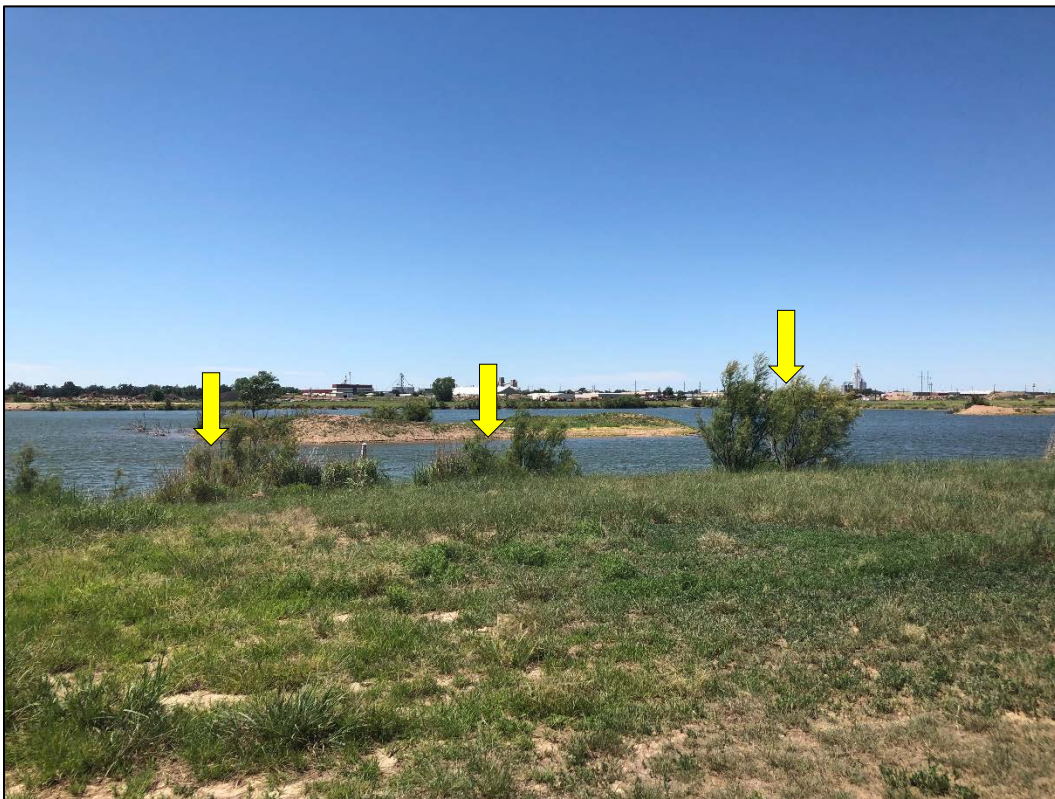
**Photo 16.** View looking southwest across area located north of easternmost pond, showing good vegetative cover in this area. Note Tamarisk trees (indicated) growing along shoreline.

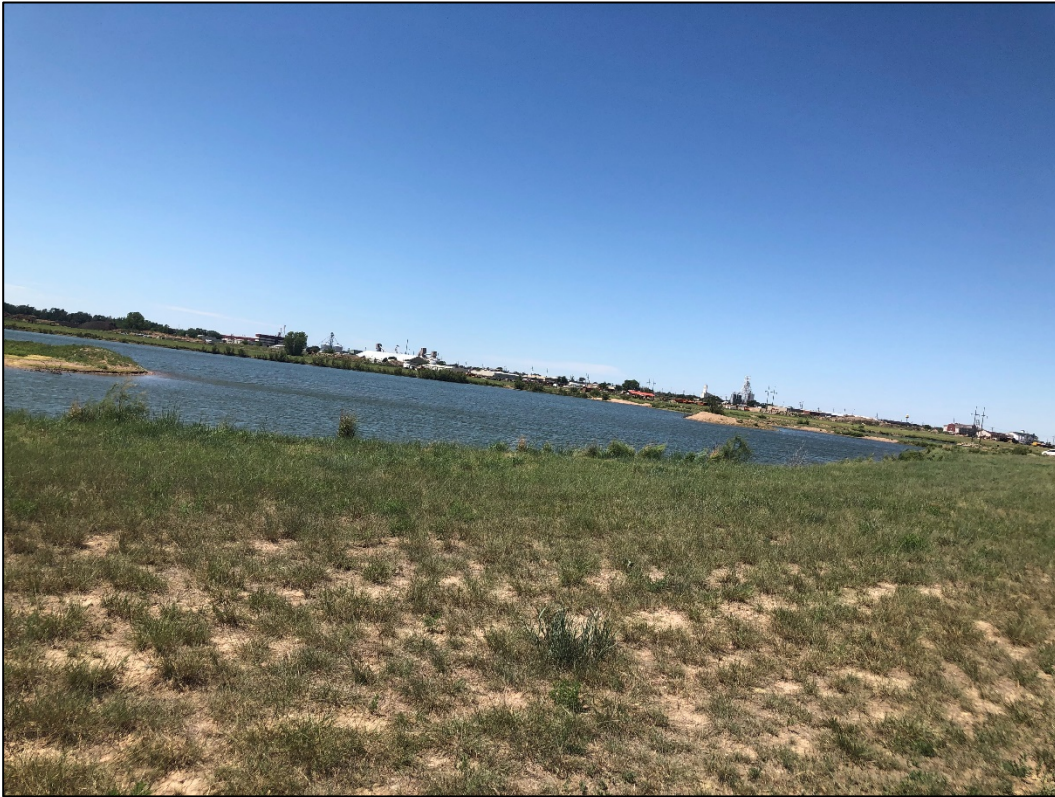
**Photo 17.** View looking southwest across area located north of easternmost pond, showing good vegetative cover in this area.

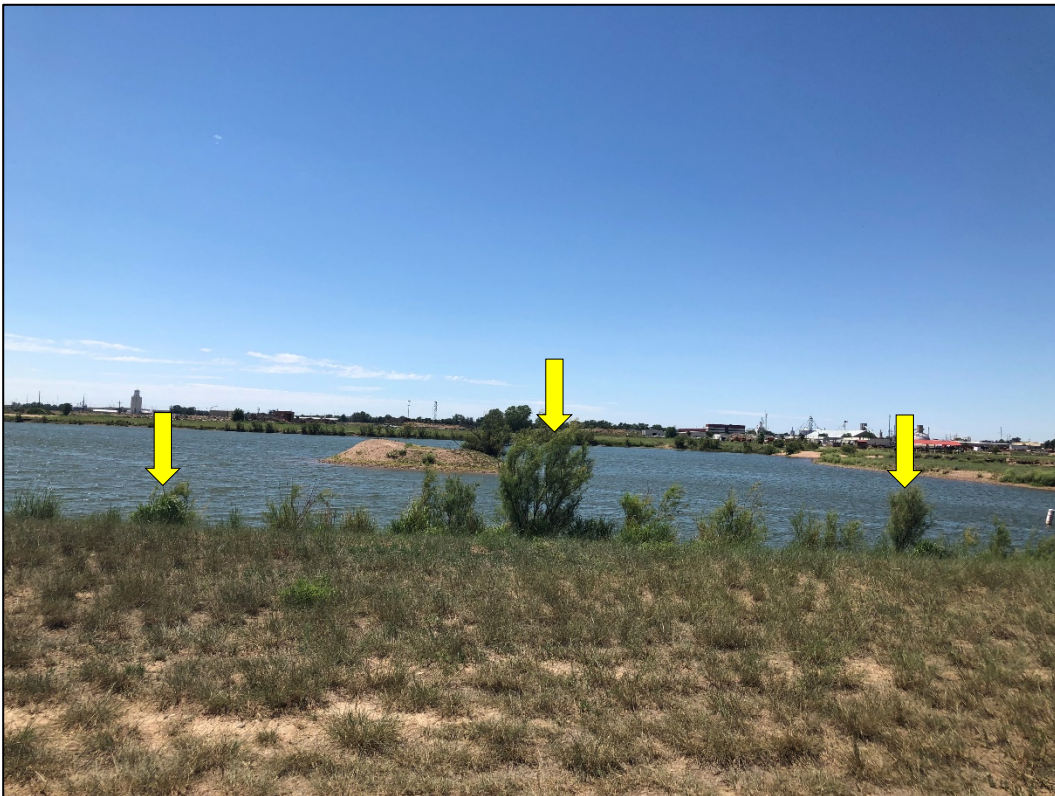
**Photo 18.** View looking south across area located northwest of easternmost pond, showing good vegetative cover in this area. Note Tamarisk trees (indicated) growing along shoreline.

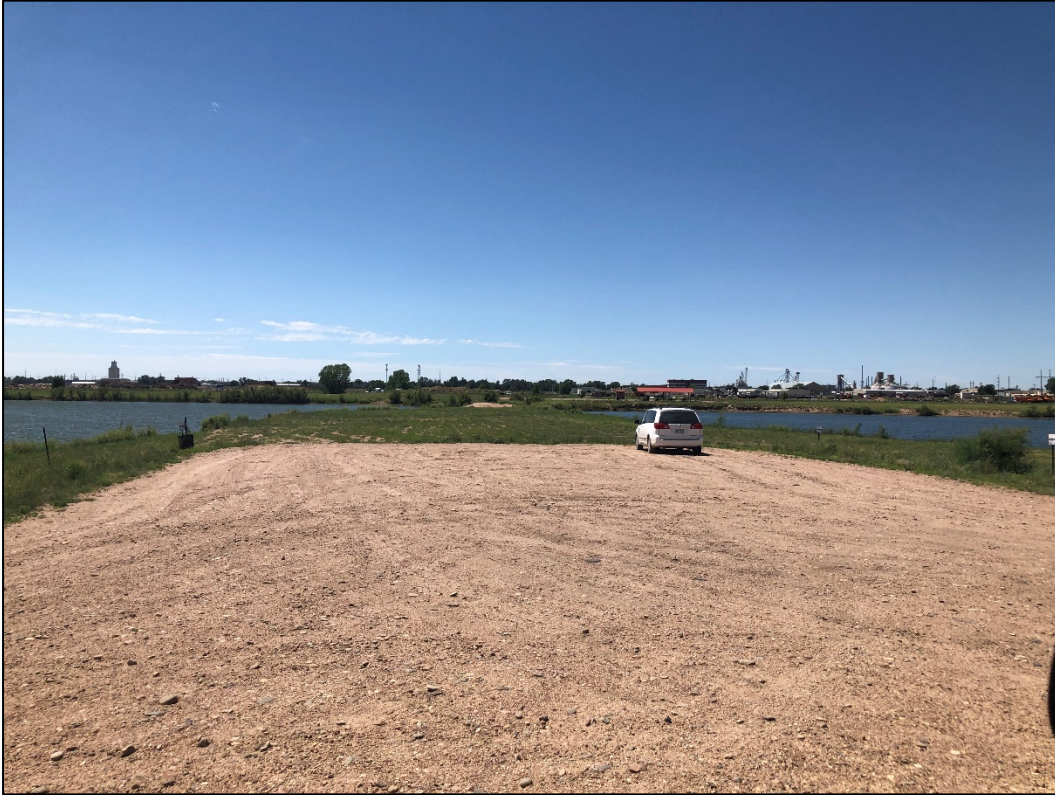
**Photo 19.** View looking south across small parking area located north of (and in between) eastern ponds.

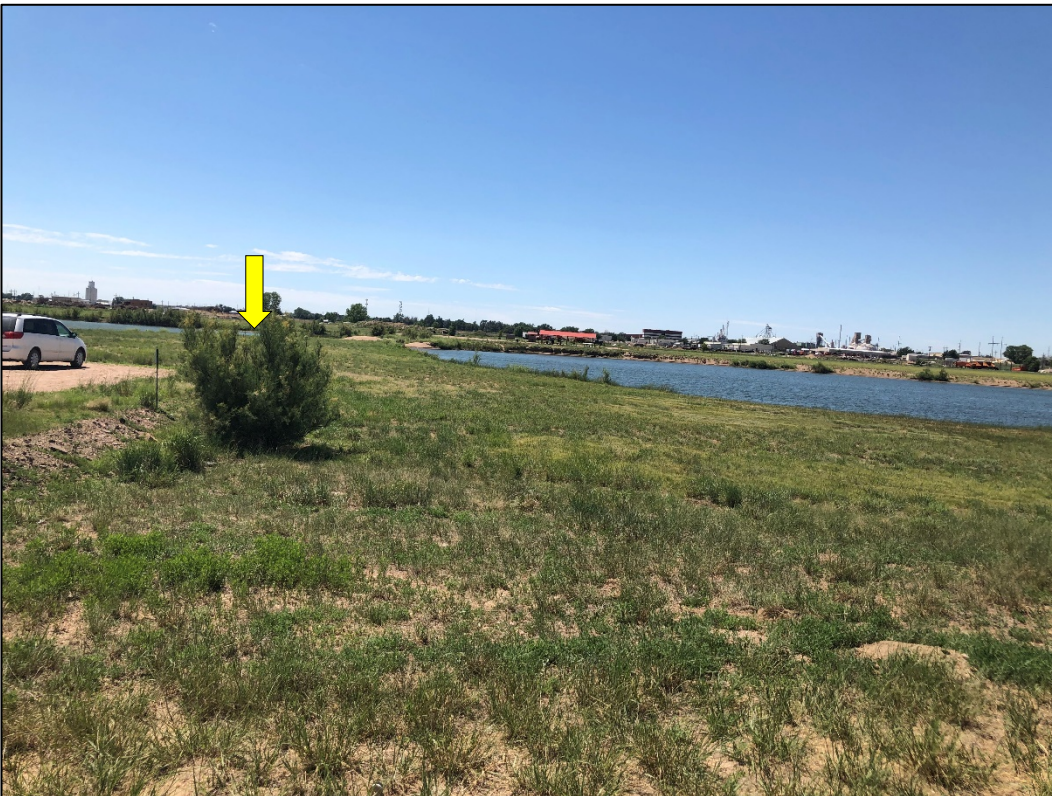
**Photo 20.** View looking south across area located northeast of middle pond, showing good vegetative cover in this area. Note Tamarisk tree (indicated) growing adjacent to parking area.

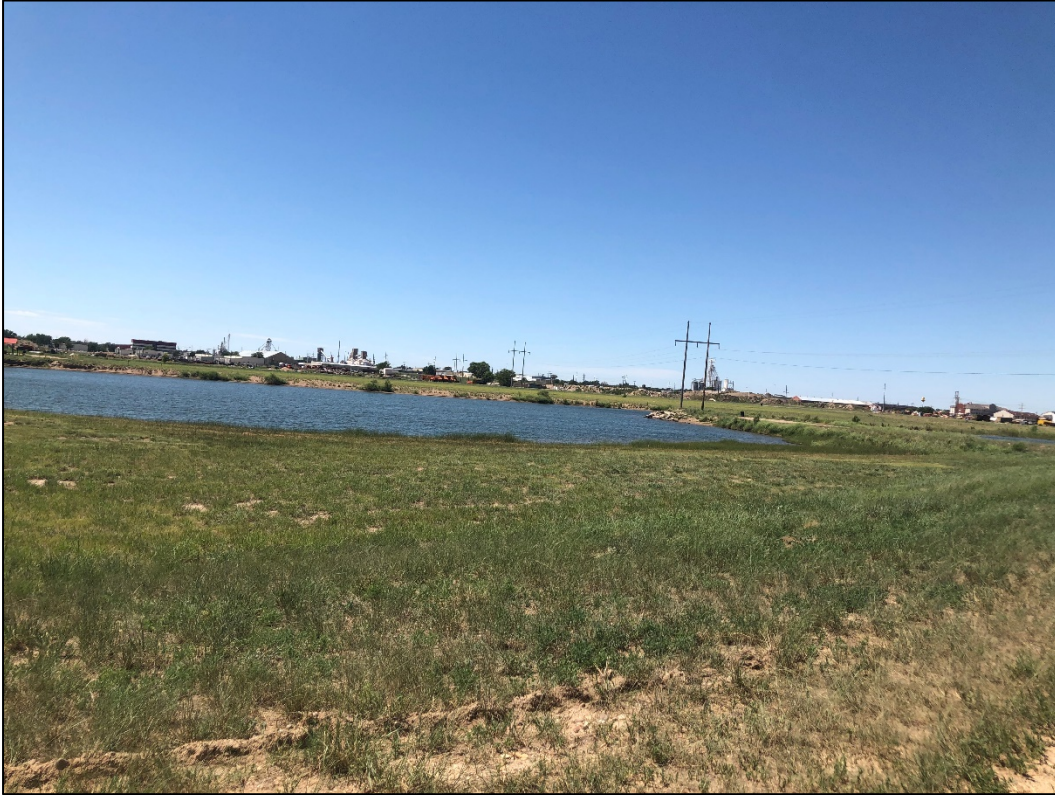
**Photo 21.** View looking southwest across area located north of middle pond, showing good vegetative cover in this area.

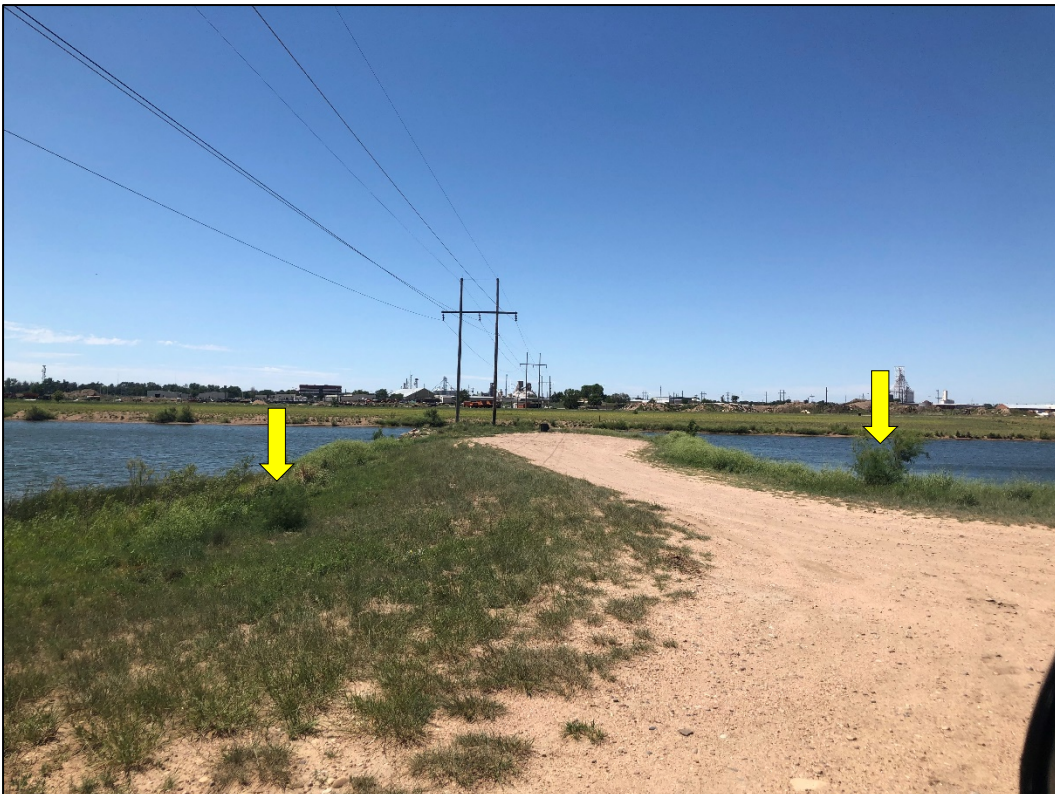
**Photo 22.** View looking south across inlet along northern shoreline of middle pond, showing access road to utility poles. Note small Tamarisk trees (indicated) growing along pond shorelines.

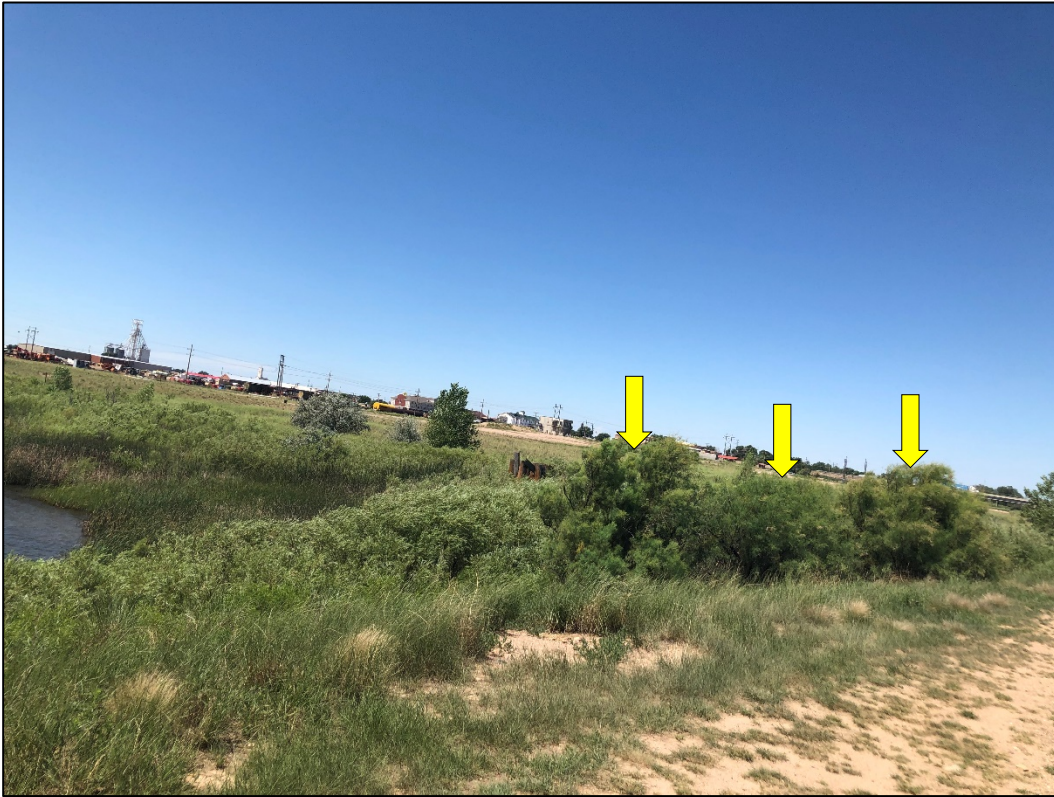
**Photo 23.** View looking southwest across northwestern edge of middle pond, showing Tamarisk trees (indicated) growing along shoreline.

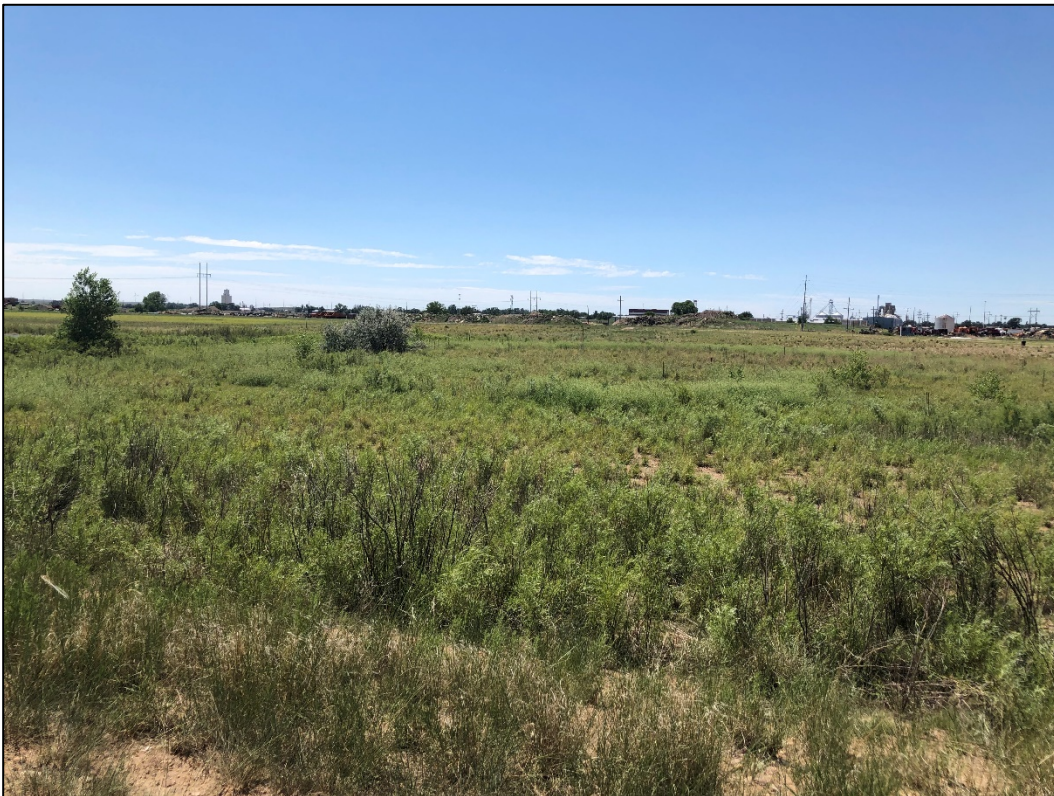
**Photo 24.** View looking south across eastern portion of backfilled pond area which was reclaimed many years ago. Tamarisk trees were observed in this area.

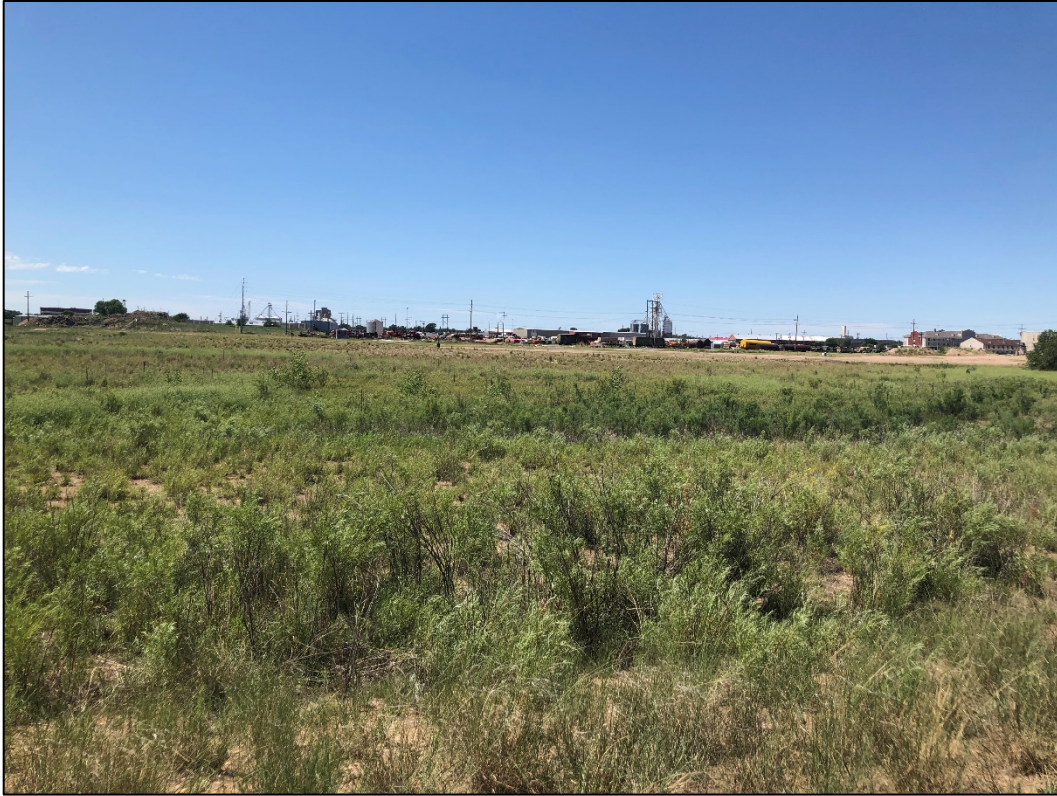
**Photo 25.** View looking south across central portion of backfilled pond area which was reclaimed many years ago. Tamarisk trees were observed in this area.
