**MINERALS PROGRAM INSPECTION REPORT**  
**PHONE: (303) 866-3567**

<b>MINE NAME:</b> Lamar East Pit	<b>MINE/PROSPECTING ID#:</b> M-1977-572	<b>MINERAL:</b> Sand and gravel	<b>COUNTY:</b> Prowers
<b>INSPECTION TYPE:</b> Monitoring	<b>INSPECTOR(S):</b> Amy Eschberger	<b>INSP. DATE:</b> July 12, 2022	<b>INSP. TIME:</b> 10:45
<b>OPERATOR:</b> City of Lamar	<b>OPERATOR REPRESENTATIVE:</b> Rick Akers, Mike Machone	<b>TYPE OF OPERATION:</b> 112c - Construction Regular Operation

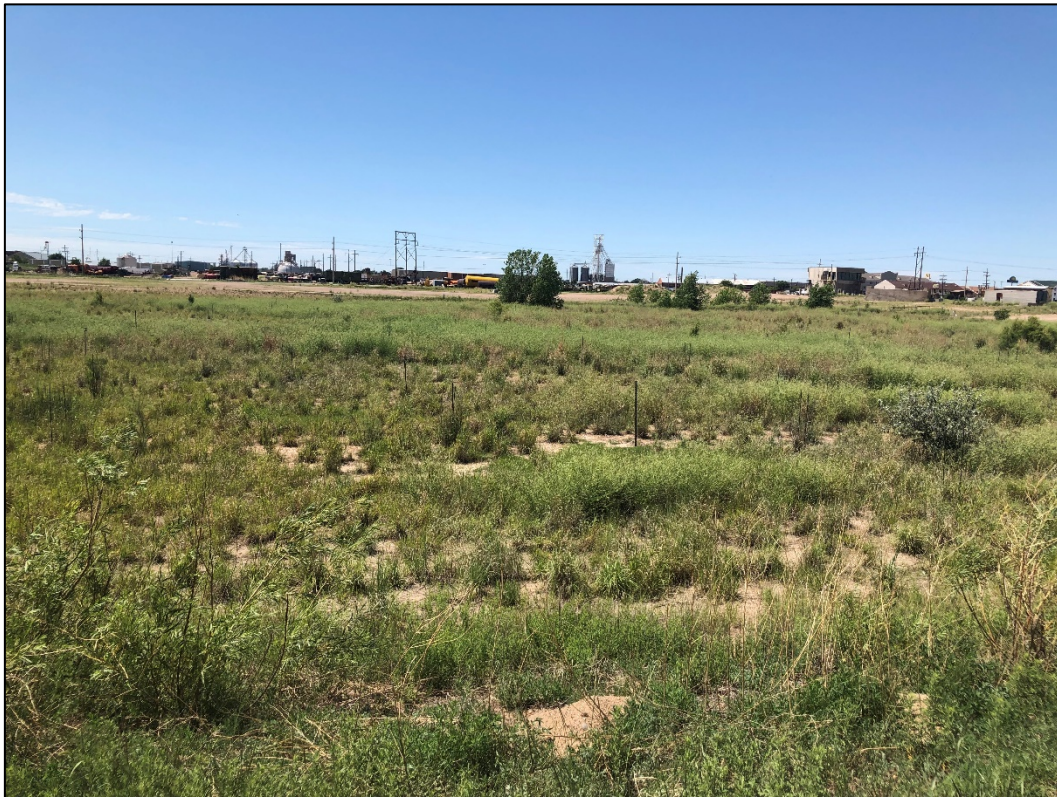
**PROBLEM:** There are state-listed noxious weeds present on site, particularly Tamarisk (Salt Cedar). This is a problem for failure to employ weed control methods for state listed noxious weed species within the permitted area, and to reduce the spread of weeds to nearby areas as required by Rule 3.1.10(6).

**Photo 26.** View looking south across western portion of backfilled pond area which was reclaimed many years ago. Tamarisk trees were observed in this area.

**CORRECTIVE ACTIONS:** The operator shall implement the approved weed control plan for the site to address the Tamarisk, and provide proof to the Division that this has been done by the corrective action date. If a weed control plan is not already in place, the operator shall develop a weed control and management plan for the site. This plan should be developed in consultation with the county extension agency or weed control district office, and should include specific control measures to be applied, a schedule for when control measures will be applied, and a post-treatment monitoring plan. This weed control plan shall be submitted to the Division as a Technical Revision, with the appropriate fee of \$216.00, by the corrective action date.

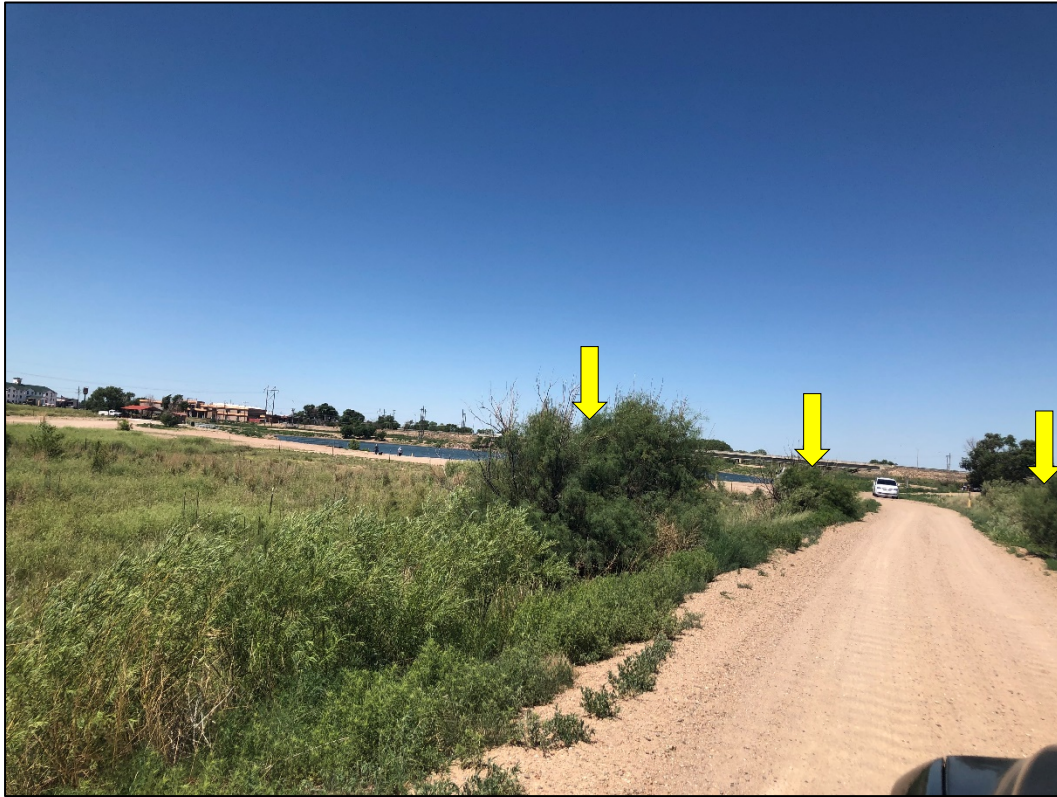
**Photo 27.** View looking west at northwestern edge of backfilled pond area, showing Tamarisk trees (indicated) growing along road.

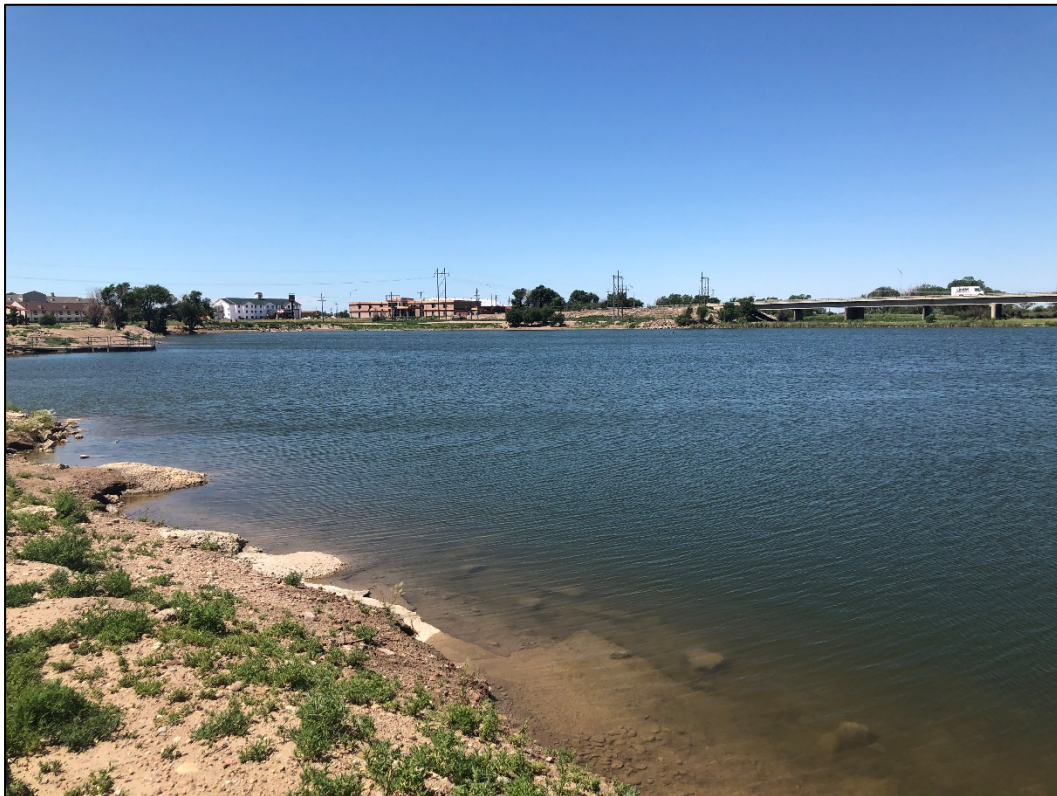
**Photo 28.** View looking southwest across western pond from its northeastern shoreline, with slopes graded flatter than 3H:1V.

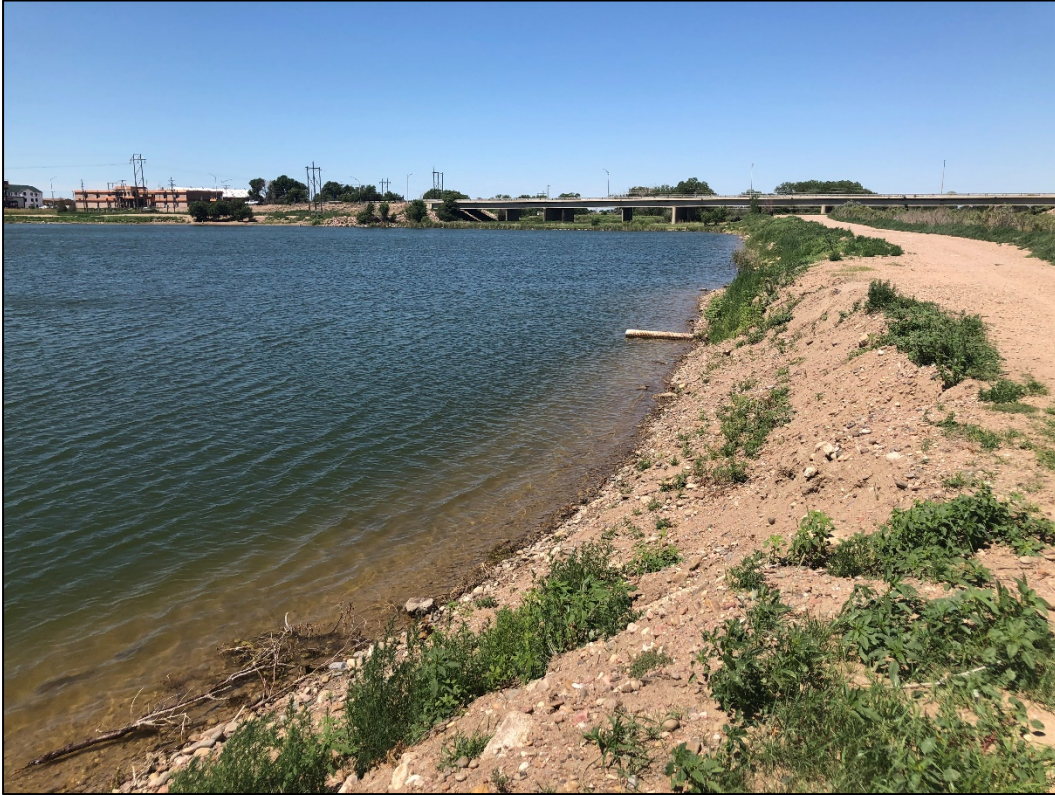
**Photo 29.** View looking west across steeper northern shoreline of western pond which appeared to be stable. The erosion gullies observed during previous inspections were repaired.

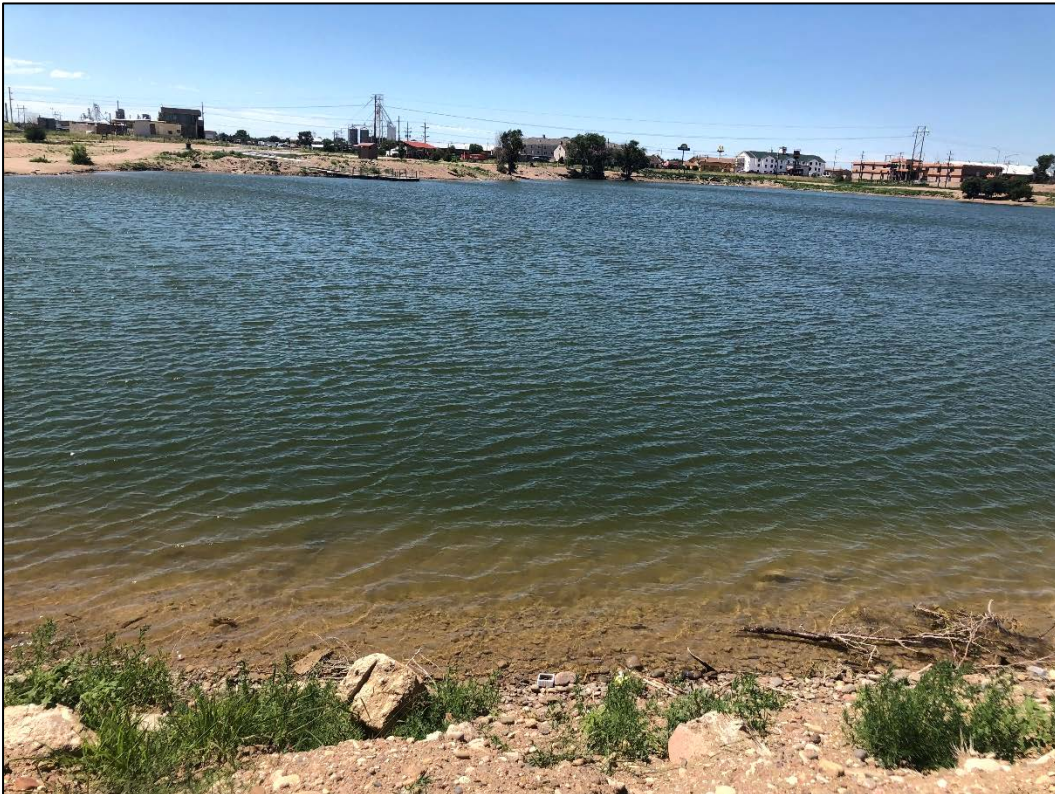
**Photo 30.** View looking south across western pond from its northern shoreline. A picnic/shade structure, restroom facility, fishing pier, and parking areas are installed along the eastern edge of this pond for park use (barely visible in background).
