MINERALS PROGRAM INSPECTION REPORT

MINE NAME: Leadville Mill	MINE/PROSPECTING ID#: M-1990-057	MINERAL: Gold	COUNTY: Lake
INSPECTION TYPE: Monitoring	INSPECTOR(S): Lucas West	INSP. DATE: June 22, 2022	INSP. TIME: 11:07
OPERATOR: Union Milling Company, LLC	OPERATOR REPRESENTATIVE: Steve Craig	TYPE OF OPERATION: 110d - Designated Limited Impact	
REASON FOR INSPECTION: Normal I&E Program	BOND CALCULATION TYPE: None	BOND AMOUNT: \$64,430.00	
DATE OF COMPLAINT: NA	POST INSP. CONTACTS: None	JOINT INSP. AGENCY: None	
WEATHER: Clear	INSPECTOR'S SIGNATURE:

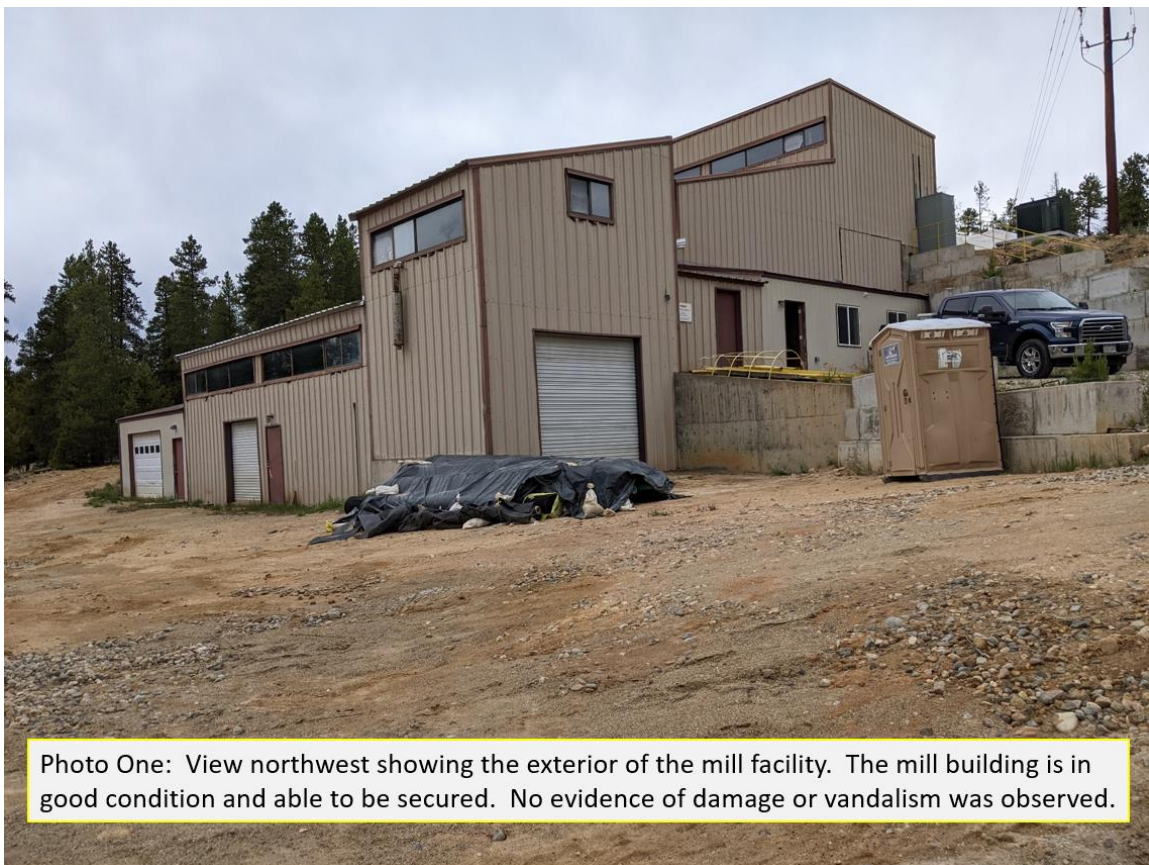
The main mill facility, seen in Photo One, is in good condition and showed no evidence of damage. The building houses a coarse ore bin, grinding circuit and remains of a flotation circuit. Most of the equipment components inside the mill facility are not installed or connected, but stored for the future reconfiguration. Examples of the equipment can be seen in Photos Two and Three. The inspection followed the flow path that material will take through the facility. All components within the facility are in good condition and appear ready for use. No reagents or designated chemicals are stored on site, and all tanks were verified to be empty. As the inspection proceeded, discussion centered around the need for establishing secondary containment within the mill. Either the use floor coatings or concrete lined ditches reporting to the lined emergency pond adjacent to the facility or some combinations thereof was discussed.

Photo One: View northwest showing the exterior of the mill facility. The mill building is in good condition and able to be secured. No evidence of damage or vandalism was observed.

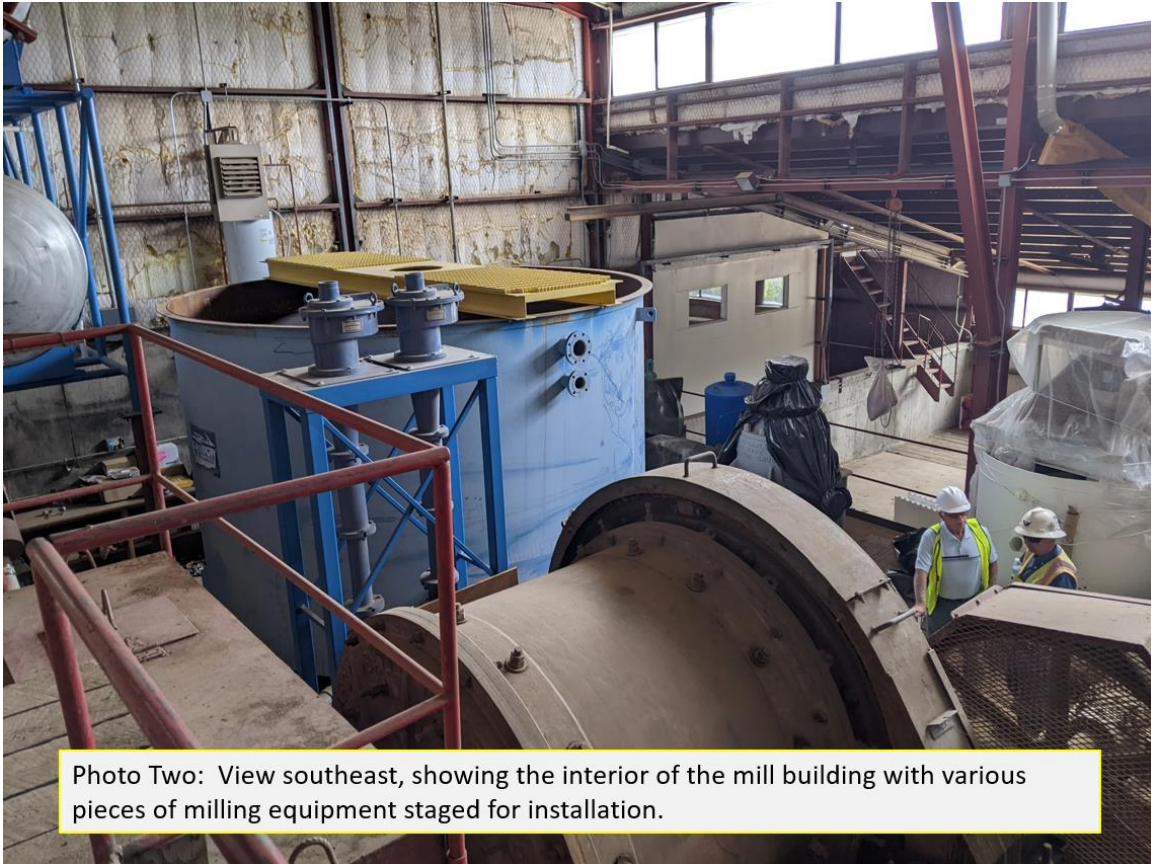
Photo Two: View southeast, showing the interior of the mill building with various pieces of milling equipment staged for installation.

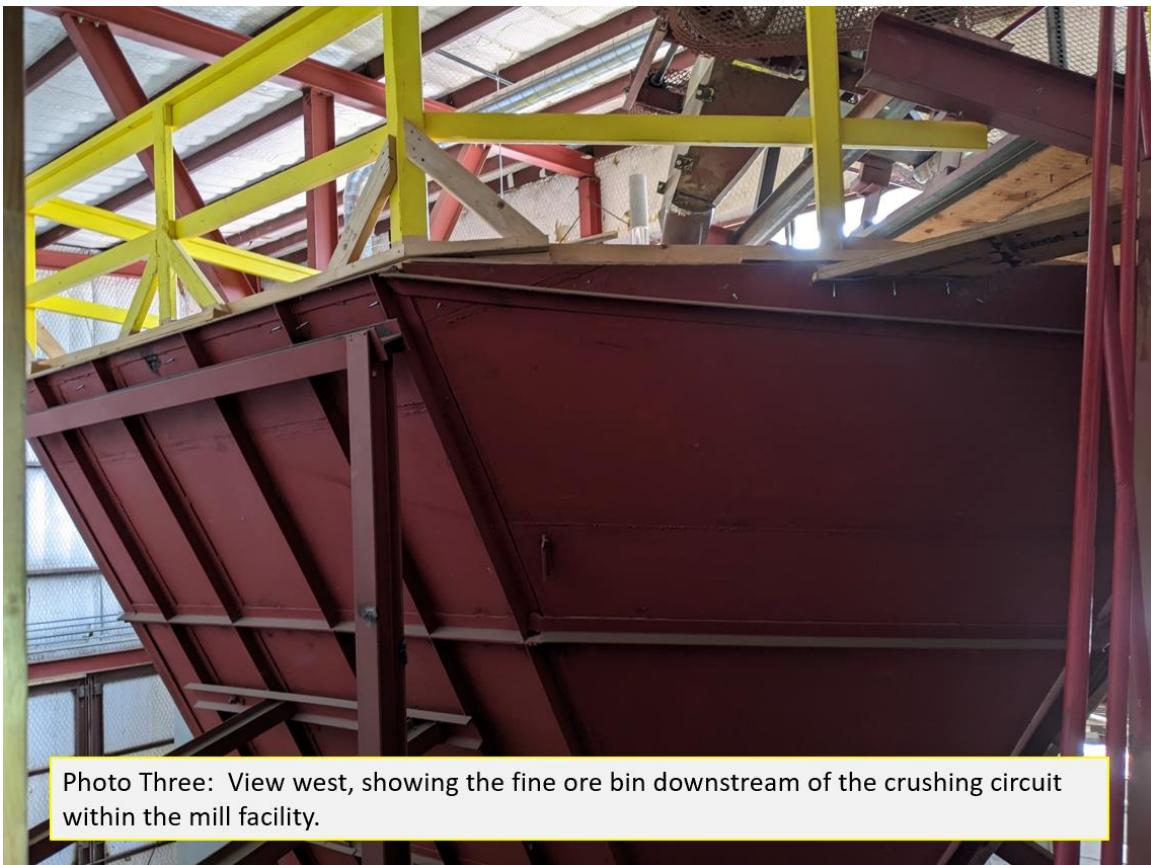
Photo Three: View west, showing the fine ore bin downstream of the crushing circuit within the mill facility.

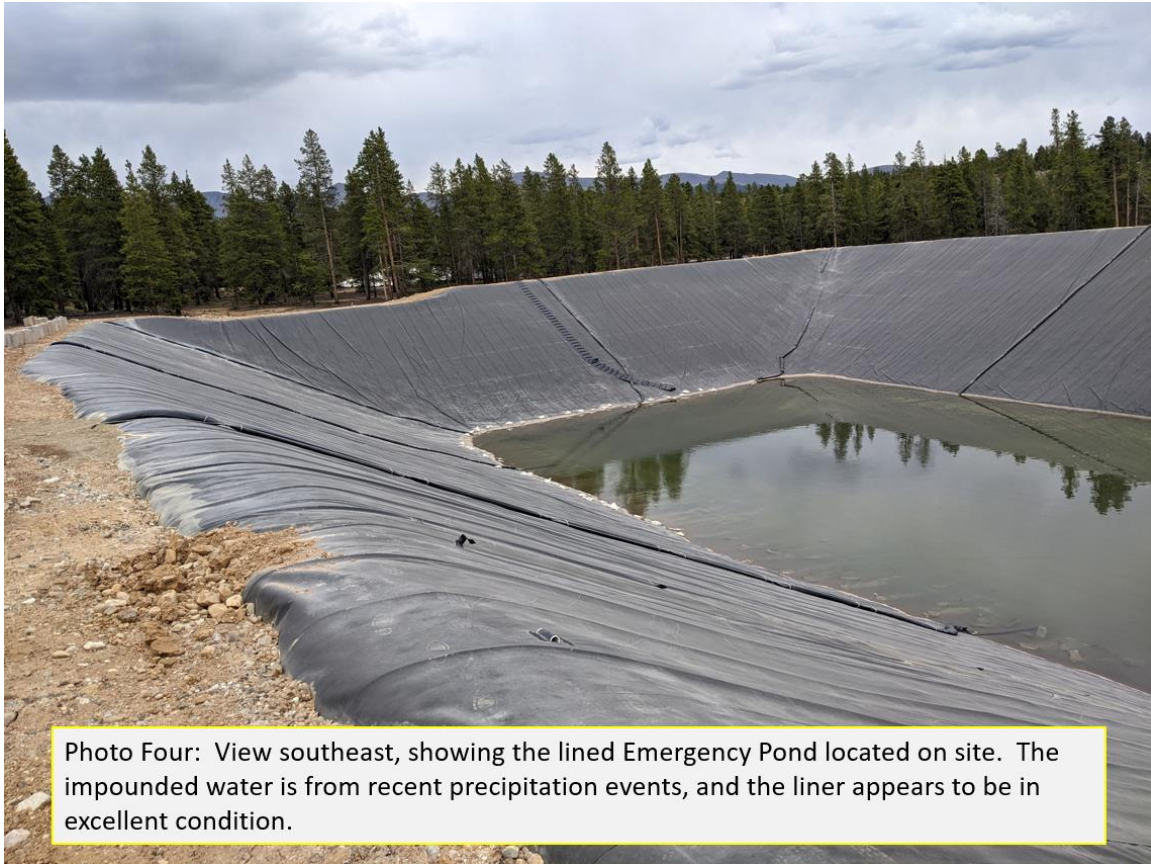
Adjacent to the mill is the large lined emergency containment pond seen in Photos Four and Five. This pond was slated at one point to be a Tailings Storage Facility. The pond is lined with an HDPE liner, and weighted down with ballasts periodically around the pond. The liner appears to be in good condition and no evidence of tears or holes was noted. The pond is considered to be an Environmental Protection Facility (EPF), and the Operator will need to supply the Division with a Certified As Built Package, prepared by a licensed engineer, that details the construction, any Quality Assurance and Quality Control tests that were performed as well as maps and drawings of the pond in order to certify this EPF. This package should be provided to the Division within 60 days of the date of this report, no later than Tuesday October 11, 2022.

Photo Four: View southeast, showing the lined Emergency Pond located on site. The impounded water is from recent precipitation events, and the liner appears to be in excellent condition.

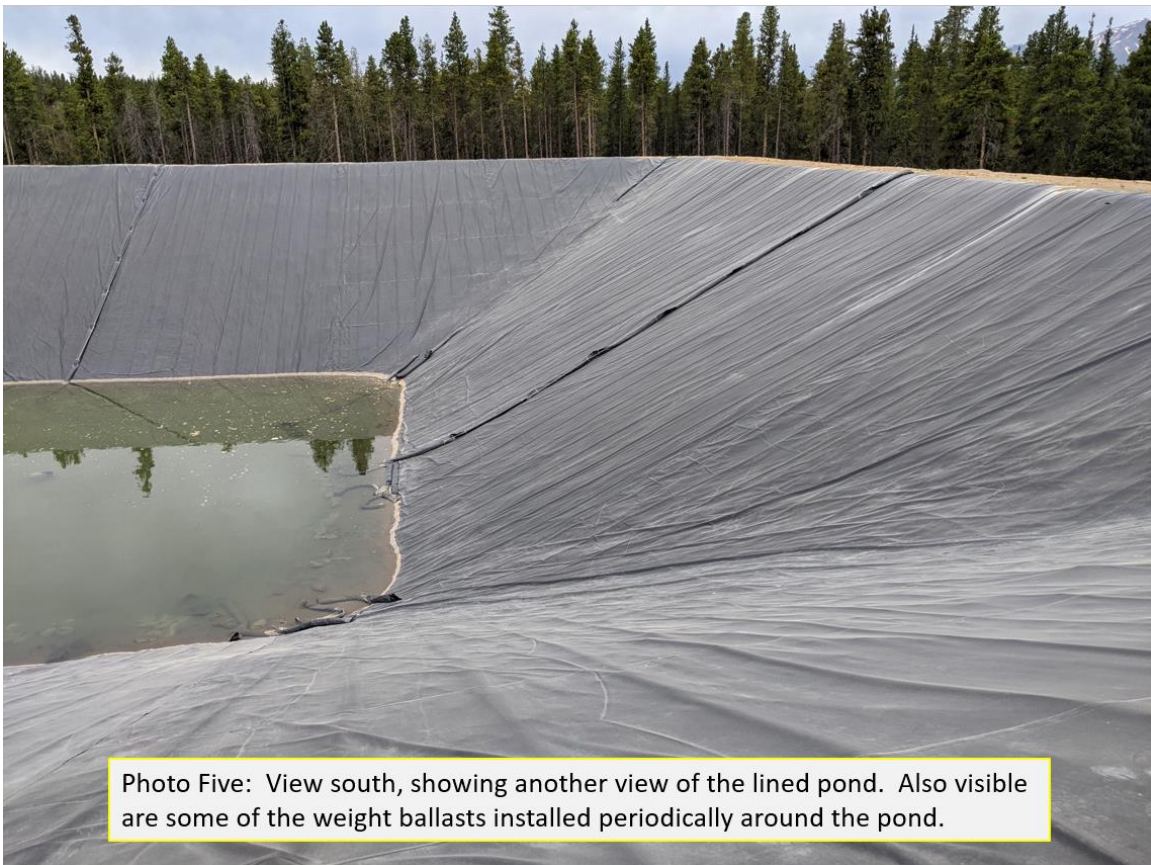
Photo Five: View south, showing another view of the lined pond. Also visible are some of the weight ballasts installed periodically around the pond.

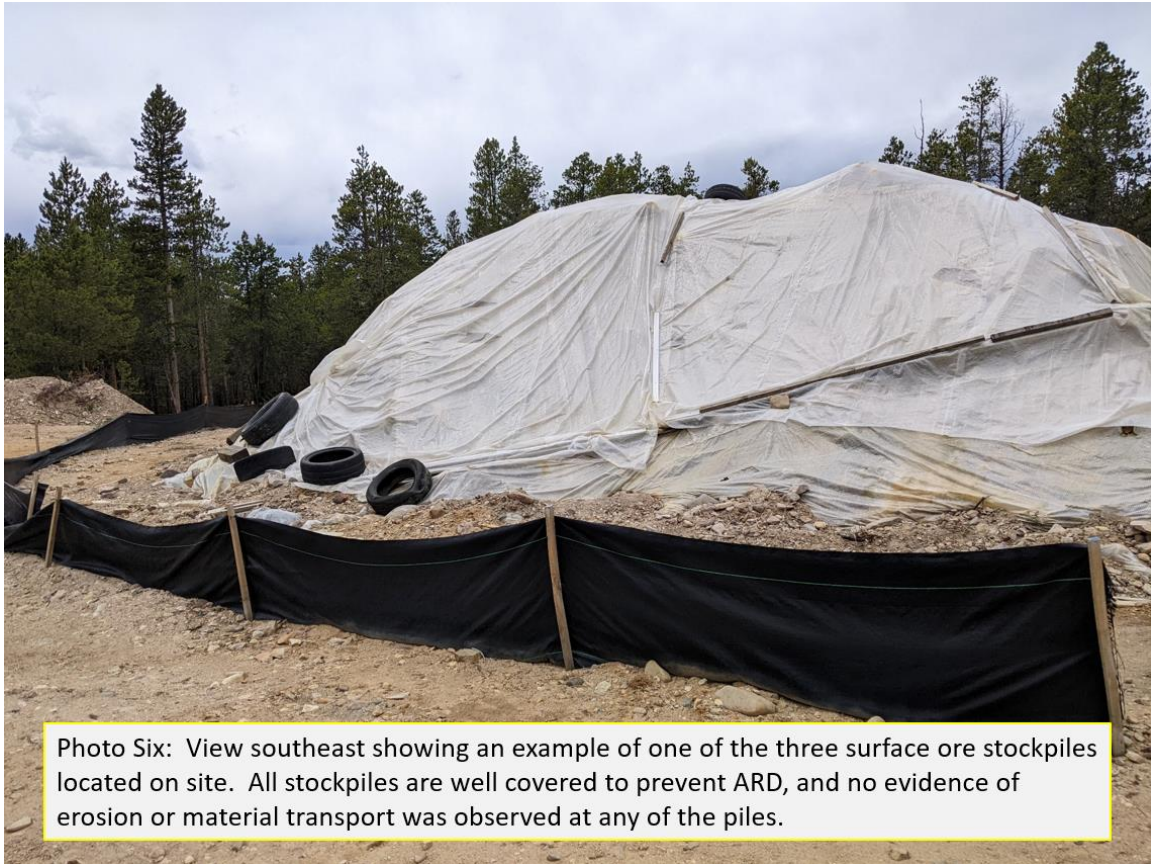
At various locations throughout the site, ore has been stockpiled and covered to prevent Acid Rock Drainage (ARD). All observed piles appeared stable at the time of the inspection, were well covered and no evidence of ARD was noted. An example of one such stockpile can be seen in Photo Six.

Photo Six: View southeast showing an example of one of the three surface ore stockpiles located on site. All stockpiles are well covered to prevent ARD, and no evidence of erosion or material transport was observed at any of the piles.
