MINERALS PROGRAM INSPECTION REPORT
PHONE: (303) 866-3567

MINE NAME: Climax Mine	MINE/PROSPECTING ID#: M-1977-493	MINERAL: Molybdenum	COUNTY: Lake, Summit
INSPECTION TYPE: Monitoring	INSPECTOR(S): Lucas West	INSP. DATE: August 8, 2022	INSP. TIME: 11:00
OPERATOR: Climax Molybdenum Company	OPERATOR REPRESENTATIVE: Meagan Graham, Paul Weber	TYPE OF OPERATION: 112d-3 - Designated Mining Operation	
REASON FOR INSPECTION: High Priority	BOND CALCULATION TYPE: None	BOND AMOUNT: \$91,011,850.00	
DATE OF COMPLAINT: NA	POST INSP. CONTACTS: None	JOINT INSP. AGENCY: None	
WEATHER: Clear	INSPECTOR'S SIGNATURE:

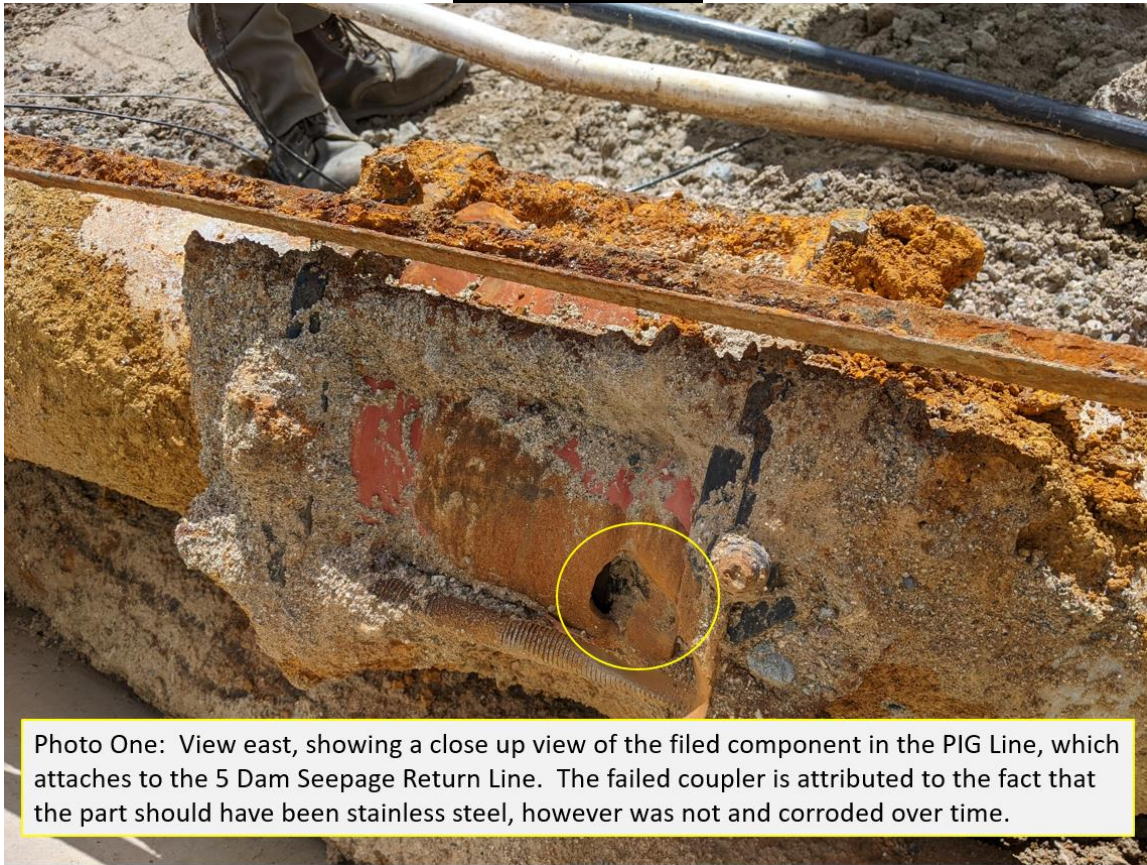
PROBLEM/POSSIBLE VIOLATION: Problem: A failure of infrastructure resulting in loss of containment of untreated waters occurred. Specifically, a coupler failed on an ancillary line to the 5 Dam Tailings seepage return line resulting in an approximately 2,000 gallon spill of untreated waters into Tenmile Creek. The spill was immediately reported to CDPHE and the Division and promptly repaired. Rapid water quality analytics were performed at the time of the spill, and a full sample was taken at the point of compliance sampling location. Immediate results suggest no water quality standards were violated and that no continued impacts are expected. The failure occurred in an area with inadequate Secondary Containment of an Environmental Protection Facility.

In addition to the inspector and Operator Representative listed on page one of this report, Reed Bennetts was present for the inspection. Reed was the responding party to the event and along with his team, completed the necessary repairs. The source of the spill was a coupler on the PIG Line attached to the 5 Dam seepage return line, located adjacent to the 5 Dam Seep Water Pump Station. The PIG line is used to send an apparatus through the Seepage Return line, so it is an ancillary line to the Return Line. The apparent cause of the failure was a corroded coupler that failed as seen in Photo One. Once the failure occurred the seepage water made a surface expression and flowed towards the 5 Dam Clear Water Emergency Decant Pond. The pond can be seen in Photo Two. The pond consists of a spillway with 4 culverts leading into Tenmile Creek. The culverts and discharge point can be seen in Photos Three and Four. As stated previously the spill was caught almost immediately, and was of finite volume. No visual evidence of impairment or environmental damage was observed at the discharge point into Tenmile Creek. Immediately following the spill, the line was isolated and pumps shut down in order to allow the crew to make the necessary repairs by replacing the failed coupler. The repairs were made the day of the event, and the area was backfilled and graded. The repair area can be seen in Photo Five. At the time of the event field pH was taken of the spilled waters. The pH was 7.7. Also, a rapid sample was analyzed by the Operator's laboratory at the Property Discharge Water Treatment Plant, specifically for manganese, the primary constituent of concern. The result from that test was 0.3 mg/l, which is below the applicable water quality standard. A full sample was taken at the Point of Compliance Surface Water Sampling Location and the results from that analysis are pending.

Photo One: View east, showing a close up view of the failed component in the PIG Line, which attaches to the 5 Dam Seepage Return Line. The failed coupler is attributed to the fact that the part should have been stainless steel, however was not and corroded over time.

CORRECTIVE ACTIONS: The Operator shall, within 60 days of the date of this report, submit a written evaluation of the failure, steps being taken to mitigate potential future failures in the area and the full water quality results from the sample taken at the time of the event. The submittal should also include an evaluation of the secondary containment devices in the area of the failure. If new additions or updates to the secondary containment features are required, the Operator shall address those changes through a permit revision. The evaluation and determination of need for a permit revision shall be submitted to the Division no later than Tuesday October 11, 2022.

Though immediate action was taken and the problem has been mitigated, the event has been cited as a Problem as it resulted in loss of containment of untreated waters. The Operator shall, within 60 days of the date of this report, submit a written evaluation of the failure, steps being taken to mitigate potential future failures in the area and the full water quality results from the sample taken at the time of the event. The submittal should also include an evaluation of the secondary containment devices in the area of the failure. If new additions or updates to the secondary containment features are required, the Operator shall address those changes through a permit revision. The evaluation and determination of need for a permit revision shall be submitted to the Division no later than Tuesday October 11, 2022.

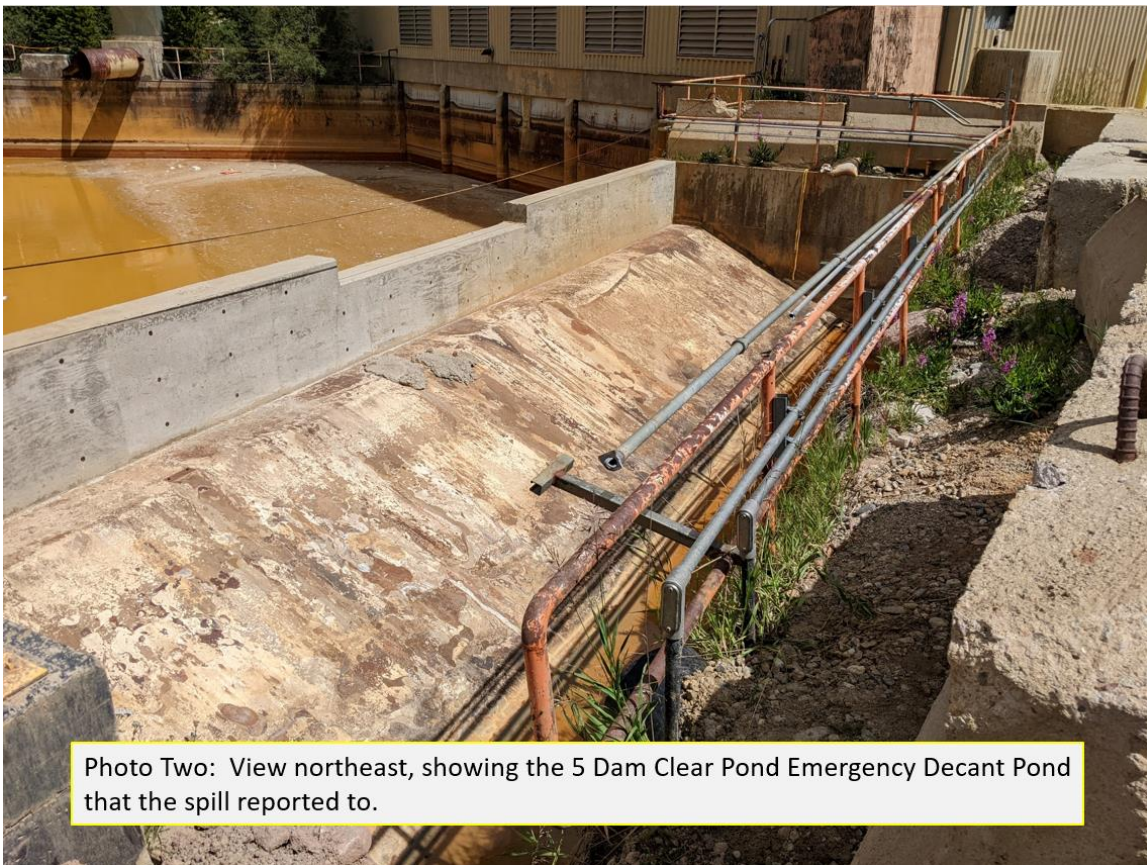
Photo Two: View northeast, showing the 5 Dam Clear Pond Emergency Decant Pond that the spill reported to.

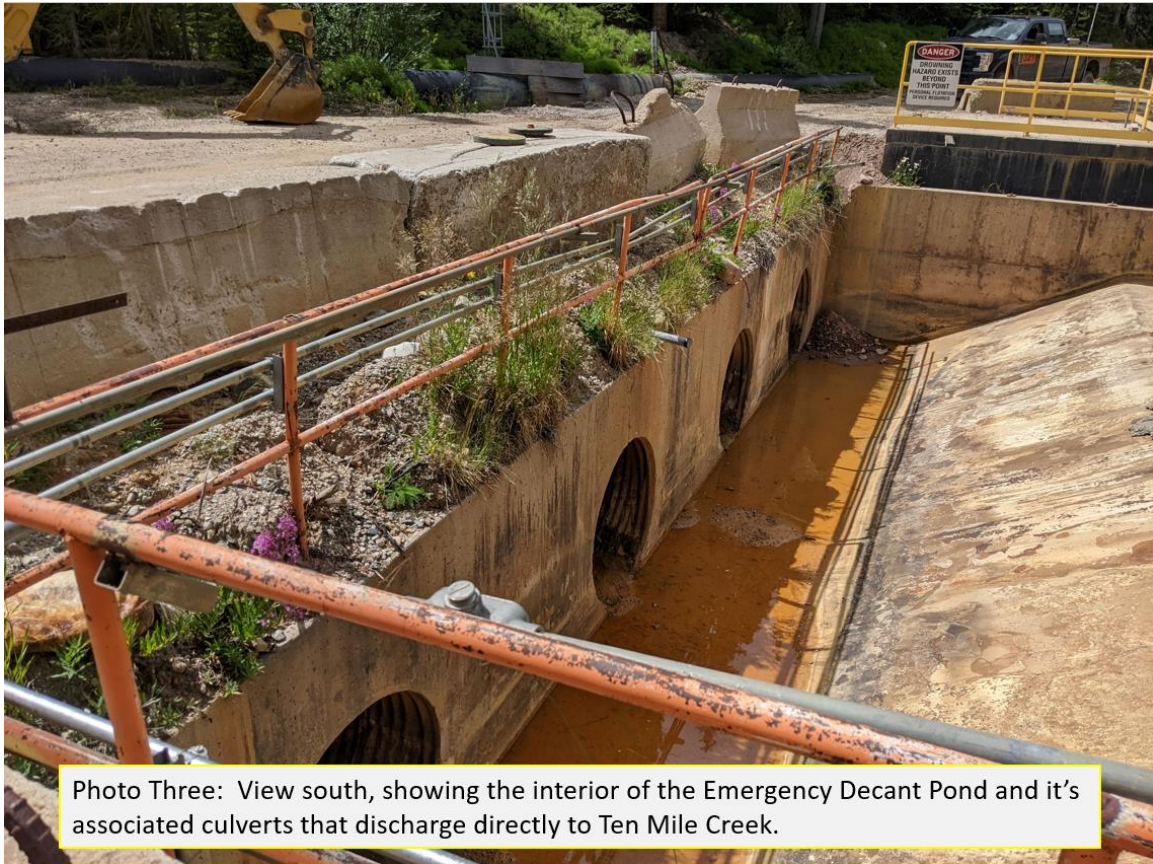
Photo Three: View south, showing the interior of the Emergency Decant Pond and it's associated culverts that discharge directly to Ten Mile Creek.

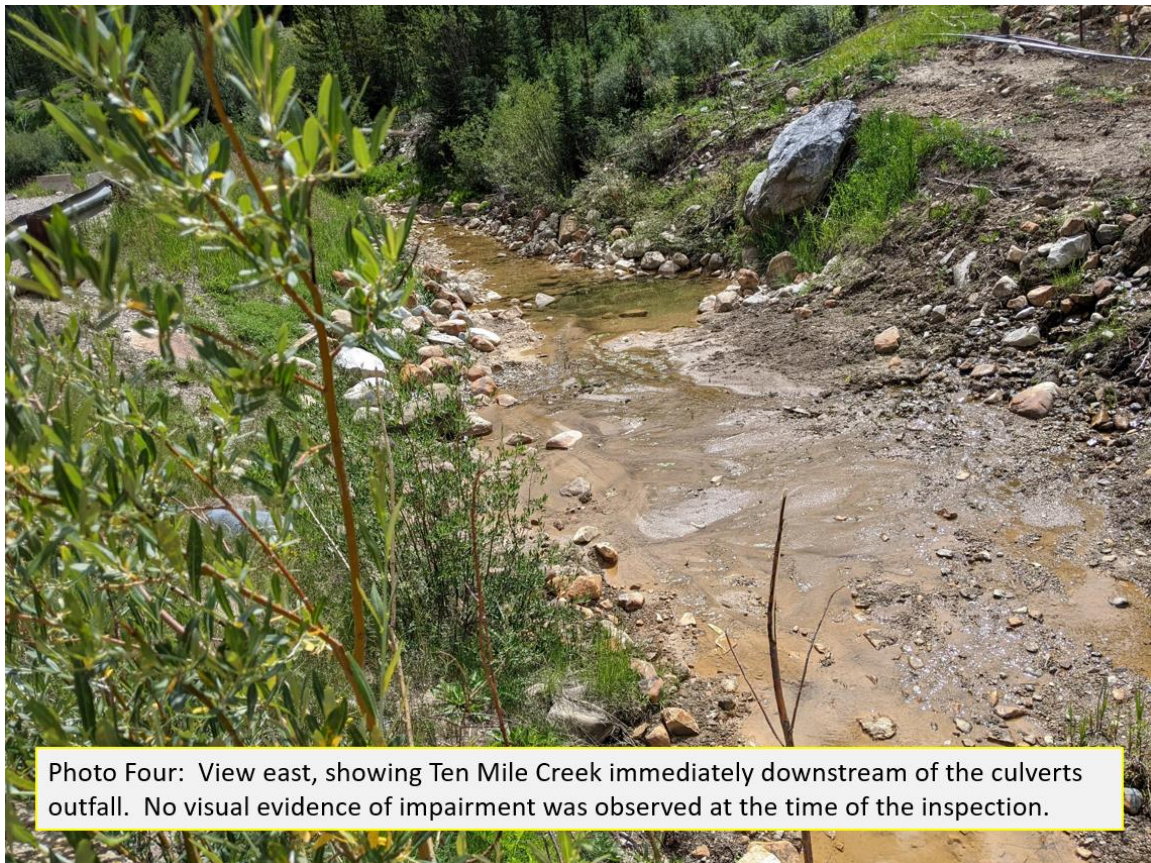
Photo Four: View east, showing Ten Mile Creek immediately downstream of the culverts outfall. No visual evidence of impairment was observed at the time of the inspection.

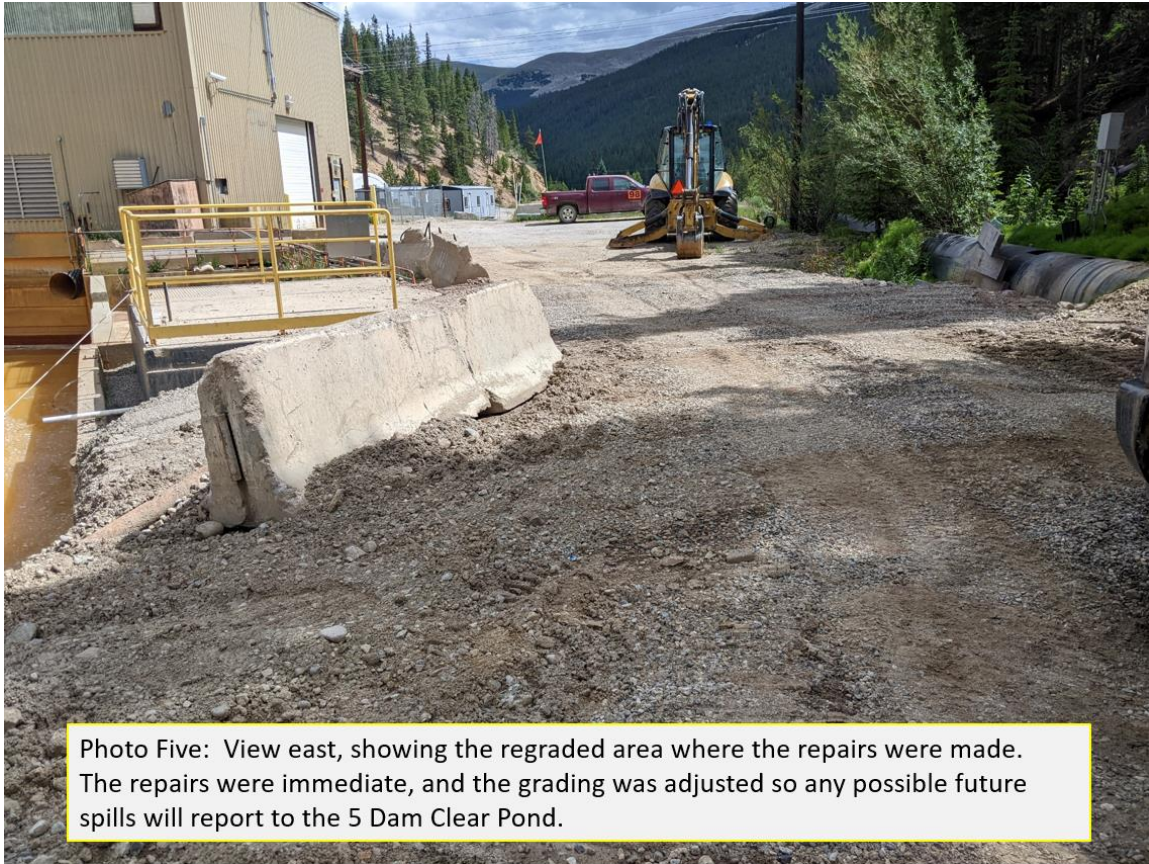
Photo Five: View east, showing the regraded area where the repairs were made. The repairs were immediate, and the grading was adjusted so any possible future spills will report to the 5 Dam Clear Pond.
