## Daniels Monthly Report

August 11, 2022  
Project No.: 19125

Regarding: Daniels Sand Pit 2, Permit No. M-1973-007-SG  
Slope Stability Monthly Monitoring Report

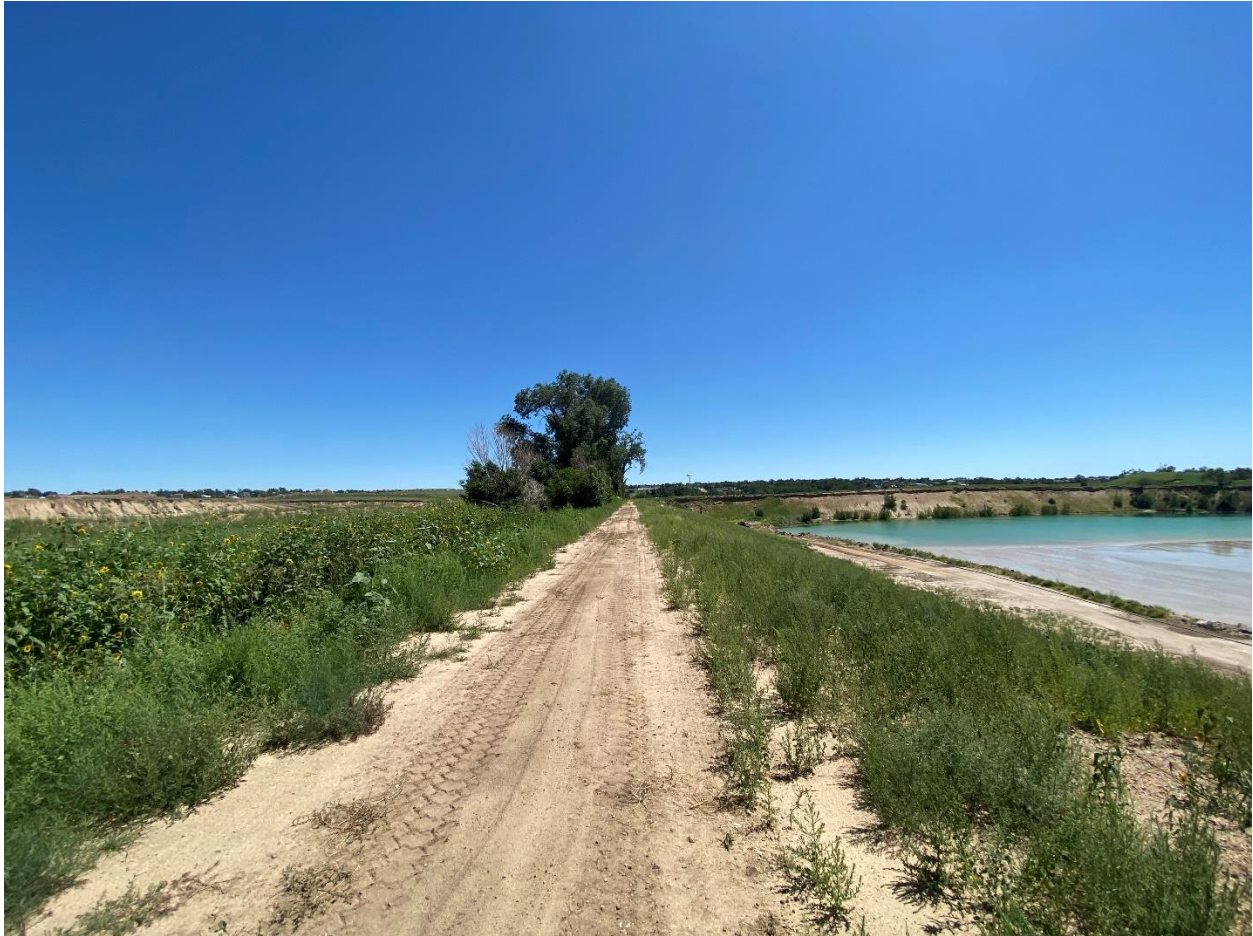
Photo 1. Fountain Mutual Ditch looking east

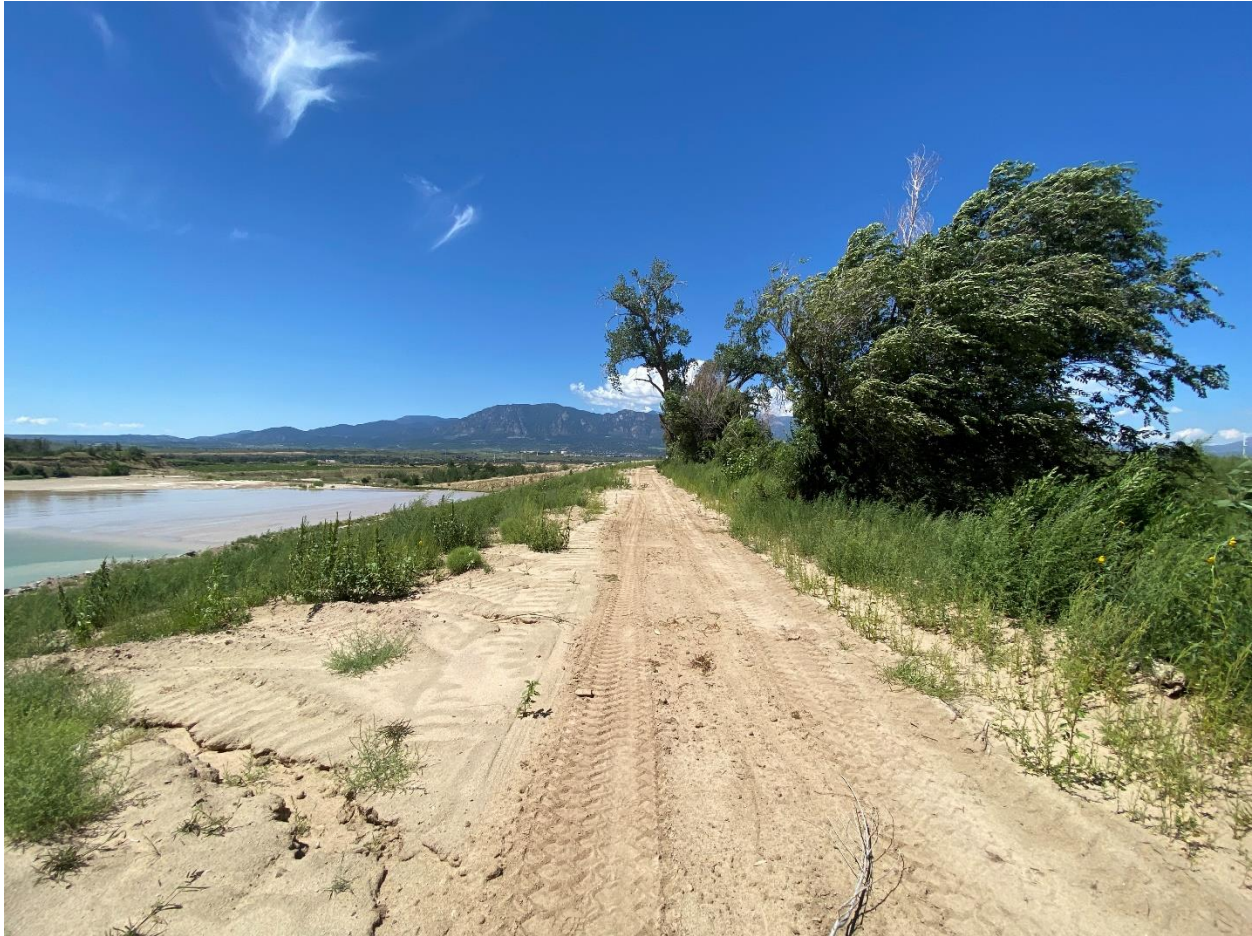
Photo 2. Fountain Mutual Ditch looking west

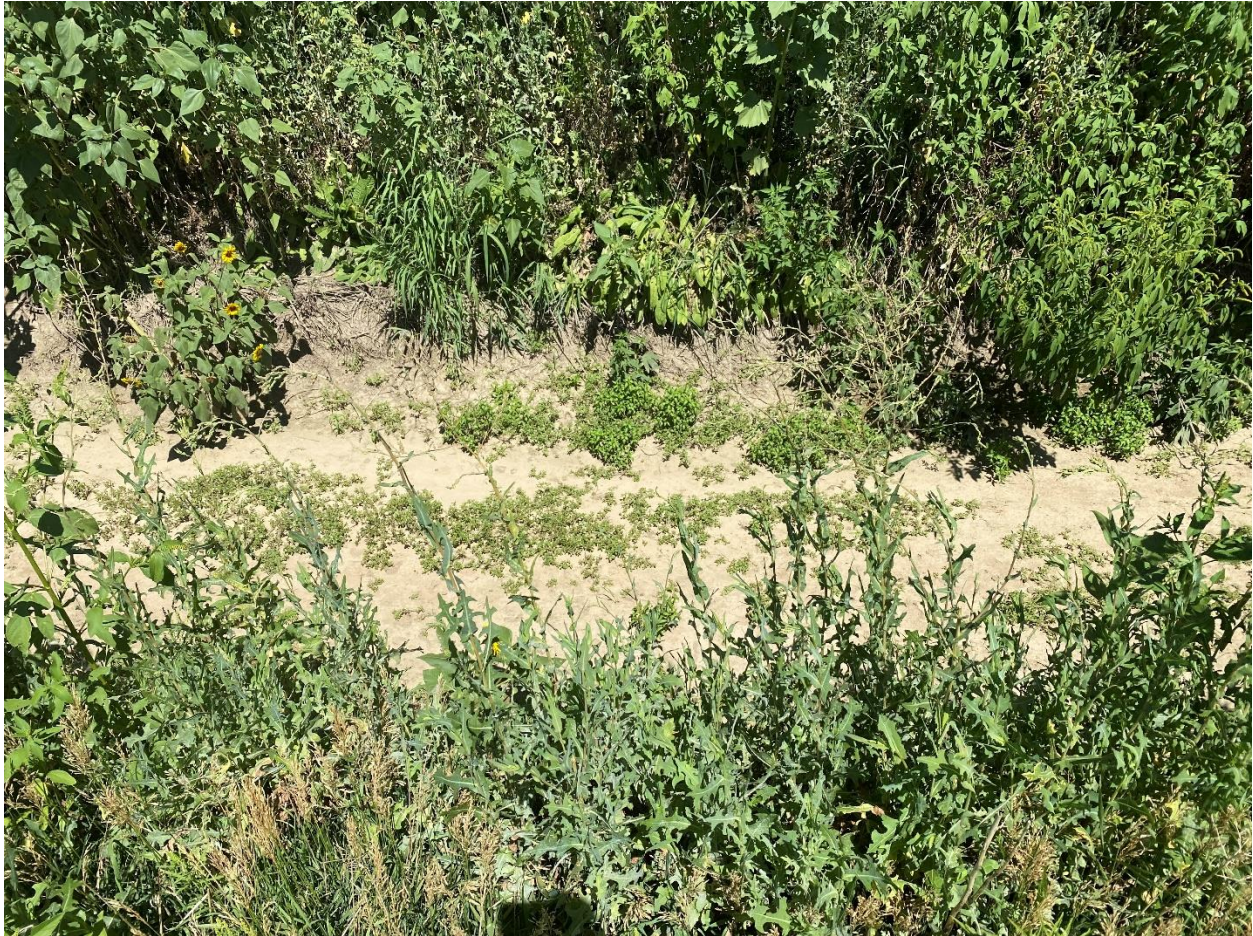
Photo 3. Fountain Mutual Ditch invert looking north (note vegetation)

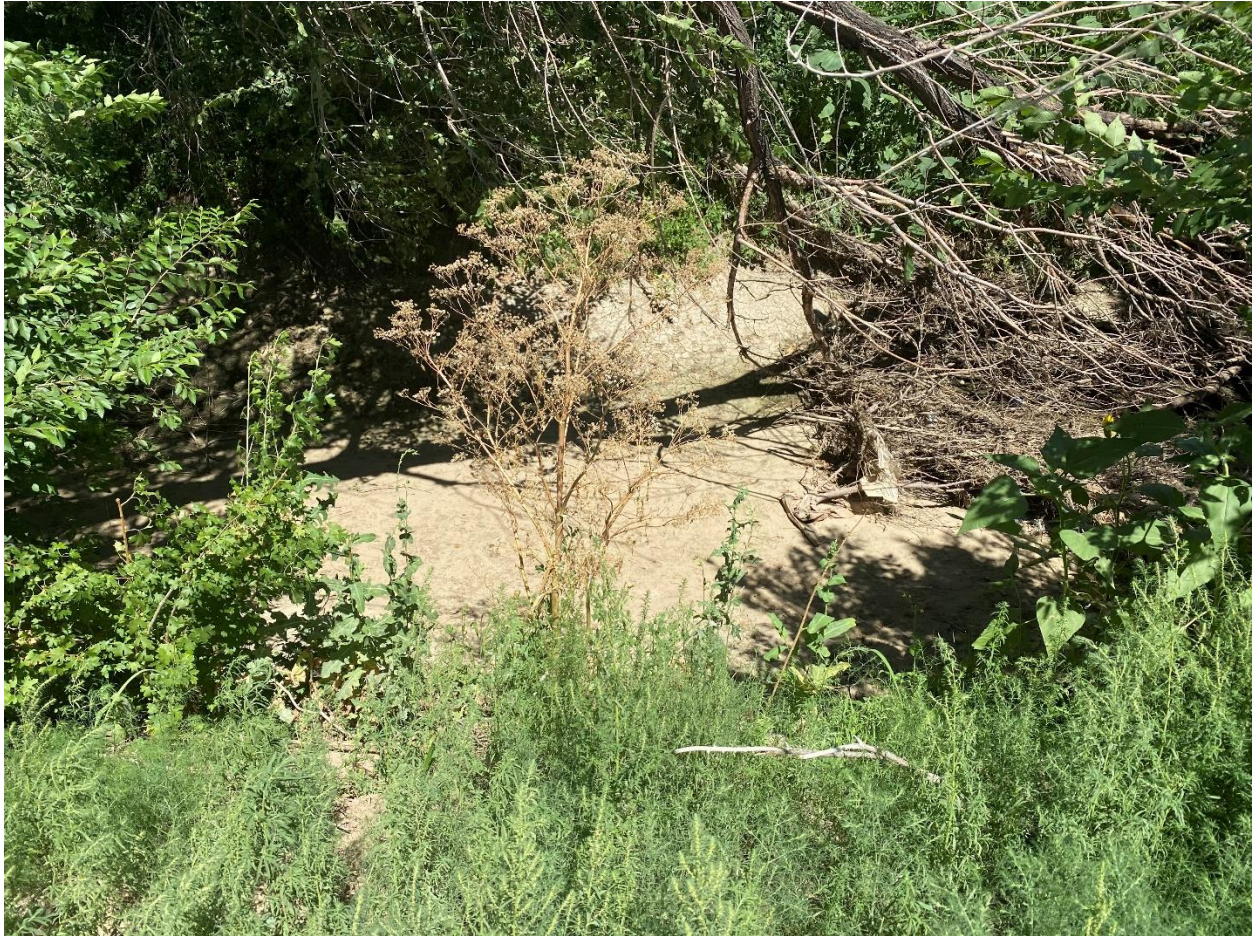
Photo 4. Fountain Mutual Ditch invert with branches

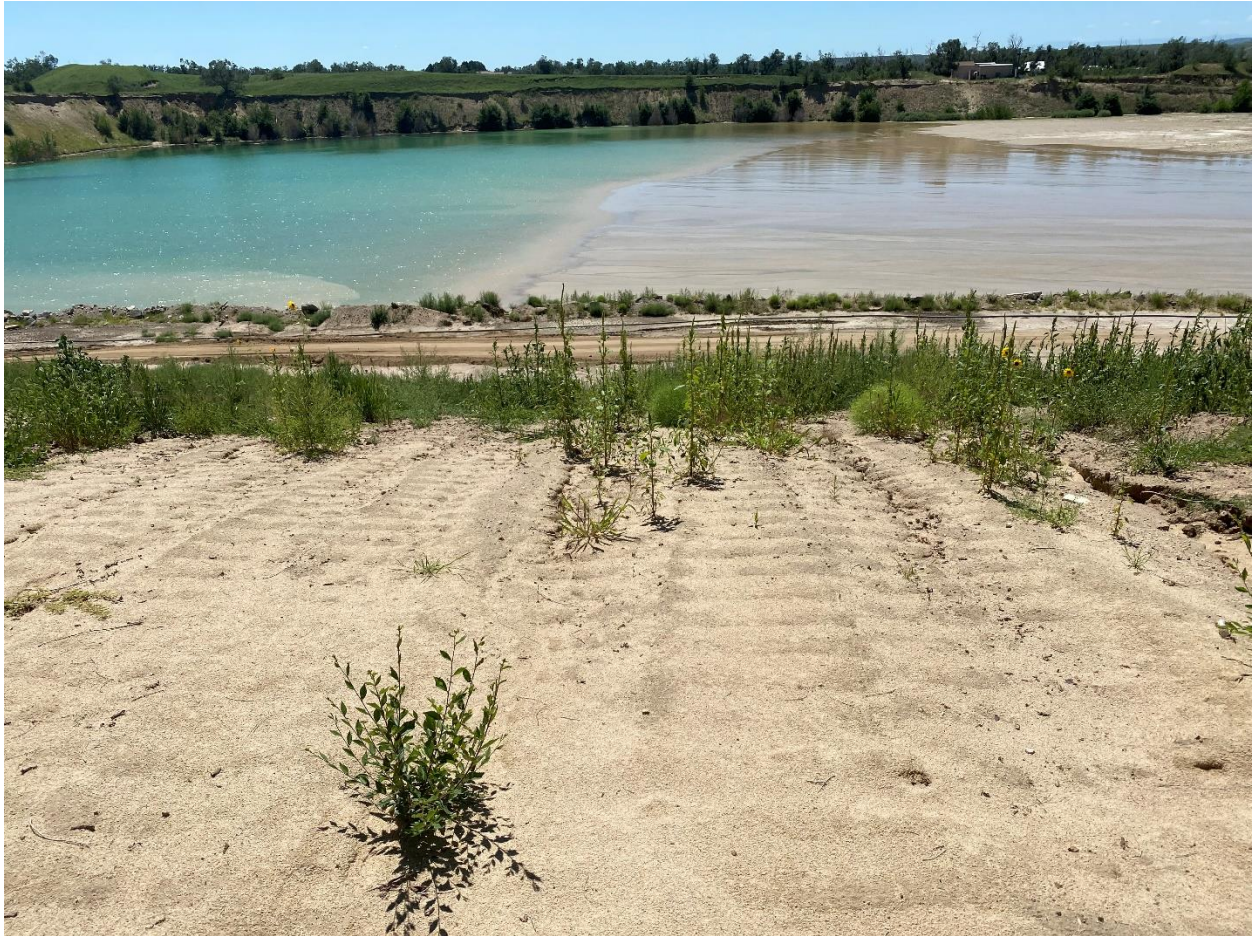
Photo 5. Buttress slope looking south

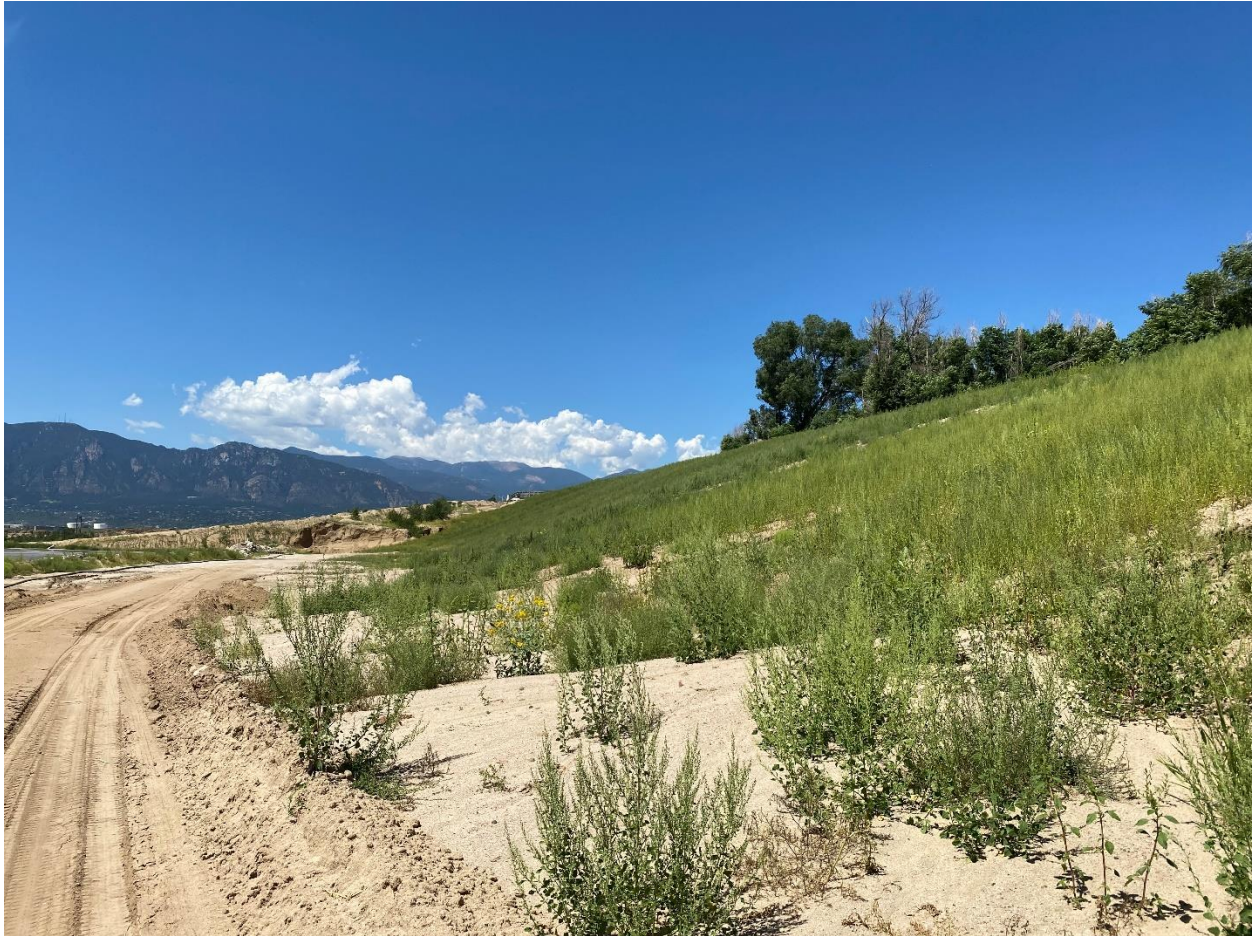
Photo 6. Buttress slope looking west from toe

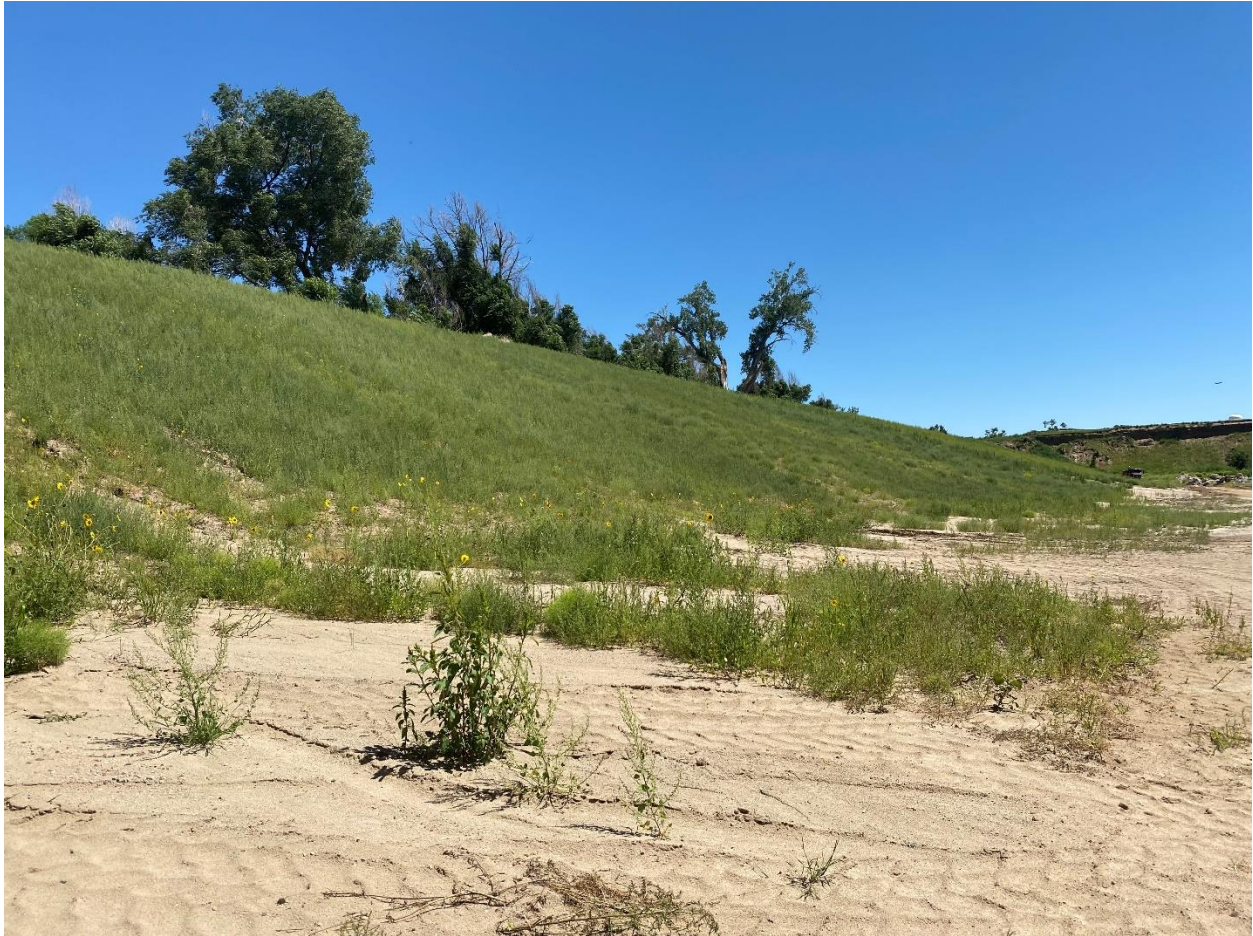
Photo 7. Buttress slope looking east from toe

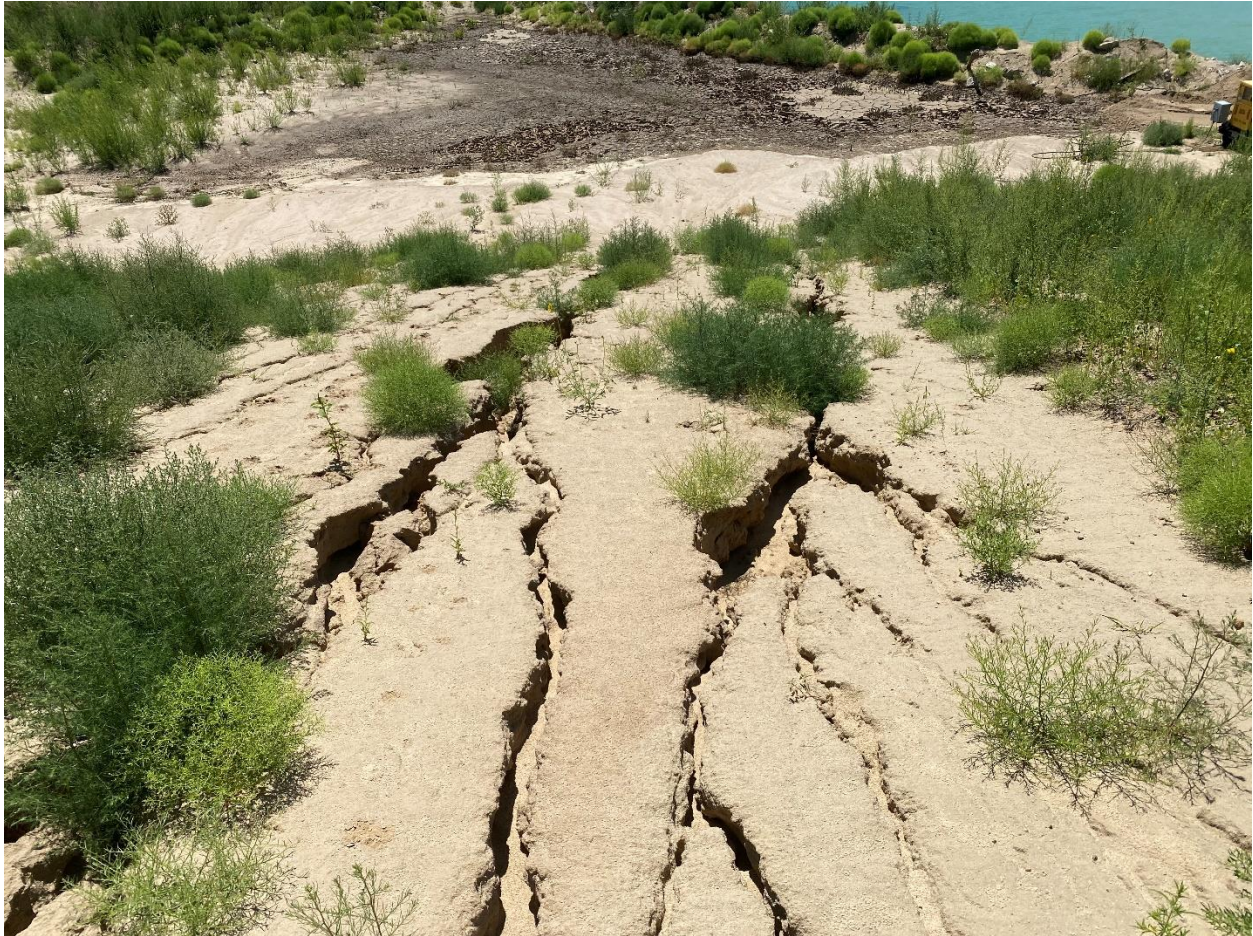
Photo 8. Butress slope looking south, evidence of surface water drainage

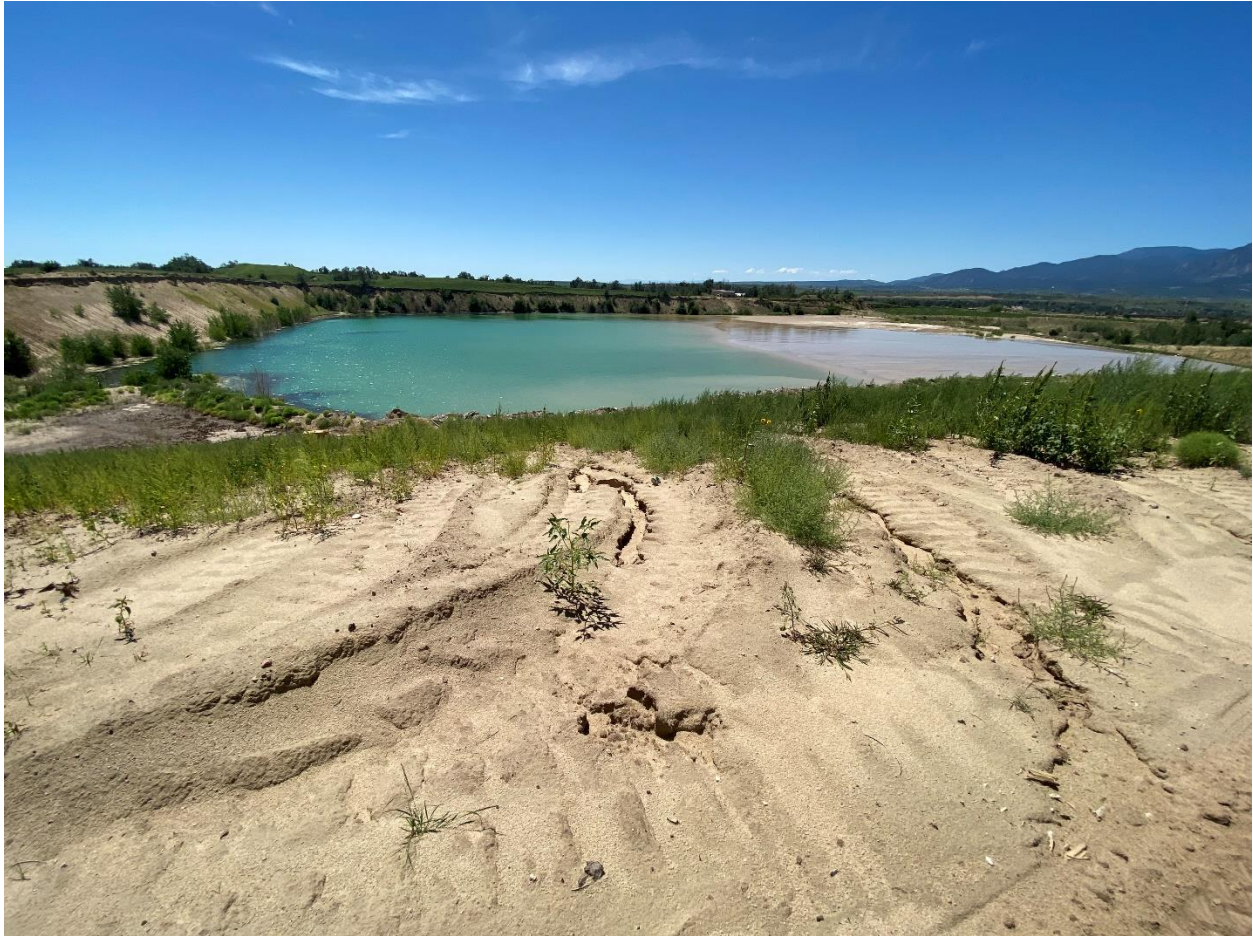
- Construction sequence
  - The buttress slope varies from 3H:1V to 4H:1V
  - The final lift needs to be regraded for some portions on the eastern side of the buttress
  - Vegetation (mainly weeds) are growing on buttress
  - Several locations visible evidence of surface water runoff

Photo 9. Buttress slope looking south, area needs regrading

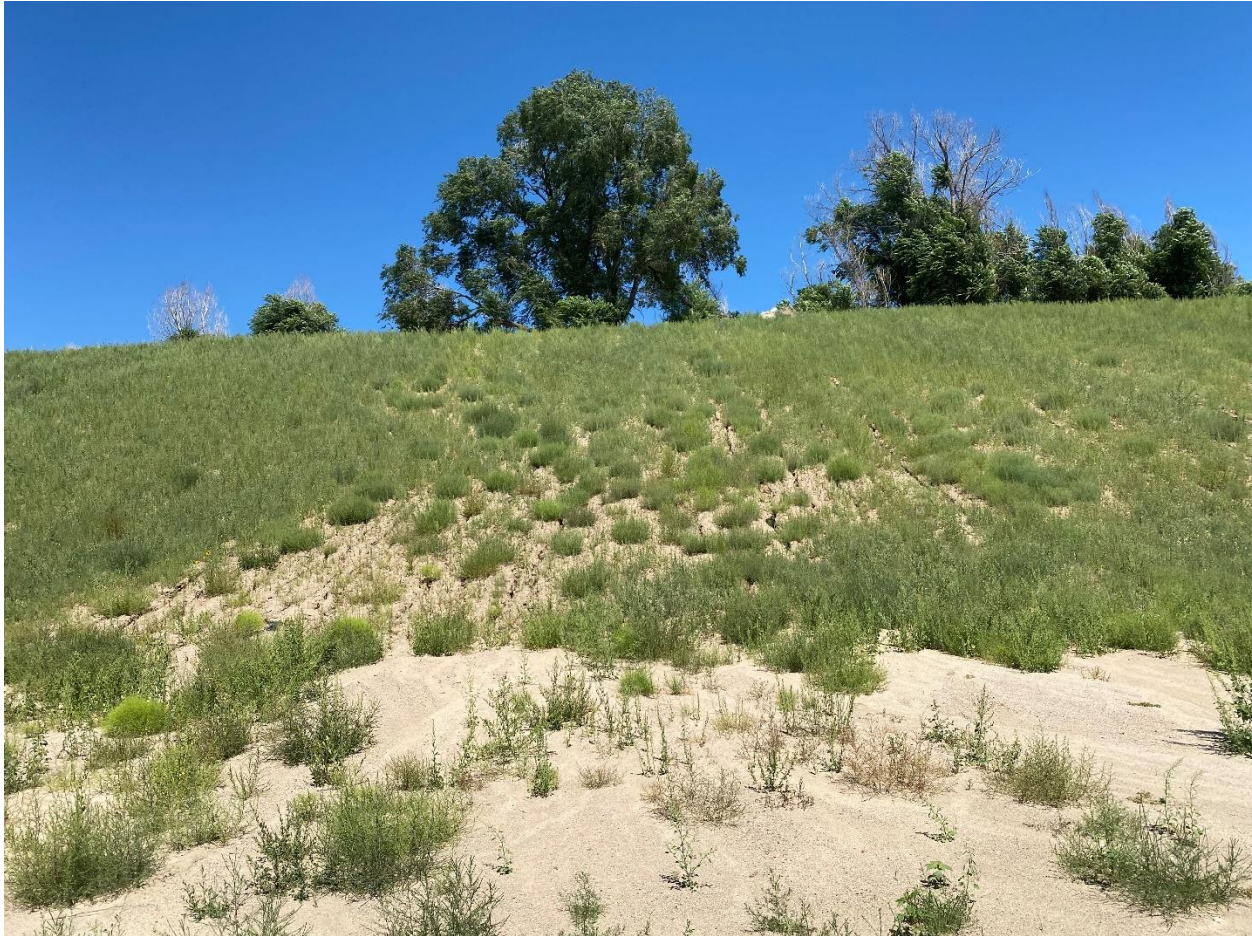
Photo 10. Buttress slope looking north, weeds growing
