COLORADO DIVISION OF RECLAMATION, MINING AND SAFETY
MINERALS PROGRAM INSPECTION REPORT
PHONE: (303) 866-3567

MINE NAME: High Flume Gravel Pit	MINE/PROSPECTING ID#: M-1990-093	MINERAL: Gravel	COUNTY: La Plata
INSPECTION TYPE: Monitoring	INSPECTOR(S): Lucas J. West	INSP. DATE: April 8, 2016	INSP. TIME: 08:00
OPERATOR: High Flume Gravel Pit, Inc.	OPERATOR REPRESENTATIVE: Matt Carnahan, MattTrenkle	TYPE OF OPERATION: 112c - Construction Regular Operation	
REASON FOR INSPECTION: Normal I&E Program	BOND CALCULATION TYPE: None	BOND AMOUNT: \$72,645.00	
DATE OF COMPLAINT: NA	POST INSP. CONTACTS: None	JOINT INSP. AGENCY: None	
WEATHER: Clear	INSPECTOR'S SIGNATURE:

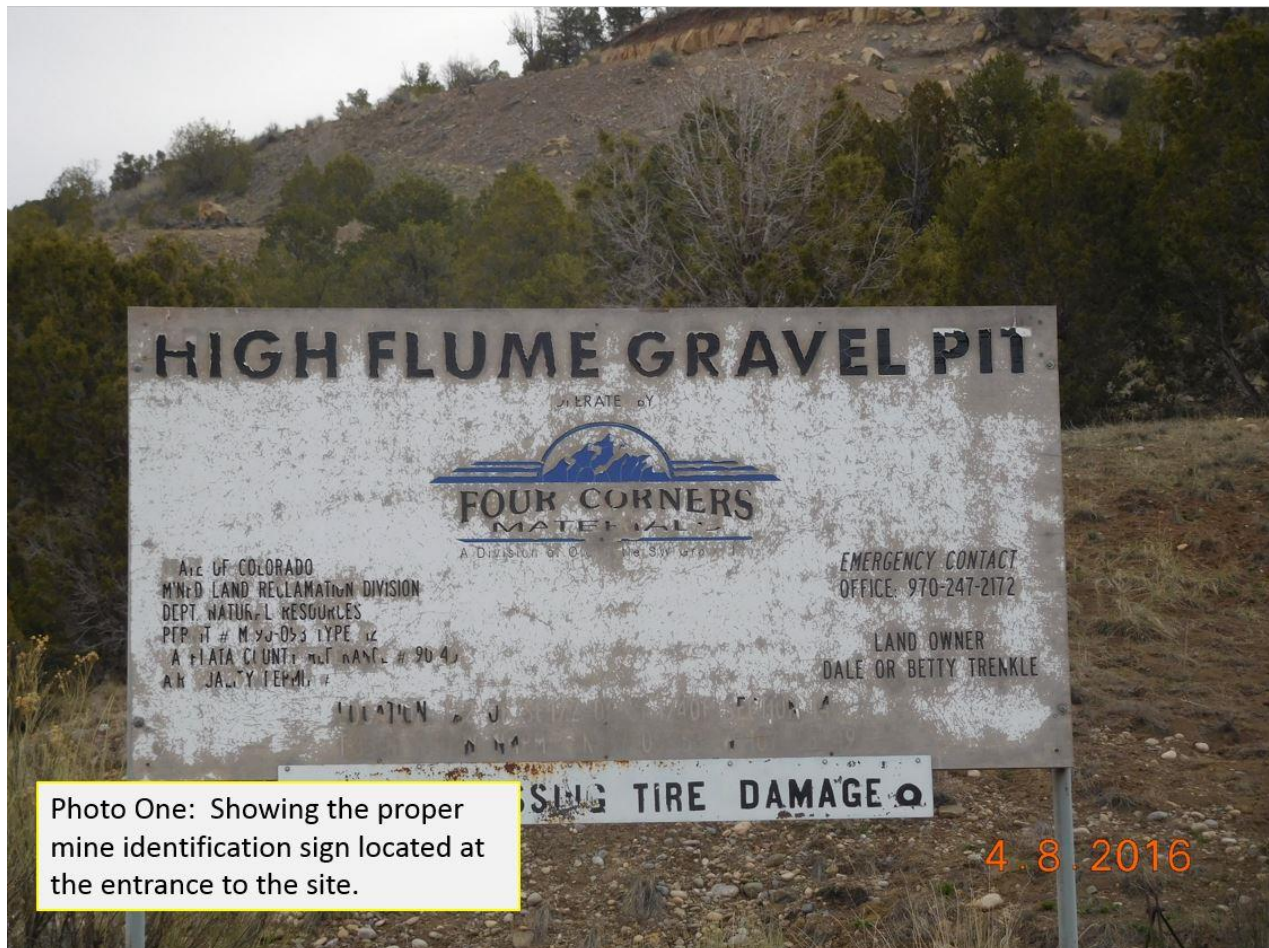
Proper mine identification signage was posted at the entrance to the site shown in Photo One and the permit boundary was clearly identified. The site was not active during the time of the inspection, as no mining has taken place recently. The scale and scale house were noted to be in good repair, a previous Technical Revision was executed to allow both structures and the access road up to the main pit area to remain onsite upon completion of reclamation. When mining activities were being conducted, materials from the main pit area would be transported to the bottom of the hill for removal by the use of a large steel tube. Photo Two shows the tube, which has been cut into sections and staged for removal near the scale house.

Photo One: Showing the proper mine identification sign located at the entrance to the site.

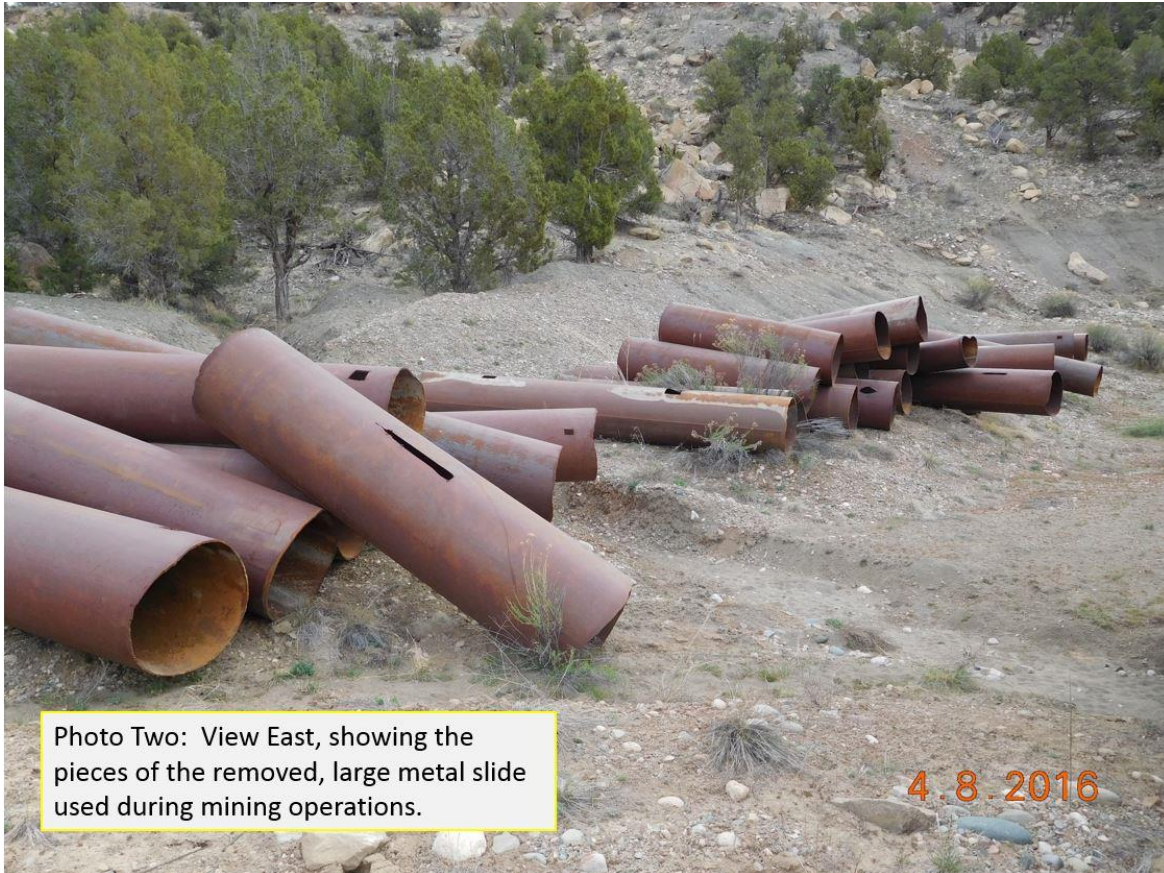
Photo Two: View East, showing the pieces of the removed, large metal slide used during mining operations.

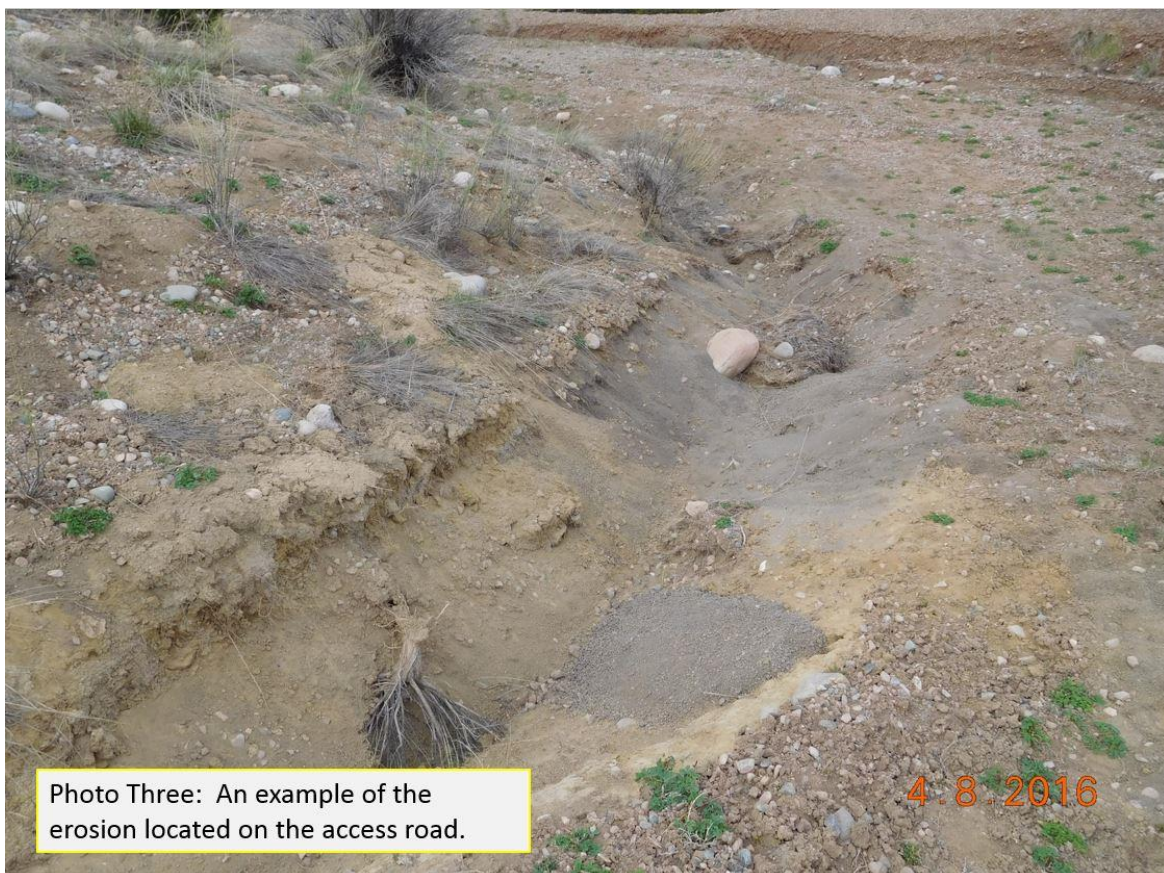
The access road leading up to the pit area is approximately .7 miles and has suffered significant erosion. Photo Three shows an example of the erosion located on the road. Also scattered along the upper portion of the access road, was miscellaneous mining equipment including a front end loader, conveyor, shaker and small dozer. Photo Four shows some of the equipment on site. The equipment is in disrepair and the Landowner explained that all the equipment on site has been sold to a scrap dealer, and is being removed. Evidence of the removal was observed, remnants of an unidentified piece of equipment were located on site, shown in Photo Five. During the removal of this piece of equipment, a large quantity of hydraulic fluid was spilled and affected the soils around it. The quantity of the fluid was unknown, and neither the Operator nor Landowner was aware of the spill. On site discussions with the Operator indicated the use of an in-situ cleaning product. The Operator shall remediate the spill and submit a final report to the Division containing at least the following the information:

Photo Three: An example of the erosion located on the access road.

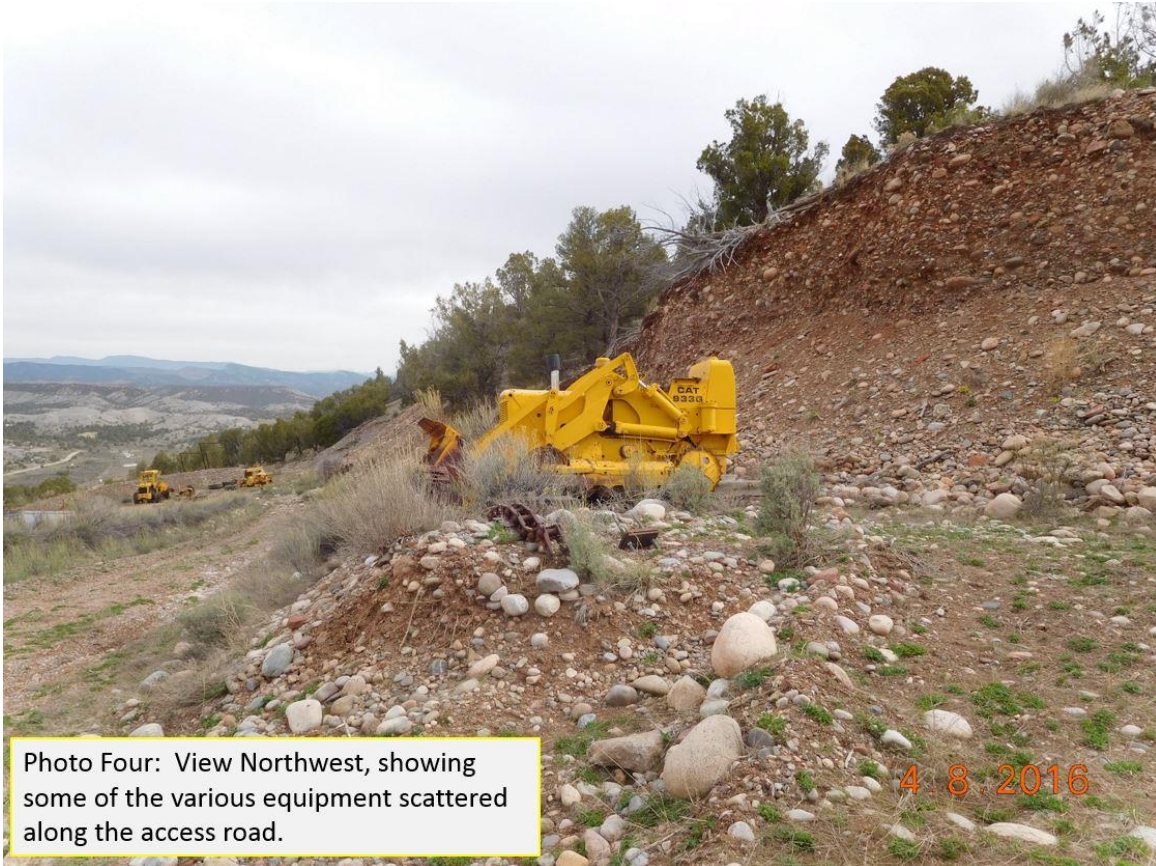
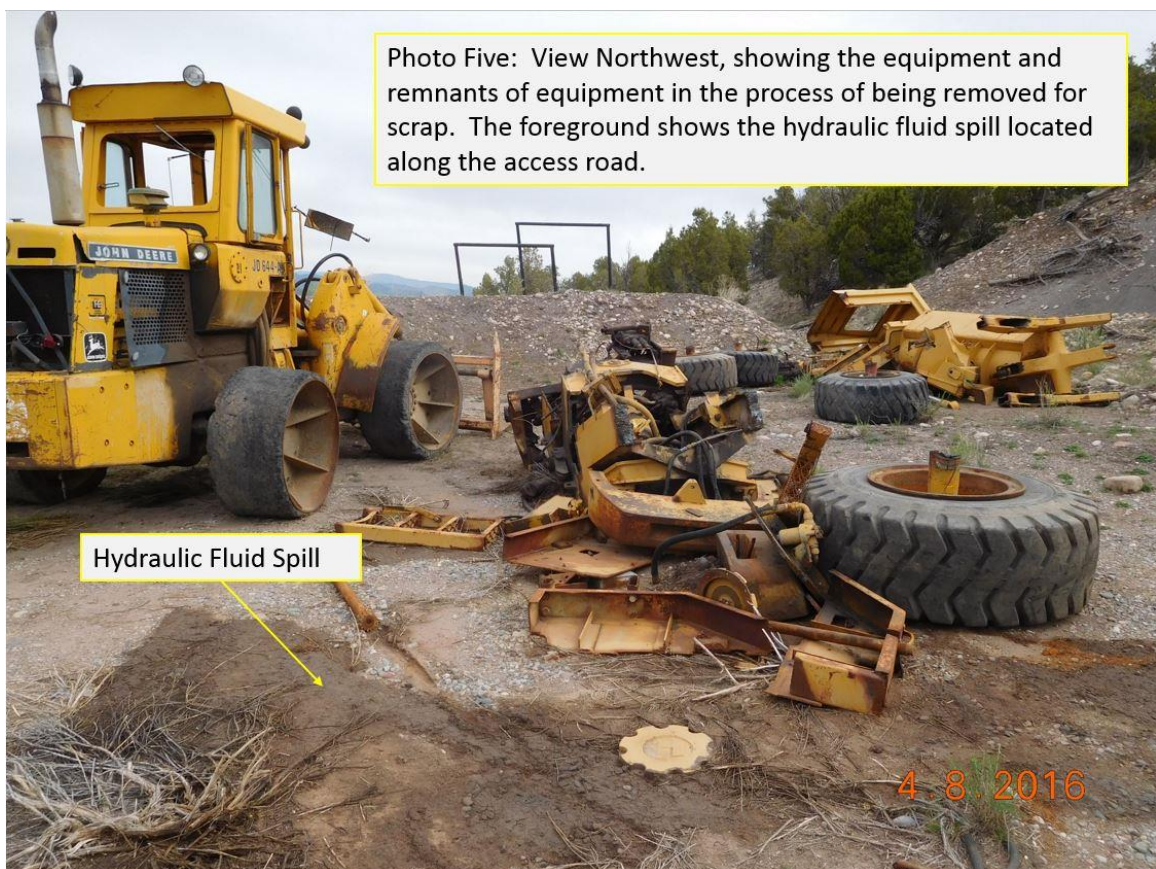
PROBLEM/POSSIBLE VIOLATION: Problem: A hydraulic fluid spill has occurred at the site which has impacted soils, surface water or groundwater.

- 1.) A description of how the spill was cleaned up containing at a minimum the appropriate maps showing the location of the spill, approximate volumes of the area remediated and photo documentation of the cleanup.
- 2.) A written narrative describing the steps taken to properly remediate the soils.

The Operator shall complete remediation and submit the required information to the Division's Denver office within 60 days. **All information outlined above must be received by the Division no later than June 21, 2016.**

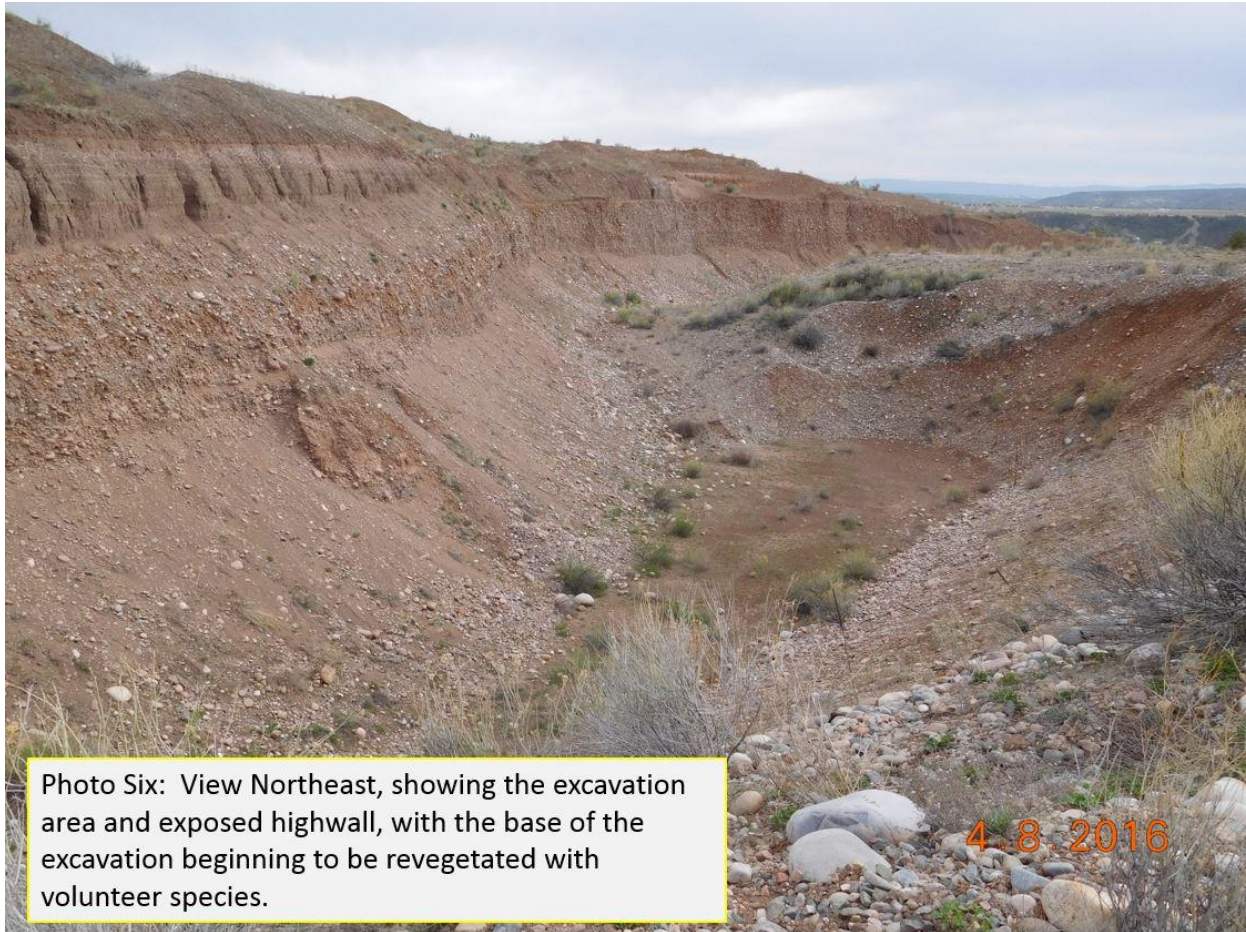
The main pit area sits on top of the mesa, with a large excavated area and an exposed highwall. Photo Six shows the excavation area. Despite its size, the excavated area and the highwall both appear to be stable and no significant erosion was noted. The main work area, and base of the excavation area is vegetated with volunteer species. No stockpiles of materials were observed on site, but a large quantity of overburden and topsoil was stockpiled. The stockpiles appear to be stable and show no signs of erosion. No noxious weeds were noted throughout the site during this inspection.
