**MINERALS PROGRAM INSPECTION REPORT**  
**PHONE: (303) 866-3567**

<b>MINE NAME:</b> Pickering Family Pit	<b>MINE/PROSPECTING ID#:</b> M-2009-086	<b>MINERAL:</b> Gravel and sand	<b>COUNTY:</b> Grand
<b>INSPECTION TYPE:</b> Pre-Operation Inspection	<b>INSPECTOR(S):</b> Peter Hays	<b>INSP. DATE:</b> July 22, 2022	<b>INSP. TIME:</b> 14:00
<b>OPERATOR:</b> Flintstone Gravel Pit Inc.	<b>OPERATOR REPRESENTATIVE:</b> Nick Waldow	<b>TYPE OF OPERATION:</b> 112c - Construction Regular Operation	
<b>REASON FOR INSPECTION:</b> Normal I&E Program	<b>BOND CALCULATION TYPE:</b> Complete Bond	<b>BOND AMOUNT:</b> \$96,100.00	
<b>DATE OF COMPLAINT:</b> NA	<b>POST INSP. CONTACTS:</b> None	<b>JOINT INSP. AGENCY:</b> None	
<b>WEATHER:</b> Clear	<b>INSPECTOR'S SIGNATURE:</b>

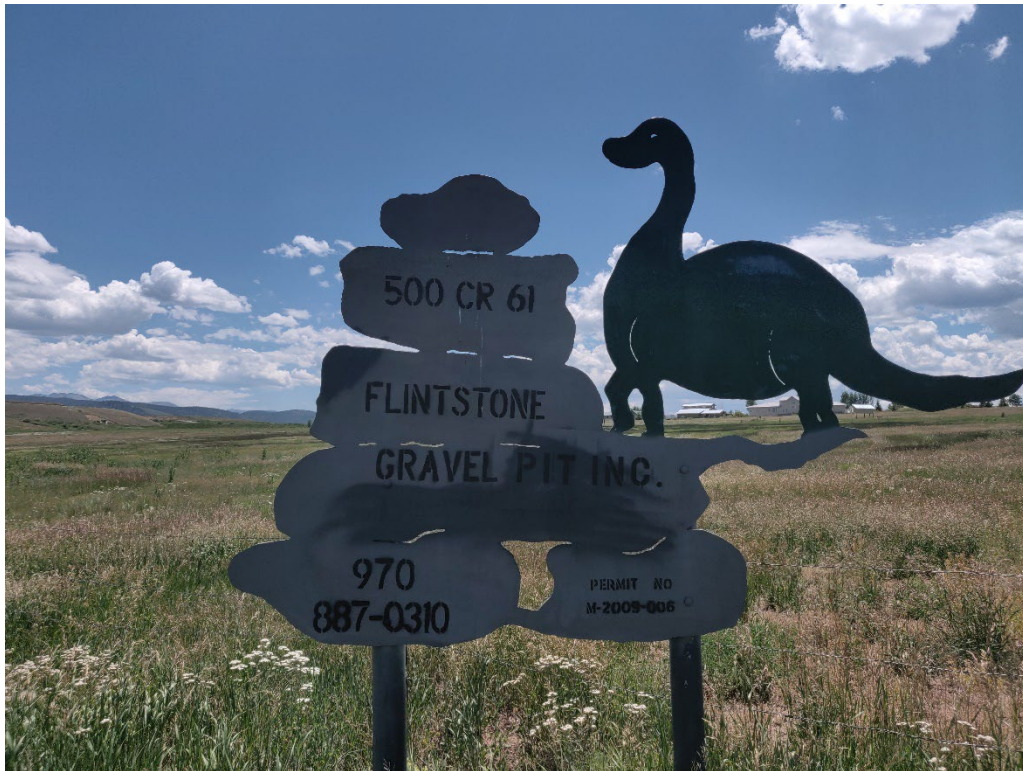
The mine sign and boundary markers for the permitted and proposed amendment boundaries were observed as required by Rule 3.1.12.

Pickering Family Pit mine sign

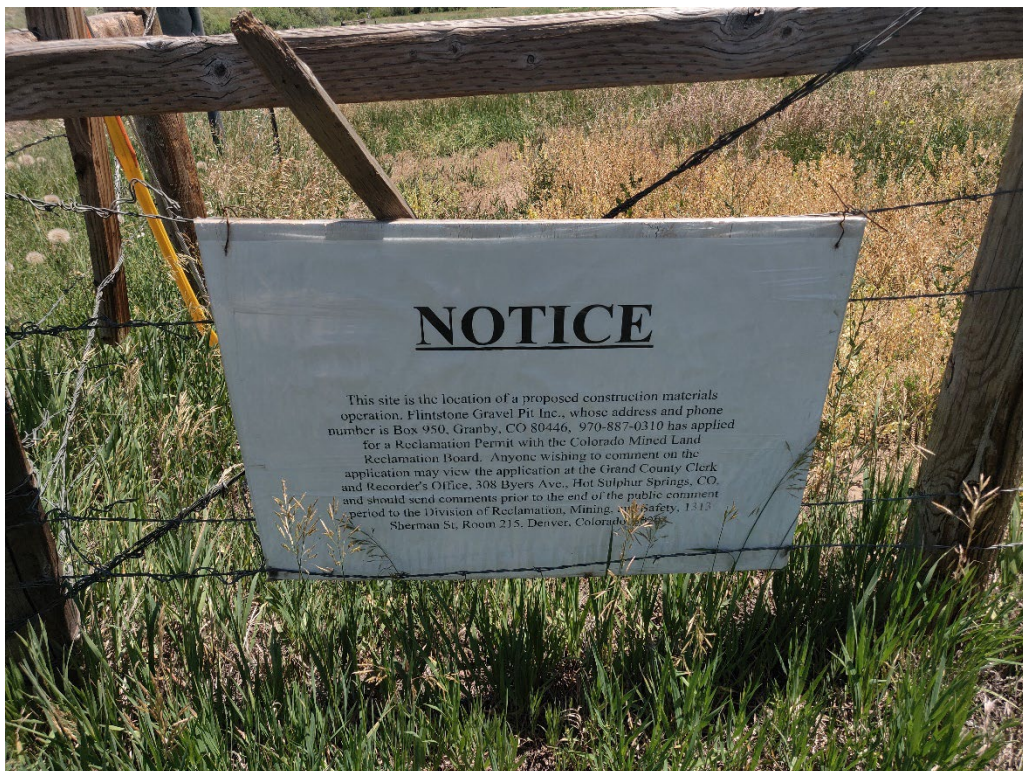
The 112c construction materials permit amendment application was received by the Division on April 21, 2022. The amendment application was deemed complete on June 9, 2022. The decision date is September 7, 2022. The Applicant published public notice as required by Rule 1.6.2(d) for four consecutive weeks. The last notice was published on July 7, 2022. The public comment period for the amendment application ended on July 27, 2022. No objections were received by the Division during the comment period. The required notice sign was posted at the entrance of the site as required by Rule 1.6.2(b).

Pickering Family Pit amendment application notice sign

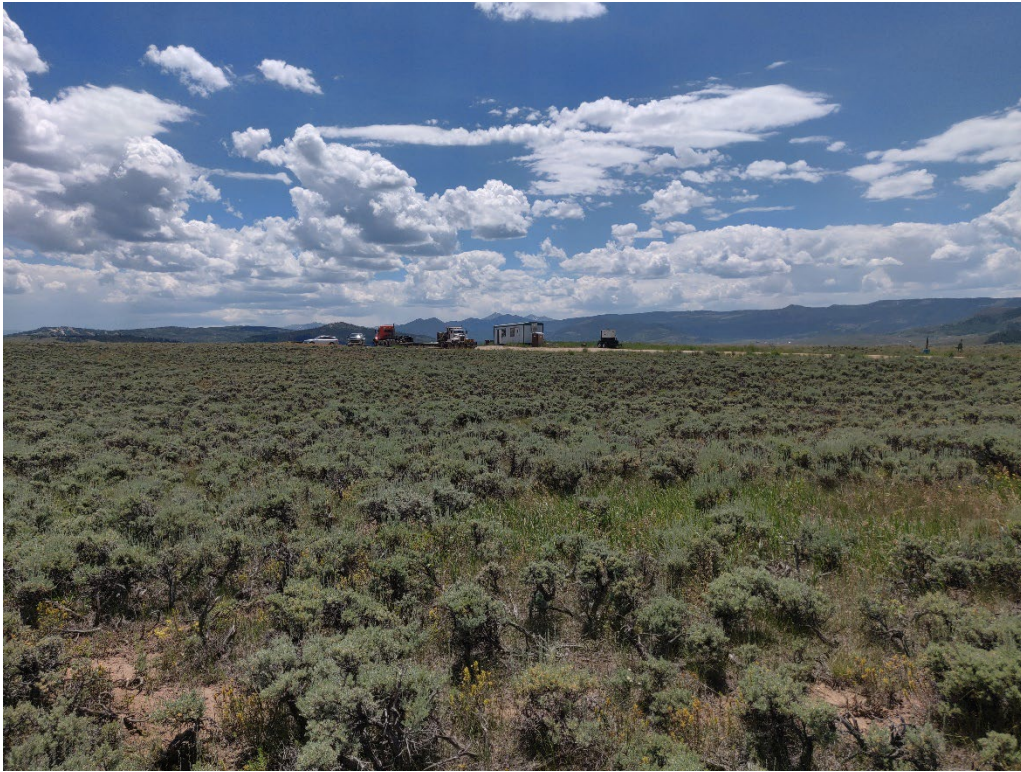
View from the NW corner of the amendment area looking southeast

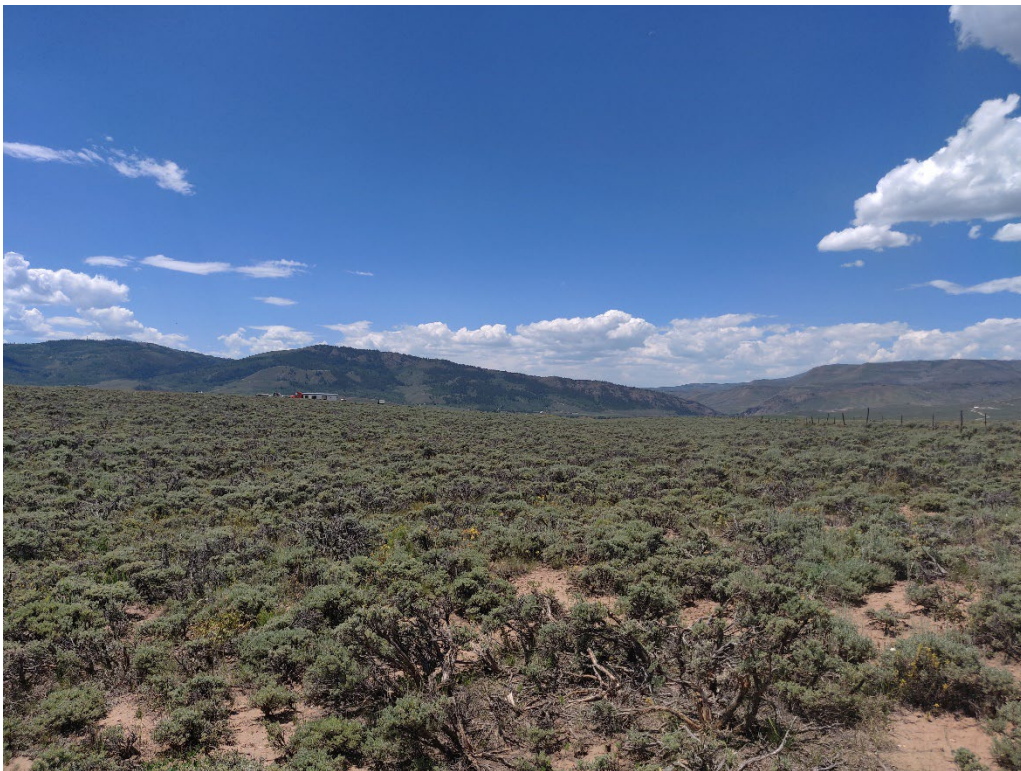
View from the NE corner of the amendment area looking southwest

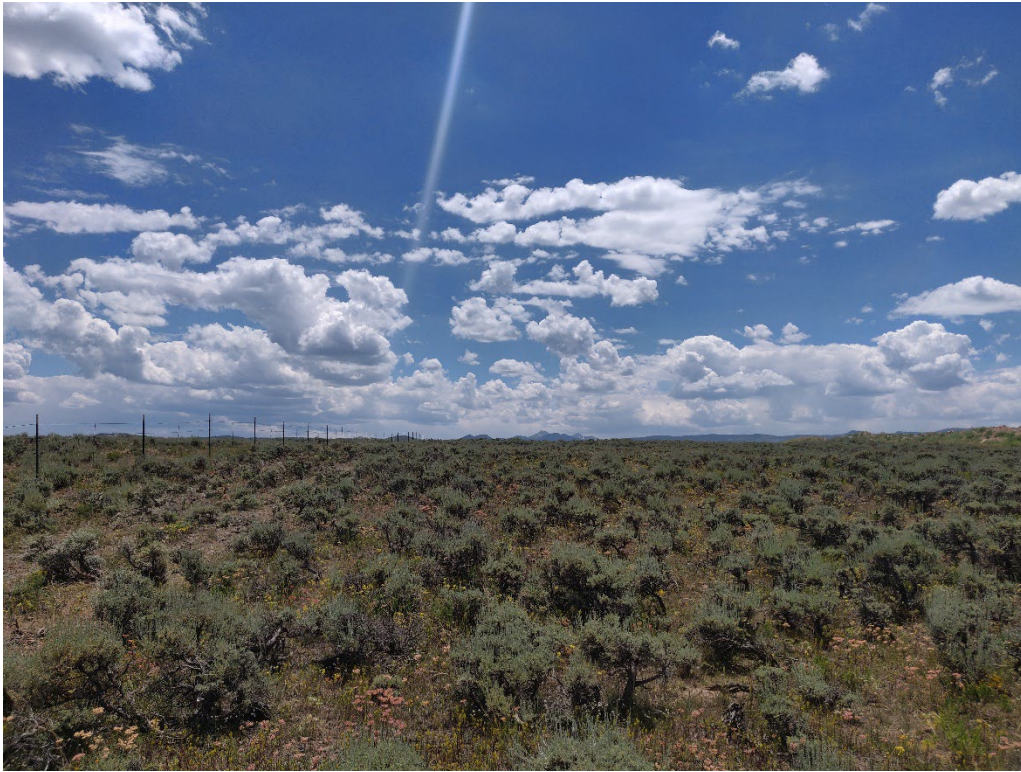
View of the eastern portion of the amendment area looking south

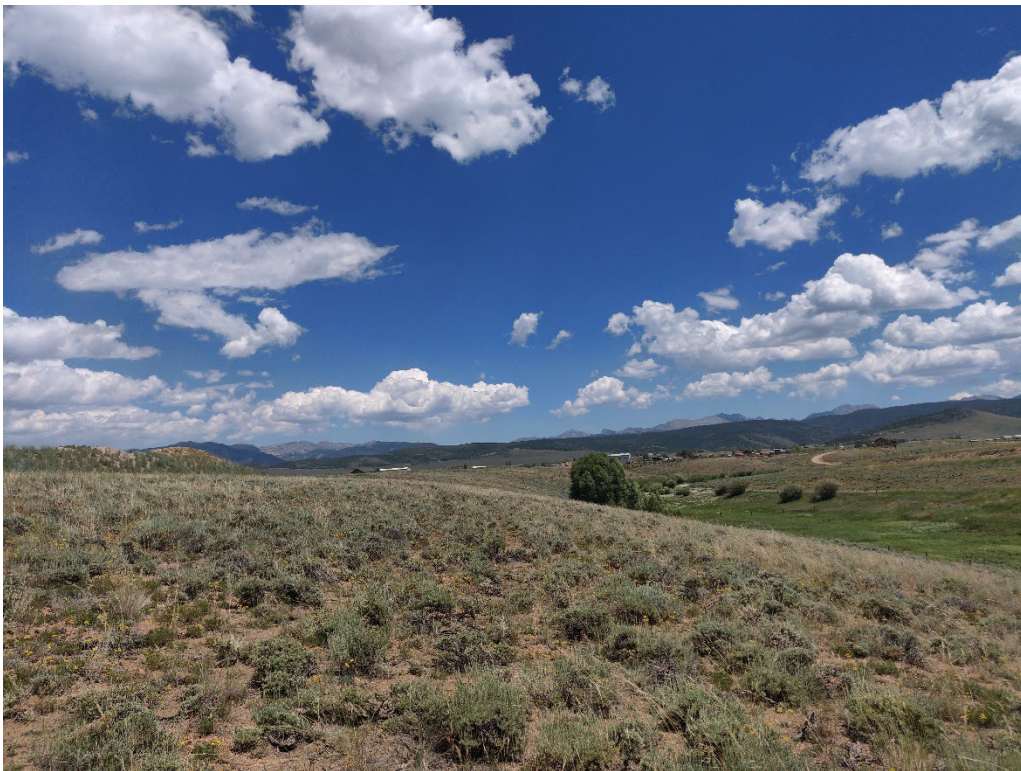
View from the SW corner of the amendment area looking east

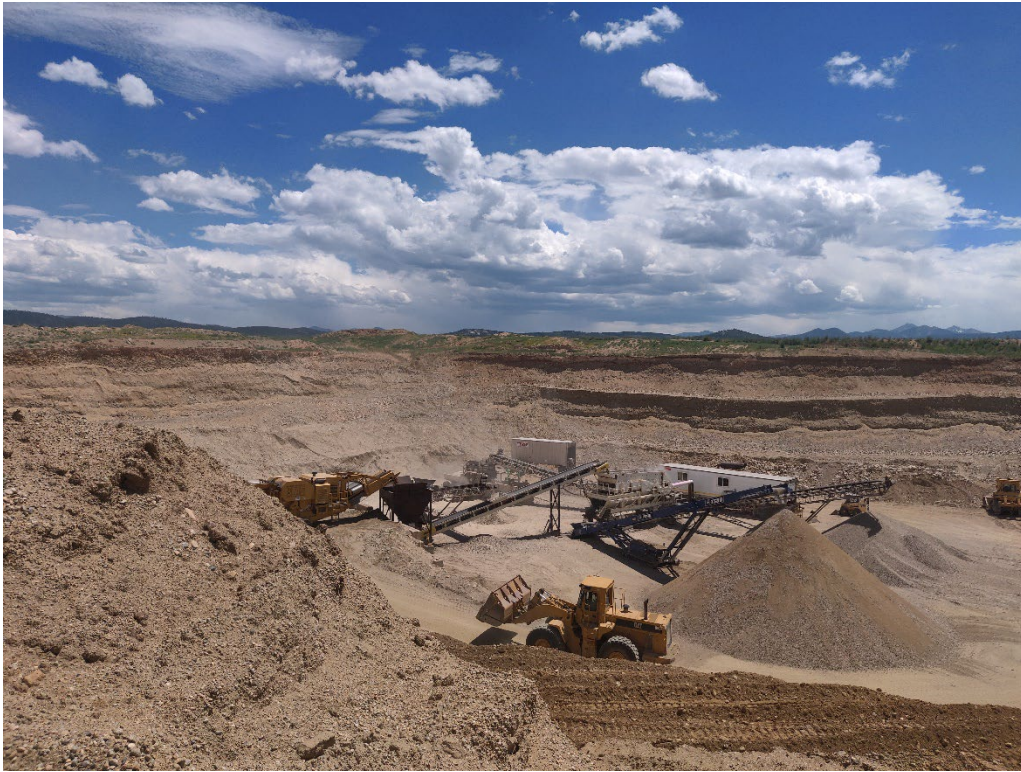
The site was active during the inspection. The processing plant was operating and material was being mined from the current highwall located in the southeast corner of Phase 1. Stockpiles of various processed materials were located in the northern portion of Phase 1 and in the southwest corner of Phase II. The current pit excavation was estimated at 55 feet in depth by the Operator. The pit floor was dry and no erosion features were observed during the inspection.

View of the current highwall and processing area located in the southeast corner of Phase I

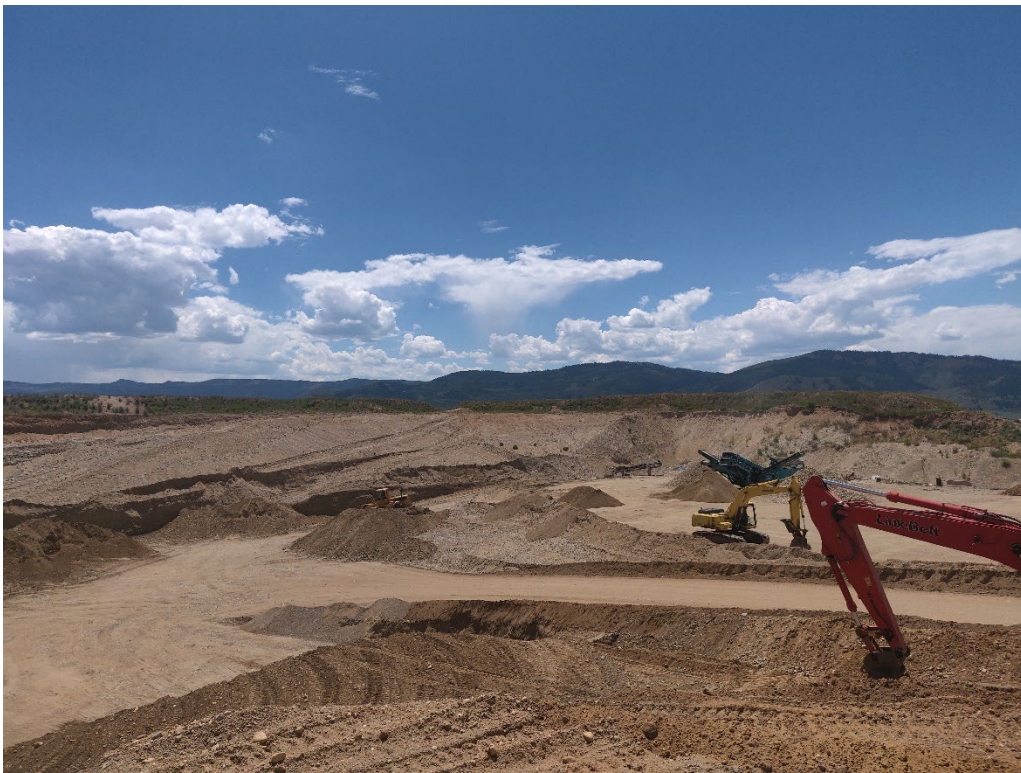
View of the southwest corner of Phase II

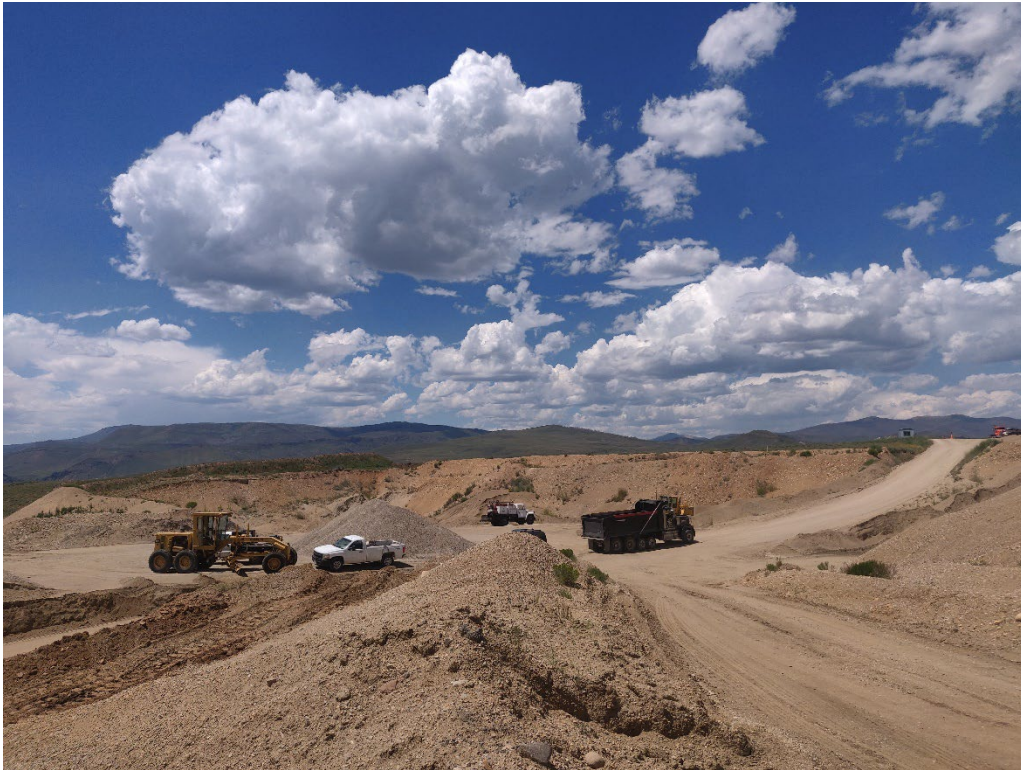
View of the northwest corner of Phase II

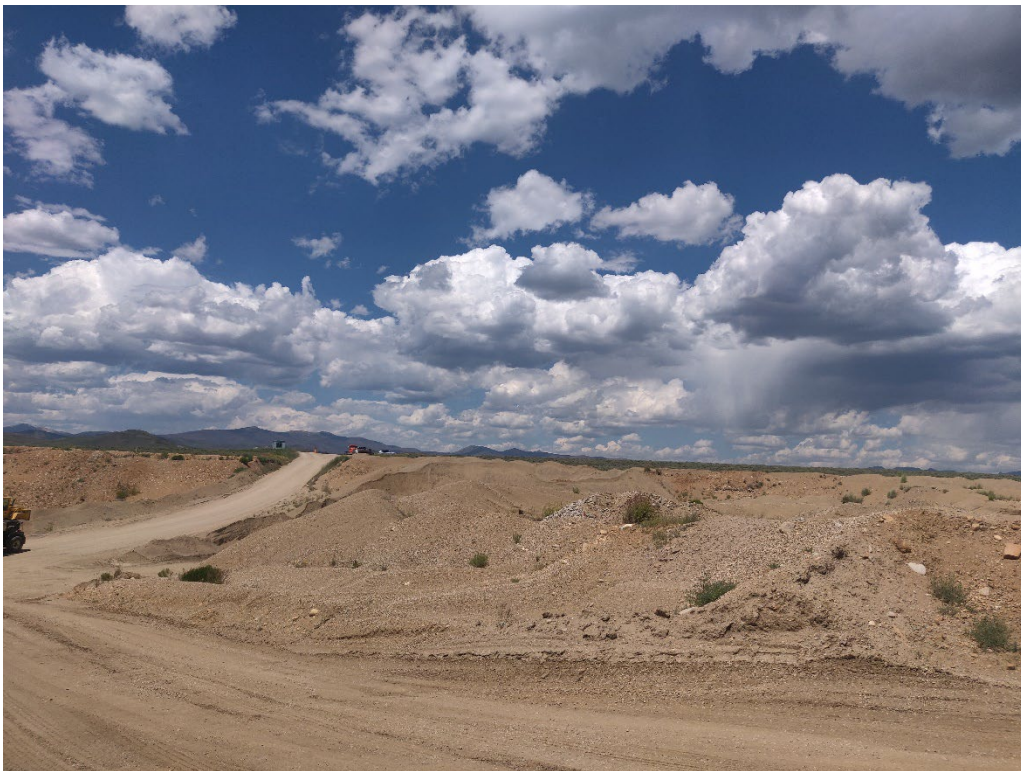
View of the northeast corner of Phase I

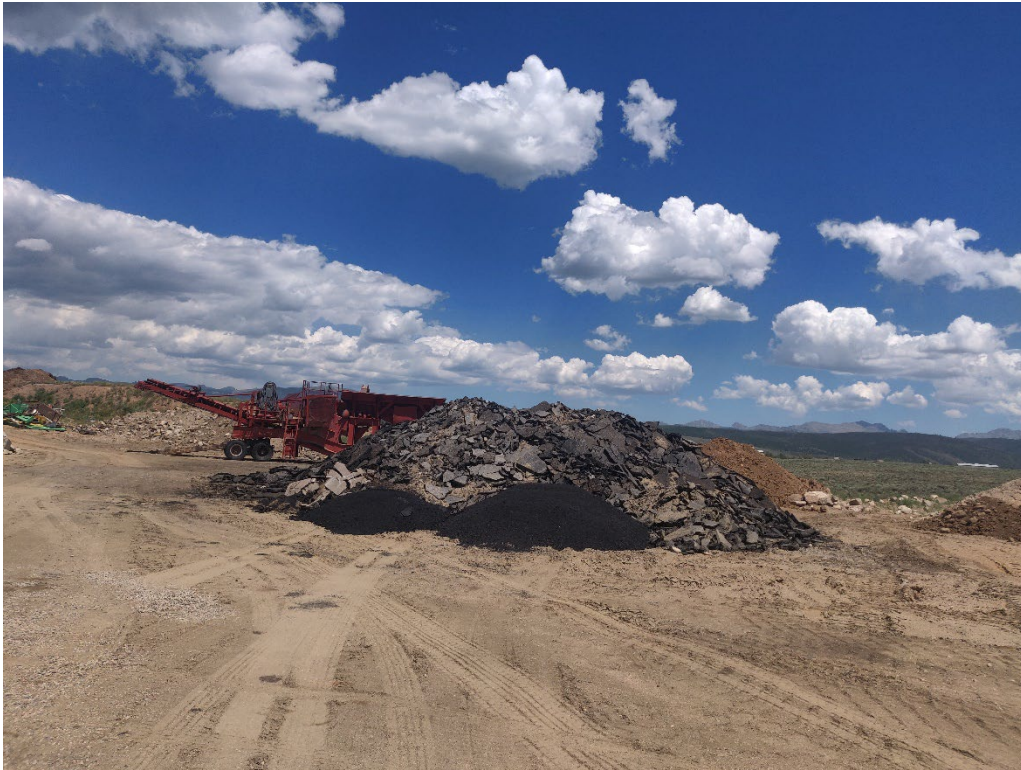
The Operator is recycling asphalt and concrete on-site. The processing area and stockpiles were observed in the northeast corner of Phase I. The Operator was reminded of the requirement to remove all recycled materials from the site and to not use the materials for reclamation. Equipment and debris were also observed in the northeast corner of Phase I. The Operator was reminded of the requirement to remove the equipment and debris from the site.

View of the asphalt recycling area located in the northeast corner of Phase I

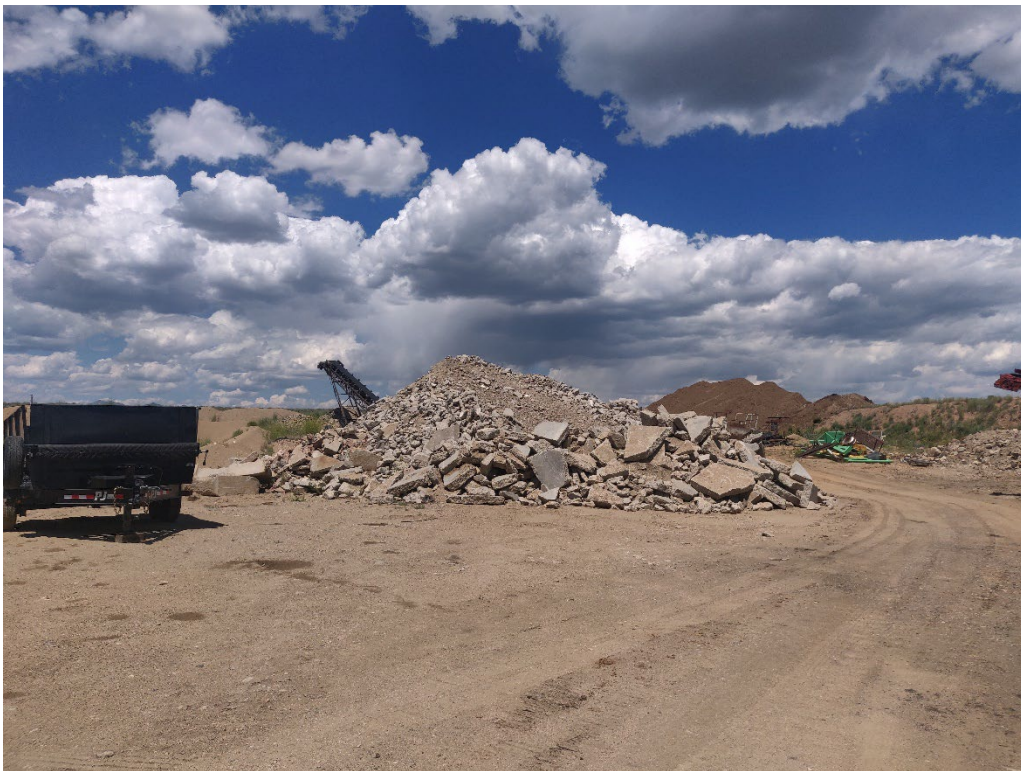
View of the concrete recycling area located in the northeast corner of Phase I
