MINERALS PROGRAM INSPECTION REPORT
PHONE: (303) 866-3567

MINE NAME: Avery Construction Pit	MINE/PROSPECTING ID#: M-1979-010	MINERAL: Sand and gravel	COUNTY: Chaffee
INSPECTION TYPE: Preoperation Inspection	INSPECTOR(S): Lucas West	INSP. DATE: August 15, 2022	INSP. TIME: 11:09
OPERATOR: ACA Products, Inc.	OPERATOR REPRESENTATIVE: Blake Bennetts	TYPE OF OPERATION: 112c - Construction Regular Operation	
REASON FOR INSPECTION: Pre-operation Inspection	BOND CALCULATION TYPE: Complete Bond	BOND AMOUNT: \$291,550.00	
DATE OF COMPLAINT: NA	POST INSP. CONTACTS: None	JOINT INSP. AGENCY: None	
WEATHER: Clear	INSPECTOR'S SIGNATURE:

OBSERVATIONS

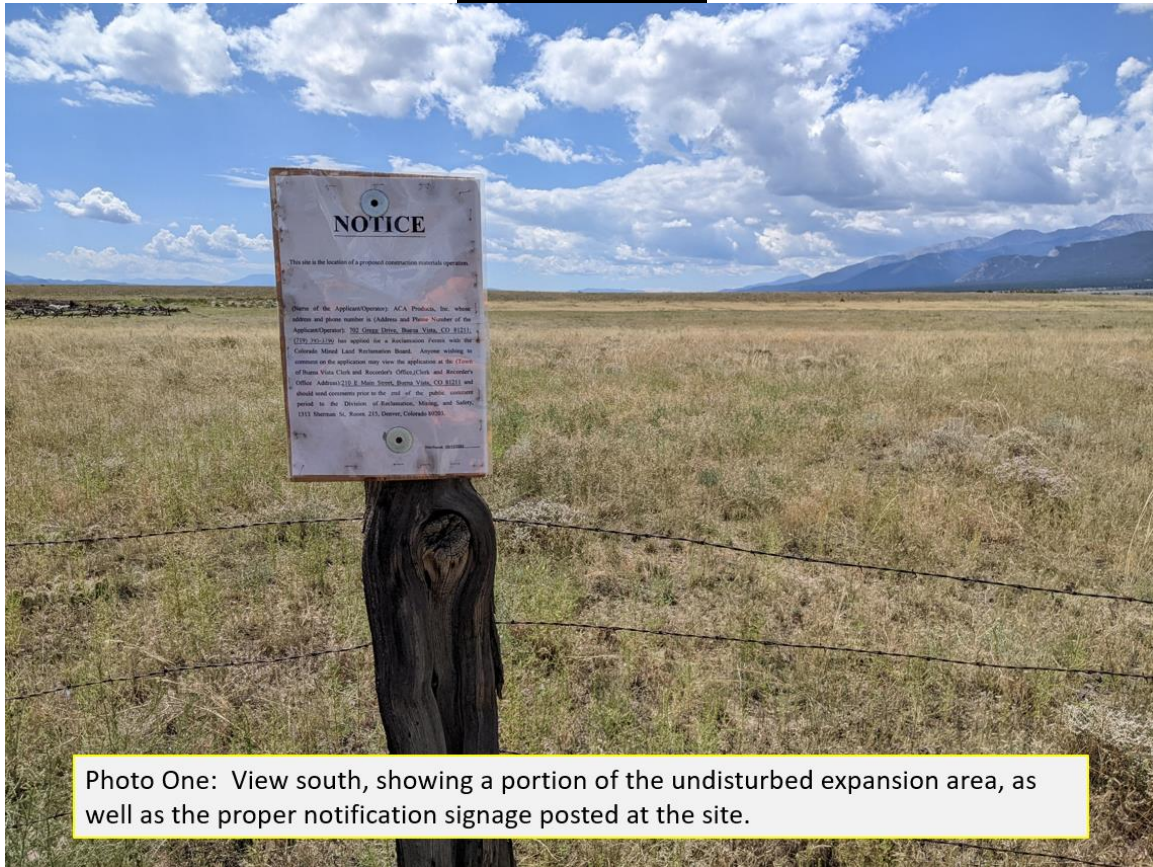
The proper Mine Identification Signage was posted at the entrance to the site, and the proper notification signage was posted at the proposed location of the expansion. The sign at the expansion area can be seen in Photo One. The application details the addition of 107.1 Acres of land adjacent to the existing pit area to the southeast, on the south side of Gregg Drive. The current land use of the expansion area is pastureland, and is proposed to be reclaimed as pastureland. The mining plan details the use of traditional highwall mining methods to a maximum pit depth of 30 to 40 feet. The mining area will inset within the property and permit boundary, surrounded by a visual impact berm. An example of the type of berm to be constructed can be seen in Photo Two. All mined material will be processed in the main Pit area on the north side of Gregg Drive. The reclamation plan details reclaiming the side slopes to a 3H:1V configuration with revegetation of the pit floor and side slopes.

Photo One: View south, showing a portion of the undisturbed expansion area, as well as the proper notification signage posted at the site.

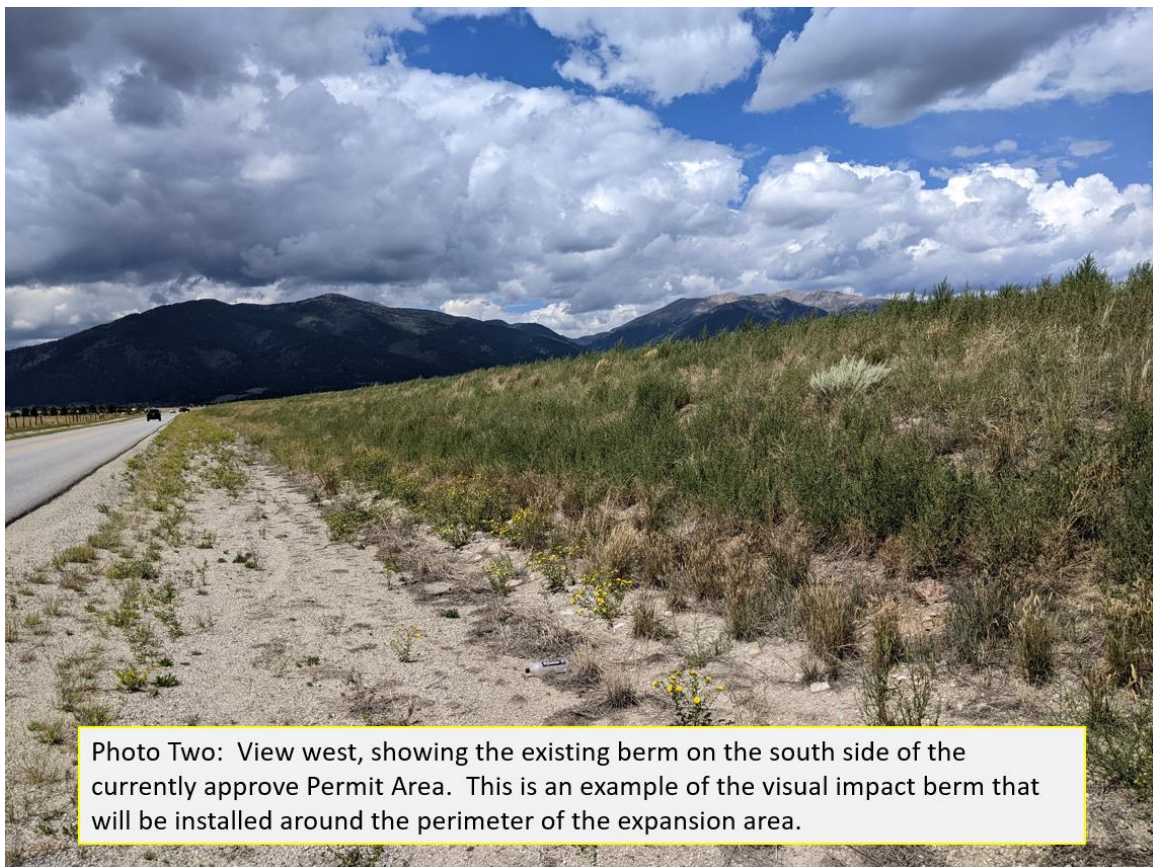
Photo Two: View west, showing the existing berm on the south side of the currently approve Permit Area. This is an example of the visual impact berm that will be installed around the perimeter of the expansion area.

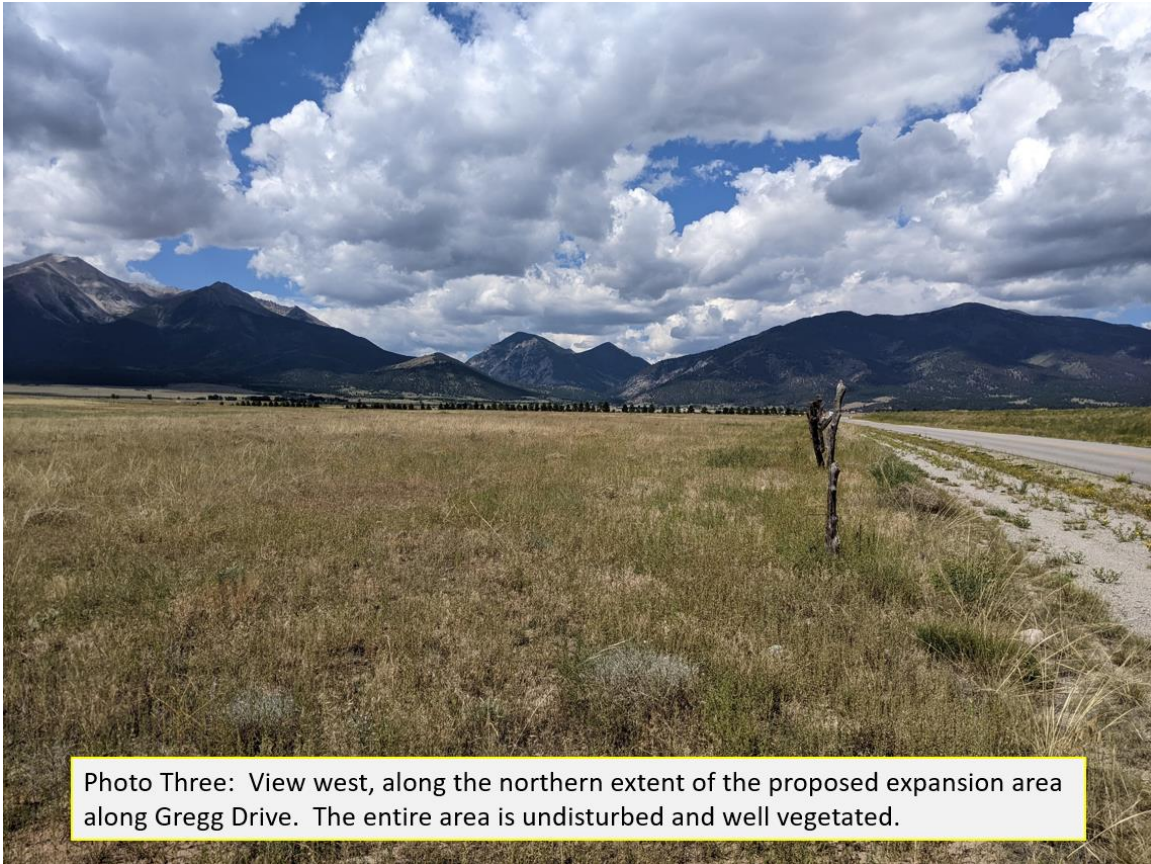
The expansion area is currently undisturbed and bordered on the north by Gregg Drive and the west by County Road 321. The area is well vegetated and dominated by native grassland and shrub species. Photos Three through Five show the current state of the proposed area. The area exhibits positive drainage and shows no signs of impounding storm water. No state listed noxious weeds were observed and signs of settling slumping or erosion was noted in the area.

Photo Three: View west, along the northern extent of the proposed expansion area along Gregg Drive. The entire area is undisturbed and well vegetated.

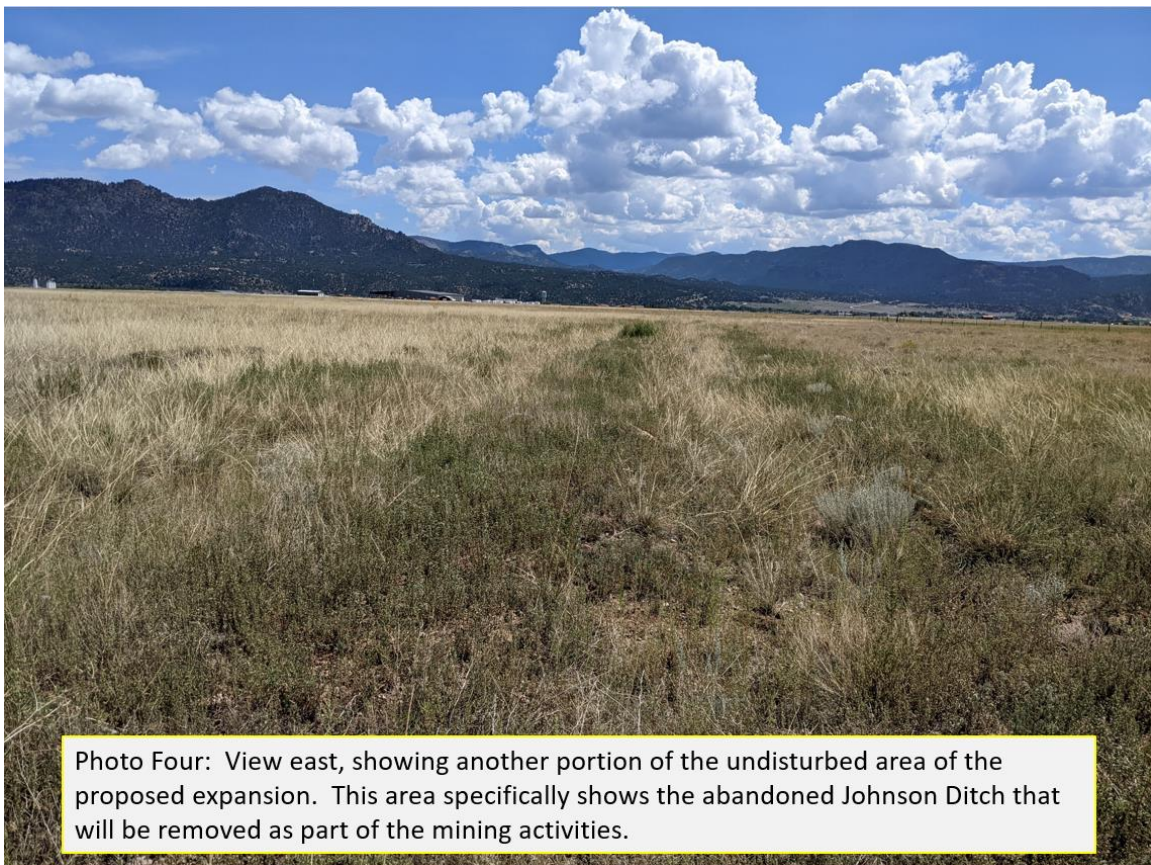
Photo Four: View east, showing another portion of the undisturbed area of the proposed expansion. This area specifically shows the abandoned Johnson Ditch that will be removed as part of the mining activities.

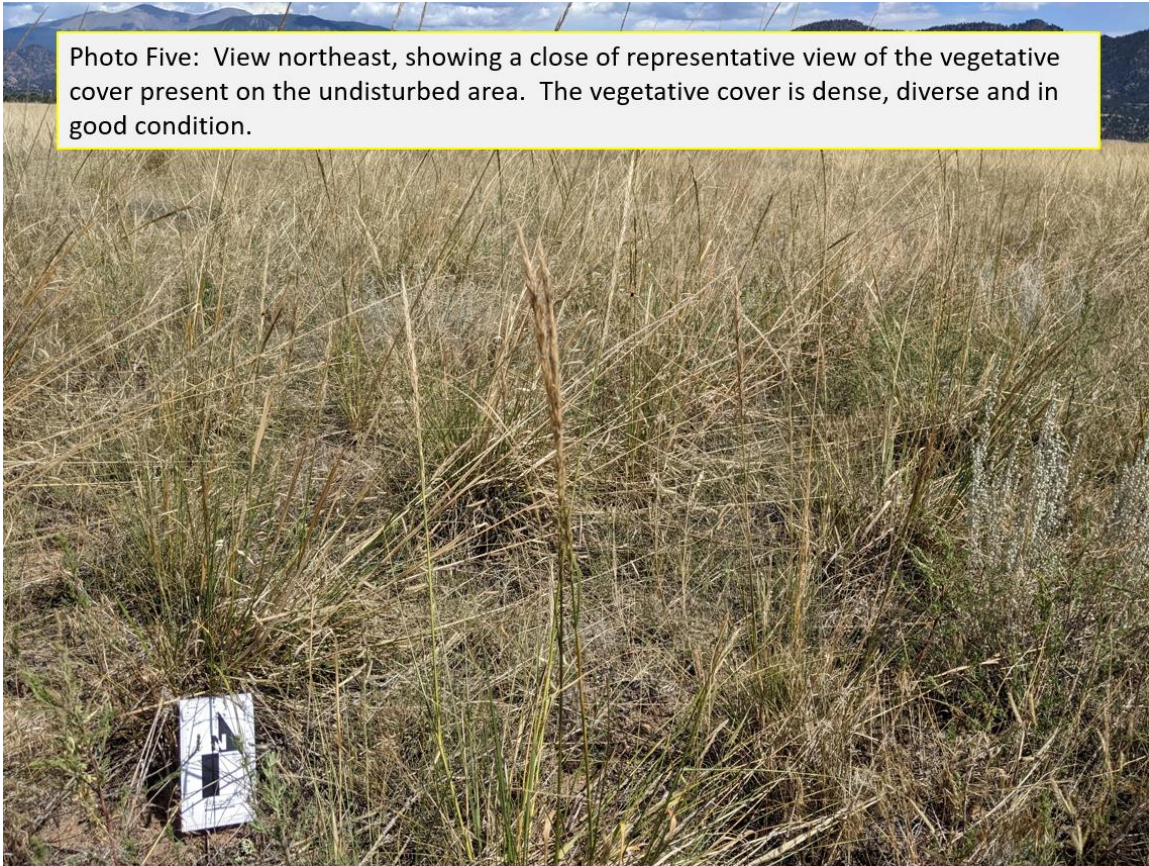
Photo Five: View northeast, showing a close of representative view of the vegetative cover present on the undisturbed area. The vegetative cover is dense, diverse and in good condition.
