MINERALS PROGRAM INSPECTION REPORT

| MINE NAME: Rocky Ford East Pit | MINE/PROSPECTING ID#: M-1977-560 | MINERAL: Sand and gravel | COUNTY: Otero |
| INSPECTION TYPE: Surety Release Inspection | INSPECTOR(S): Patrick Lennberg | INSP. DATE: July 26, 2022 | INSP. TIME: 08:30 |

| REASON FOR INSPECTION: Surety Release Requested | BOND CALCULATION TYPE: None | BOND AMOUNT: \$97,604.00 |

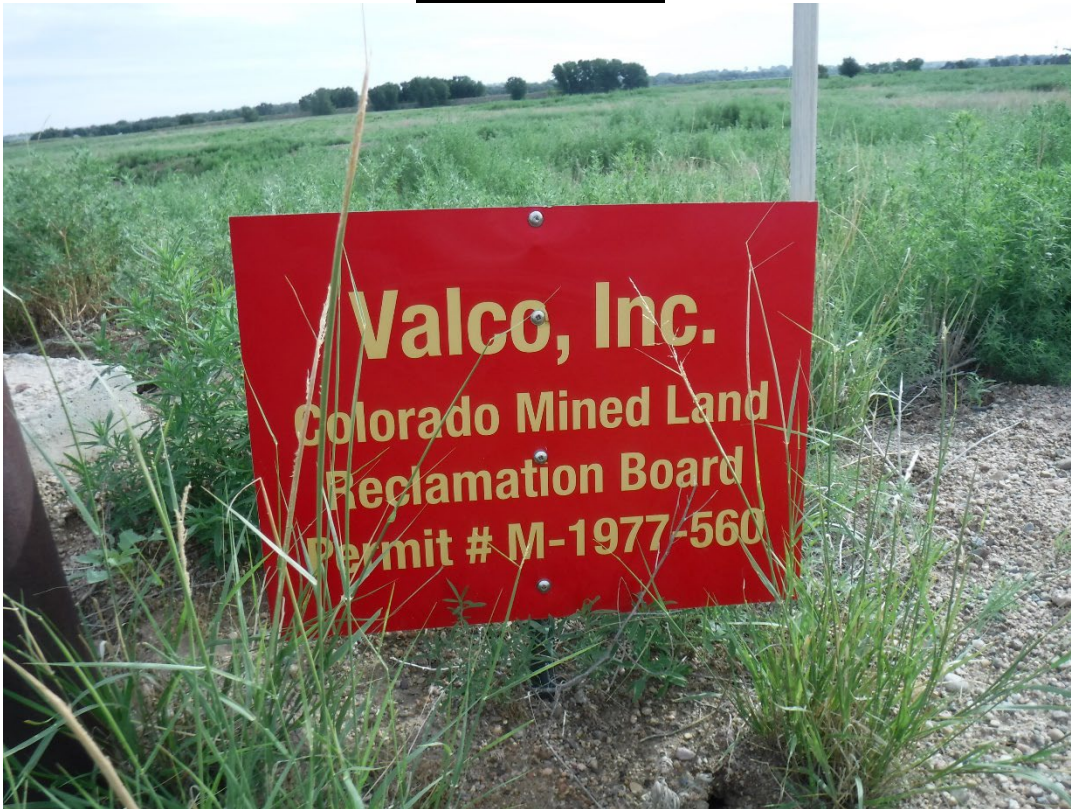
Photo 1: Mine sign at entrance of permit off of Co Rd 22

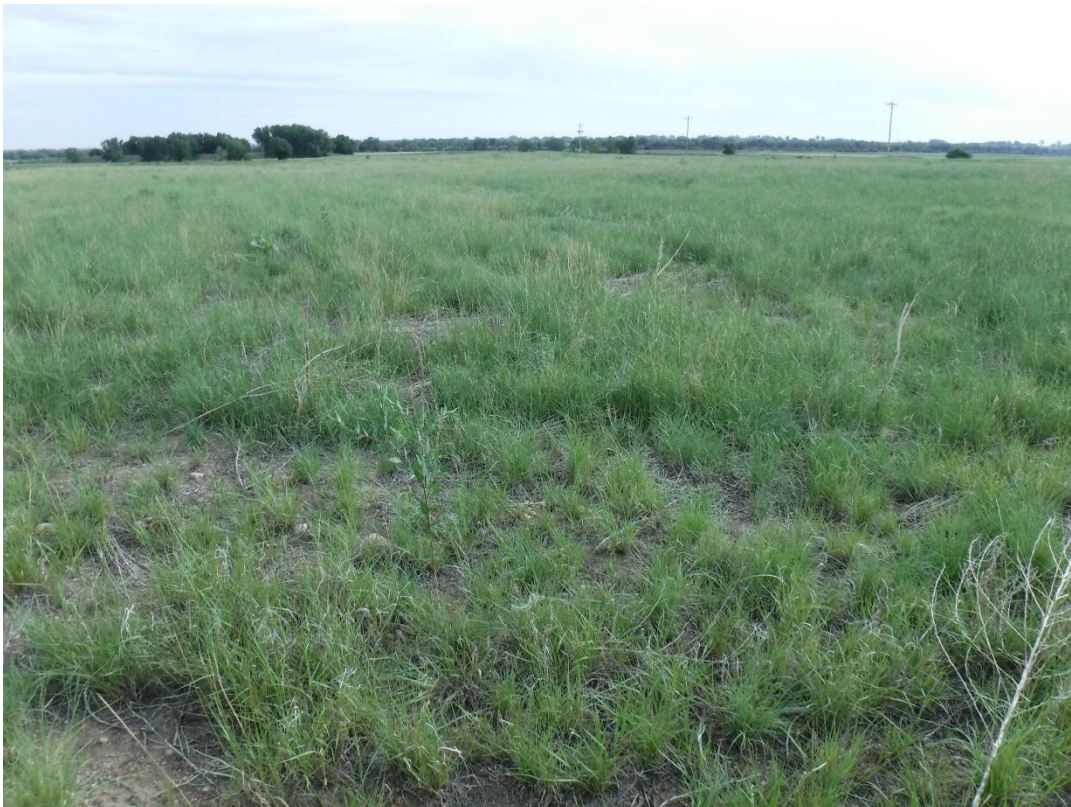
Photo 2: Typical vegetation cover in reclaimed areas

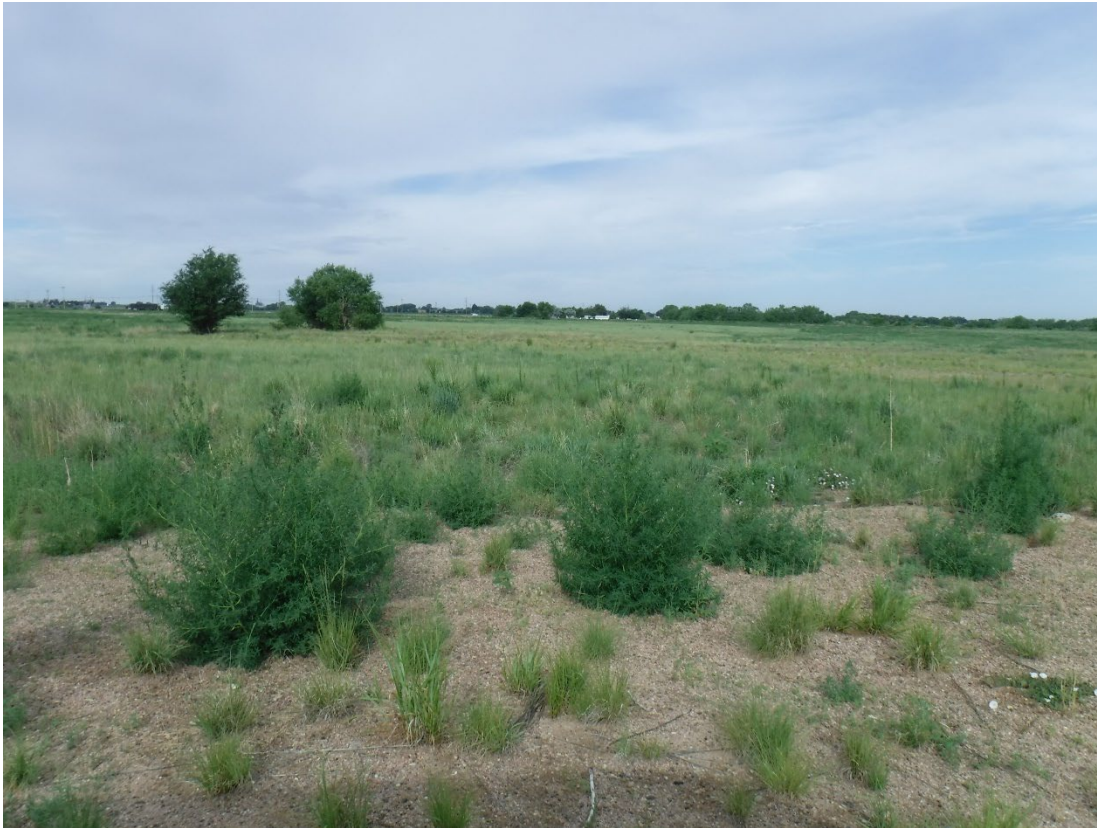
Photo 3: Typical vegetation cover in reclaimed areas

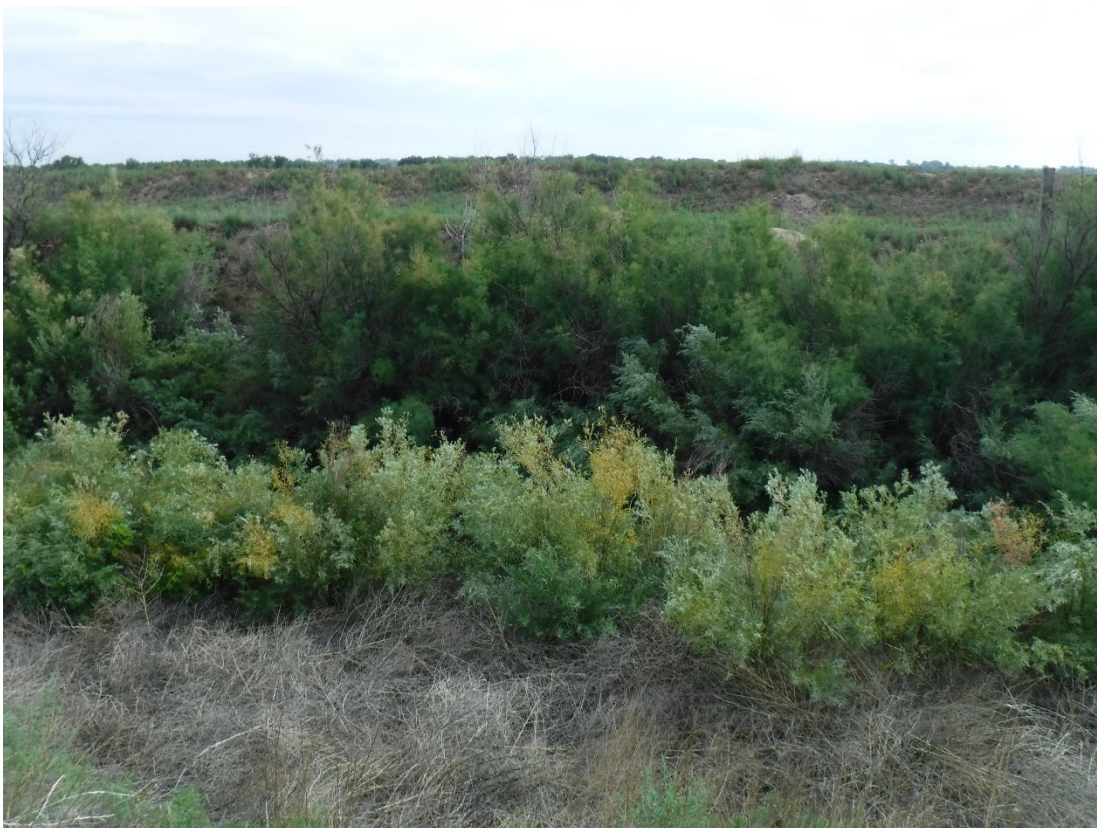
Photo 4: Typical vegetation found within the ditch that is outside the northern border of permit

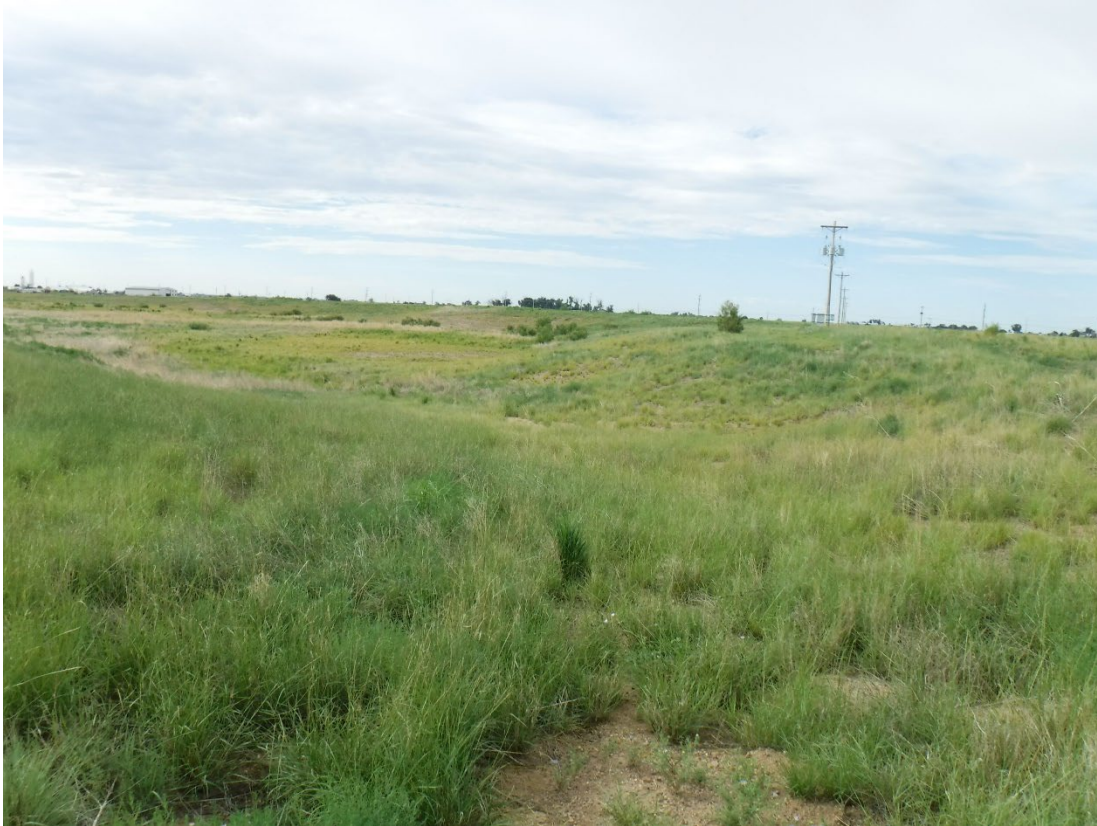
Photo 5: Vegetation conditions within the backfilled pond area, looking southeast

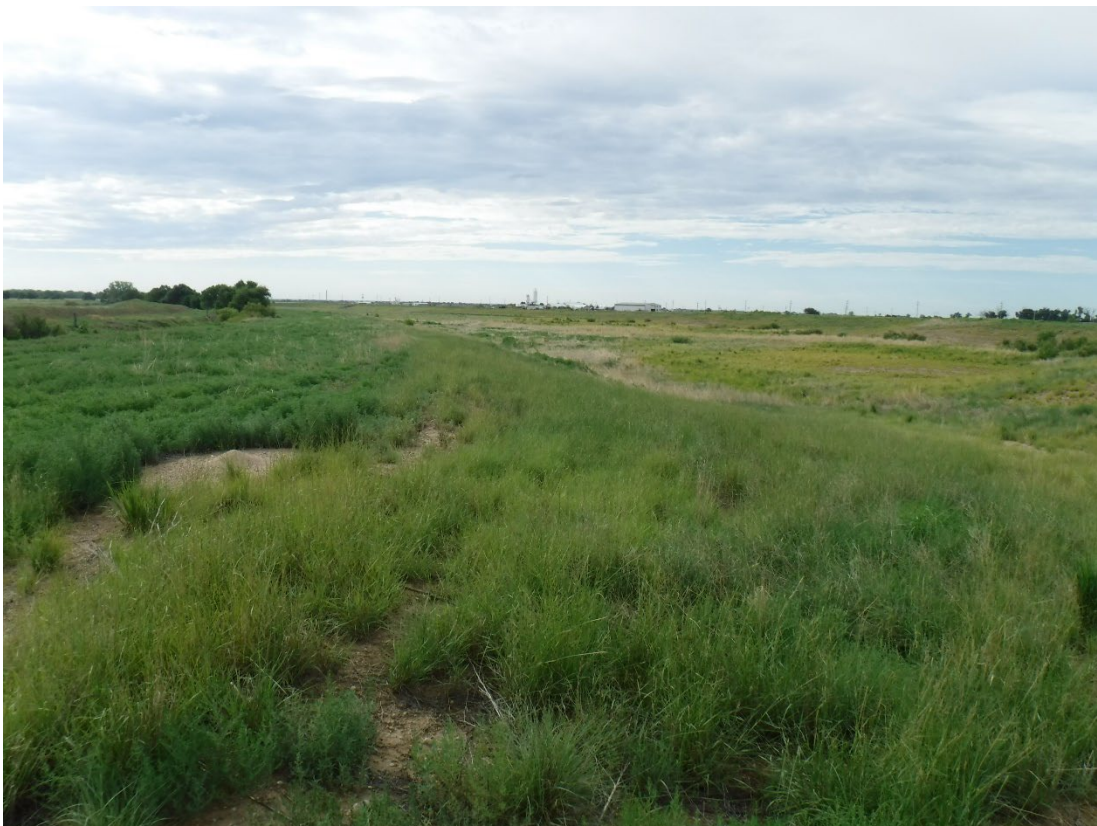
Photo 6: Vegetation conditions within the backfilled pond area, looking east

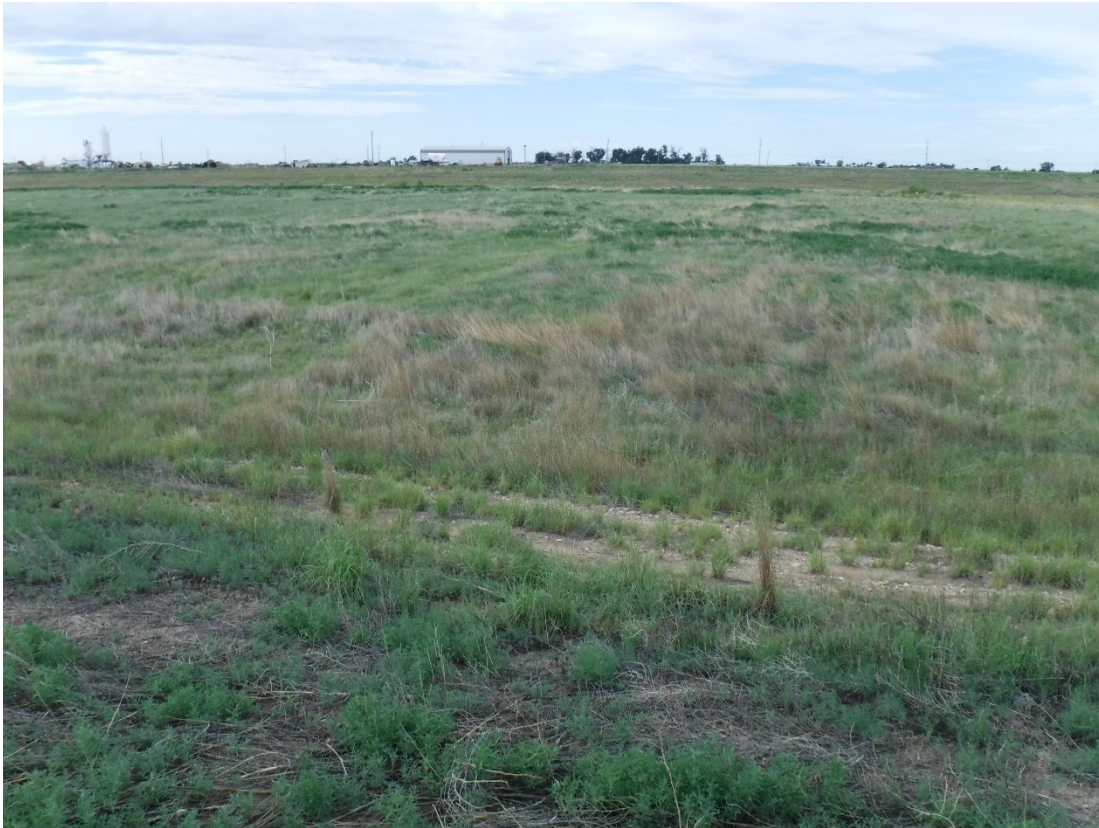
Photo 7: Vegetation conditions within the backfilled pond area, looking south

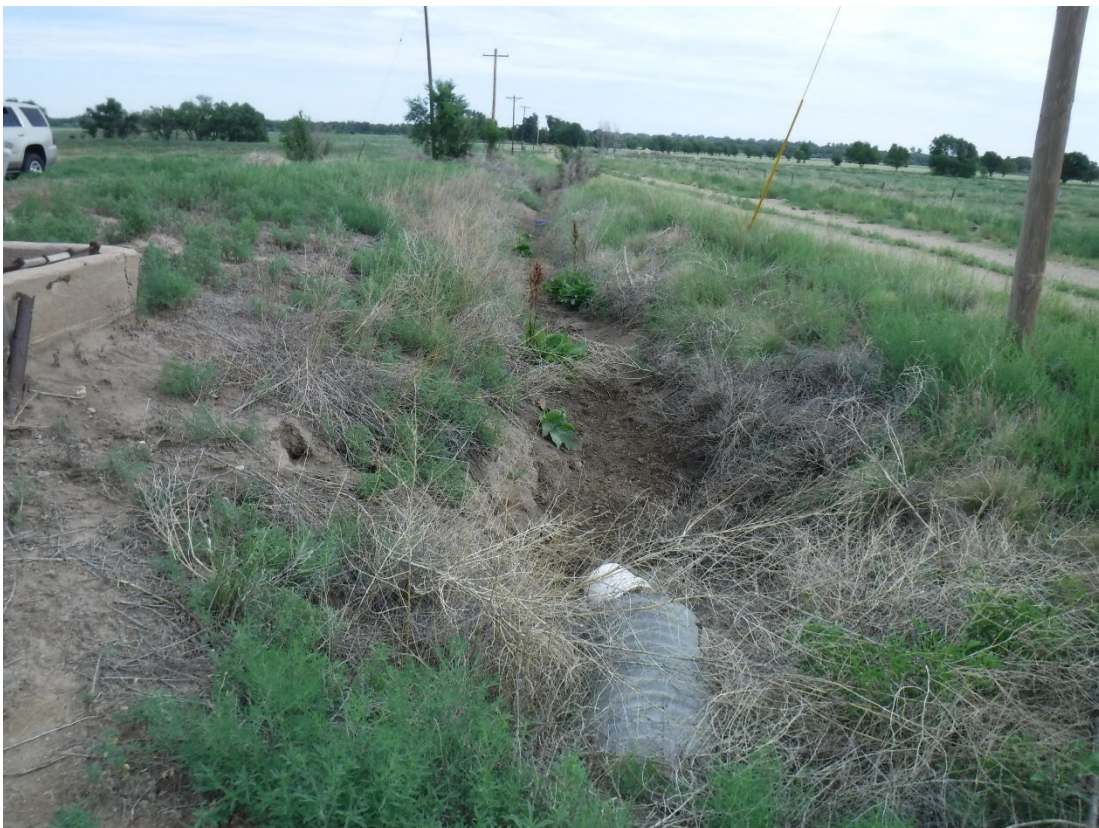
In the southeastern corner of the permit area a culvert conveying stormwater runoff to the north along the eastern side of the permit area became plugged from storm event approximately two weeks prior to the inspection. The plugged culvert allowed water to pool in a drainage ditch that borders the south side of the permit area. Approximately 280 feet from the southeastern corner the pooled water caused a piping failure and the slope failed into the reclaimed area. At the time of inspection the Operator stated they had contacted Habitat Construction, LLC to design a permanent mitigation measure to insure the incident does not happen again. Preliminarily, the idea was to remove the culvert that plugged and replace it with a rock lined ditch then repair the failed area with riprap. The area involved with the failure is very minor compared the overall site area.

Photo 8: Outfall of plugged culvert to ditch draining to the north, permitted area to the left of picture

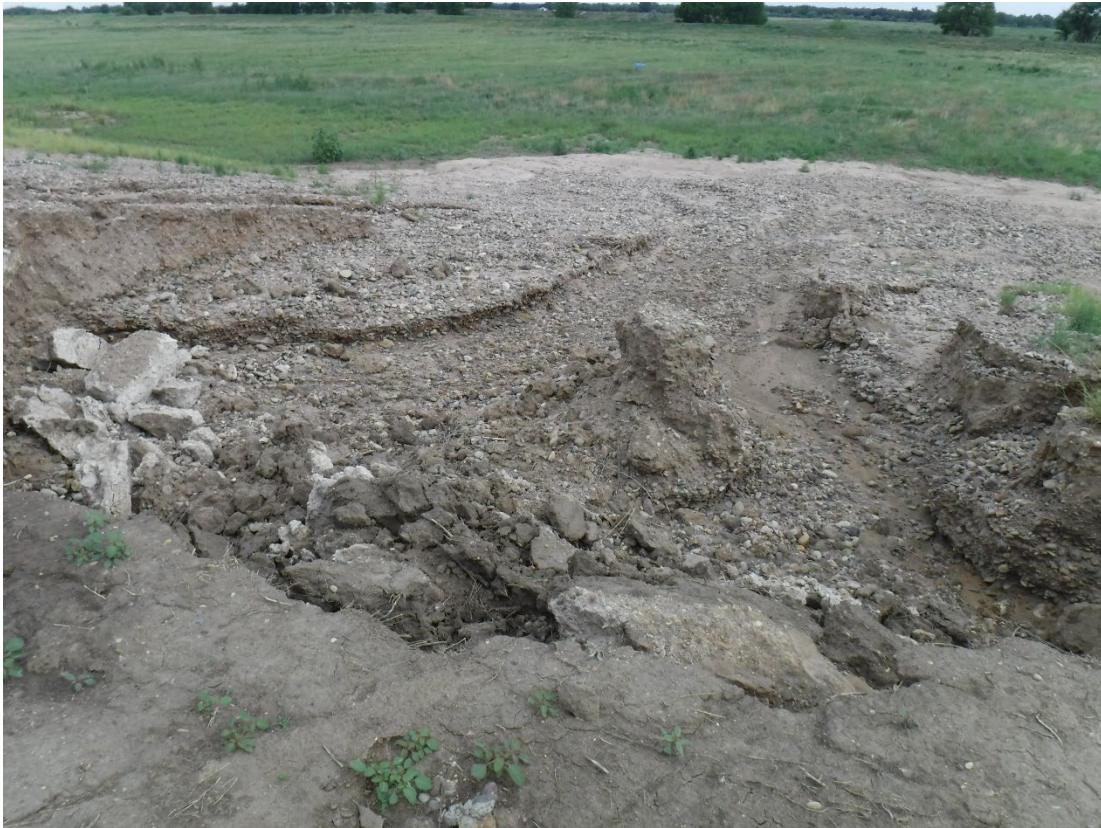
Photo 9: Area of failure

Based on observations made during this inspection, the Operator has completed the reclamation in accordance with the reclamation plan. The majority of the revegetated area has suitable vegetation cover and appears stable. However, the Operator shall submit photo documentation of the slope failure repair work and permanent ditch mitigation work. Once the documentation has been submitted and accepted by the Division the release request of the permit will be approved. Once approved a notice of the Division's decision regarding the release request will be sent under a separate cover letter. The current decision date for the release request is August 29, 2022. If the Operator needs additional time for the repair work to be completed an extension to the decision date may be requested.

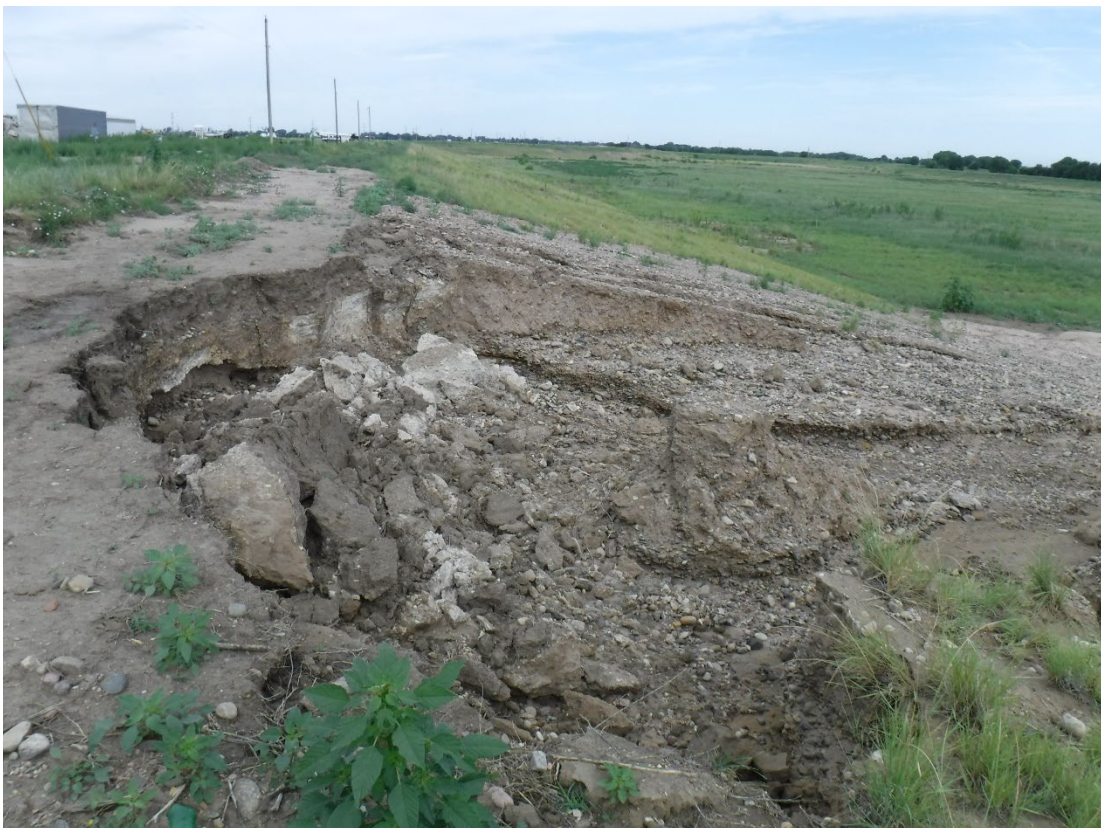
Photo 10: Area of failure looking west

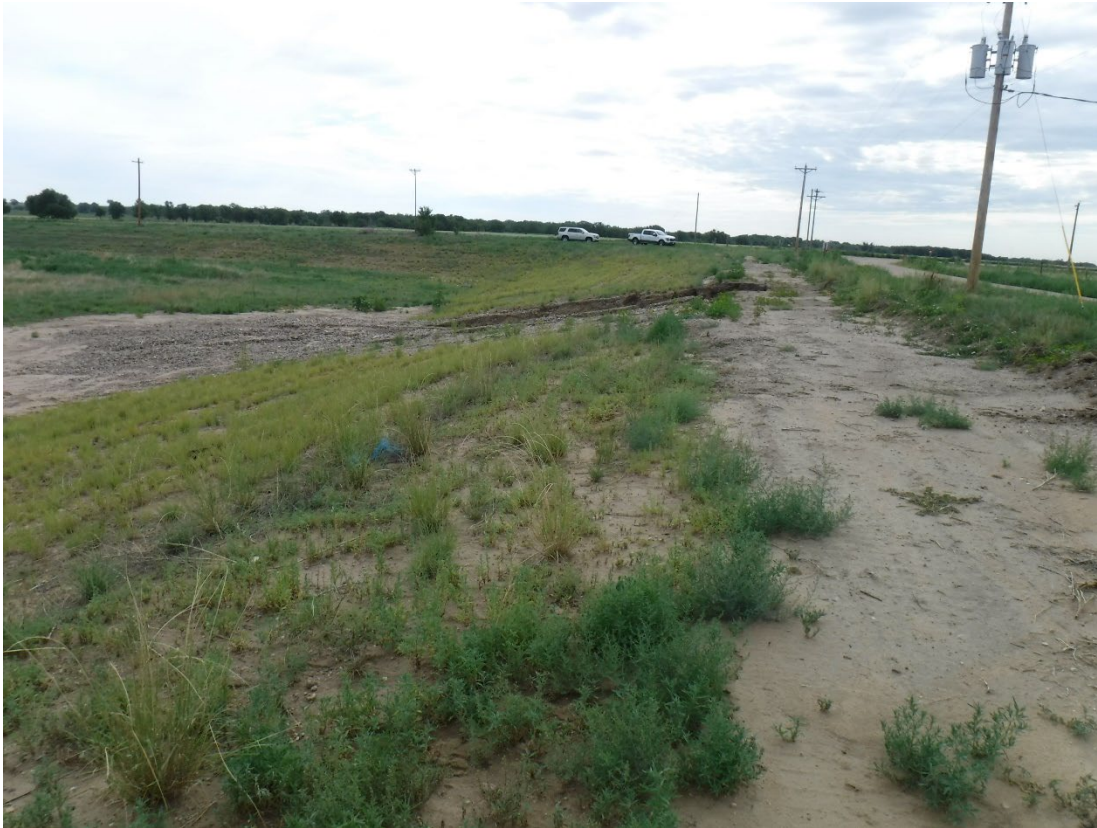
Photo 11: Area of failure looking east

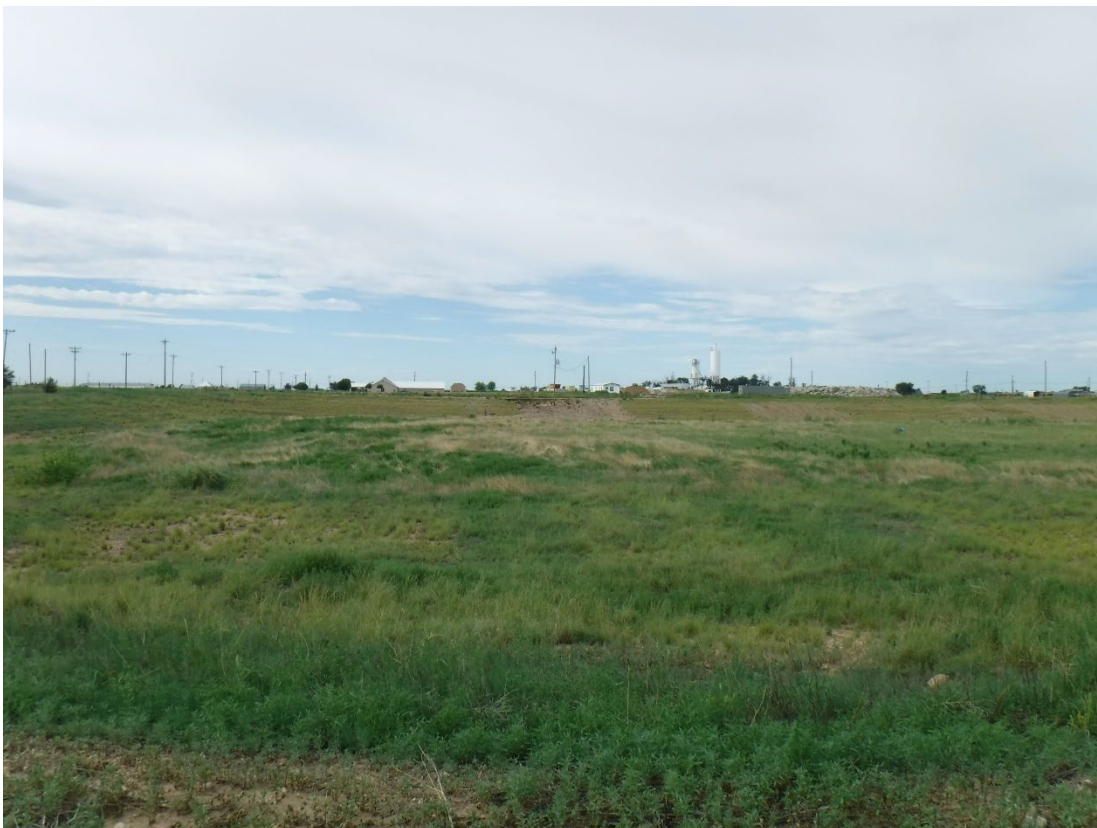
Photo 12: Area of failure looking south
