Inspection Report, SL-1, Rocky Ford East, M1977-560

Rocky Ford East, Permit # M 1977-560

Attached are photos of the completed slope failure repair work and permanent ditch mitigation structure at the Rocky Ford East Pit.

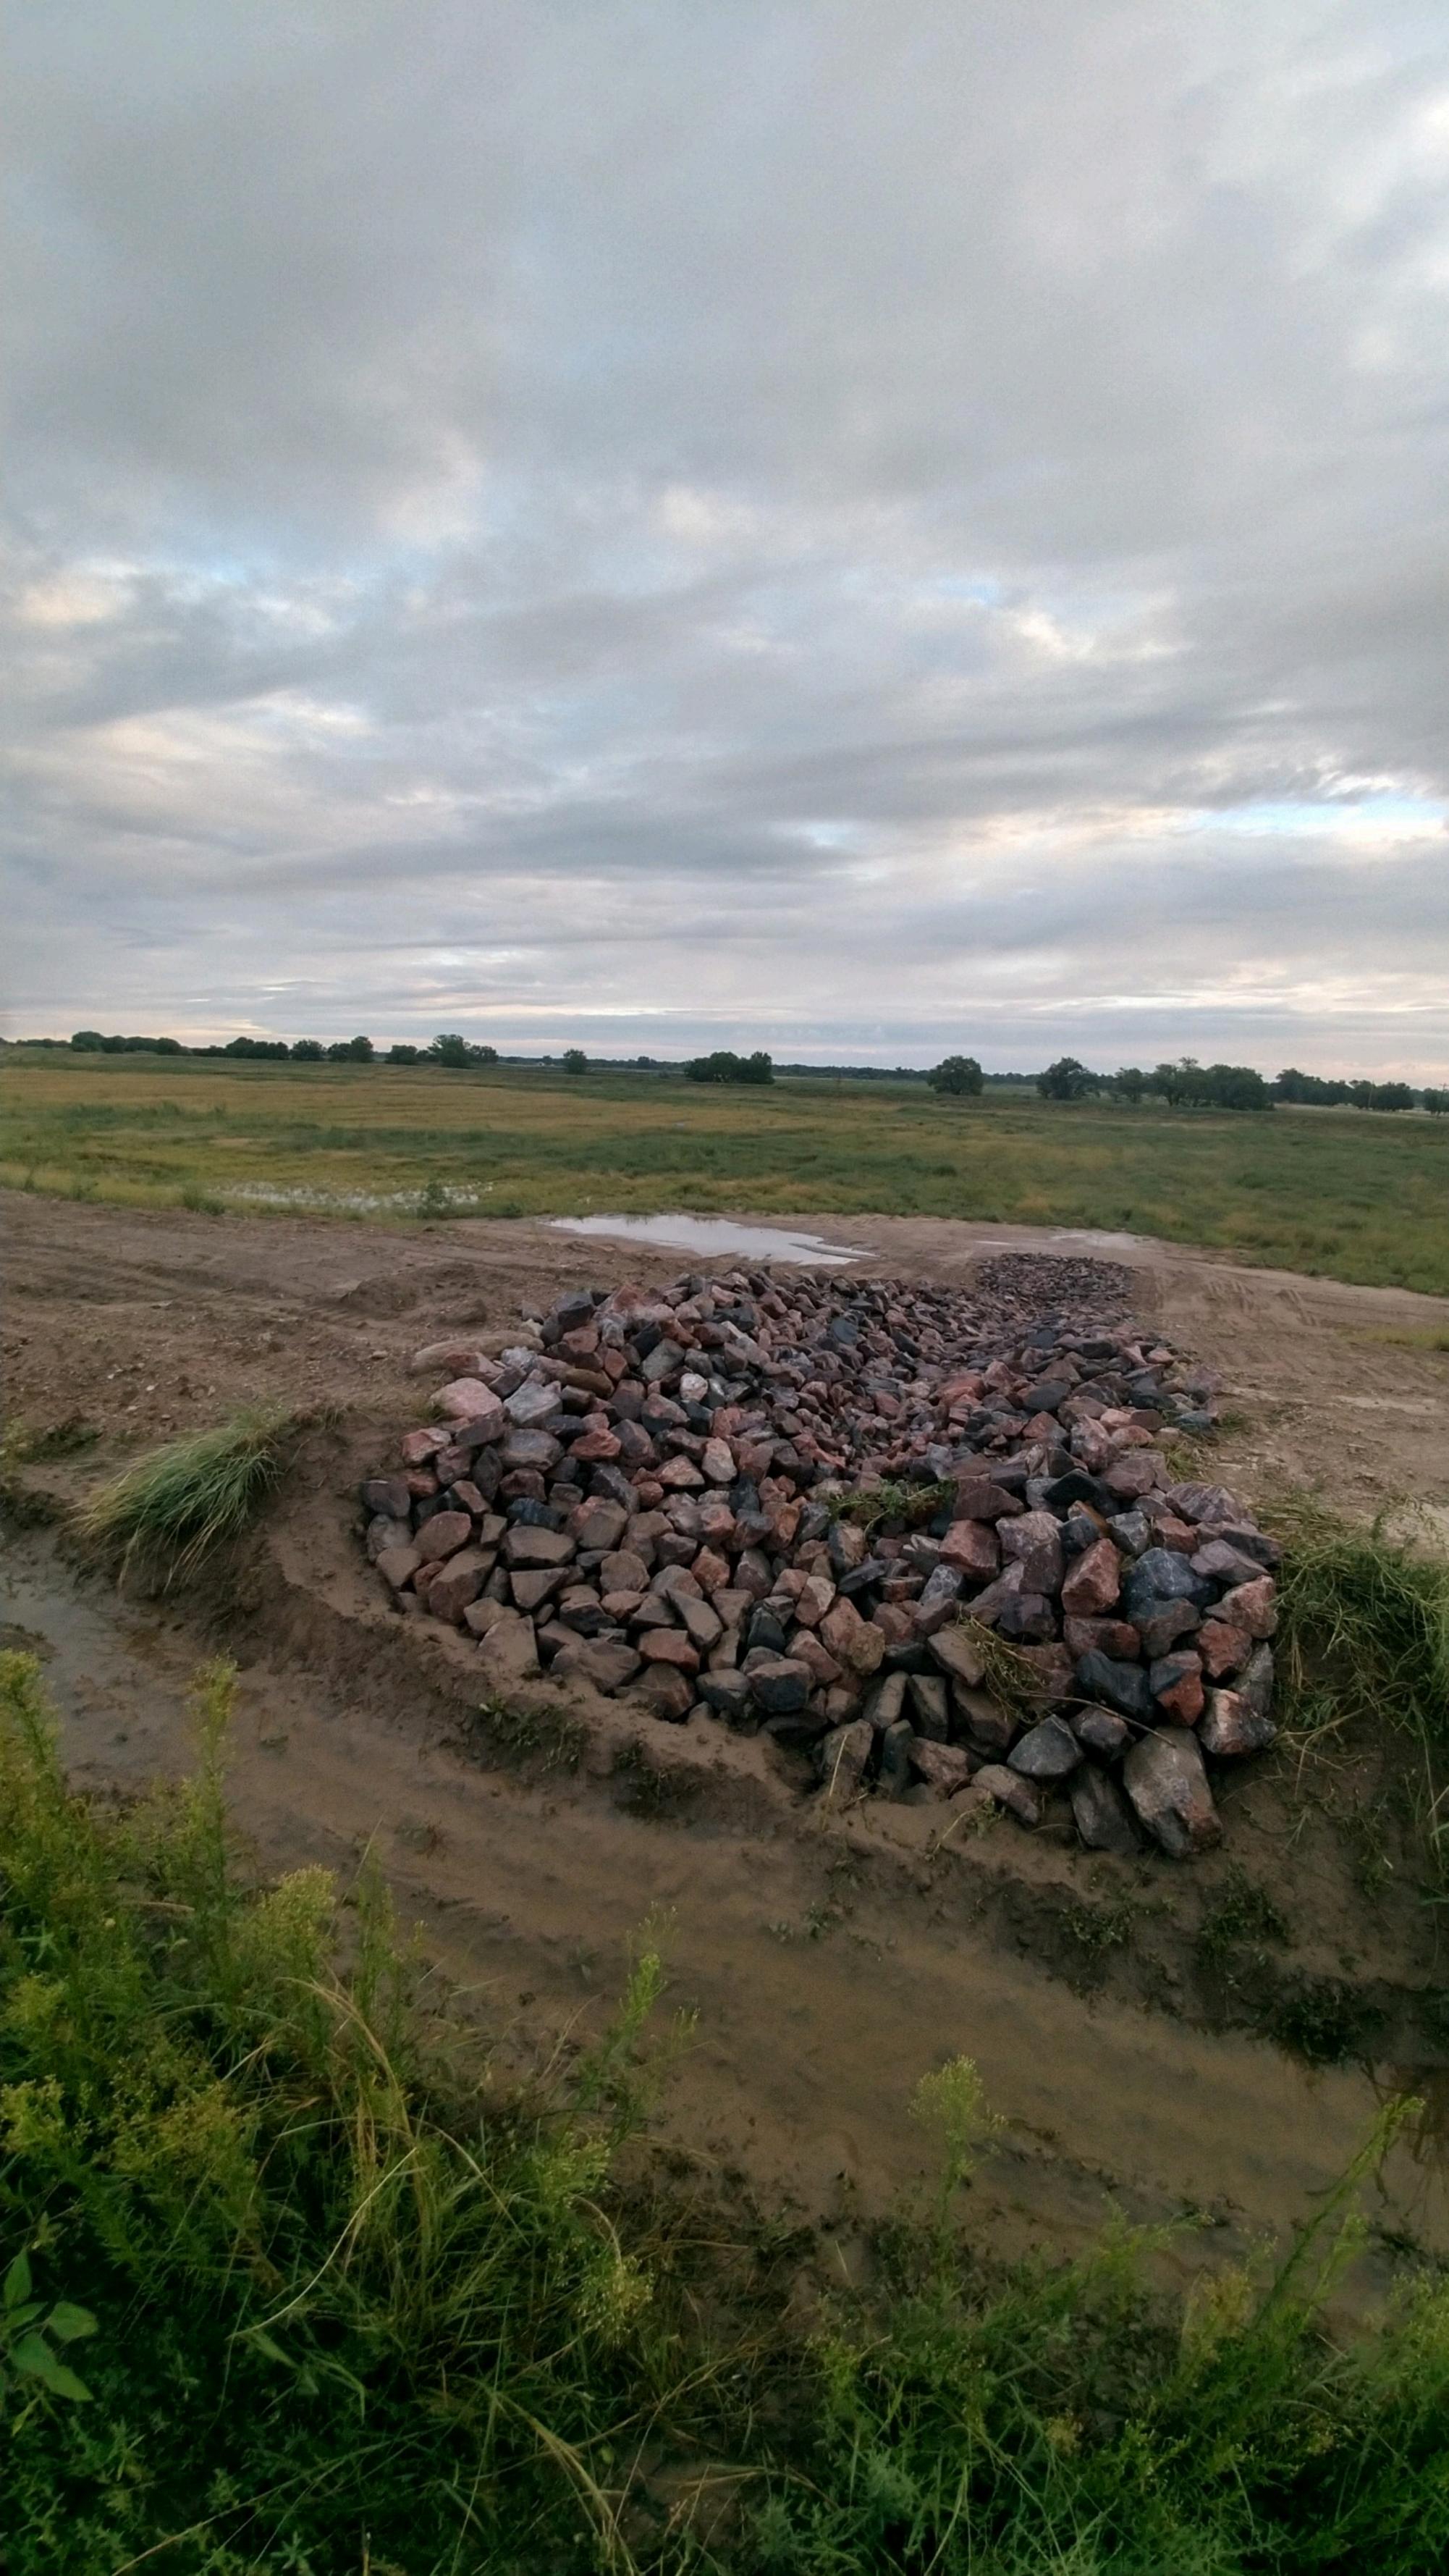
RFEAST8172022.JPG

The repair is complete. It was complete 8/16/2022. 8/17/2022 there was another major rain event and the structure worked as planned.

Attached a picture of the structure after the rain yesterday. The contractor sent me the shot this morning.

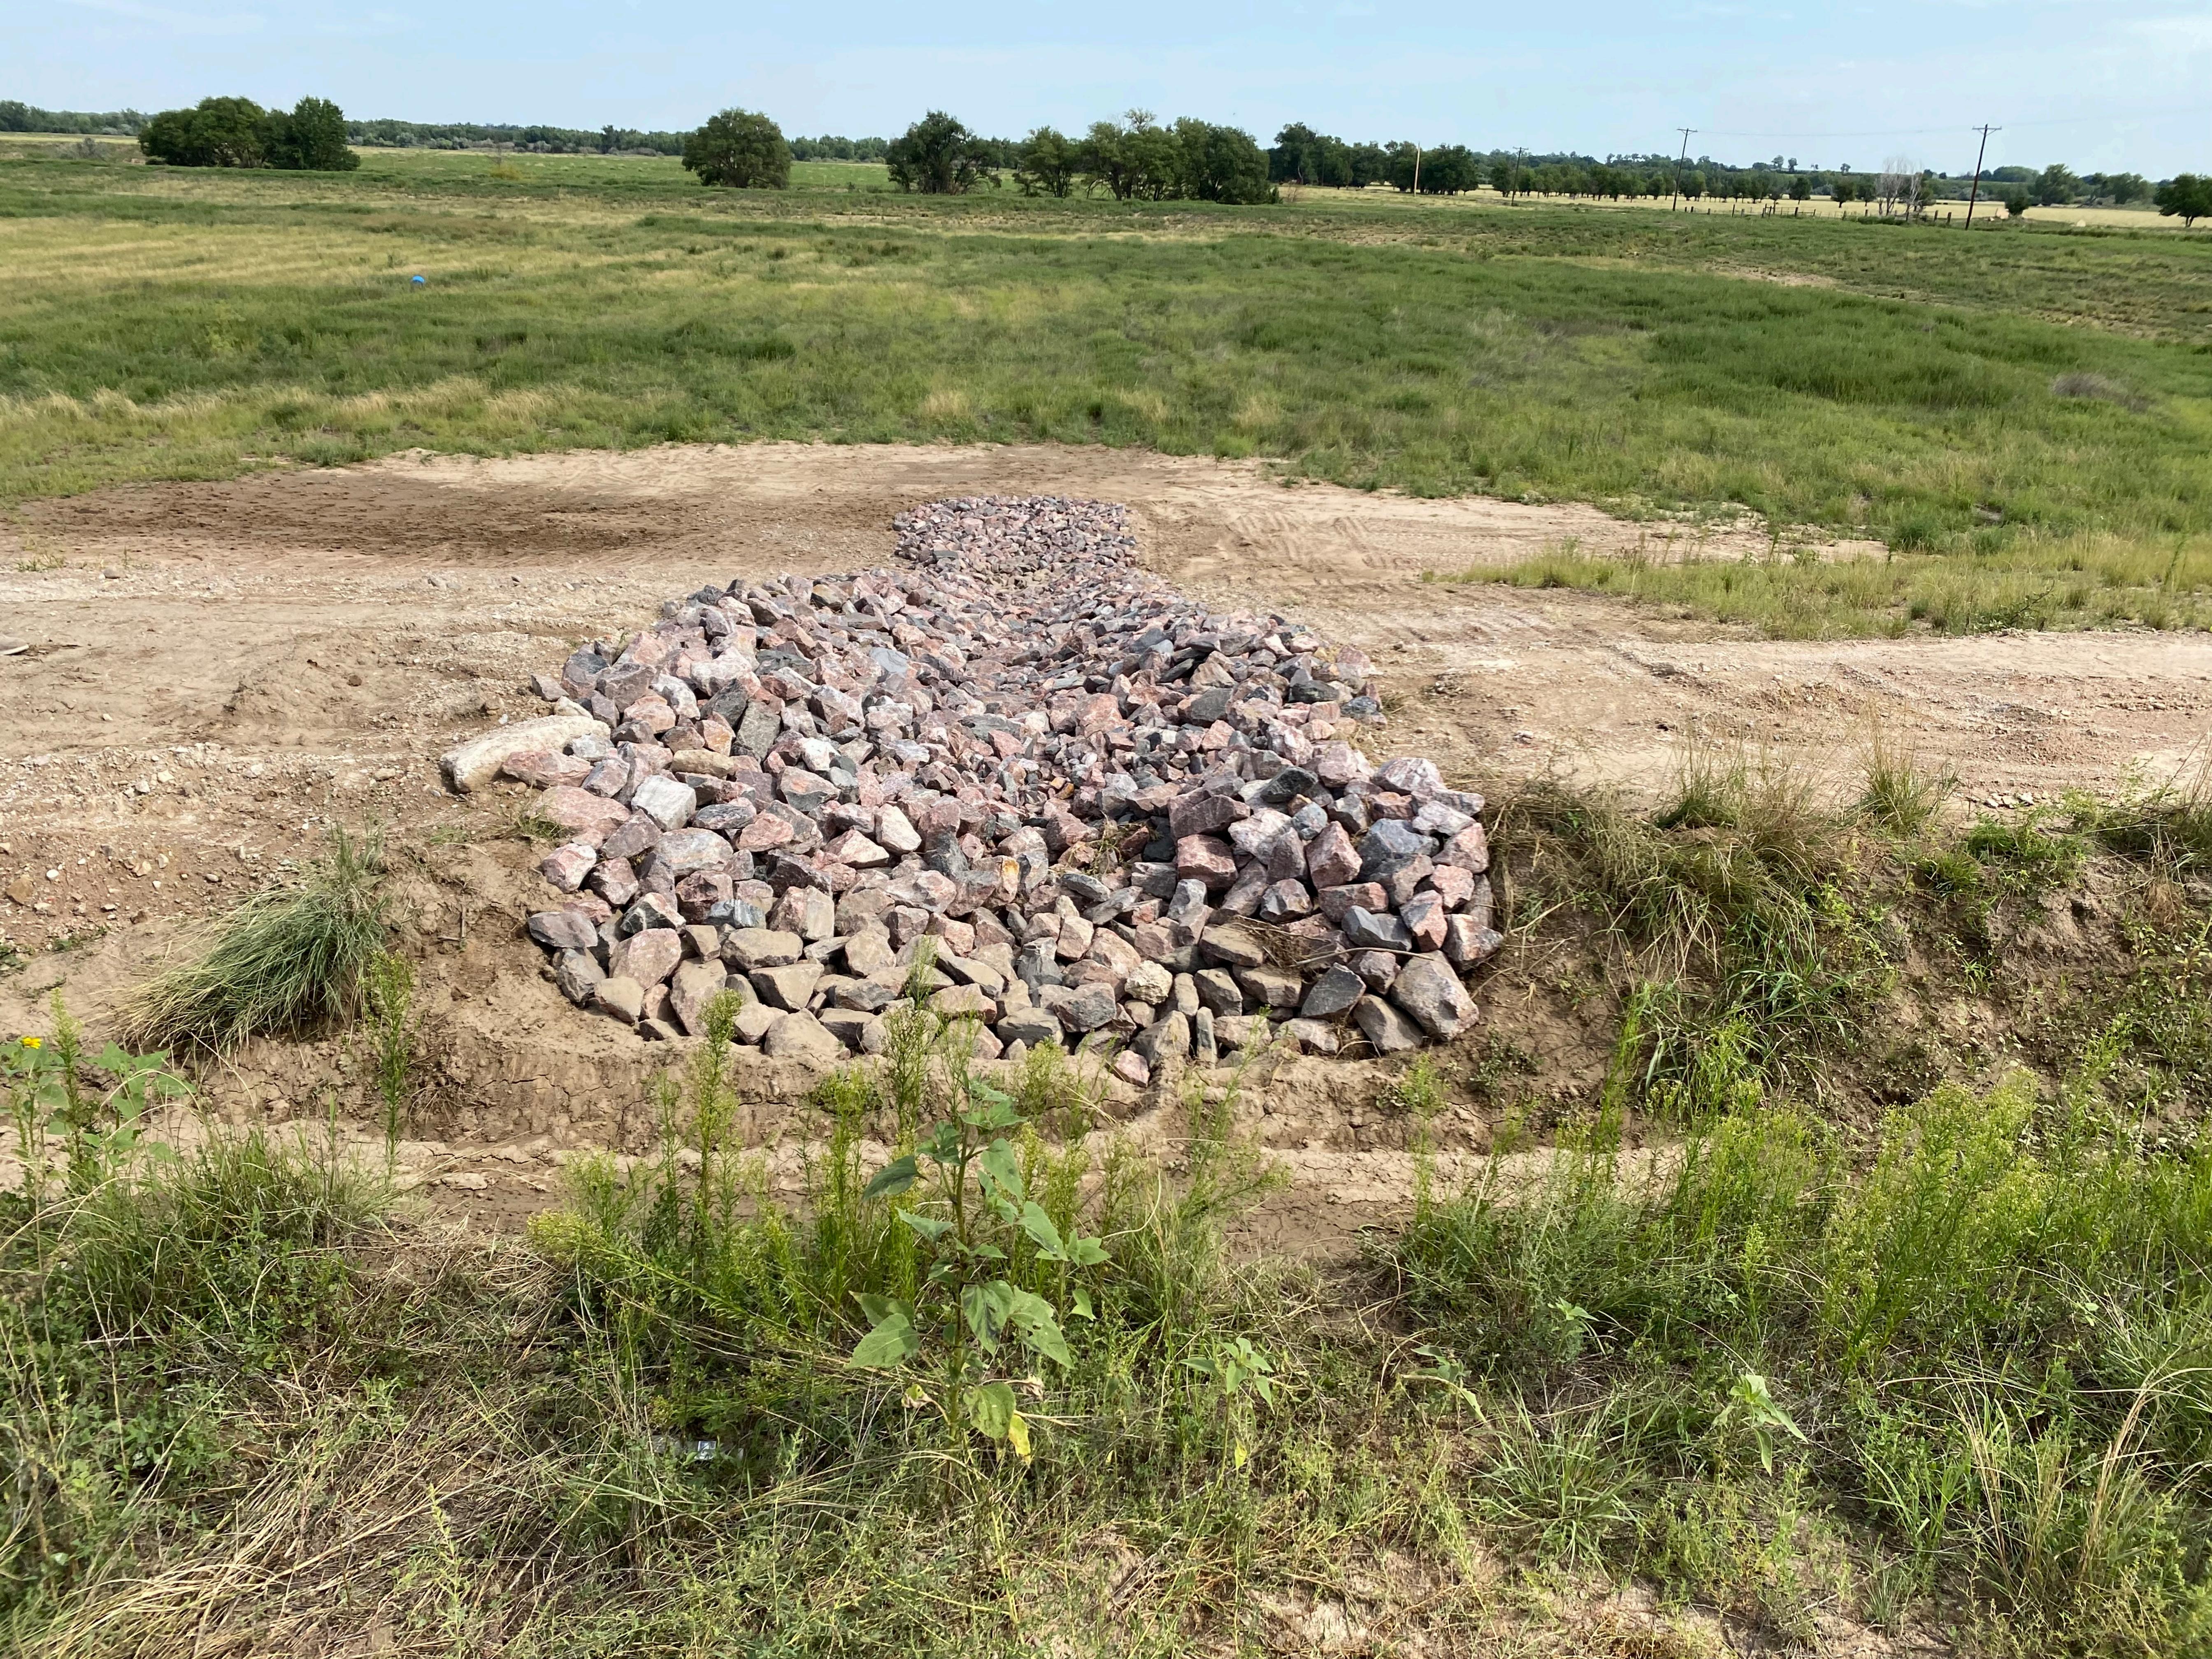
RFEAST1.JPG 8756K

RFEAST1 shows the structure looking north from the south property line.

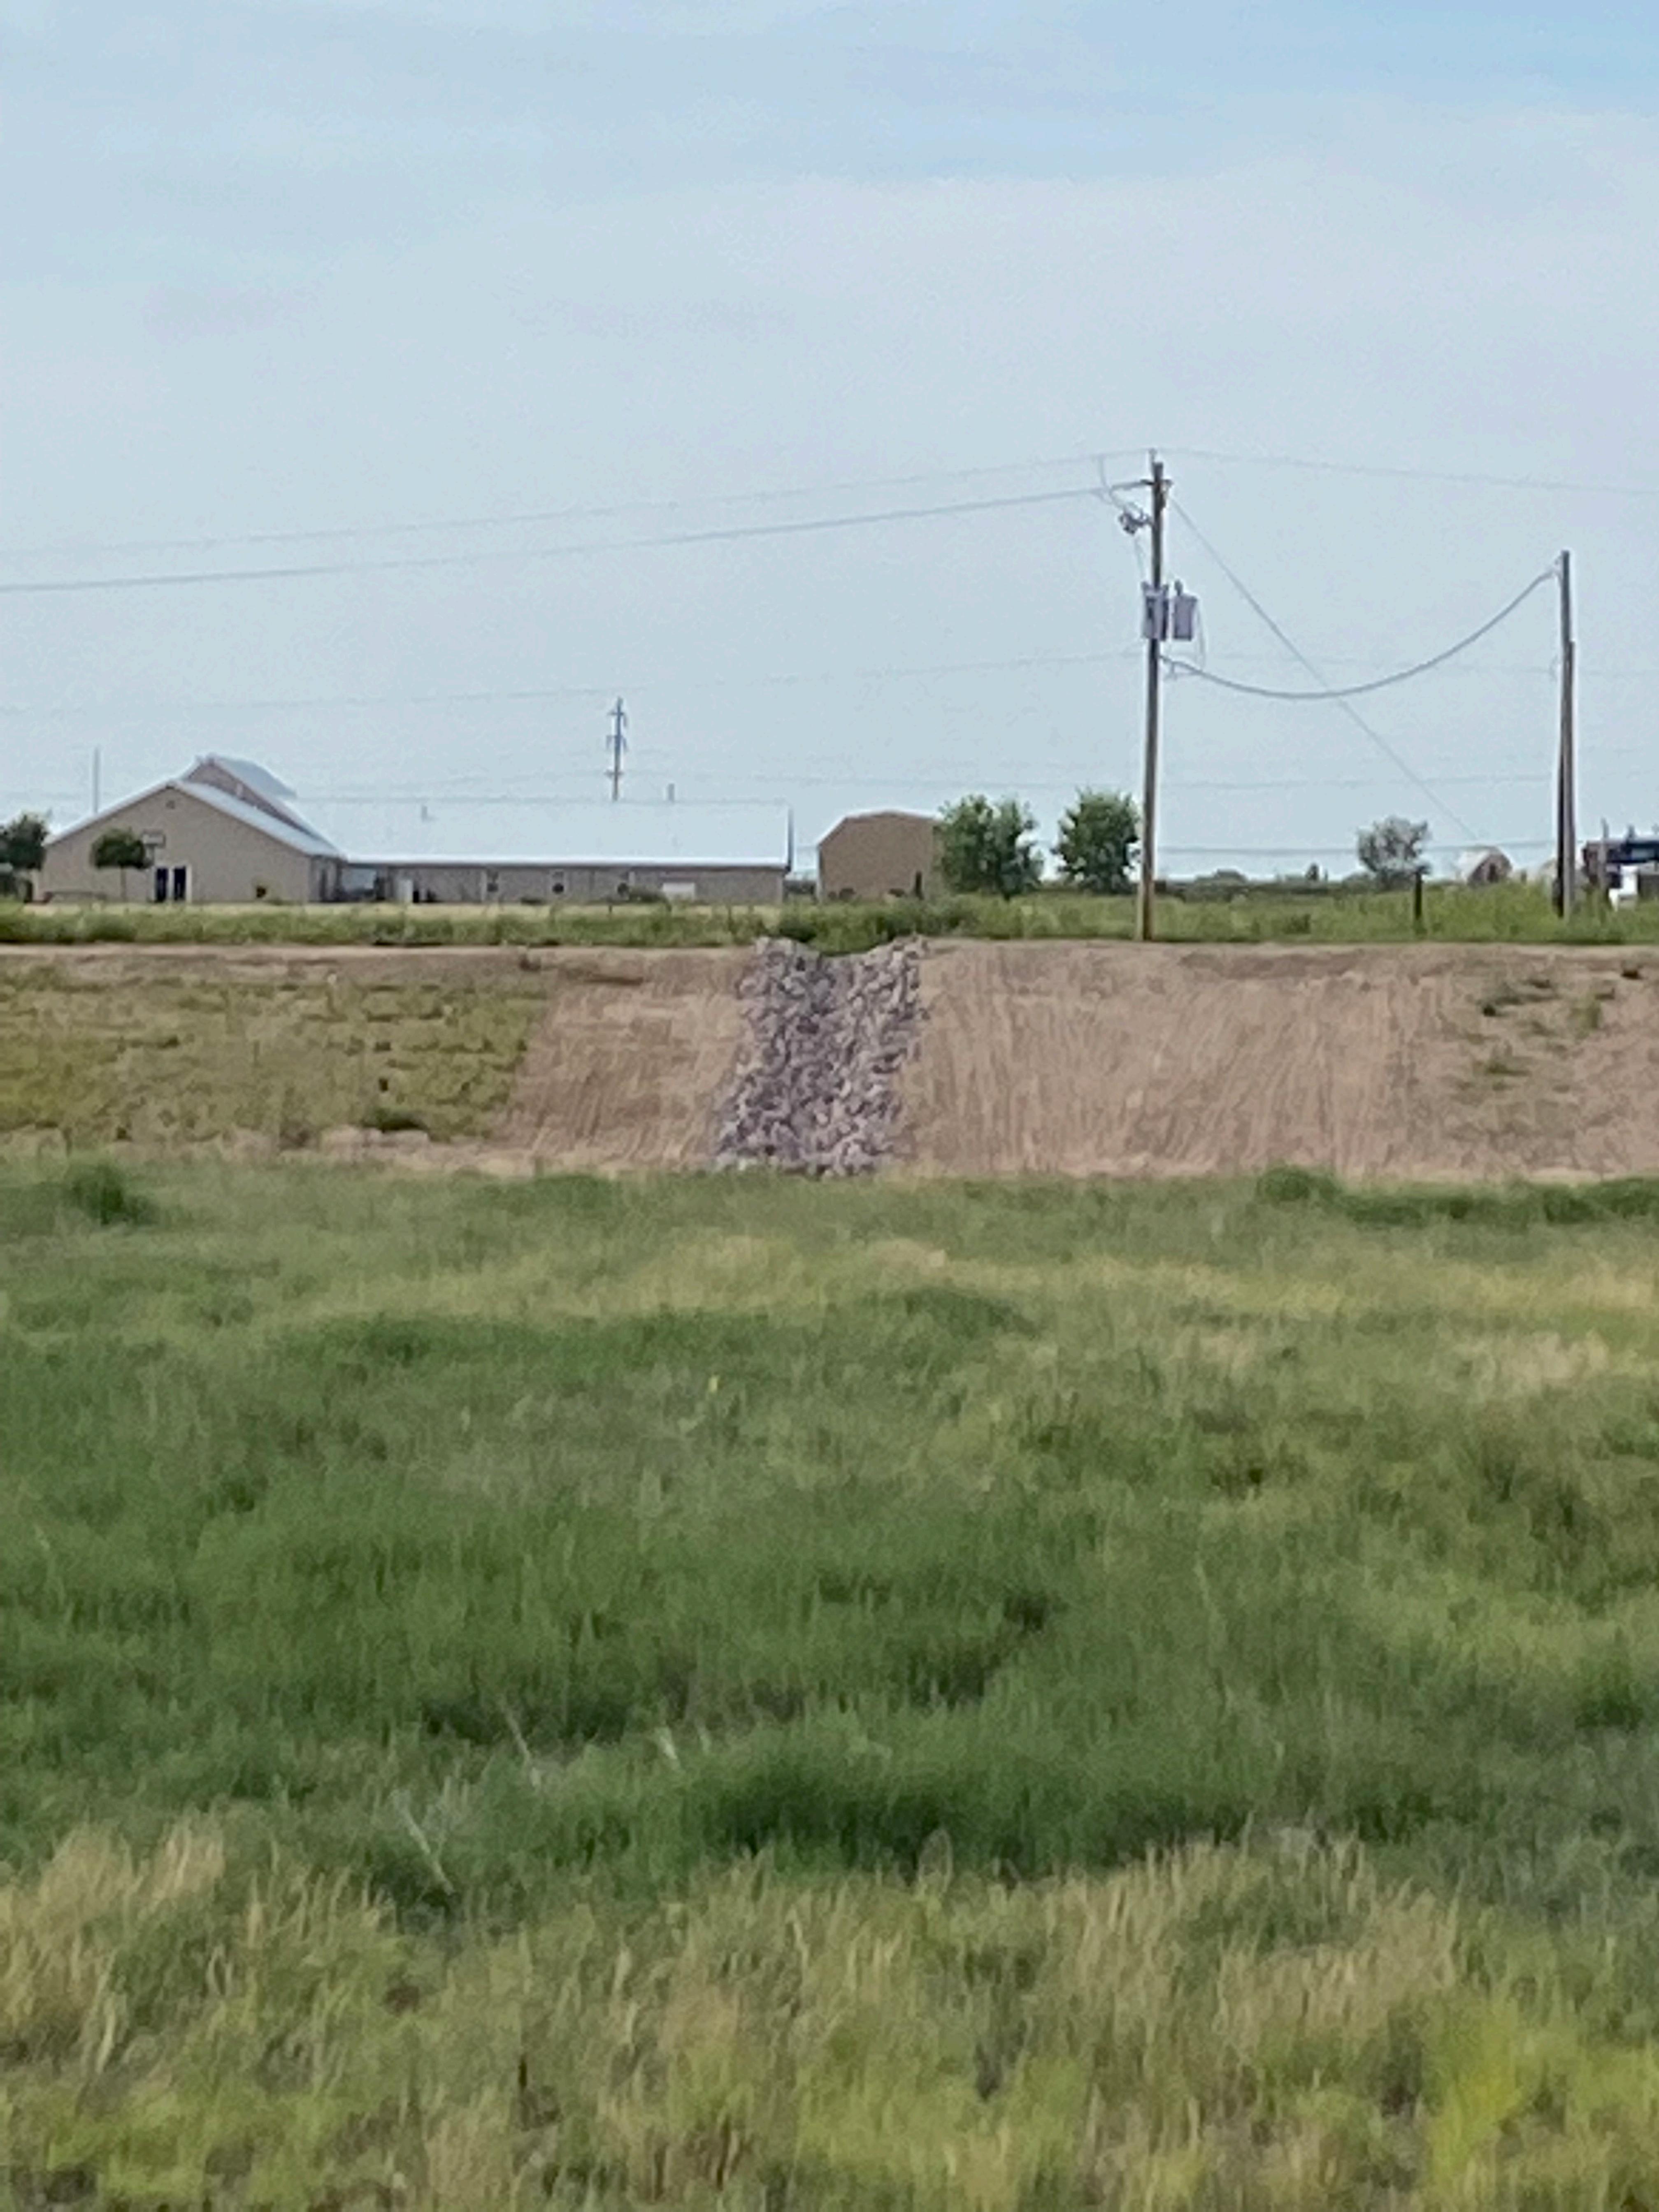
RFE2.JPG 1256K

RFE2 shows the structure from the north property looking south.

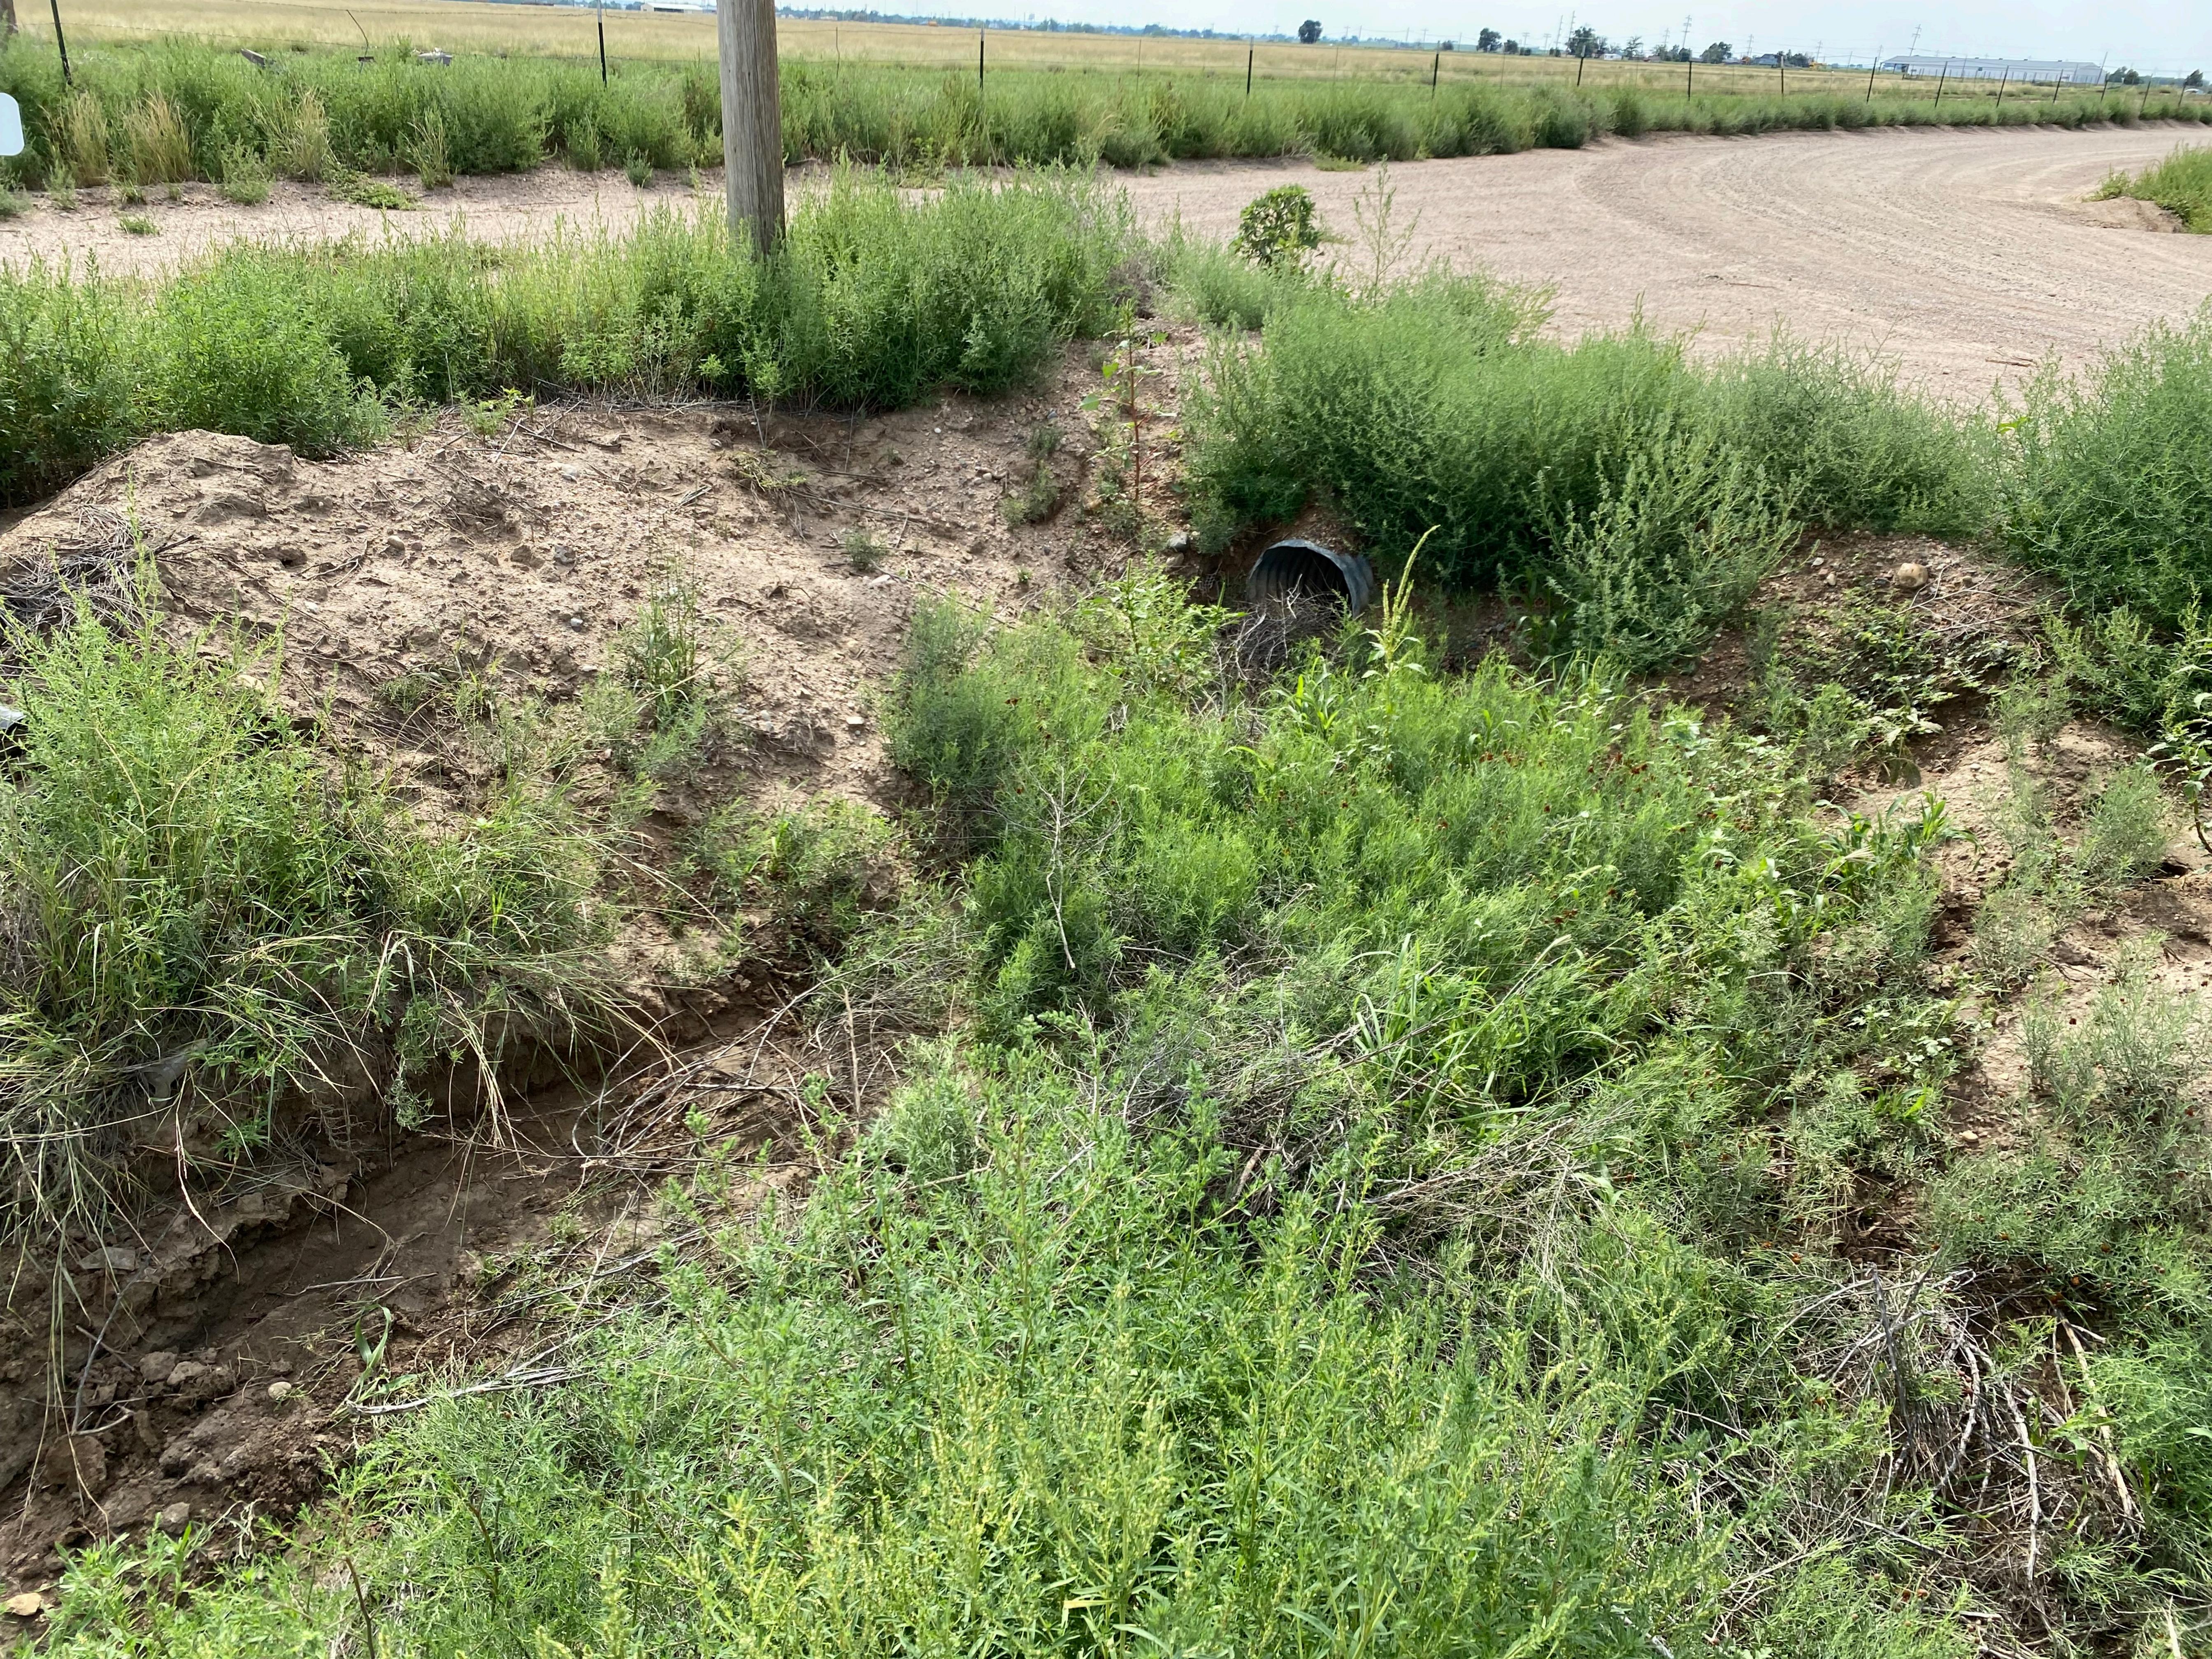
RFE3.JPG 10171K

The attached photo RFE3 shows the area where the old culvert, that was restriction flow, was removed.

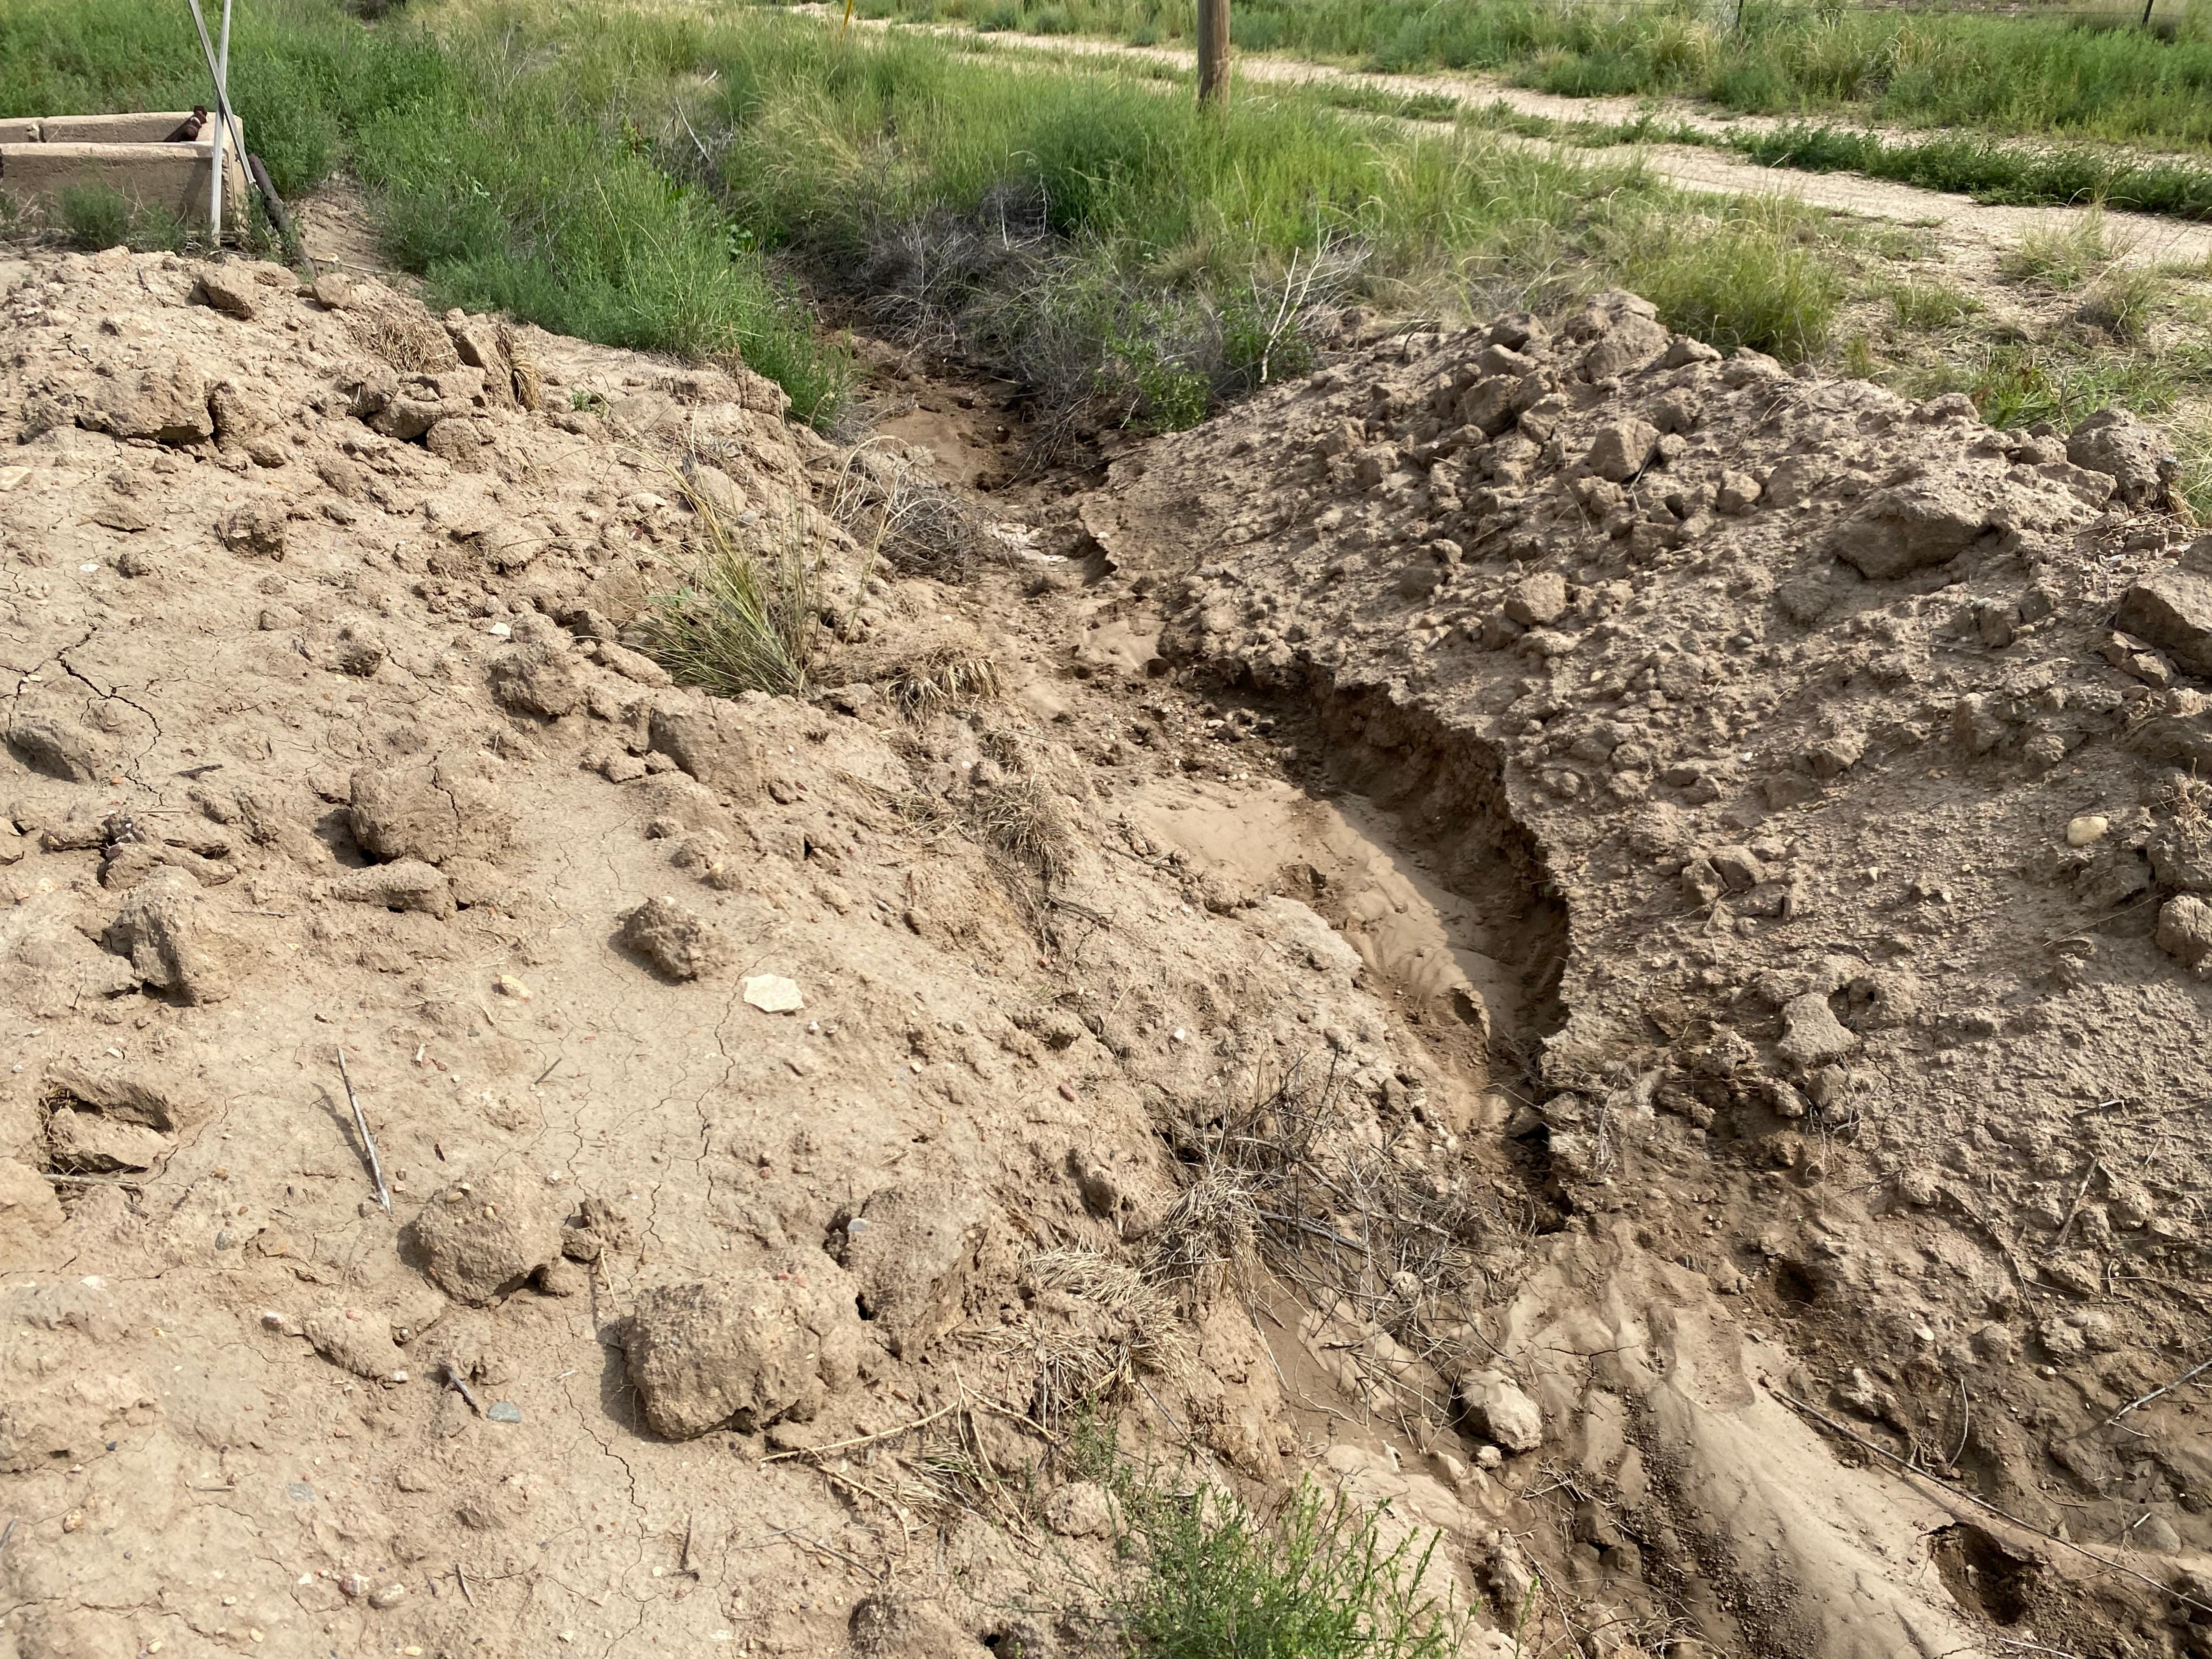
RFE5.JPG 8816K

RFE5 shows the ditch clean out north of where the culvert was removed.
