MINERALS PROGRAM INSPECTION REPORT
PHONE: (303) 866-3567

MINE NAME: Beech Hill Quarries	MINE/PROSPECTING ID#: M-1981-277	MINERAL: Sandstone	COUNTY: Boulder
INSPECTION TYPE: Monitoring	INSPECTOR(S): Patrick Lennberg	INSP. DATE: July 28, 2022	INSP. TIME: 10:30
OPERATOR: Loukonen Bros. Stone Company	OPERATOR REPRESENTATIVE: Michael Loukonen	TYPE OF OPERATION: 112c - Construction Regular Operation

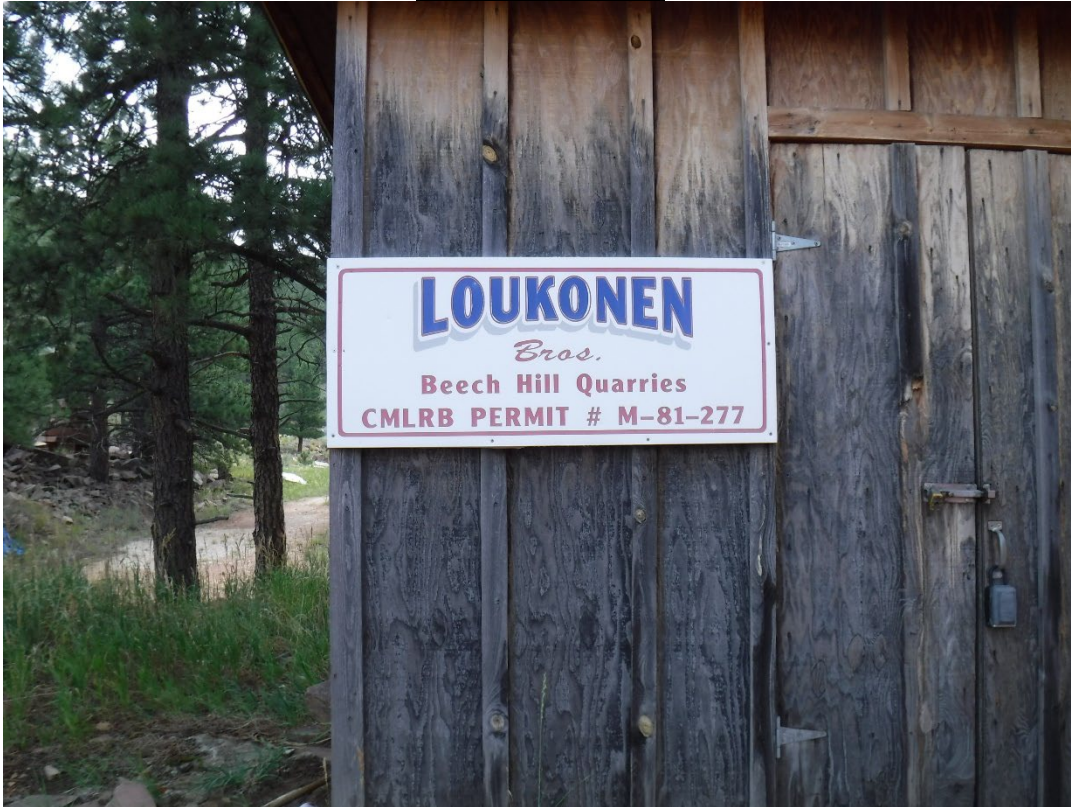
Photo 1: Mine sign at the primary mine entrance

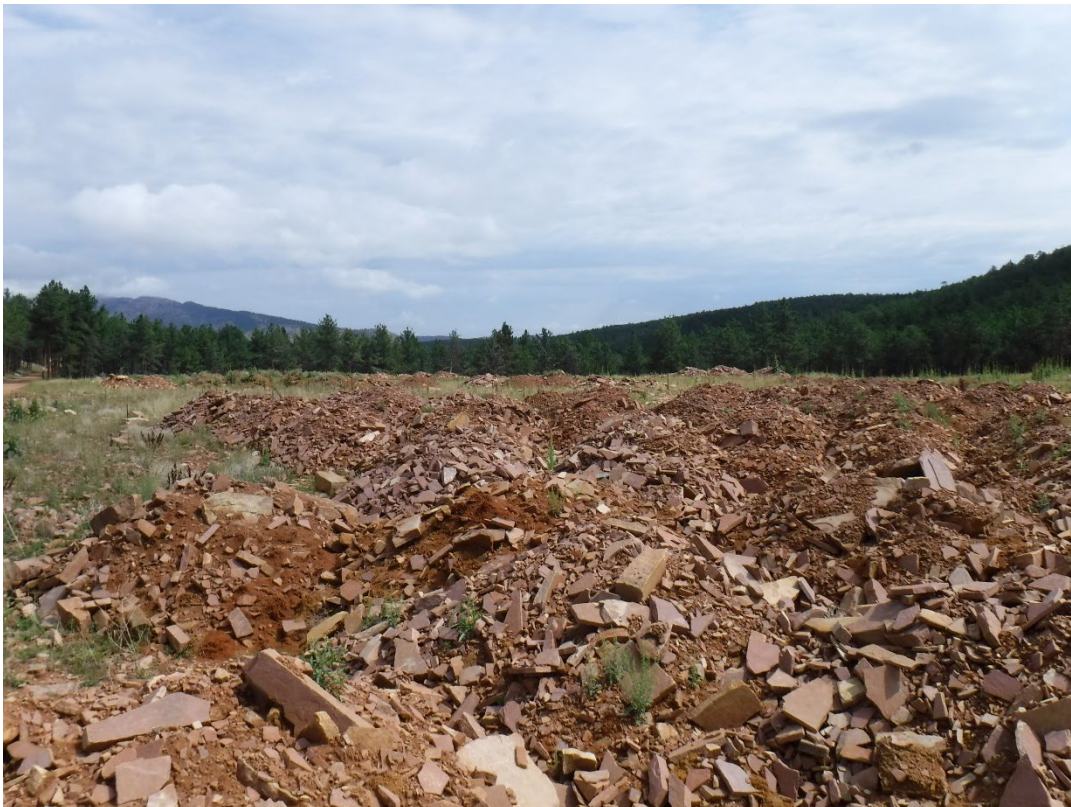
Photo 2: Staging Area 2.5 acres

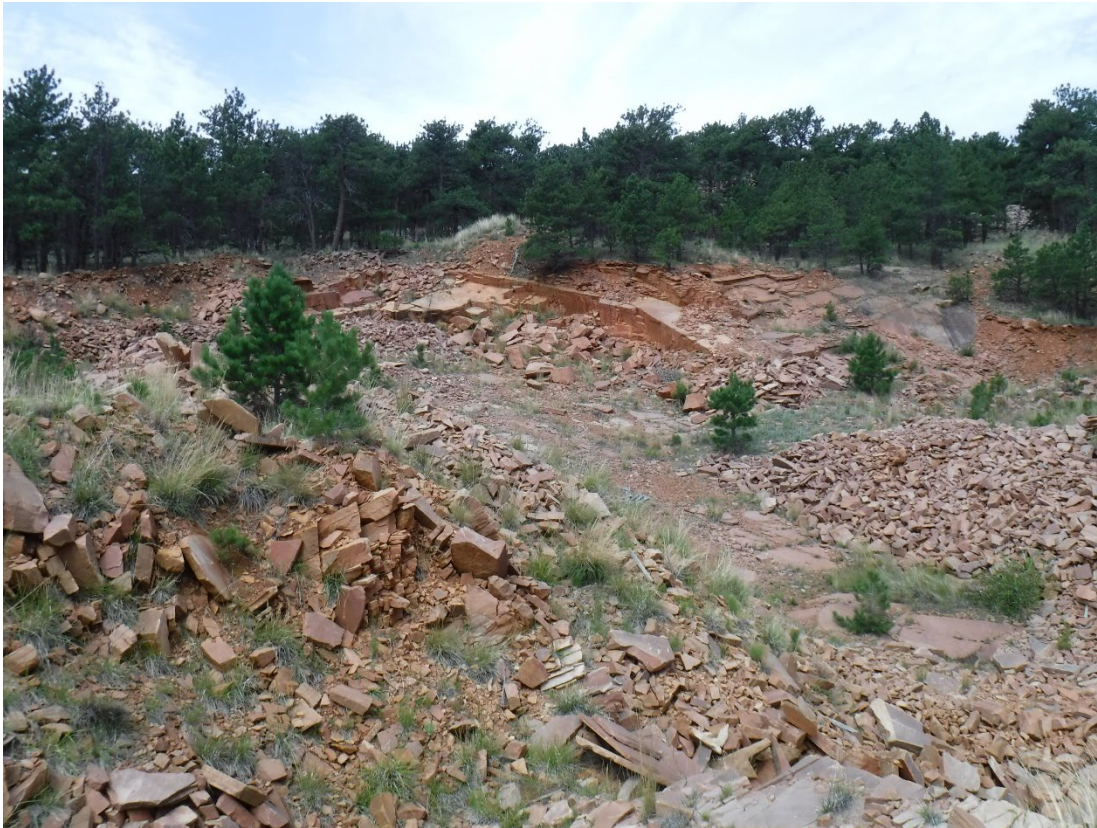
Photo 3: Katri quarry 1.5 acres

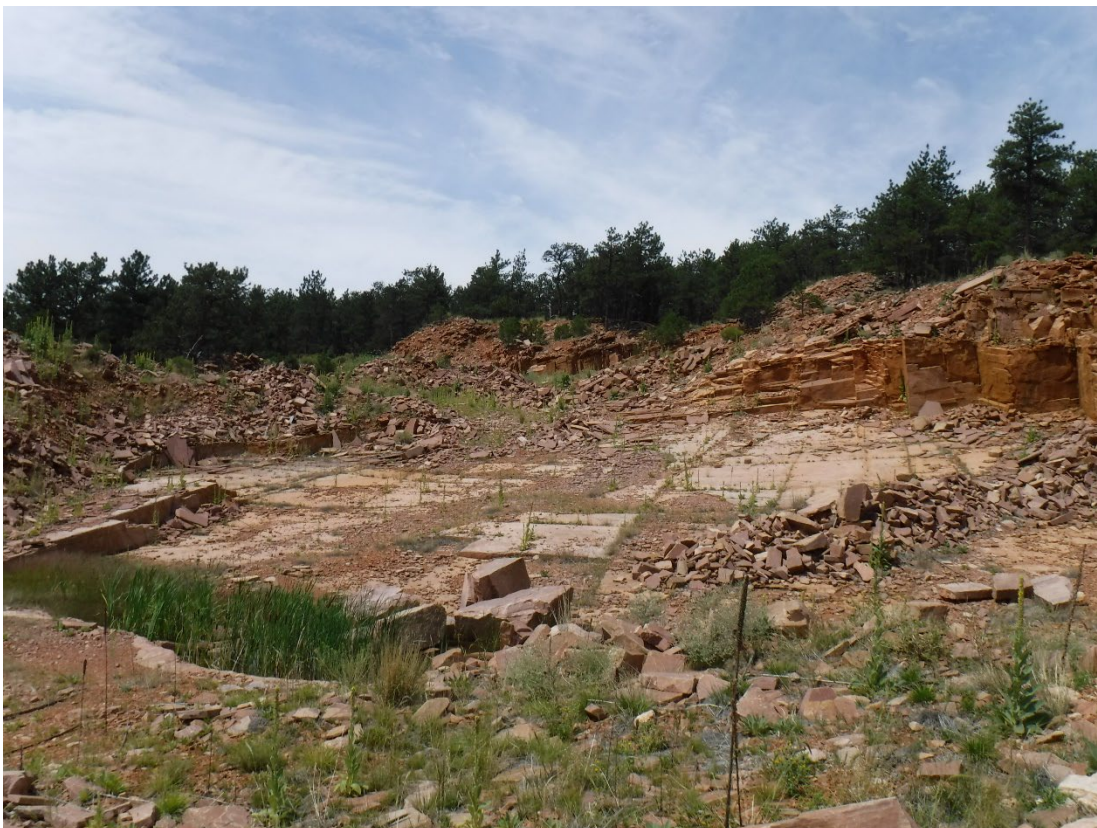
Photo 4: Emil quarry 5.75 acres including the Dump area

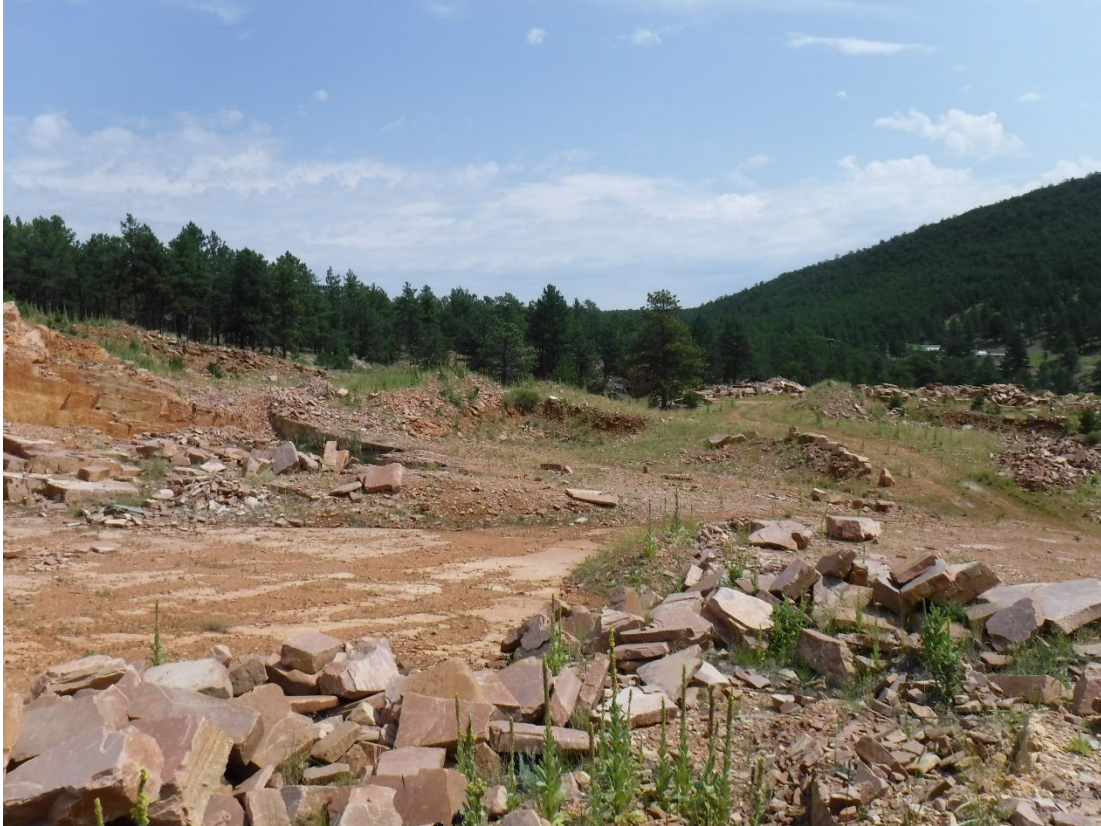
Photo 5: Emil quarry to the left and Dump to the right of the picture

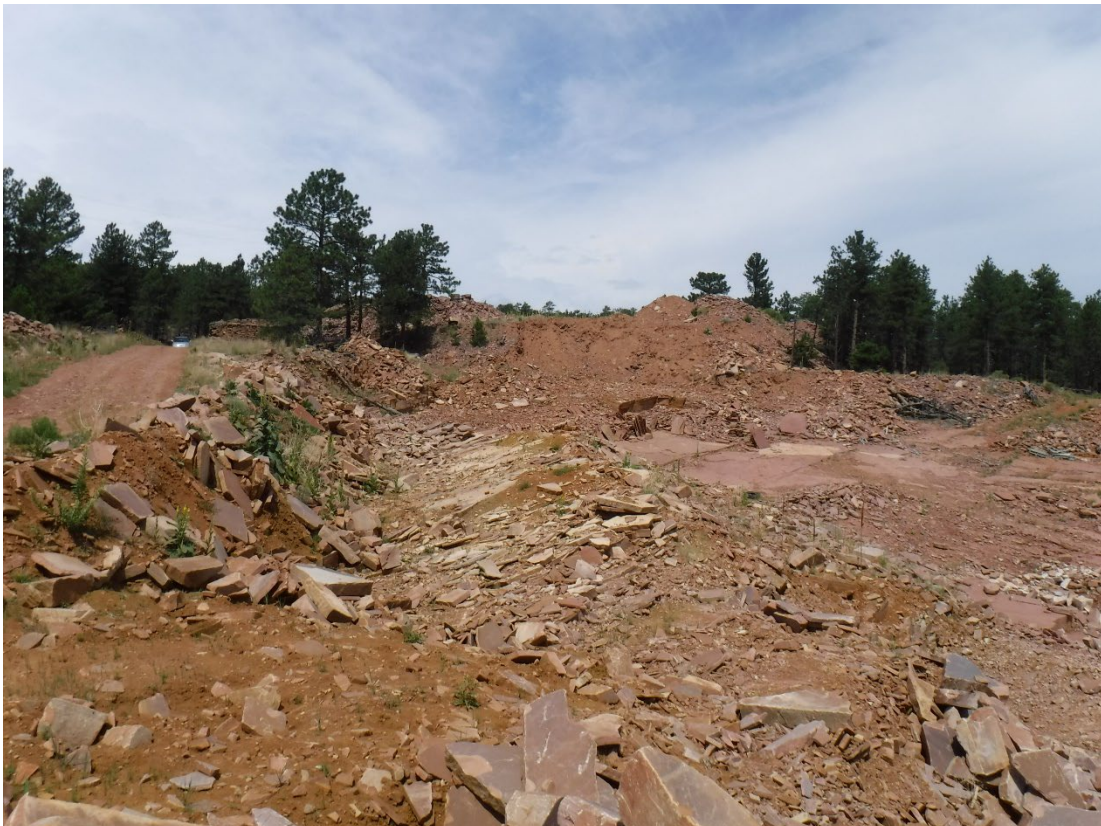
Photo 6: Kupio quarry 7.7 acres, looking west

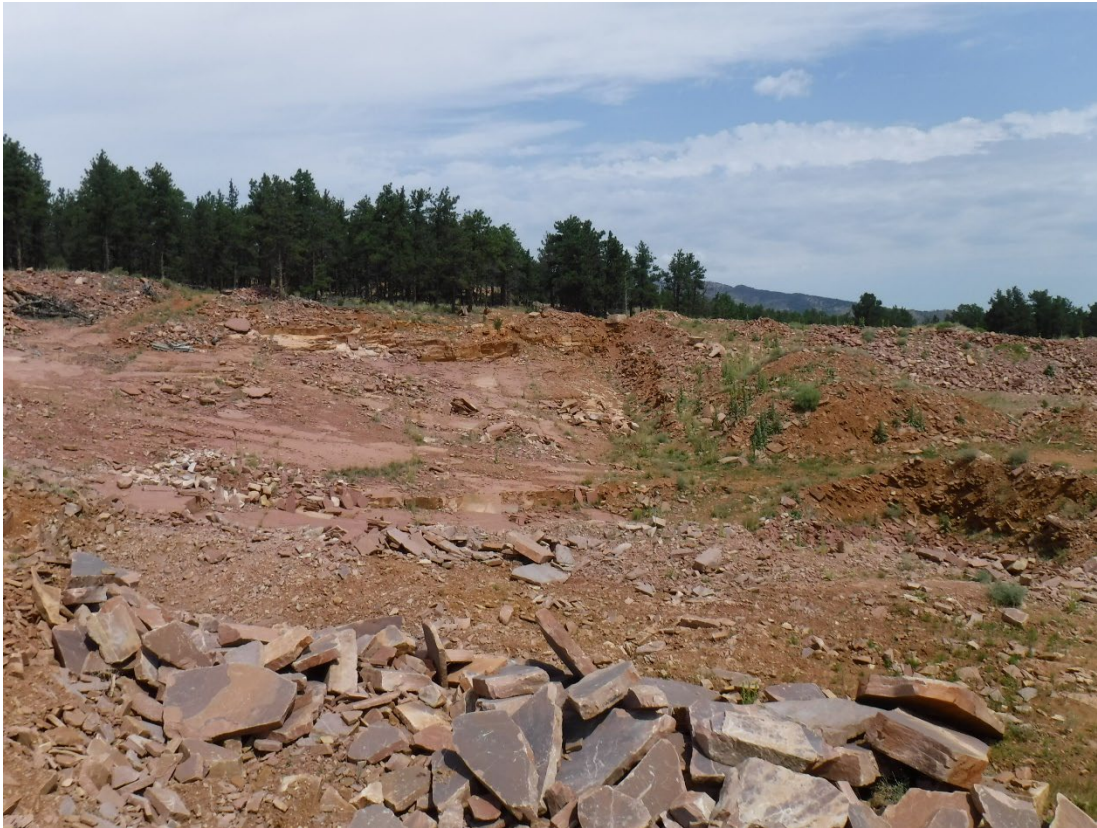
Photo 7: Kupio quarry 7.7 acres, looking north

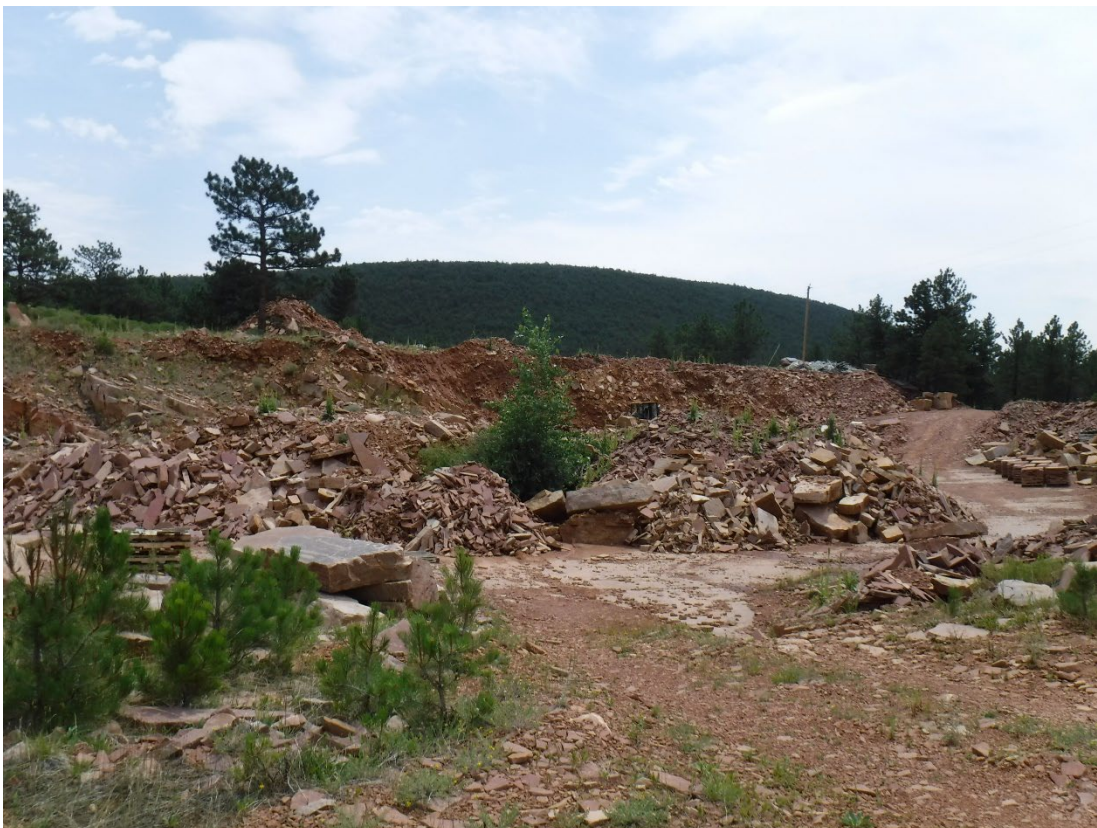
Photo 8: Soumi quarry 5.4 acres, looking south

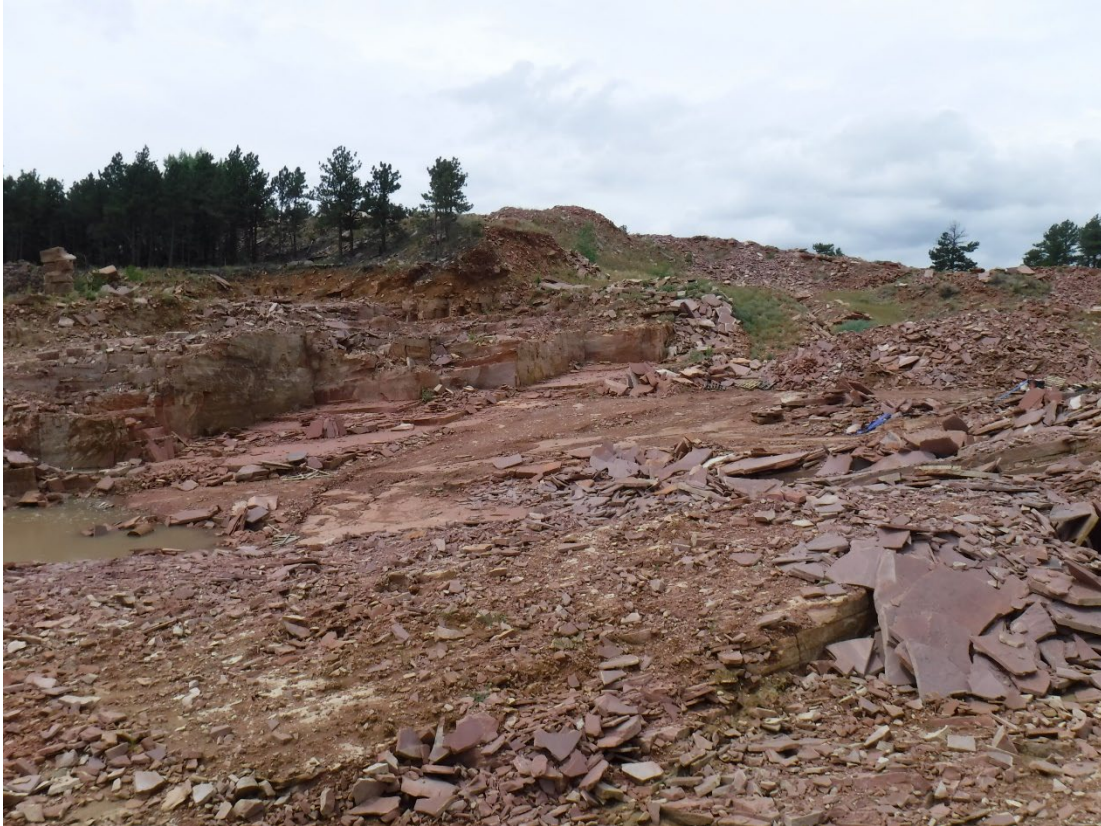
Photo 9: Gust quarry 1.8 acres, looking south

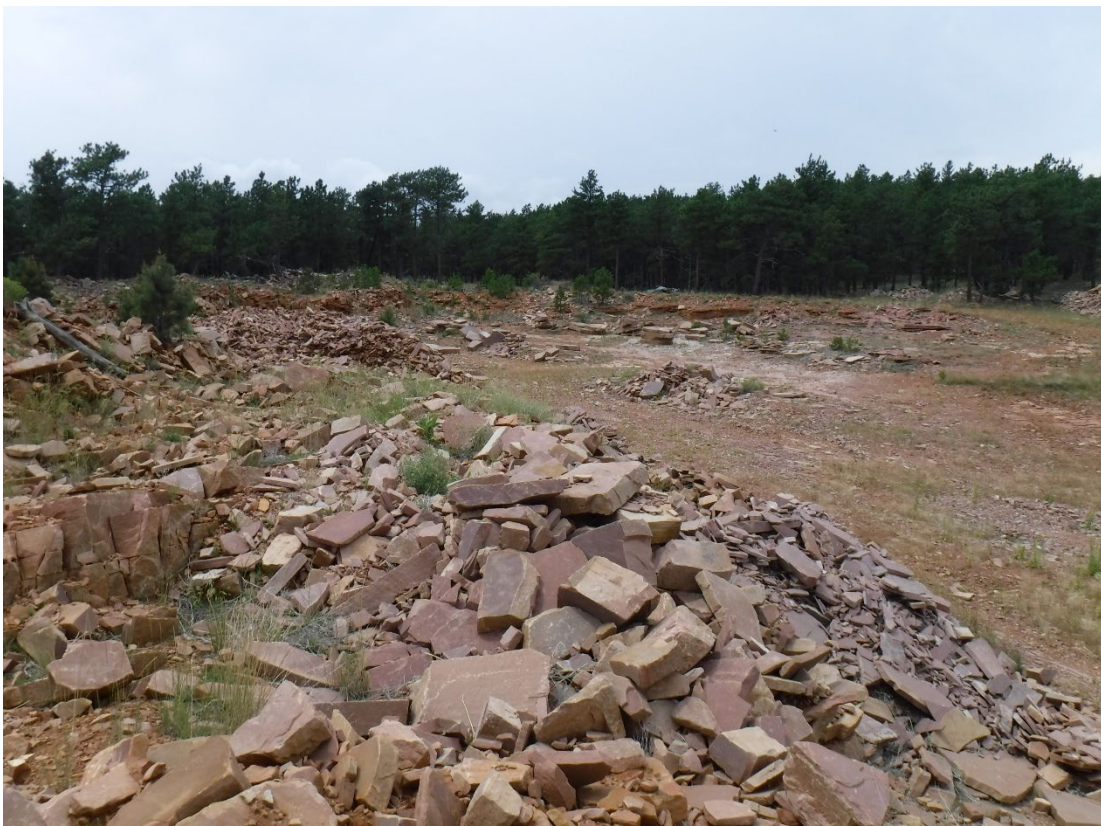
Photo 10: Helsinki quarry 2 acres
