MINERALS PROGRAM INSPECTION REPORT
PHONE: (303) 866-3567

MINE NAME: Cargill Cattle Feeders Dirt Pit	MINE/PROSPECTING ID#: M-2016-040	MINERAL: Clay (general), gravel	COUNTY: Yuma
INSPECTION TYPE: Monitoring	INSPECTOR(S): Nikie Gagnon	INSP. DATE: August 11, 2022	INSP. TIME: 11:30
OPERATOR: Green Plains Cattle Company LLC	OPERATOR REPRESENTATIVE:	TYPE OF OPERATION: 110c - Construction Limited Impact

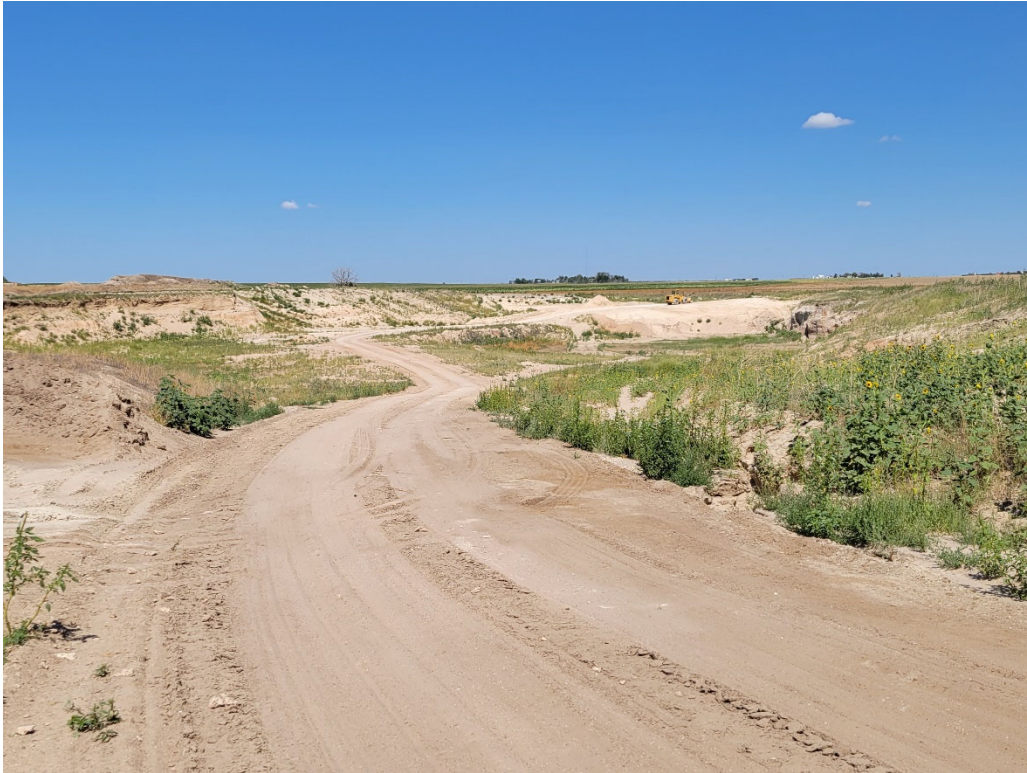
Looking northwest from the entrance to the pit.

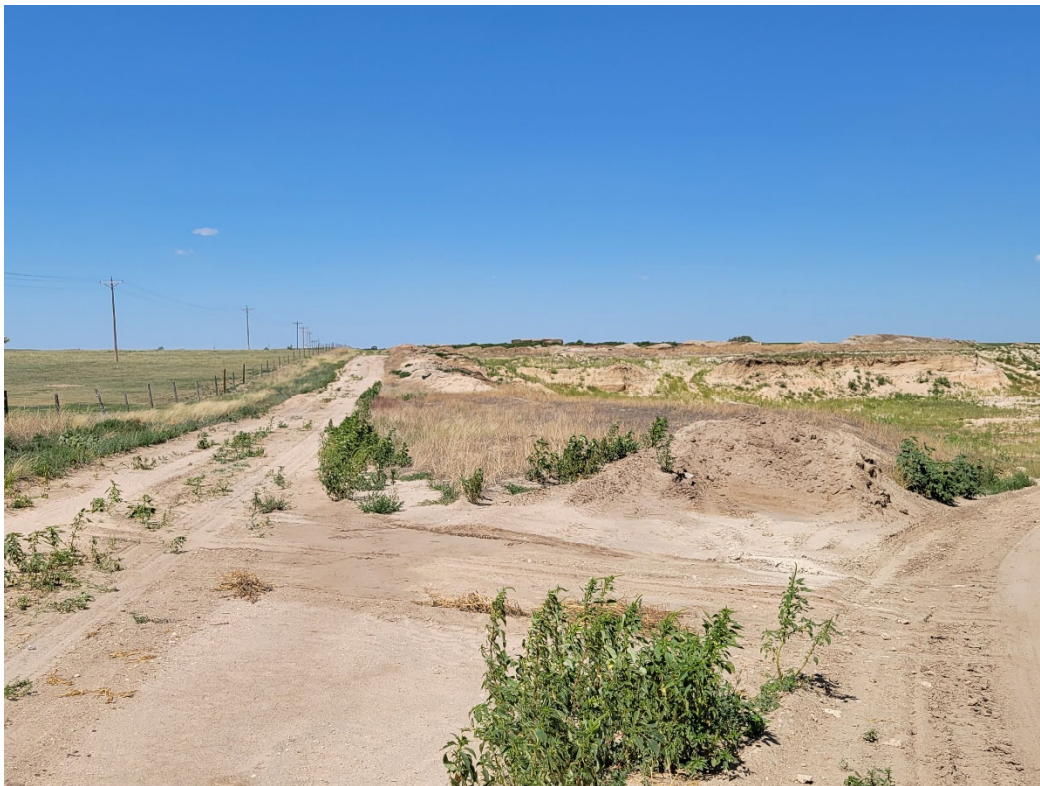
Mine Sign and Boundary Markers: A mine sign is posted at the entrance just off the county road. The permittee listed on the sign is Green Plains Cattle Company. No permit boundary markers are installed around the perimeter. A wire fence runs along the western side of the permit boundary, and the interior road delineates the extent of the disturbance the south and east sides. Per Rule 3.1.12 the boundaries of the affected area must be marked by markers or monuments that are clearly visible and adequate to delineate the permit boundary. Note, upon approval of the Request for Transfer, the mine sign at the entrance will need to be replaced to show Cobalt Cattle Company and the new Operator.

Looking west from the entrance, road and fence line run along the southern edge of permit area.

CORRECTIVE ACTIONS: Install boundary markers and send photos showing the markers in place.

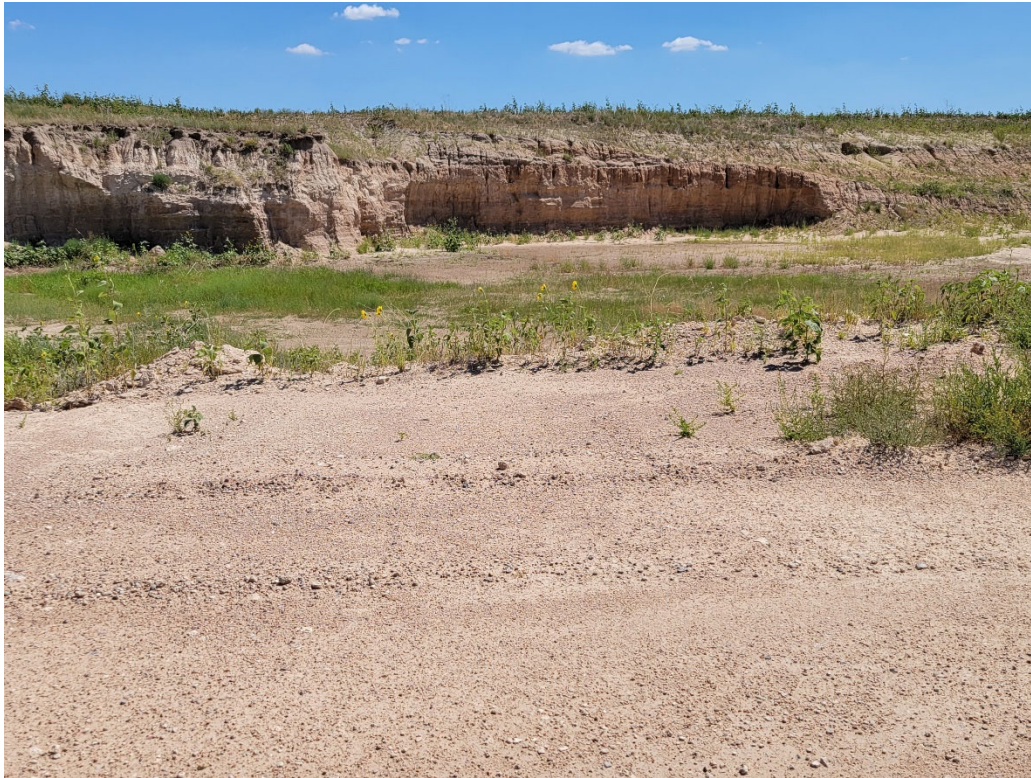
Water appears to flow into the bottom of the pit and infiltrate into the ground. A low spot in the pit near the eastern wall was damp during the inspection, however, no pool of water was visible. The operator on site indicated a recent heavy rain event left water in the pit which drained over a few days.

Looking east at the vertical highwall. Water collects at the base of this wall during heavy rain and infiltrates into the ground.

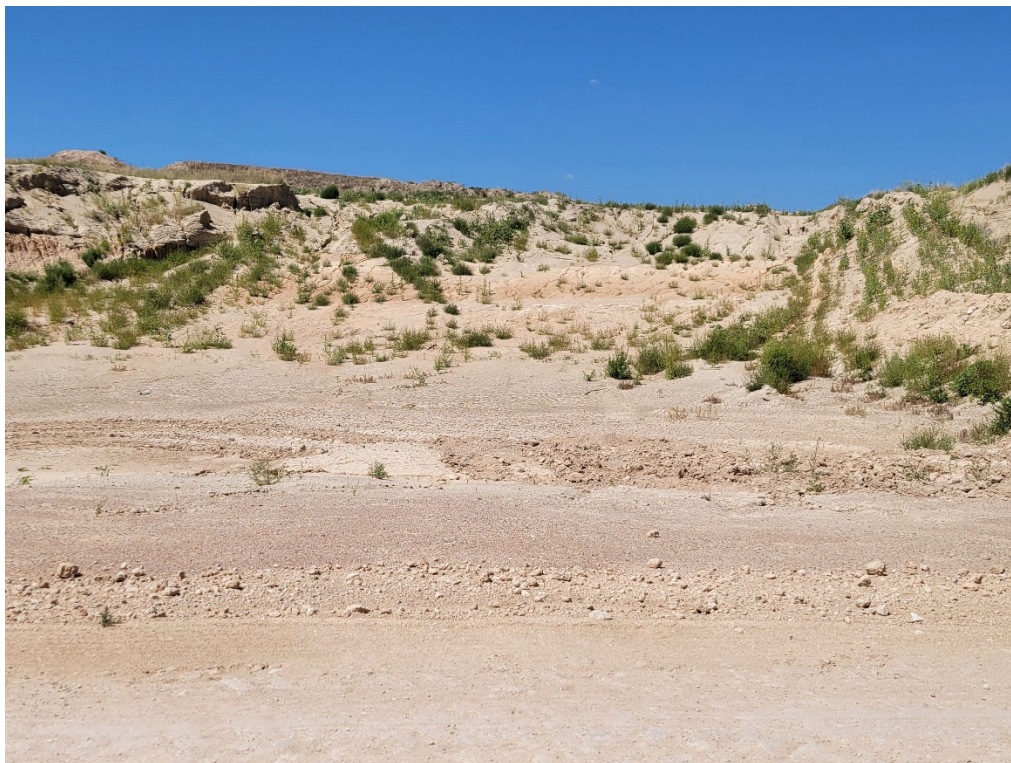
Looking northwest at the highwall. No recent disturbance noted.

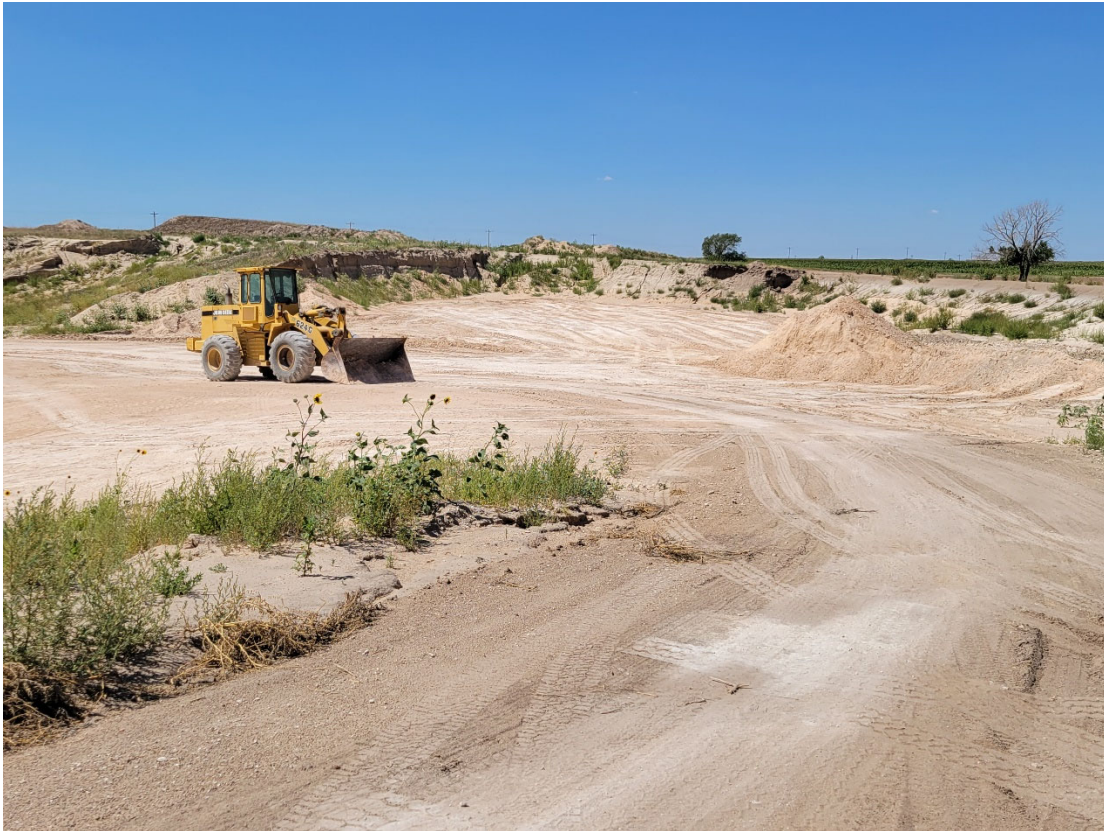
Looking west across pit. Stockpiled material for loading in the northern center of the pit.

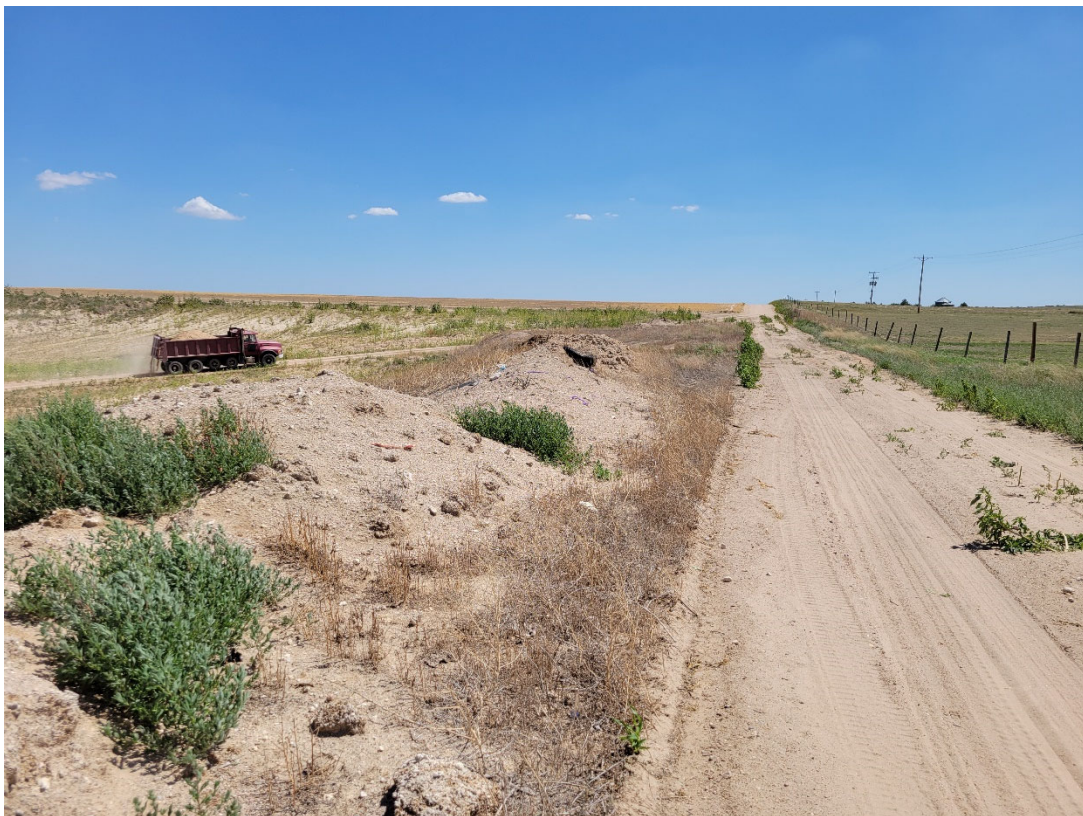
Looking east at dump truck taking material from the site. Piles of soil and mulch stored along road.

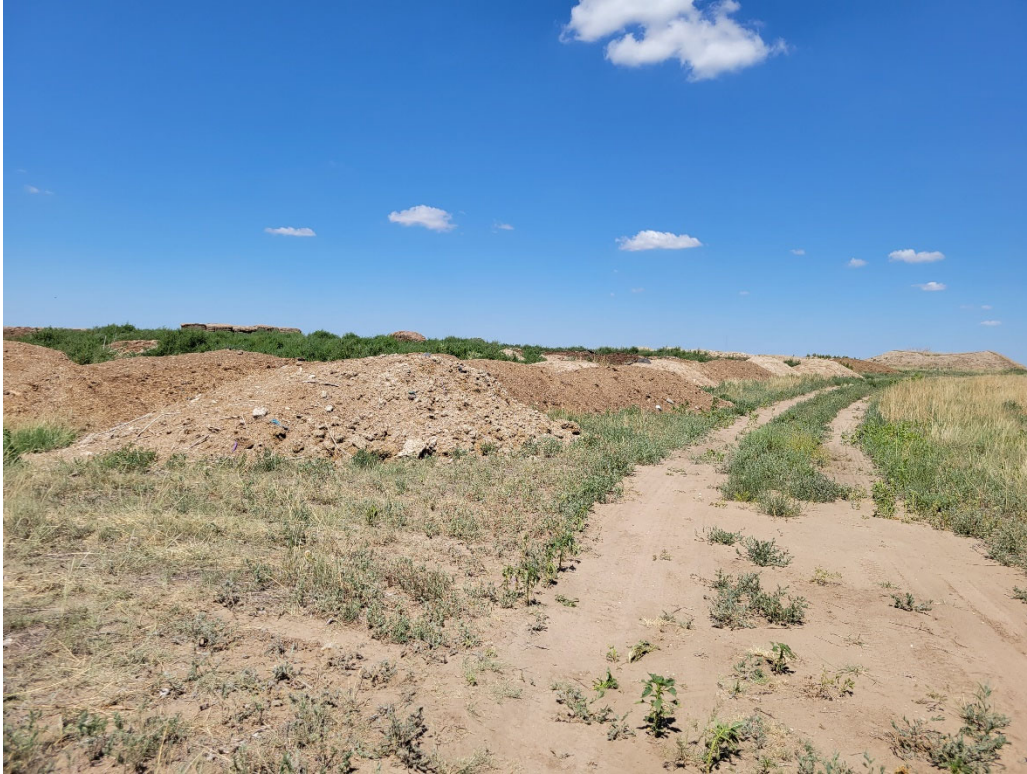
Topsoil: According to the permit application, no topsoil would be stockpiled prior to mining. However, numerous mounds of organic material have been placed above the south and southwest highwalls. The operator on site indicated this mulch will be used for reclamation in the future.

Looking east from the western tip of disturbance, soil/mulch piles stored above the pit for future reclamation.

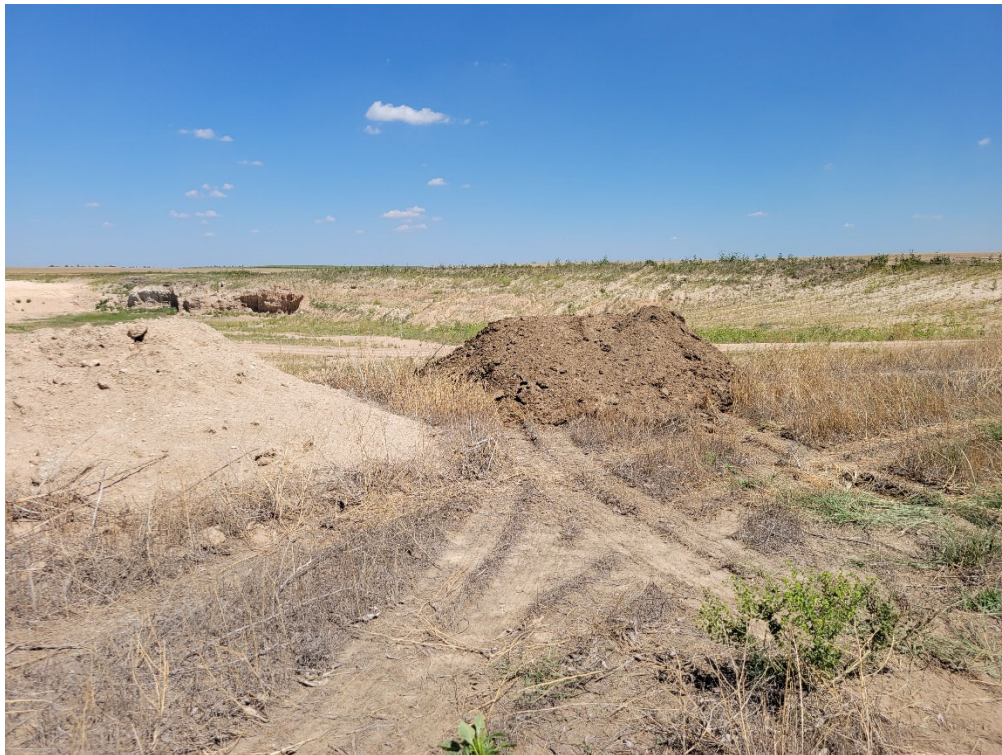
Looking east from the southern access road. Soil pile, dumped from truck during inspection.

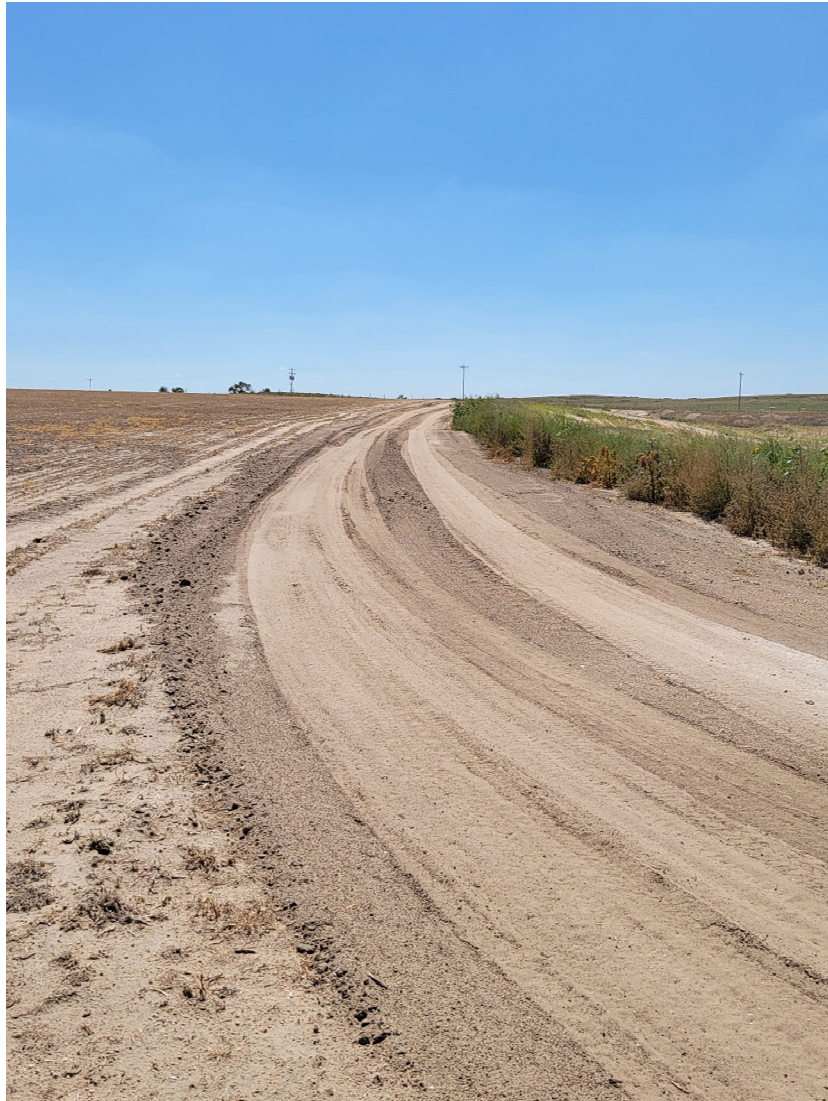
A gravel access road to the site is adequately maintained. An interior dirt road runs along three sides of the pit and was used by the dump truck to access the pit during the inspection.

Looking southeast along road used by dump truck to access pit. Road delineates area of mining disturbance from the farm operation to the east.

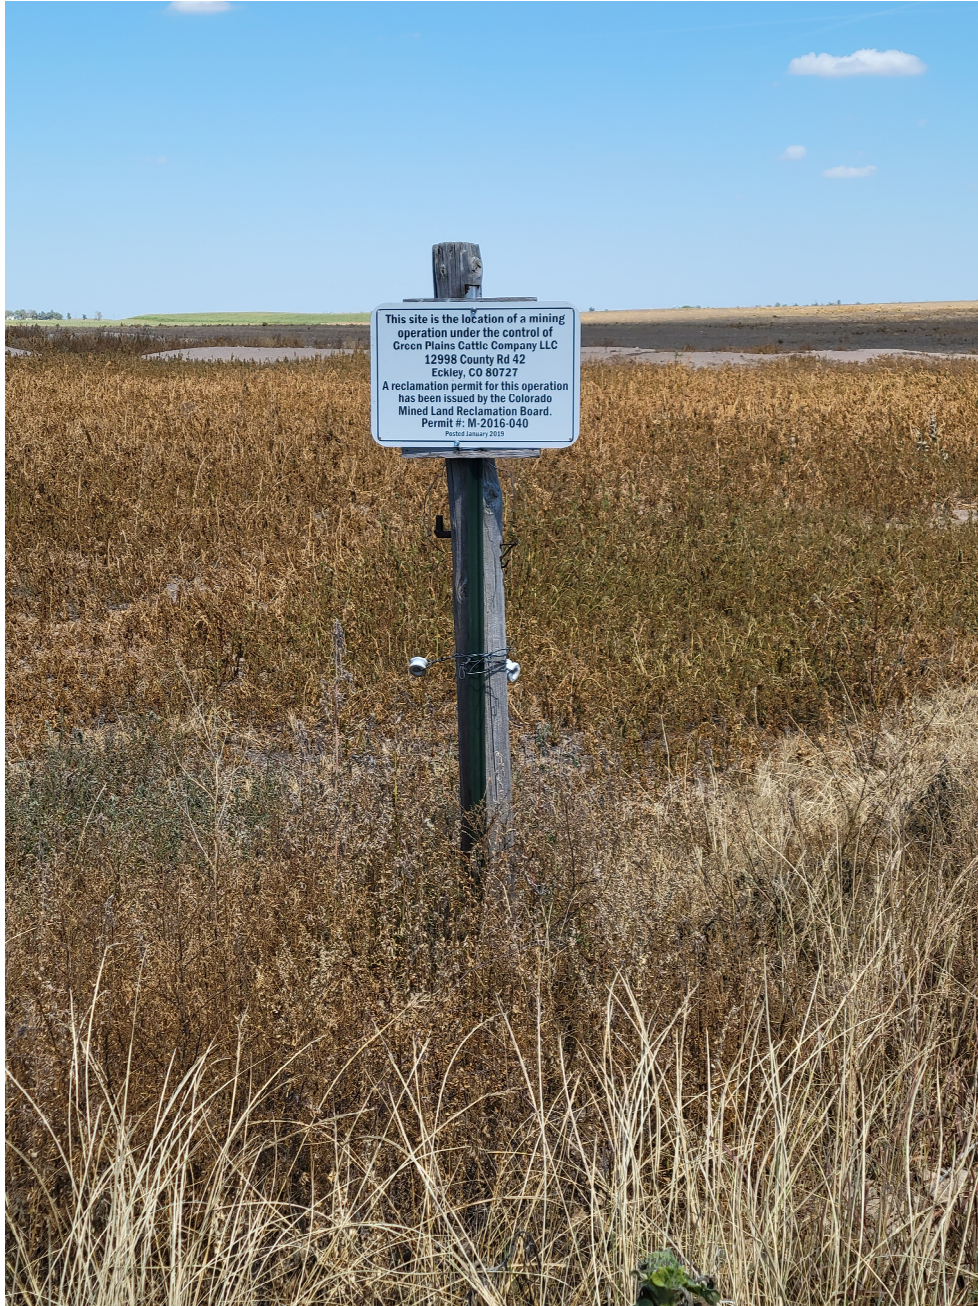
Mine sign posted at the entrance, shows Green Plains Cattle Company, LLC as the operator.
