**MINERALS PROGRAM INSPECTION REPORT**  
**PHONE: (303) 866-3567**

<b>MINE NAME:</b> Smith Pit	<b>MINE/PROSPECTING ID#:</b> M-2021-035	<b>MINERAL:</b> Clay (general) and sand gravel	<b>COUNTY:</b> Yuma
<b>INSPECTION TYPE:</b> Monitoring	<b>INSPECTOR(S):</b> Nikie Gagnon	<b>INSP. DATE:</b> August 11, 2022	<b>INSP. TIME:</b> 10:00
<b>OPERATOR:</b> Yuma County	<b>OPERATOR REPRESENTATIVE:</b> Tom Andersen	<b>TYPE OF OPERATION:</b> 112c - Construction Regular Operation

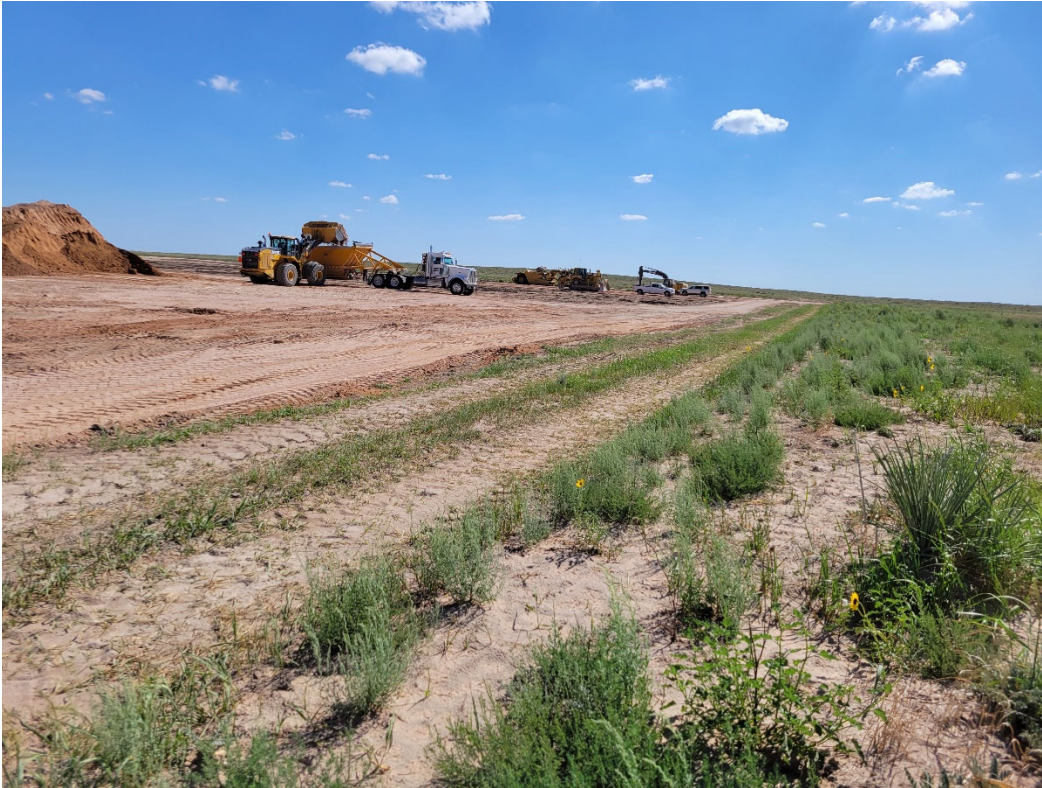
Looking east from the interior access road. Entrance to the active mining area, parking/staging area.

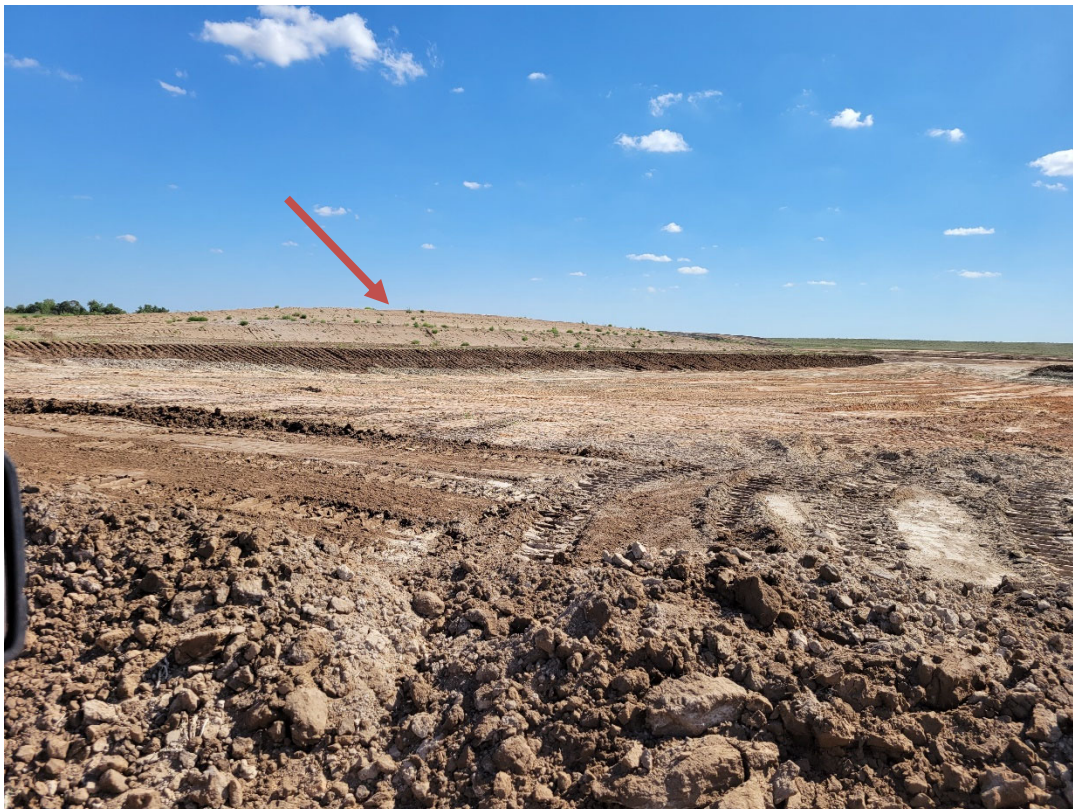
The approved mine plan calls for placing topsoil and overburden along the northern boundary of the permit area. During the inspection, topsoil was stored along the northern edge of the Phase 1 mining area, and along the northern permit boundary. Tom Andersen indicated the topsoil location near the active mining cell is preferred because they would like to reclaim in phases and would prefer to keep the topsoil closer to the active pit for ease of replacing the soil. During the inspection, the Division discussed with Mr. Anderson that a Technical Revision is needed to update the mine and reclamation plan maps and narratives to address the phased mining and reclamation approach and the location of the topsoil as it differs from the current approved plan.

Looking north across phase 1 pit area of active mining. Topsoil pile along northern edge of pit.

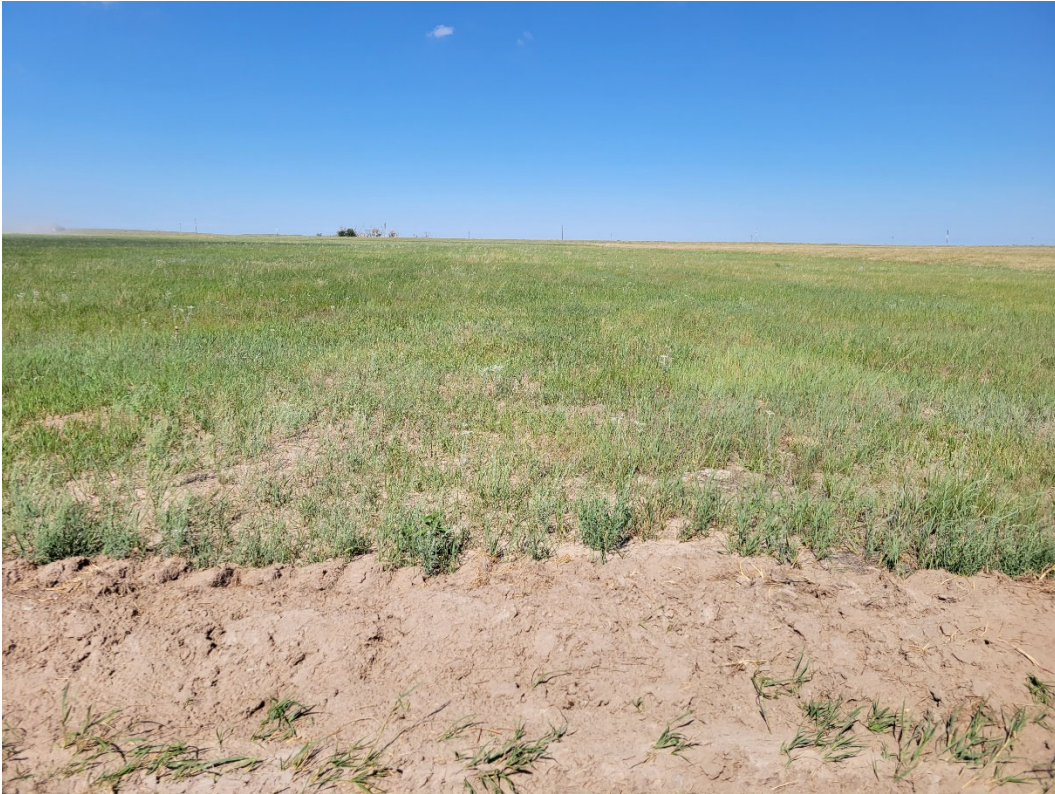
Looking west across phase 2 area, edge of current disturbance in foreground.

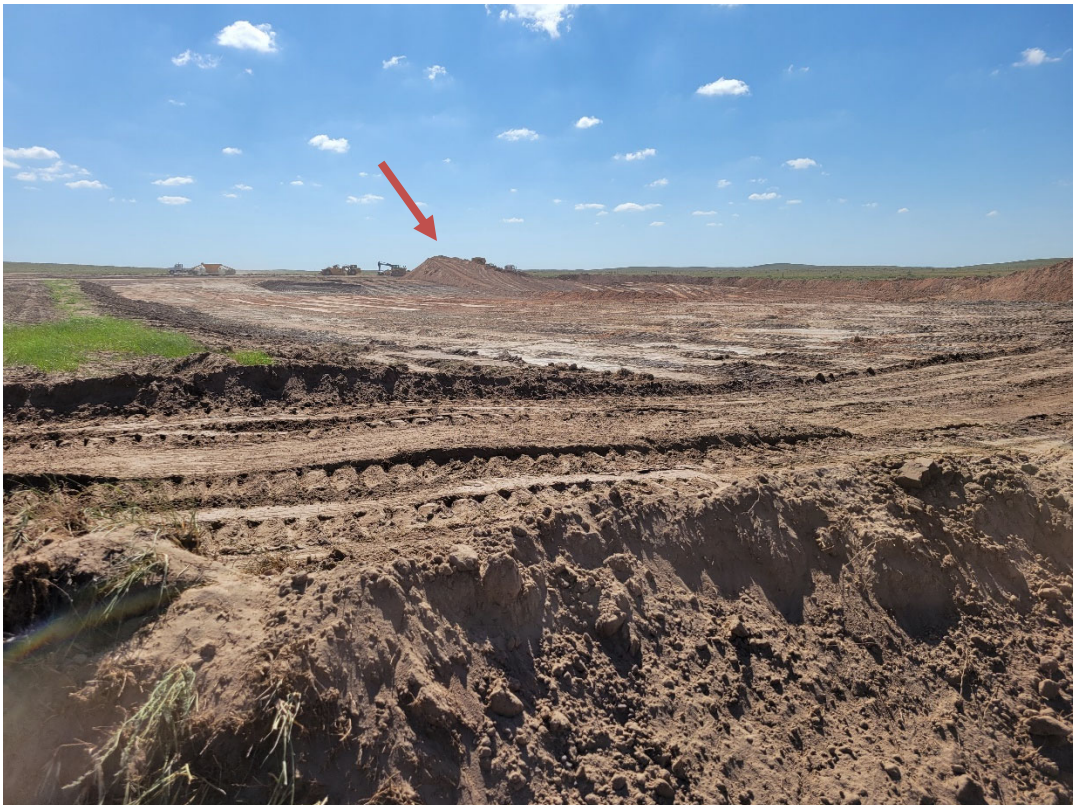
Looking south across phase 1 area. Stockpiled product in distance.

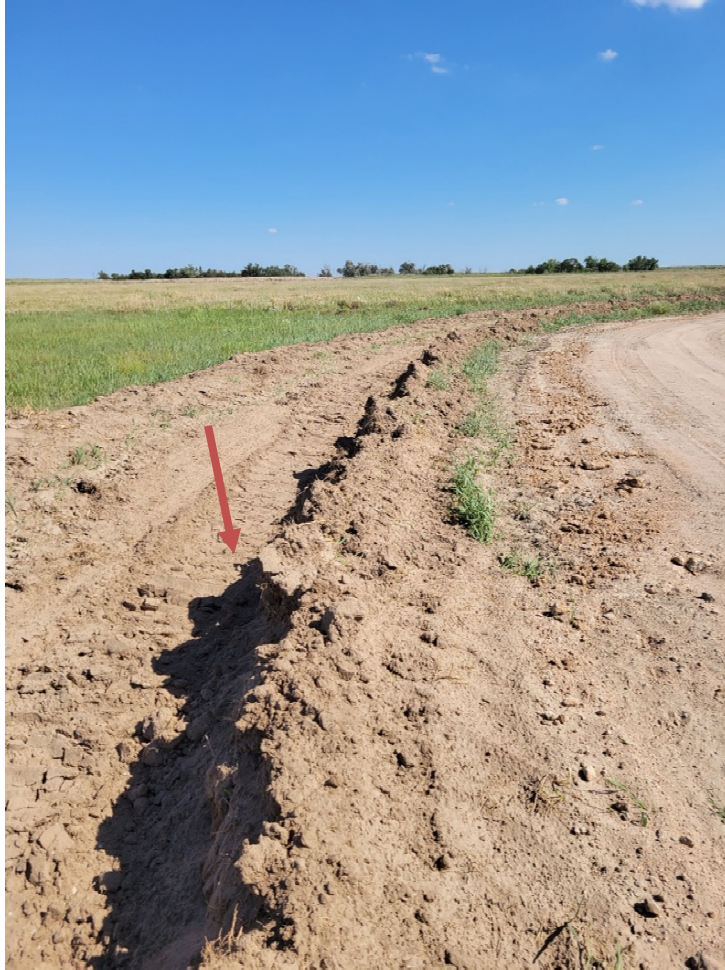
The pit was dry during the inspection. A trench runs along the interior road to move stormwater around the active mining area. Per Rule 6.4.4(c) this water diversion feature should be added to the narrative in the Mine Plan in the Technical Revision.

Looking north along interior access road. Arrow points to water diversion trench.

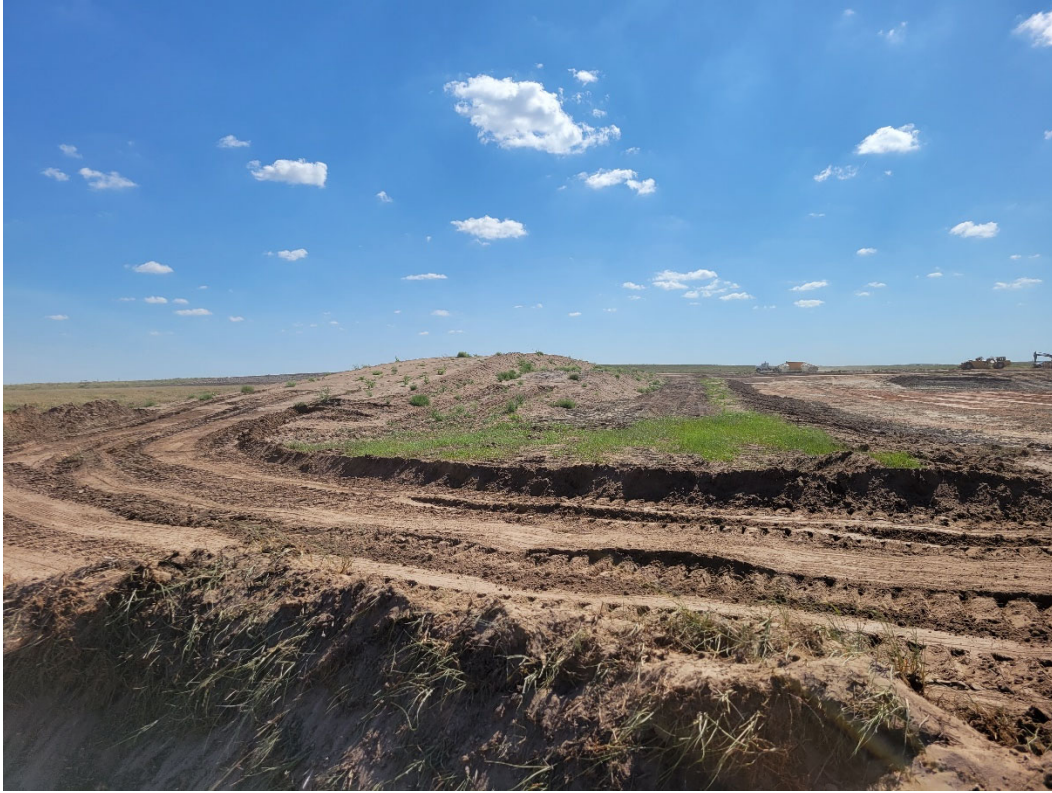
**PROBLEM/POSSIBLE VIOLATION:** Problem: The topsoil stockpiles do not have established vegetation on them and are therefore susceptible to erosion. Rule 3.1.9(1) states if topsoil is not replaced into the backfill area within a time short enough to avoid deterioration of the topsoil, vegetative cover or other means shall be employed so that the topsoil is protected from erosion.

Side view of topsoil pile, edge of phase 1 pit.

**CORRECTIVE ACTIONS:** The operator shall seed the stockpiles with the seed mix that was submitted as part of the approved Reclamation Plan. The Operator shall demonstrate compliance by submitting seed tags, a bill of sale or photographs of seeding activities. The Operator may also request a follow up inspection.

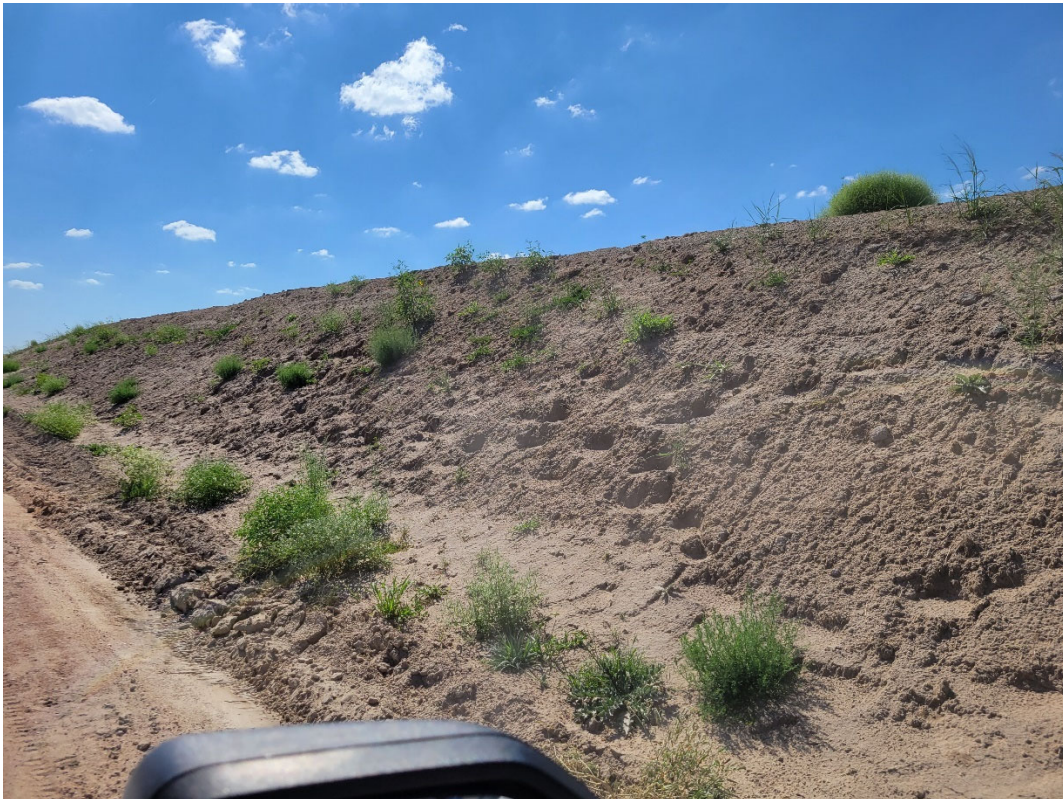
Close-up of topsoil pile, northern boundary of Phase 1 pit.

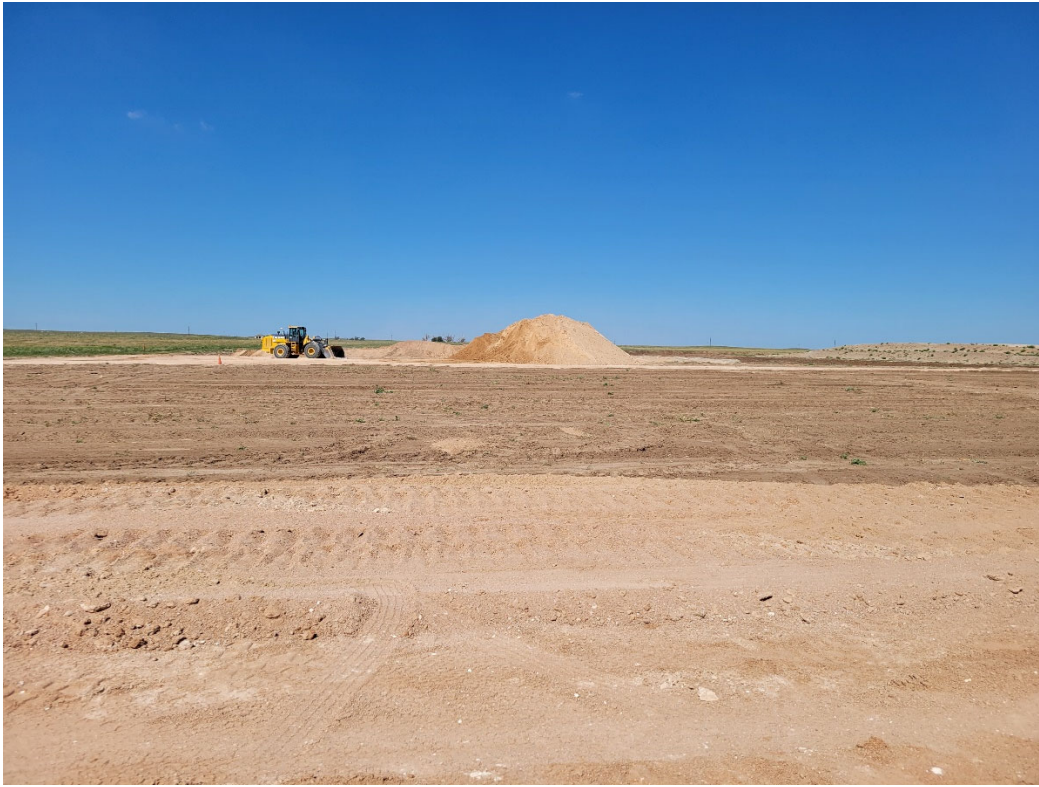
Product stockpile behind Phase 1 pit.

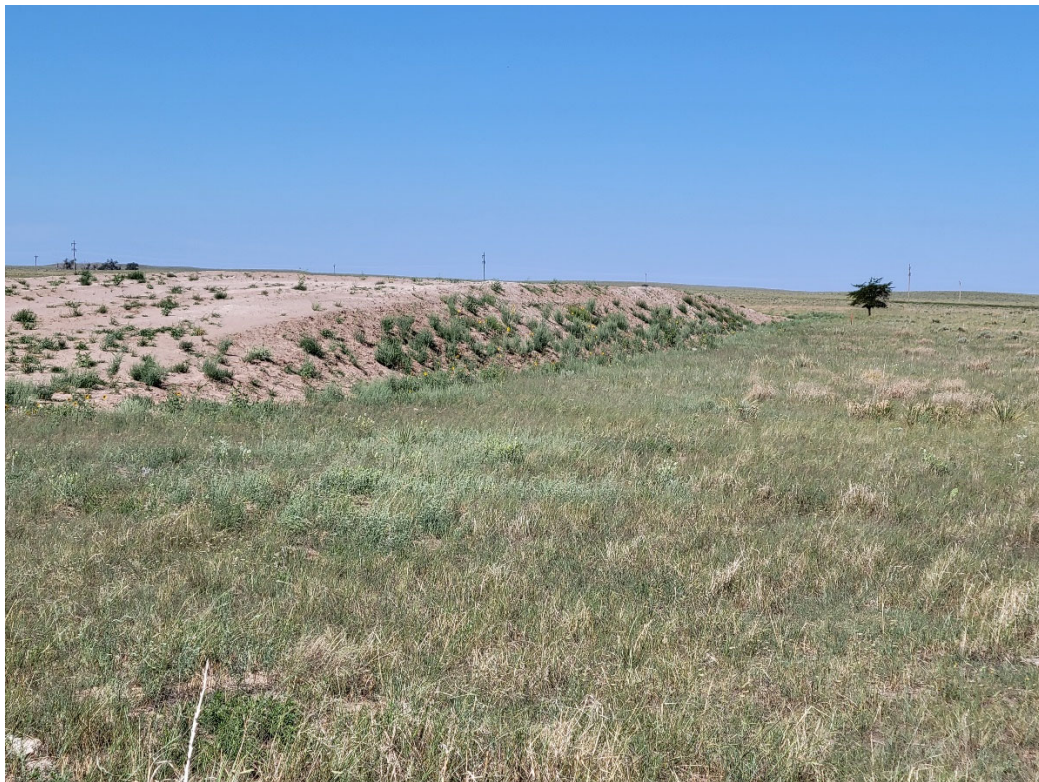
Topsoil/overburden pile along northern boundary permit area.

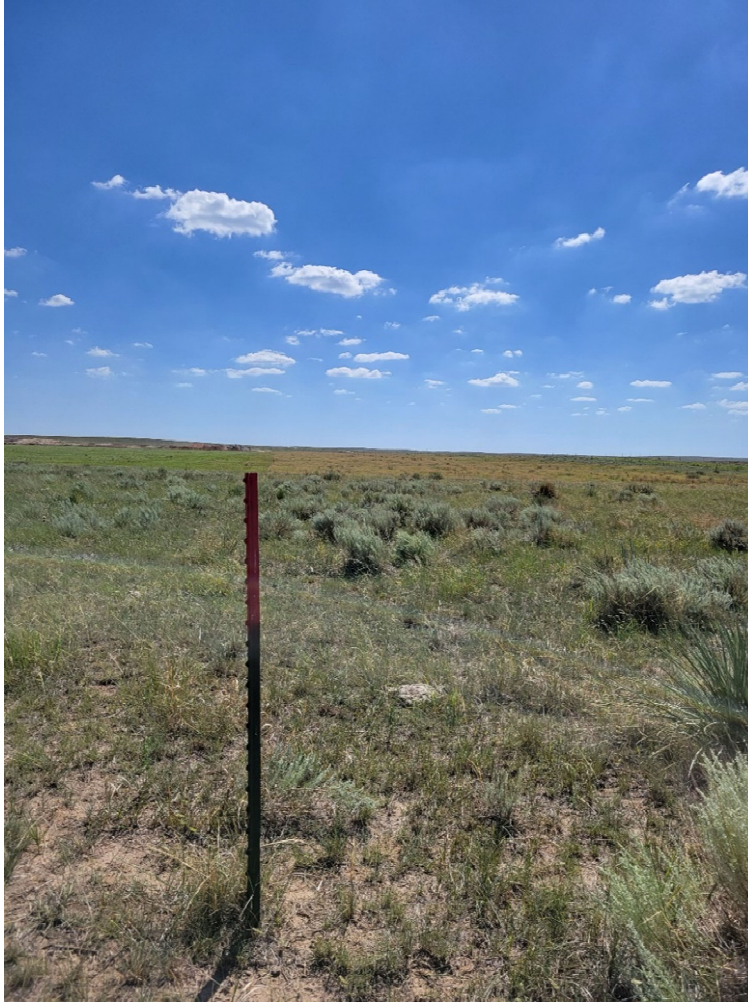
A mine sign is posted at the entrance and the permit boundary is clearly marked with t-posts painted red at the top.

Southwest corner boundary marker, looking east.
