MINERALS PROGRAM INSPECTION REPORT

MINE NAME: Robins Pit No. 1	MINE/PROSPECTING ID#: M-2002-014	MINERAL: Gravel	COUNTY: Conejos
INSPECTION TYPE: Monitoring	INSPECTOR(S): Clayton Wein	INSP. DATE: August 9, 2022	INSP. TIME: 11:15
OPERATOR: Robins Construction, LLLP	OPERATOR REPRESENTATIVE: Randy Robins	TYPE OF OPERATION: 112c - Construction Regular Operation	
REASON FOR INSPECTION: Normal I&E Program	BOND CALCULATION TYPE: Complete Bond	BOND AMOUNT: \$41,834.71	
DATE OF COMPLAINT: NA	POST INSP. CONTACTS: None	JOINT INSP. AGENCY: None	
WEATHER: Clear	INSPECTOR'S SIGNATURE:

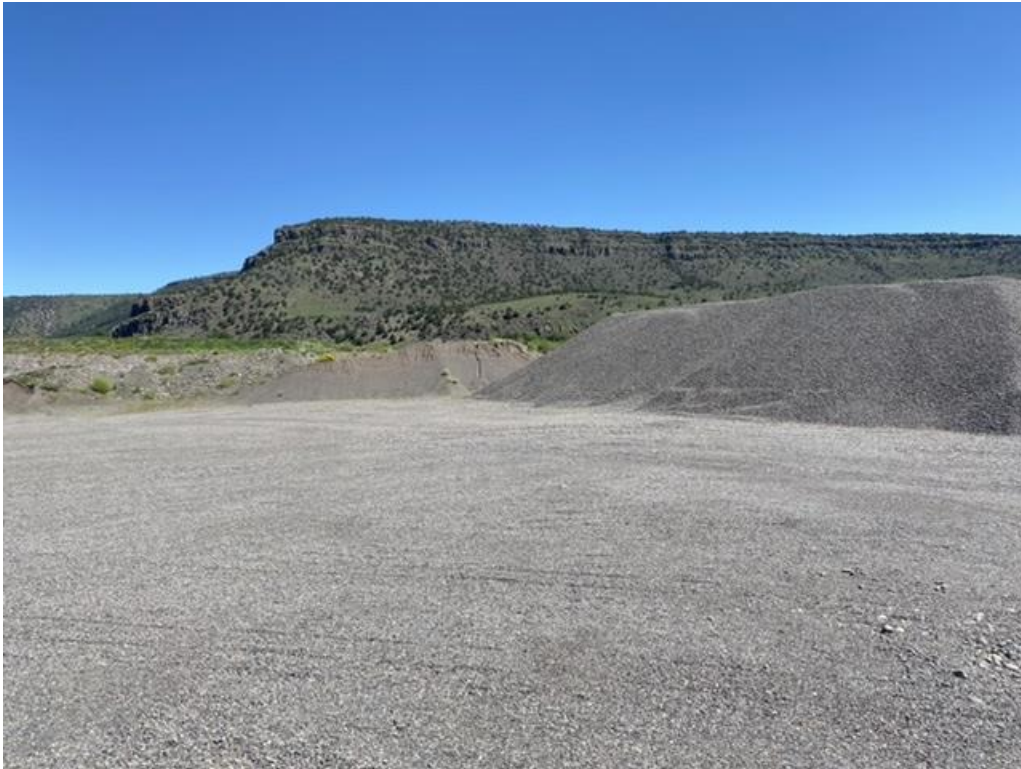
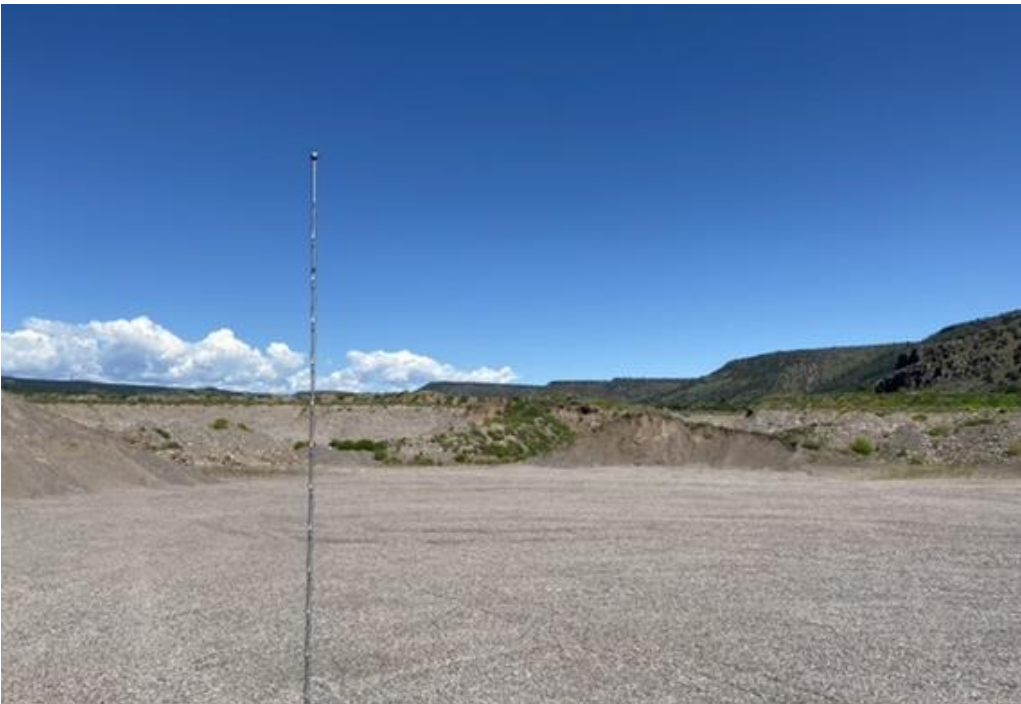
PHOTOGRAPHS

This report documents the observations made during a normal monitoring inspection of the Robins Pit #1 conducted on August 9, 2022. The inspection was conducted by Clayton Wein of the Colorado Division of Reclamation, Mining and Safety (the Division). Randy Robins and Scott Johnson represented Robins Construction, LLLP during the inspection. The weather was clear with a temperature near 80 degrees F. The ground conditions were dry. Please see the attached photographs for a visual of the site conditions during the inspection.
