TRAPPER MINING INC.
CRAIG, COLORADO

HORSE GULCH FILL
QUARTERLY FILL CERTIFICATION

Horse Gulch Fill Quarterly Inspection Report

Third Quarter 2022

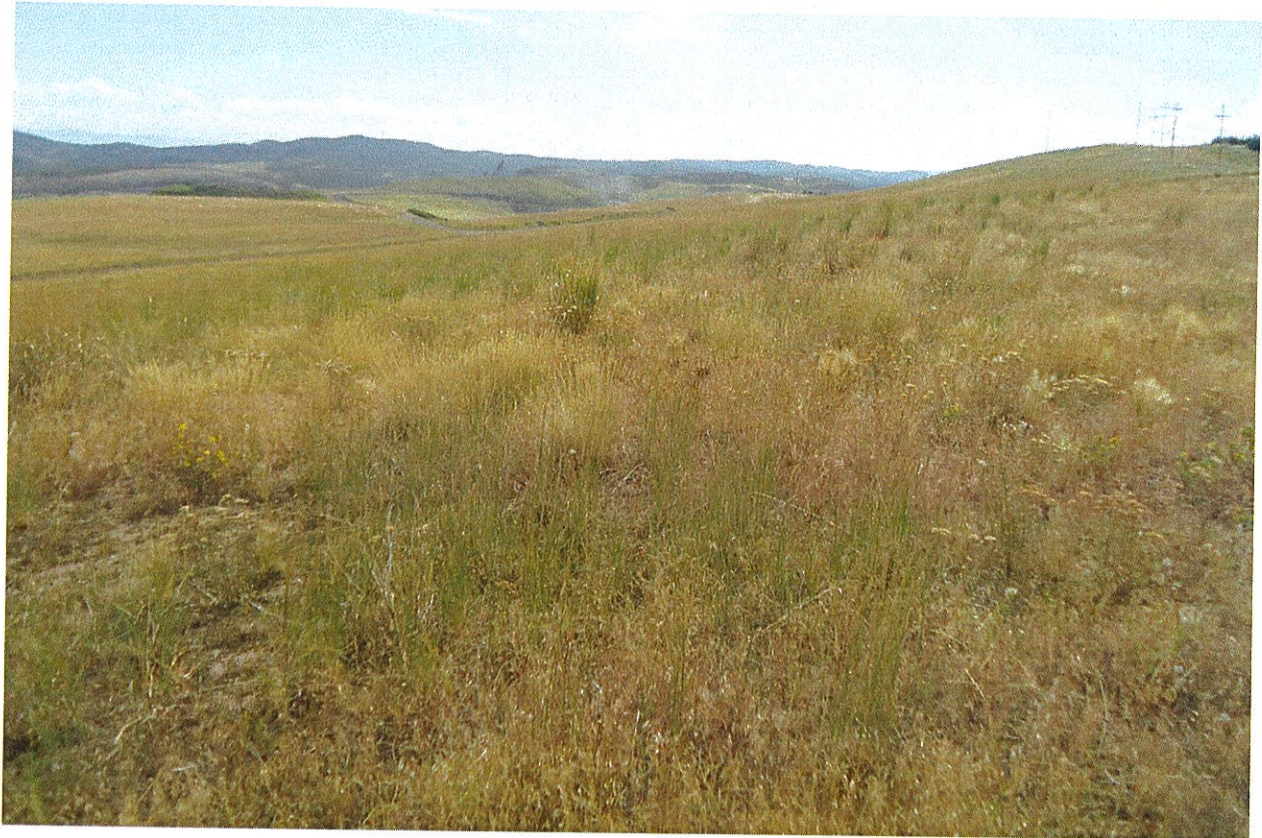
No appearances of instability, structural weakness, or other hazardous conditions were observed. Both the south east side of the fill and the north east side of the fill were inspected this quarter (Photographs 1 and 2). The area where cracks were detected on the top south portion of the dump during the first quarter of 2013 inspection was checked. There was no additional cracking found.

Photograph 1: North Side Looking South (8/24/2022)

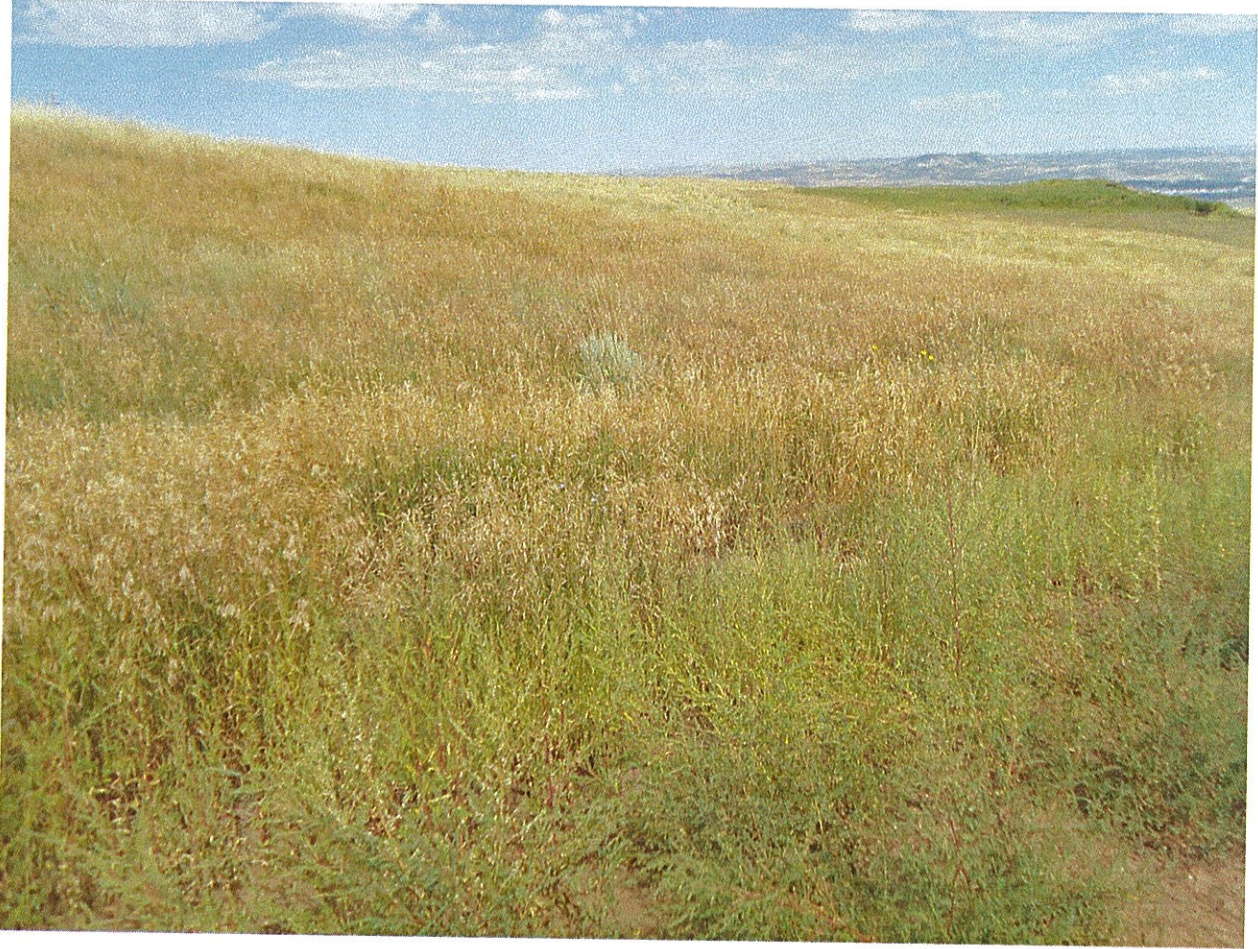
Photograph 2: South Side Looking North (8/24/2022)

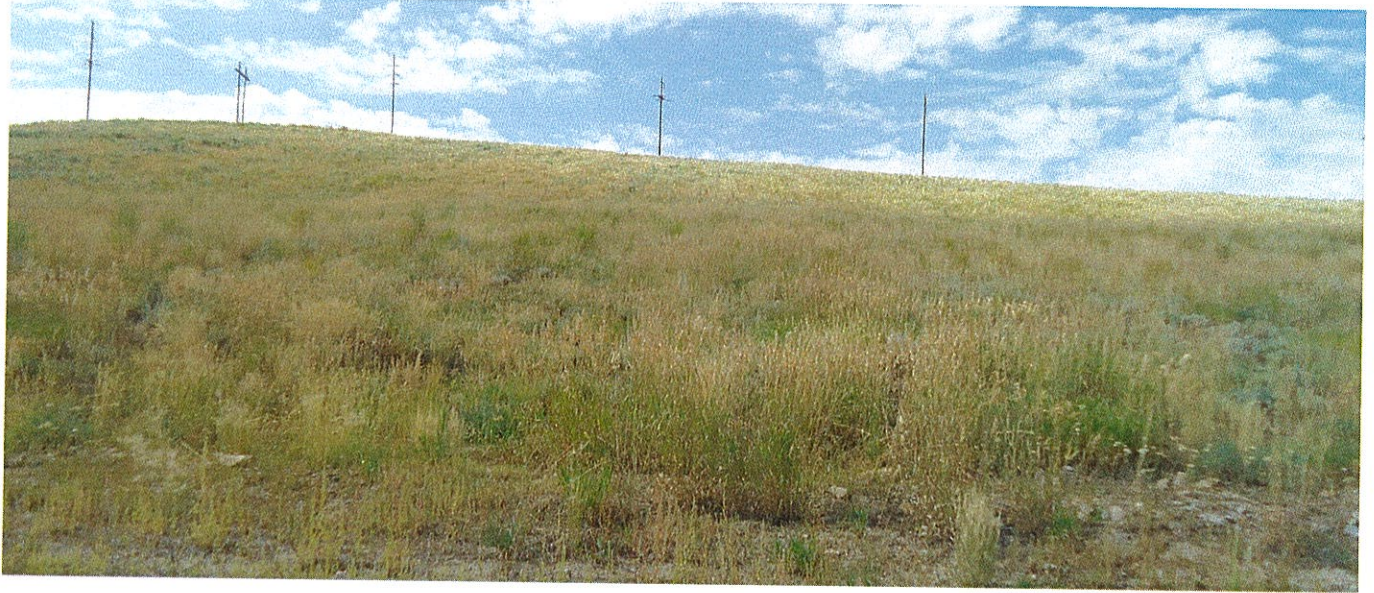
There was no placement of material or contour work done on the fill this quarter. All of the required material for the fill has been placed and compacted. It's anticipated there will be no more additional fill material placed on the fill.

Photograph 3: East Side of the Fill Looking West (8/24/2022)
