**MINERALS PROGRAM INSPECTION REPORT**  
**PHONE: (303) 866-3567**

<b>MINE NAME:</b> Wand Pit	<b>MINE/PROSPECTING ID#:</b> M-2010-007	<b>MINERAL:</b> Gravel and sand	<b>COUNTY:</b> Moffat
<b>INSPECTION TYPE:</b> Monitoring	<b>INSPECTOR(S):</b> Zach Trujillo	<b>INSP. DATE:</b> July 27, 2022	<b>INSP. TIME:</b> 09:00
<b>OPERATOR:</b> Northwest Aggregates, Inc.	<b>OPERATOR REPRESENTATIVE:</b>	<b>TYPE OF OPERATION:</b> 112c - Construction Regular Operation	
<b>REASON FOR INSPECTION:</b> Normal I&E Program	<b>BOND CALCULATION TYPE:</b> Complete Bond	<b>BOND AMOUNT:</b> \$126,990.00	
<b>DATE OF COMPLAINT:</b> NA	<b>POST INSP. CONTACTS:</b> None	<b>JOINT INSP. AGENCY:</b> None	
<b>WEATHER:</b> Clear	<b>INSPECTOR'S SIGNATURE:</b>

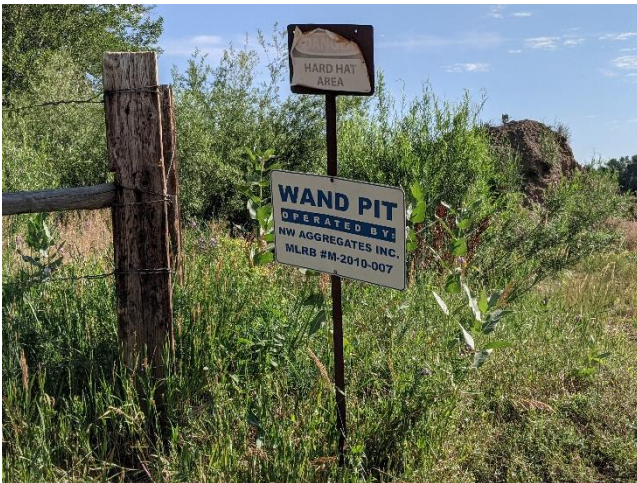
The mine identification sign and affected area boundary markers are in place and in compliance with Rule 3.1.12.

Mine ID sign.

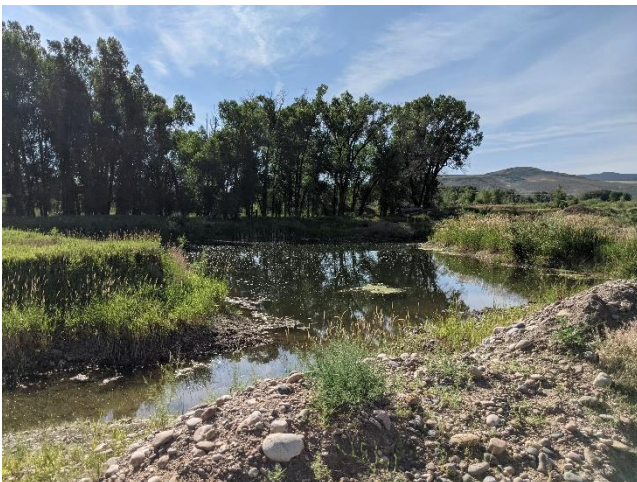
The site was inactive at the time of the inspection. No processing equipment was observed on site along with no fuel, equipment, trailers, etc. The only thing observed on site were staged culverts. Some material remained stockpiled along the southern excavated pond. There are currently two excavated areas both holding water with mining still within phase 1. The two excavated areas are connected by culvert two dewater the pond located north east of the current boundary.

North eastern pond.

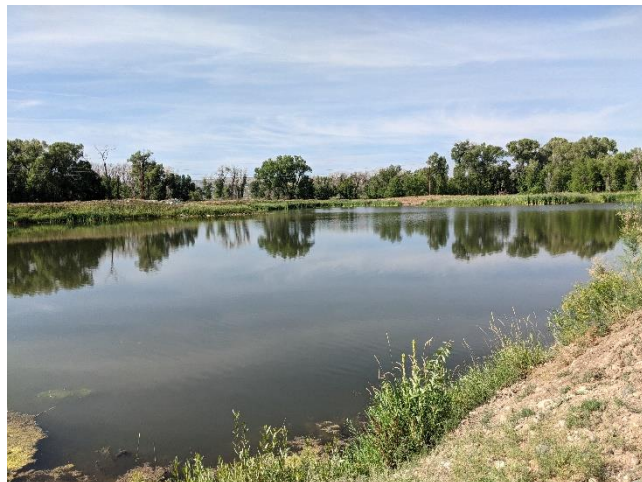
Southern pond.

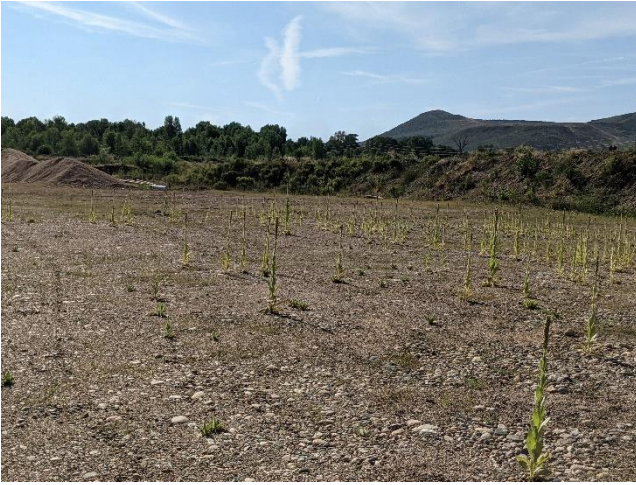
Houndstongue was observed along the center of the working area of Phase I. This is not cited as a problem at this time but the operator is encouraged to remain vigilant in their treatment of noxious weeds to avoid a major infestation.

Houndstongue.
