MINERALS PROGRAM INSPECTION REPORT
PHONE: (303) 866-3567

MINE NAME: Cresson Project	MINE/PROSPECTING ID#: M-1980-244	MINERAL: Gold	COUNTY: Teller
INSPECTION TYPE: Monitoring	INSPECTOR(S): Amy Eschberger	INSP. DATE: July 26, 2022	INSP. TIME: 09:30
OPERATOR: Cripple Creek & Victor Gold Mining Company	OPERATOR REPRESENTATIVE: Johnna Gonzalez, Brian Doering	TYPE OF OPERATION: 112d-3 - Designated Mining Operation

This was a normal monthly monitoring inspection of the Cresson Project (Permit No. M-1980-244) conducted by Amy Eschberger of the Division of Reclamation, Mining and Safety (Division). The operator was represented by Johnna Gonzalez and Brian Doering during the inspection. This is a 112d-3 Designated Mining Operation (DMO) permitted for 6,007 acres to mine and process gold ore. The site is located between the towns of Cripple Creek and Victor in Teller County. The approved post-mining land use is a combination of rangeland and wildlife habitat. **Photos 1-83** taken during the inspection are included with this report.

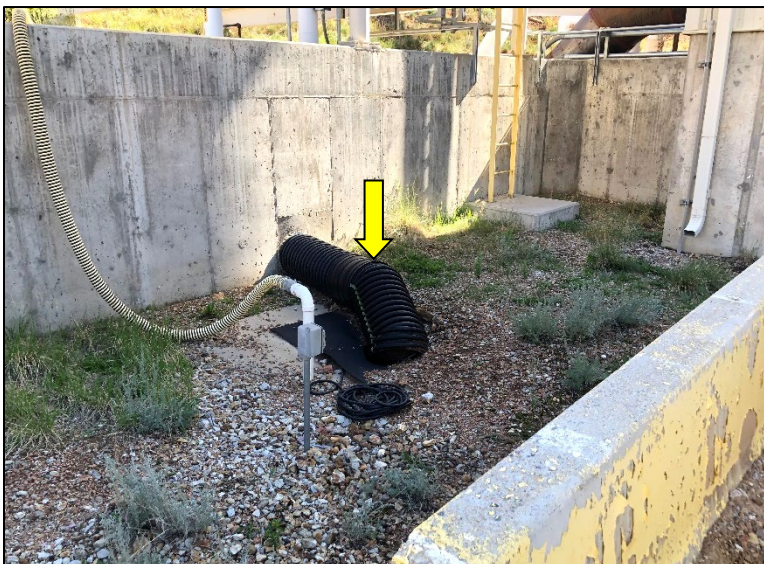
Photo 3. View looking northeast at VLF-1 Phase 4A underdrain (indicated; not shown on AM-13 map), showing this area dry.

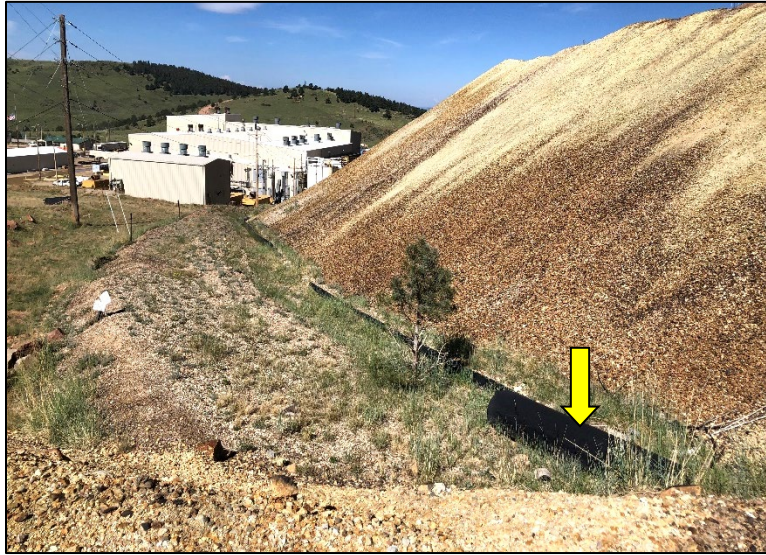
Photo 4. View looking west at VLF-1 Phase 5 underdrain (indicated), showing this area dry.

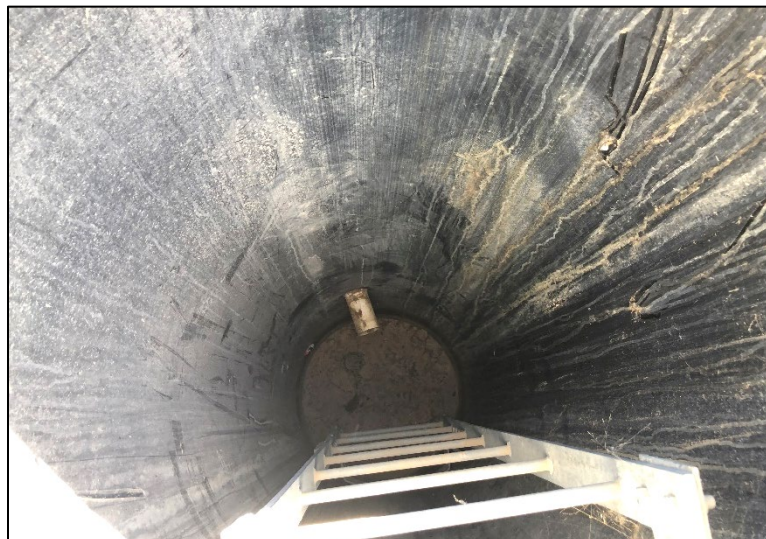
In 10 of the 18 LDSs inspected, a visual indicator (i.e., red and white reflective tape) had been placed to mark one foot above the bottom of the sump, as approved in TR-127. However, the Division did not observe a visual indicator in 8 of the LDSs (for VLF-1), including LDS-1, LDS-2, LDS-4, LDS-5, LDS-6, LDS-7, LDS-12, and LDS-13. For LDS-12 and LDS-13, the visual indicator (if present) would have been obscured by the muddy water present in these sumps. The operator stated during the inspection that a visual indicator could not be placed in some of the sumps, and therefore, any water present in these sumps is physically measured during the weekly inspection. The reason for an indicator not being placed in some of the sumps was not clear, as it did not appear to be based on depth (some deeper sumps did have a visual indicator).

Photo 6. View looking inside VLF-1 LDS-1, showing sump dry. No visual indicator was observed in this sump.

The lack of visual markers in some of the LDSs and the continued practice of hanging buckets from the sump inlets is not consistent with the monitoring and sampling plan approved in TR-127. **Therefore, a problem is cited in this report (see pages 1 and 2), requiring the operator to provide photographic evidence demonstrating that visual markers have been placed in all LDSs in accordance with TR-127, and that any buckets have been removed from the LDSs.**

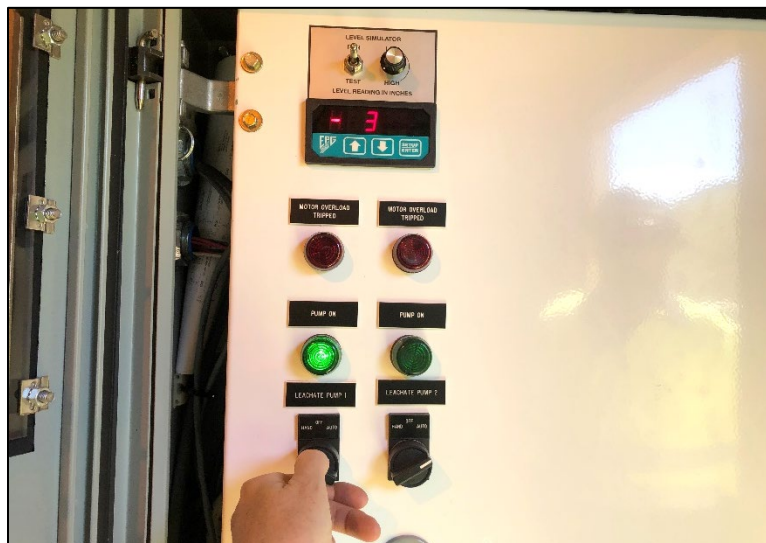
Photo 12. View of displays inside shed at VLF-1 ESP LVSCS, showing pump #1 operable per manual test (despite issue with displays).

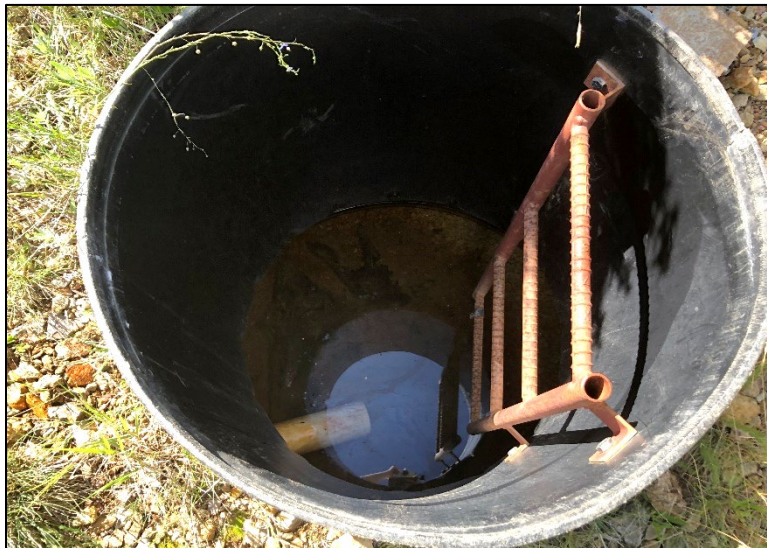
Photo 17. View looking inside VLF-1 LDS-2, showing water present in sump (depth estimated at ~5 inches based on 4 inch inlet pipe). No visual indicator was observed in this sump.

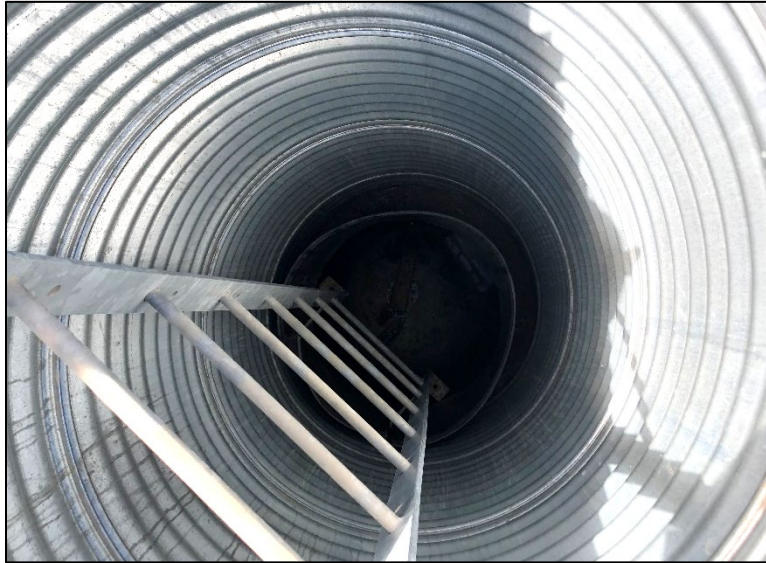
Photo 28. View looking inside VLF-1 LDS-7, showing sump dry. No visual indicator was observed in this sump.

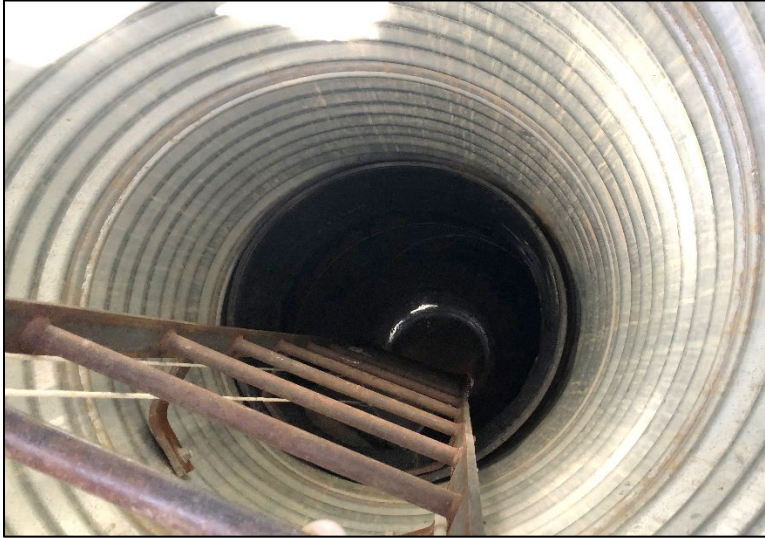
Photo 34. View looking inside VLF-1 LDS-6, showing < 1 inch of water present in sump. No visual indicator was observed in this sump.

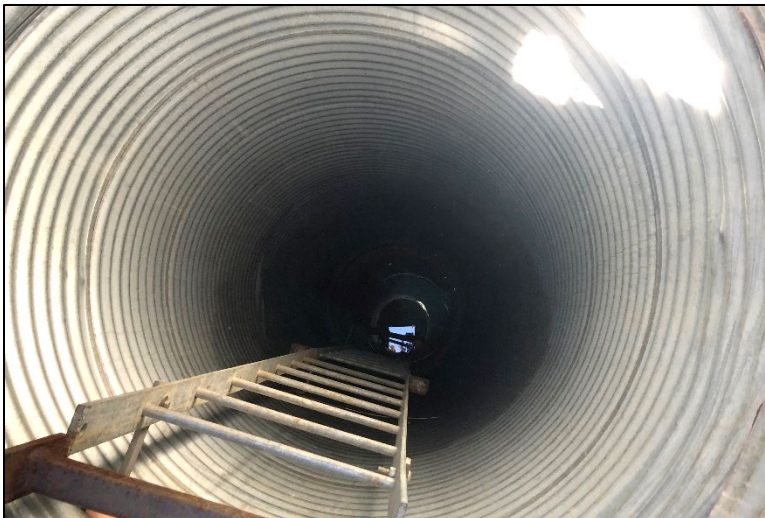
Photo 36. View looking inside VLF-1 LDS-4, showing < 1 inch of water present in sump. No visual indicator was observed in this sump.

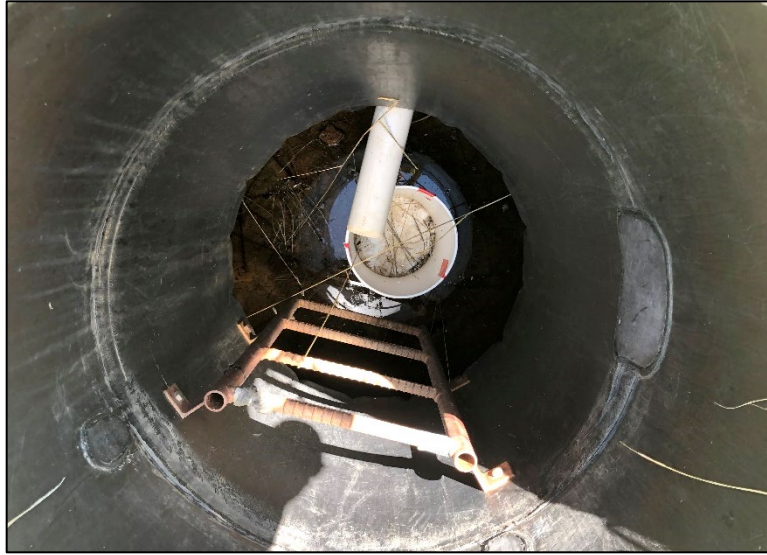
Additionally, the Division noticed that four of the sumps (for VLF-1), including LDS-3, LDS-5, LDS-10, and LDS-11, still had a bucket hanging from the inlet pipe. This practice was utilized prior to TR-127 approval, as a means for determining if the water observed in the sump came from the inlet or from meteoric infiltration. However, in TR-127, the operator committed to placing a visual indicator one foot above the bottom of each sump, and to collecting samples from the water if it is observed to be at or above the marker during the weekly inspection. Keeping the buckets in the sumps interferes with the monitoring and sampling plan approved in TR-127.

Photo 37. View looking inside VLF-1 LDS-5, showing approx. 1 inch of water present in sump. No visual indicator was observed in this sump. Bucket hanging from sump inlet needs to be removed.

CORRECTIVE ACTIONS: By the corrective action due date, the operator shall provide photographic evidence demonstrating that visual markers have been placed in accordance with TR-127 in the following eight LDSs (for VLF-1): LDS-1, LDS-2, LDS-4, LDS-5, LDS-6, LDS-7, LDS-12, and LDS-13. Additionally, photographic evidence must be provided to demonstrate the buckets have been removed from the following LDSs (for VLF-1): LDS-3, LDS-5, LDS-10, and LDS-11.

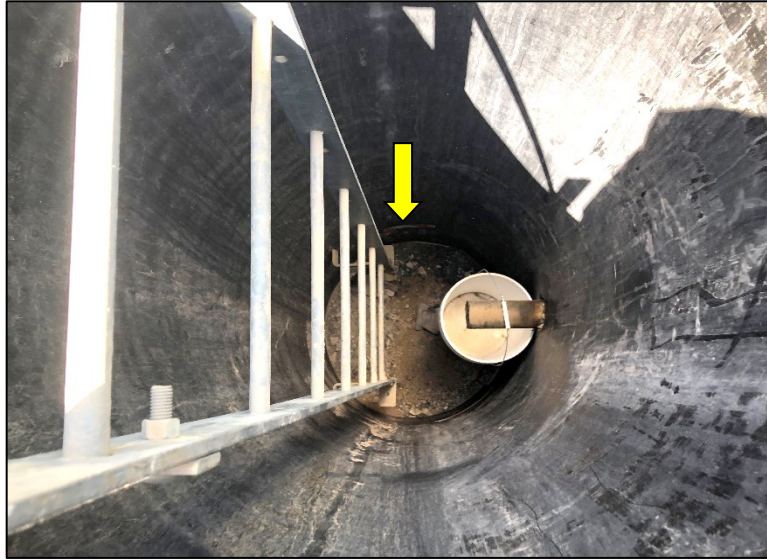
Photo 40. View looking inside VLF-1 LDS-10, showing sump dry. Note visual indicator (red/white tape; indicated) marking 1 foot from bottom of sump. Bucket hanging from sump inlet needs to be removed.

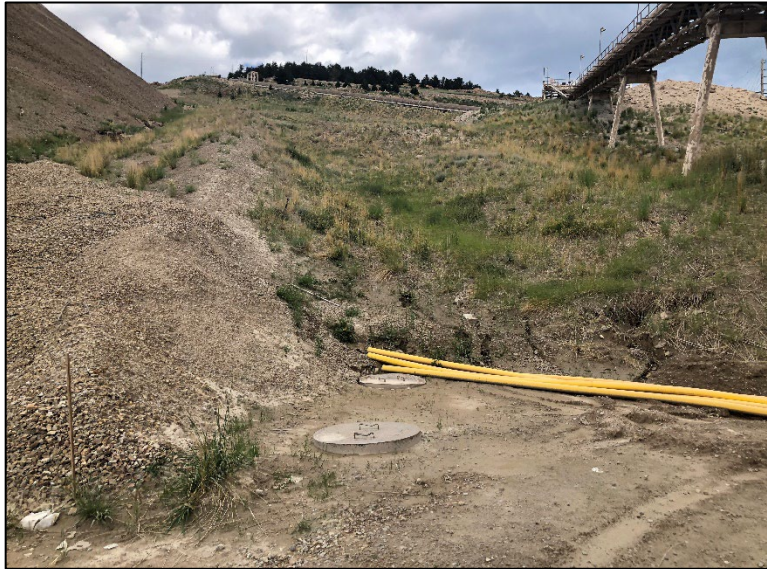
PROBLEM: The operator is not following the monitoring plan approved in Technical Revision No. 127 (TR-127) for the Valley Leach Facility (VLF) Leak Detection Sumps (LDSs). Specifically, LDS-12 and LDS-13 (for VLF-1) are regularly infiltrated by meteoric water and sediment, and sometimes completely buried by sediment, resulting in these sumps not being sampled per TR-127 due to "mud" present in the sumps, or in these sumps not being accessible for inspection. This is a problem as the purpose of the LDSs is to allow for the detection of leaks in the VLF, and these sumps are not being regularly inspected and/or sampled per the approved monitoring plan.

LDS-12 and LDS-13 are located in the crusher area, beneath a conveyor that transports crushed material to the Load Out Bin near the High Grade Mill. The tops of these sumps are flush with the surrounding ground surface, and the sumps are located at the base of a fairly steep slope. This causes the sumps to become buried at times from crusher fines and/or sediments washed downslope during storm events, which prevents the sumps from being sampled (until the sediment can be removed). Due to this design issue as well as the sump lids being rusted through in some areas, these sumps are regularly infiltrated by meteoric water and sediment. The operator indicated when the sumps contain mud a sample is not taken for analysis, even if the depth of the mud is at or above one foot. A vacuum truck is used to remove the mud from the sumps. However, according to the LDS monitoring data provided (described below), it appears the operator is not always able to remove the mud from the sumps before the next monitoring event. Therefore, the monitoring plan approved in TR-127 is not being consistently followed for LDS-12 and LDS-13, as these sumps are not always inspected on a weekly basis (if buried in sediment), and are not always sampled when water levels inside the sump are at or above one foot in depth (due to the water being mixed with mud). Additionally, the Division is concerned that the regular infiltration of mud into these sumps may have clogged the inlet pipes, so that water from the Leak Detection System would be unable to flow into the sumps, as intended. **A problem is cited in this report (see page 1), requiring the operator to submit a detailed plan for how LDS-12 and LDS-13 will be modified to prevent the infiltration of meteoric water and sediment into these sumps, and a schedule for completing the proposed modifications. This plan should also address how the sump inlet pipes will be inspected to ensure they are clear from any obstructions (e.g., mud, debris).**

Photo 61. View looking northeast at VLF-1 LDS-12 and LDS-13. These sumps need to be modified to prevent future infiltration of meteoric water and sediment.

CORRECTIVE ACTIONS: By the corrective action due date, the operator shall provide a detailed plan for how LDS-12 and LDS-13 will be modified to prevent the infiltration of meteoric water and sediment into these sumps, and a schedule for completing the proposed modifications. This plan should also address how the sump inlet pipes will be inspected to ensure they are clear from any obstructions (e.g., mud, debris).

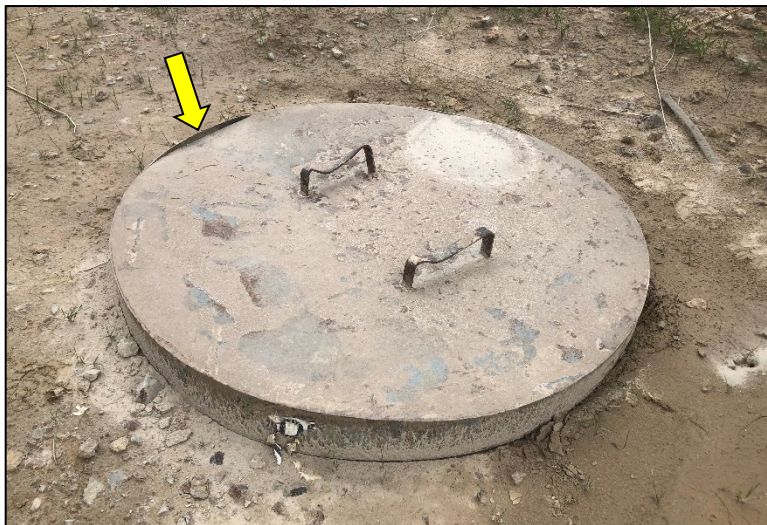
Photo 62. Closer view of VLF-1 LDS-12, showing top of sump flush with ground surface and hole in sump lid (indicated).

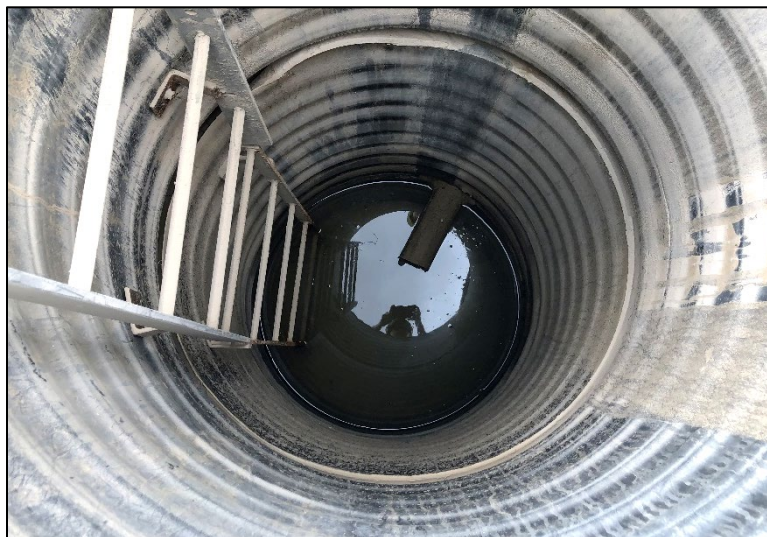
Photo 63. View looking inside VLF-1 LDS-12, showing approx. 1 foot of water in sump. No visual indicator could be observed in this sump.

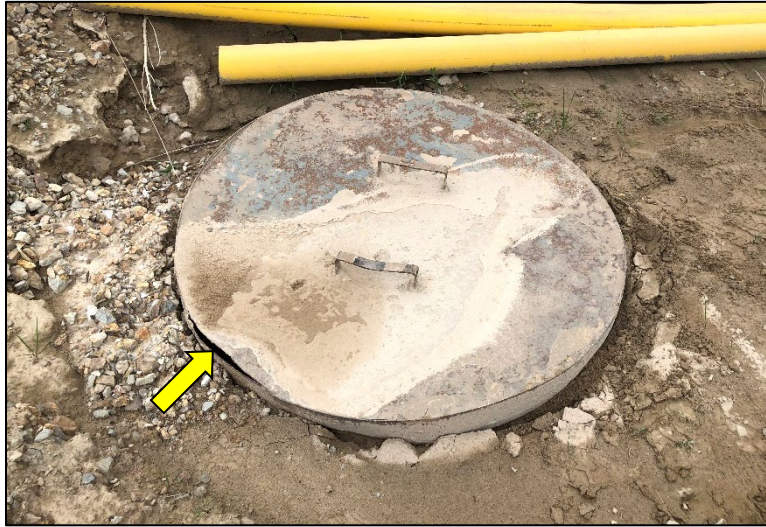
Photo 64. Closer view of VLF-1 LDS-13, showing top of sump flush with ground surface and hole in sump lid (indicated).

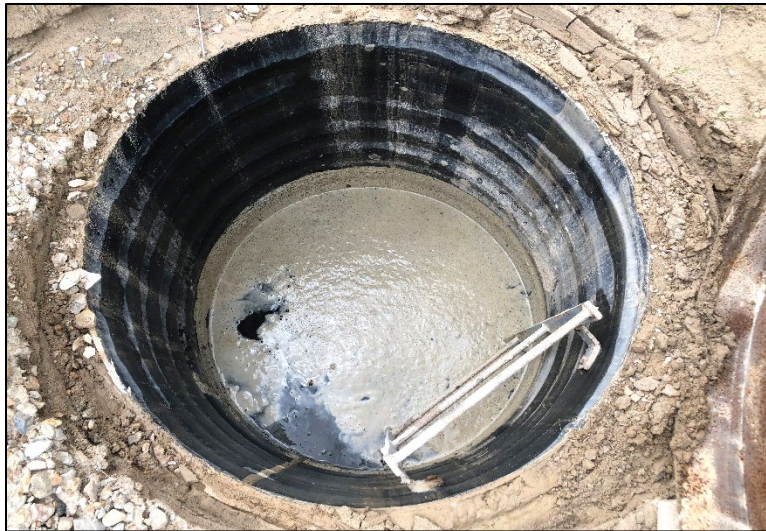
Photo 65. View looking inside VLF-1 LDS-13, showing > 1 foot of muddy water in sump. No visual indicator could be observed in this sump.

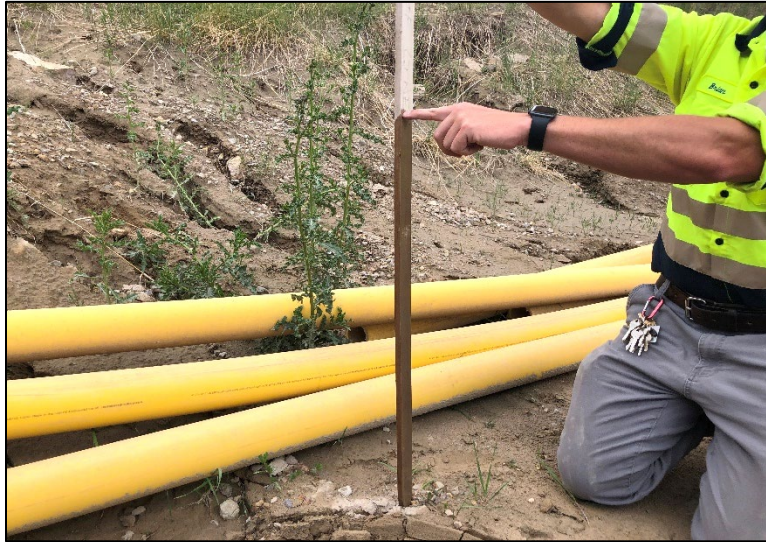
Photo 67. View of stick used to measure approximate depth of muddy water inside VLF-1 LDS-13, showing a depth > 1 foot.
