To: Jerald Schnabel  
Continental Materials Corp.  
File: July 2022 Monitoring Summary

From: Paul Kos  
Denver, CO 80222  
Date: August 26, 2022

**Reference: July 2022 Geotechnical Monitoring Summary Pikeview Quarry**

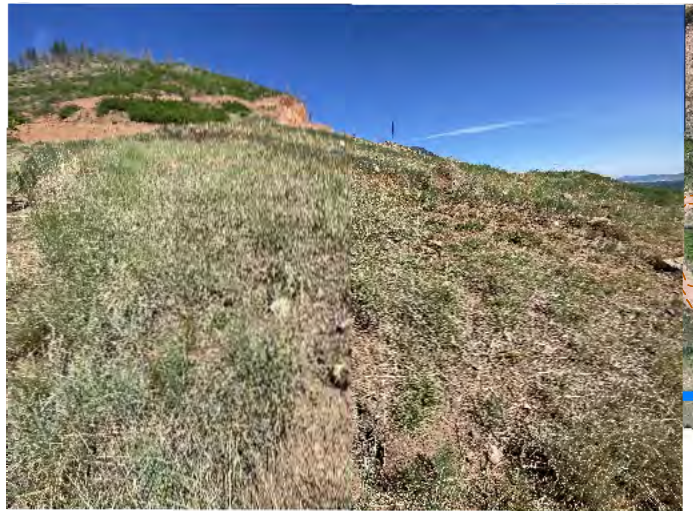
- Known cracks were monitored for changes. Currently the cracks are not growing in any of the areas on the slopes of the site. The hummocky field in the area immediately above the southern extent of the slide shows evidence of cracking but they are not fresh or active. No new or open cracks were found immediately inside or next to the slide area. (Photo 8)

8. Healed cracks on the slope on south end of site.

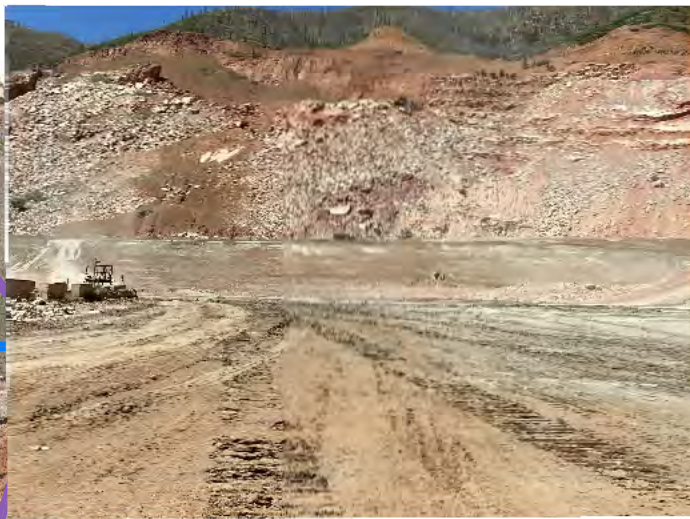
- Offsite fill was placed near the reclamation benches. The material was spread by dozers and compacted in one-foot lifts in accordance with the project specifications. (Photo 2)

2. View of elevation change in pit floor - about 26 feet.

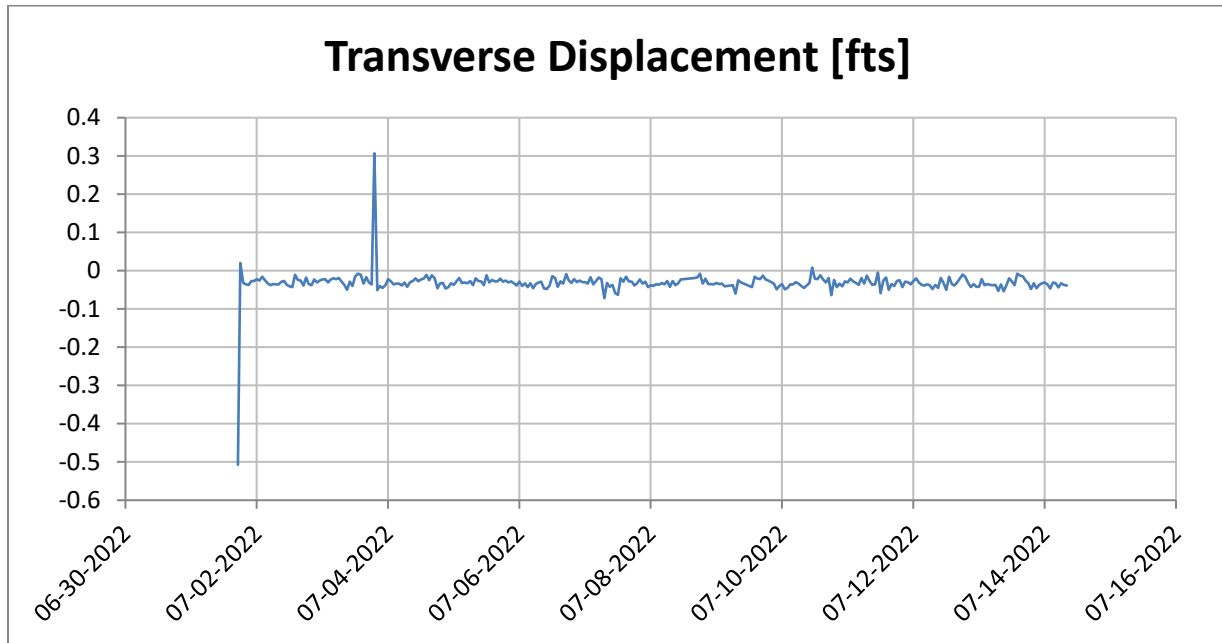
## Prism BR1

1. Survey accuracy is +/-0.016 feet.
2. Alarm threshold is +/-0.35 feet.
3. Transverse displacement is in the horizontal direction. Positive direction means closer to the robotic station.
4. Height displacement is in the vertical direction. Positive direction means higher in elevation.
5. Prism records slope creep movements with slow velocity.
6. Plot displays data for 7/1/22 through 7/14/22.

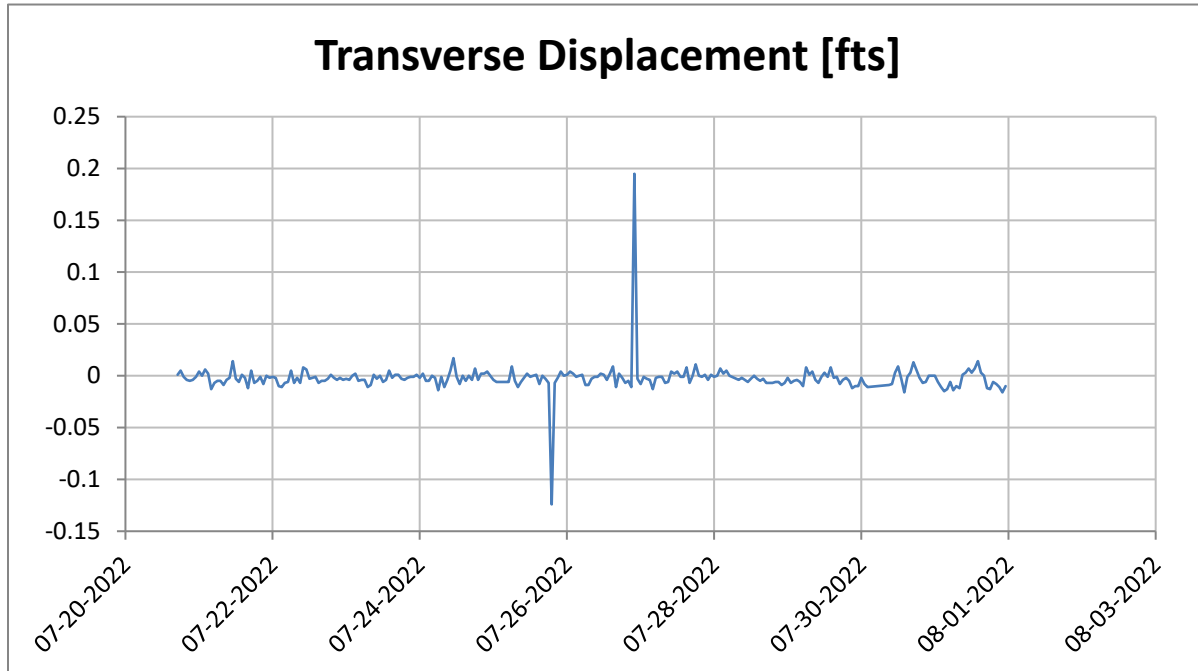
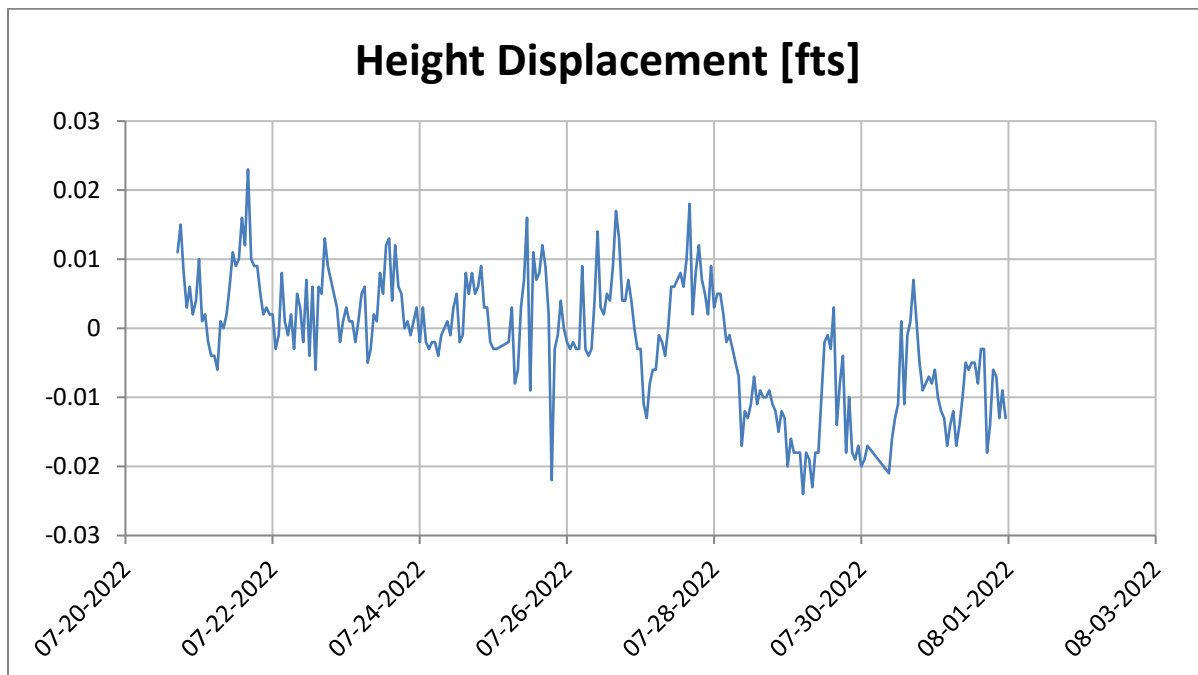
## Prism BR1

1. Survey accuracy is  $\pm 0.016$  feet.
2. Alarm threshold is  $\pm 0.35$  feet.
3. Transverse displacement is in the horizontal direction. Positive direction means closer to the robotic station.
4. Height displacement is in the vertical direction. Positive direction means higher in elevation.
5. Prism records slope creep movements with slow velocity.
6. Plot displays data for 7/20/22 through 7/30/22.

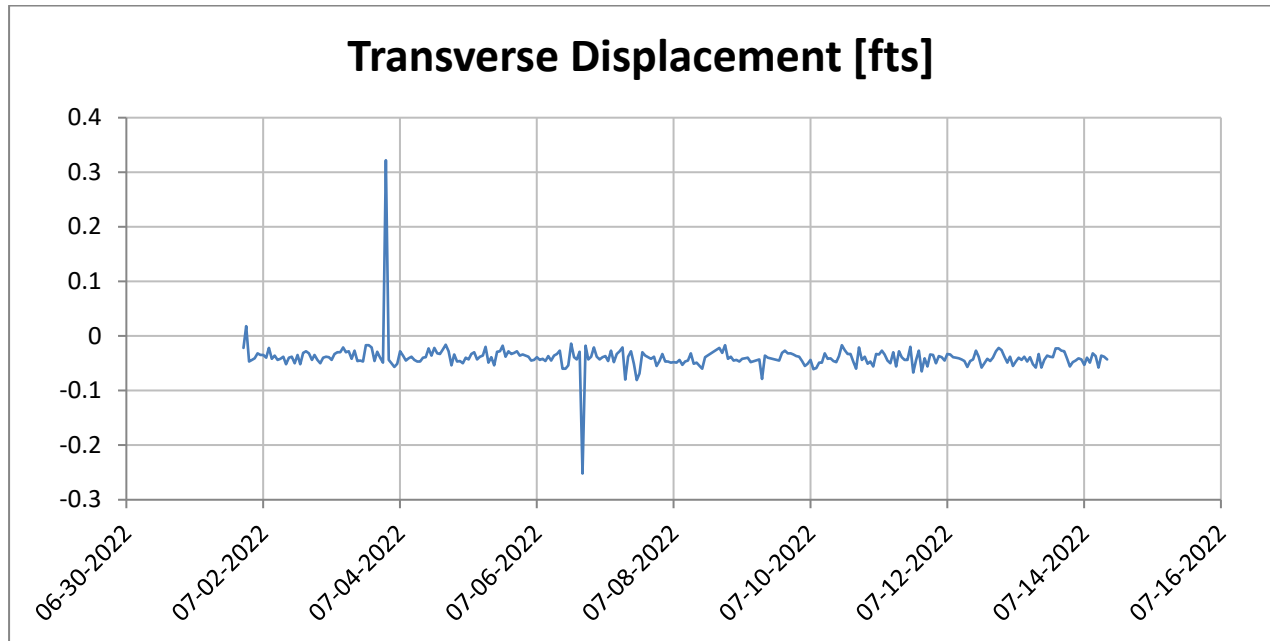
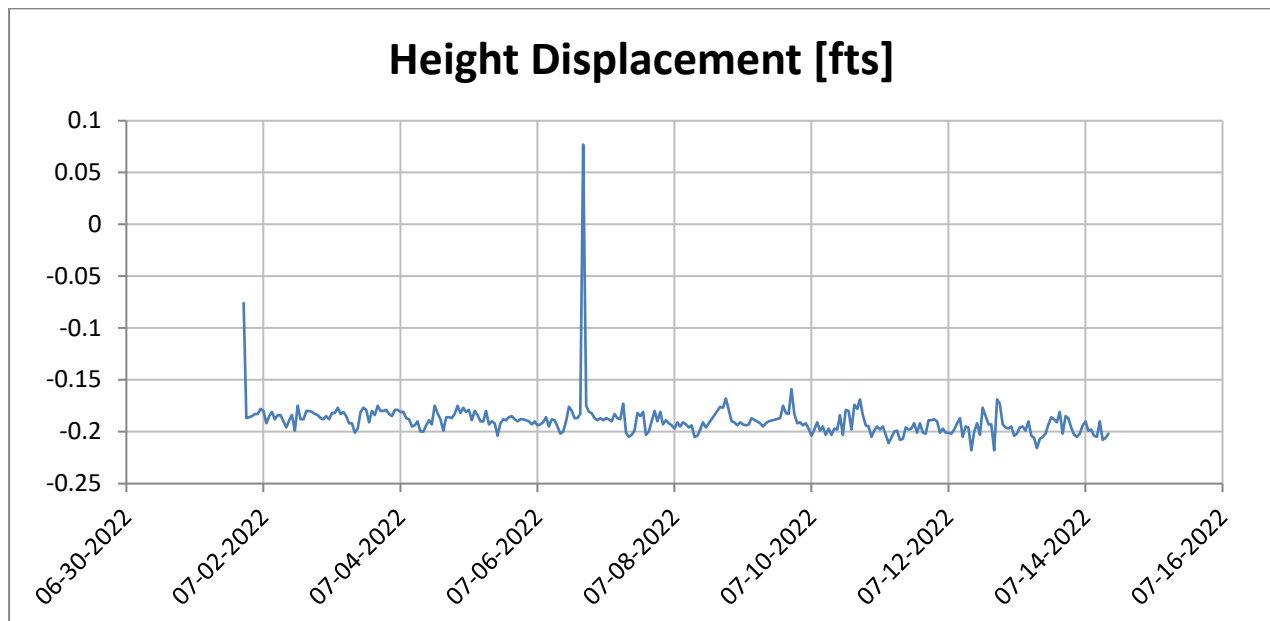
## Prism BR2

1. Survey accuracy is  $\pm 0.016$  feet.
2. Alarm threshold is  $\pm 0.35$  feet.
3. Transverse displacement is in the horizontal direction. Positive direction means closer to the robotic station.
4. Height displacement is in the vertical direction. Positive direction means higher in elevation.
5. Prism is located in an area where ongoing movements are expected. The prism records slope creep movements with slow velocity.
6. Plot displays data for 7/1/22 through 7/14/22. Data were not collected from prism BR2 from July 18 through August 3.

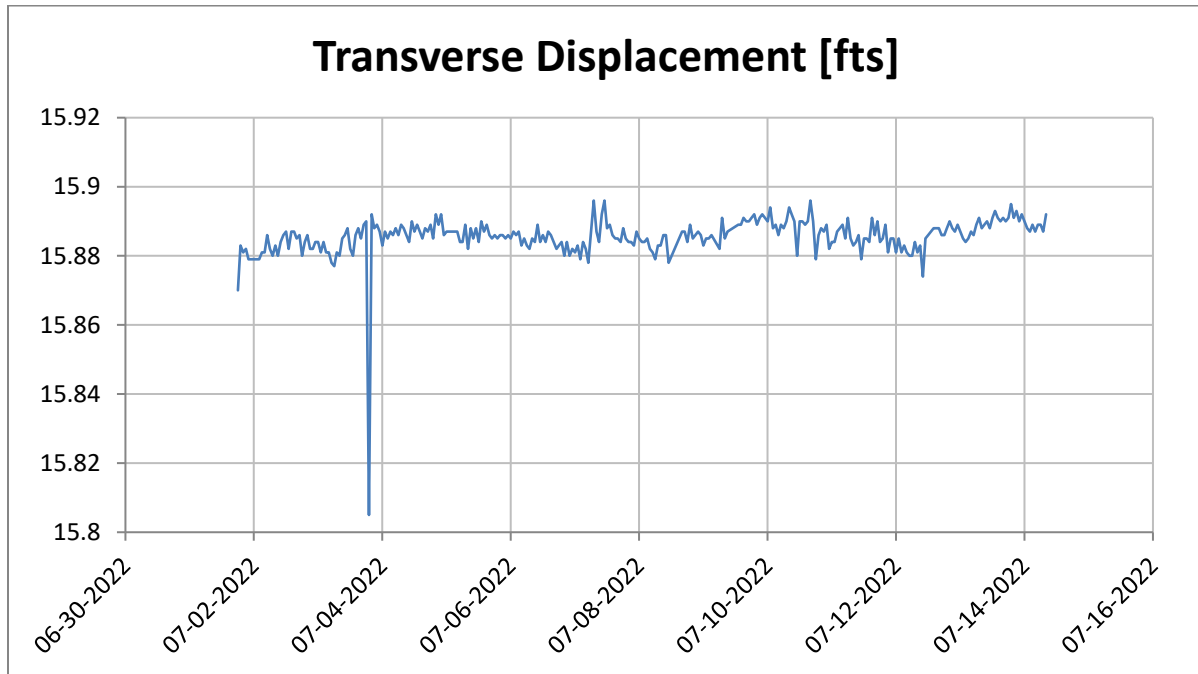
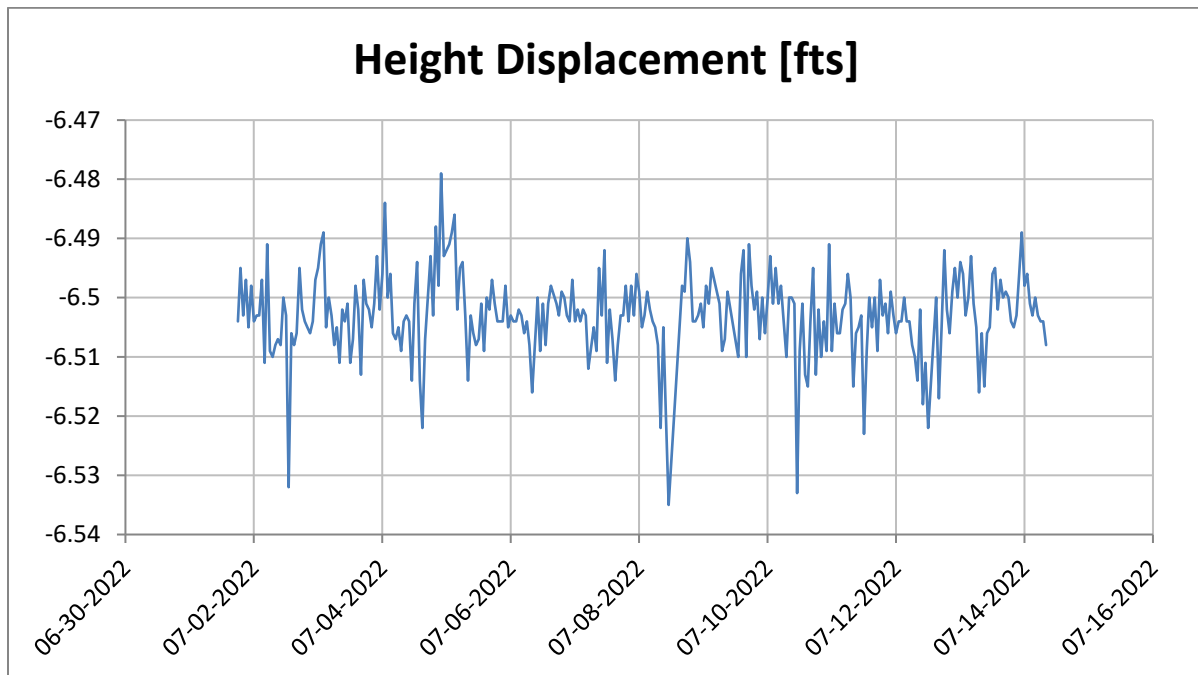
## Prism P63

The data show stable conditions with no movement for 14 of 21 prisms with recorded displacements limited to data scatter and not actual movements. Prisms P63, TOE4, and TOE5 are located at the toe of the landslide, and these locations showed slope creep movements at slow velocities. Prisms BR1, BR2, NP66, and P69 are located above the landslide, and these prisms also recorded slope creep movements at slow velocity. This settlement is likely related to the landslide material consolidating under its own weight. New prisms are placed in areas where slope creep movements are likely to be recorded; therefore, slope creep movements being recorded at more locations is expected to occur. Plots of the transverse and height displacements for each prism are included in Appendix B.

1. Survey accuracy is  $\pm 0.016$  feet.
2. Alarm threshold is  $\pm 0.35$  feet.
3. Transverse displacement is in the horizontal direction. Positive direction means closer to the robotic station.
4. Height displacement is in the vertical direction. Positive direction means higher in elevation.
5. Prism records slope creep movements with slow velocity.
6. Exceedance alerts received on 7/26.
7. Prism reading for 7/1/22 through 7/14/22.

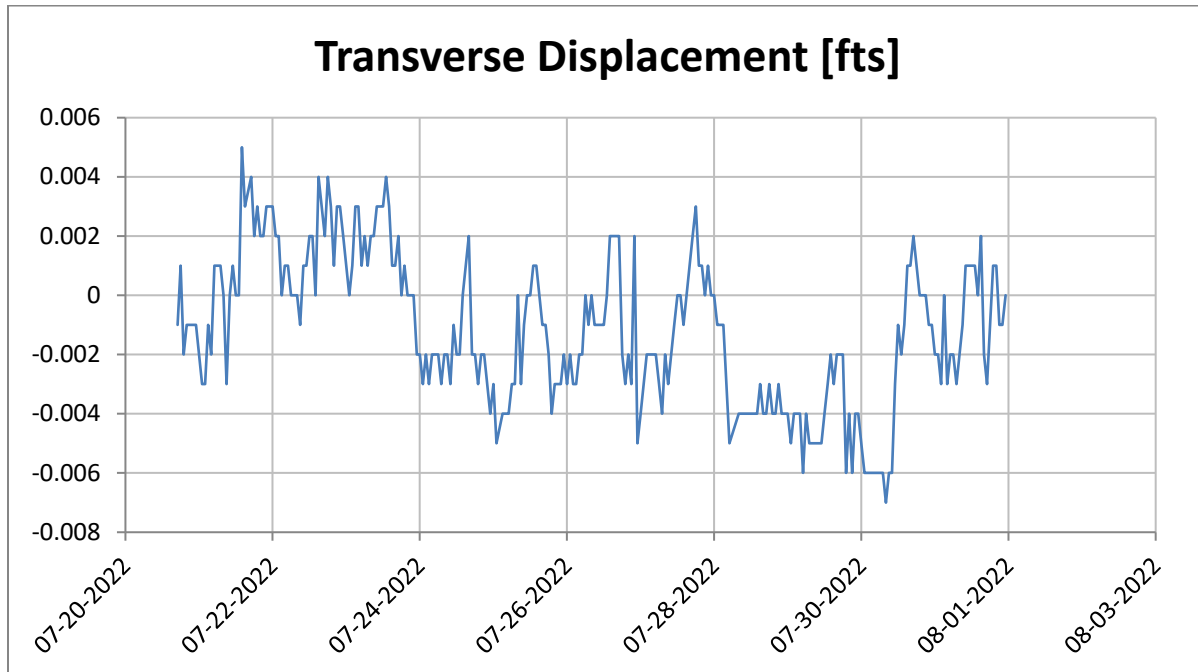
## Prism P63

1. Survey accuracy is  $\pm 0.016$  feet.
2. Alarm threshold is  $\pm 0.35$  feet.
3. Transverse displacement is in the horizontal direction. Positive direction means closer to the robotic station.
4. Height displacement is in the vertical direction. Positive direction means higher in elevation.
5. Prism records slope creep movements with slow velocity.
6. Exceedance alerts received on 7/26.
7. Prism reading for 7/20/22 through 7/30/22.

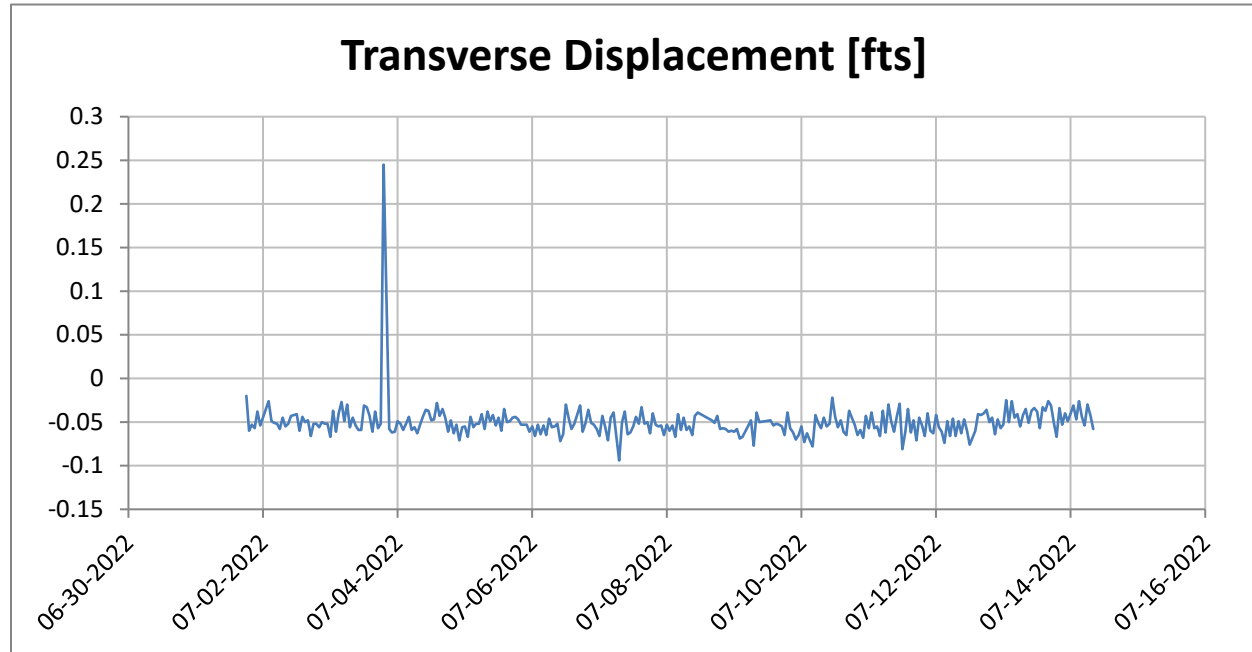
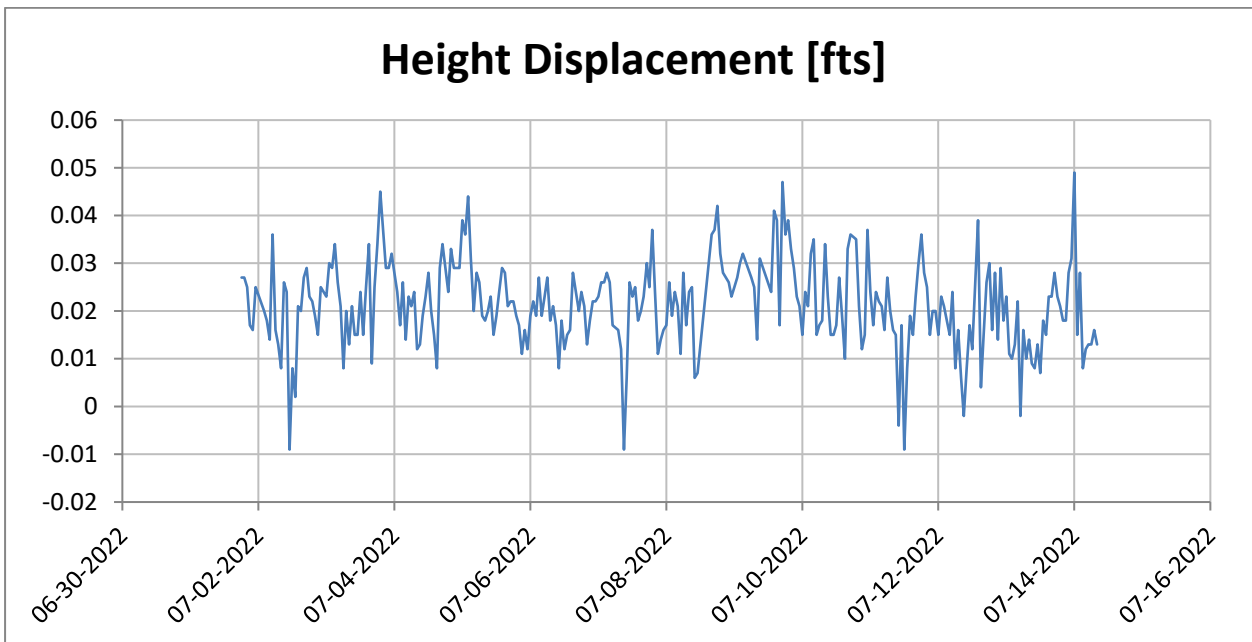
## Prism TOE4

1. Survey accuracy is +/-0.016 feet.
2. Alarm threshold is +/-0.35 feet.
3. Transverse displacement is in the horizontal direction. Positive direction means closer to the robotic station.
4. Height displacement is in the vertical direction. Positive direction means higher in elevation.
5. Prism records slope creep movements with slow velocity.
6. Prism was removed 7/14/2022.

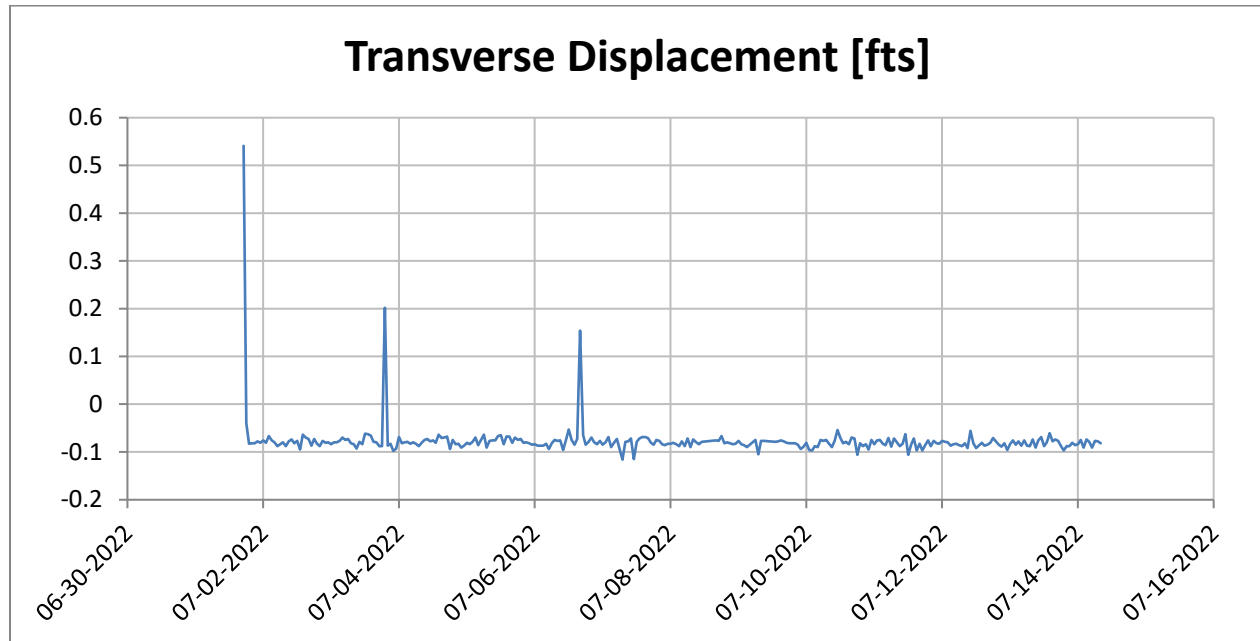
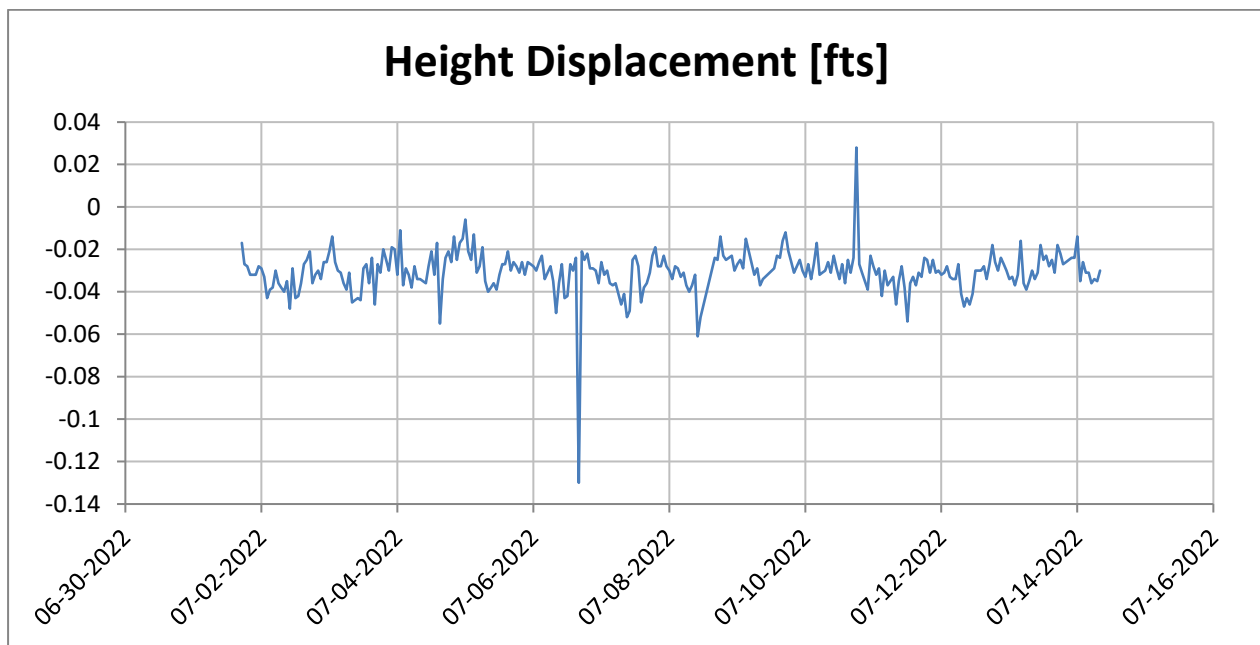
## Prism TOE5

1. Survey accuracy is +/-0.016 feet.
2. Alarm threshold is +/-0.35 feet.
3. Transverse displacement is in the horizontal direction. Positive direction means closer to the robotic station.
4. Height displacement is in the vertical direction. Positive direction means higher in elevation.
5. Prism records slope creep movements with slow velocity.
6. Prism reading for 7/1/22 through 7/14/22.

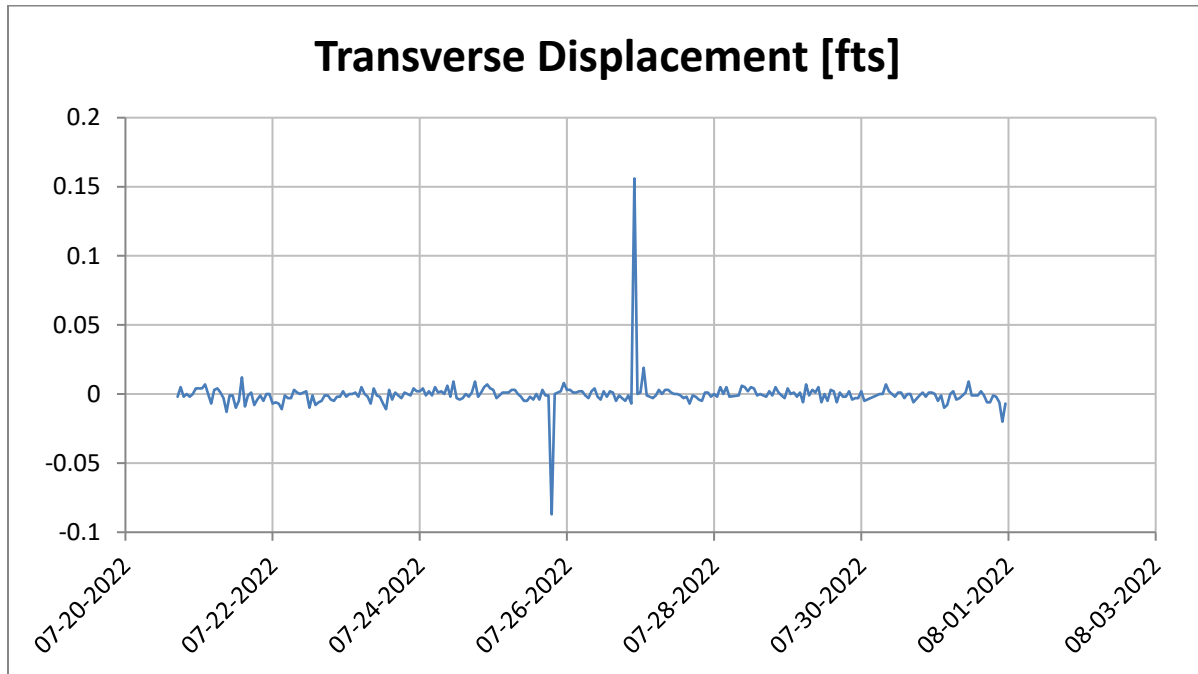
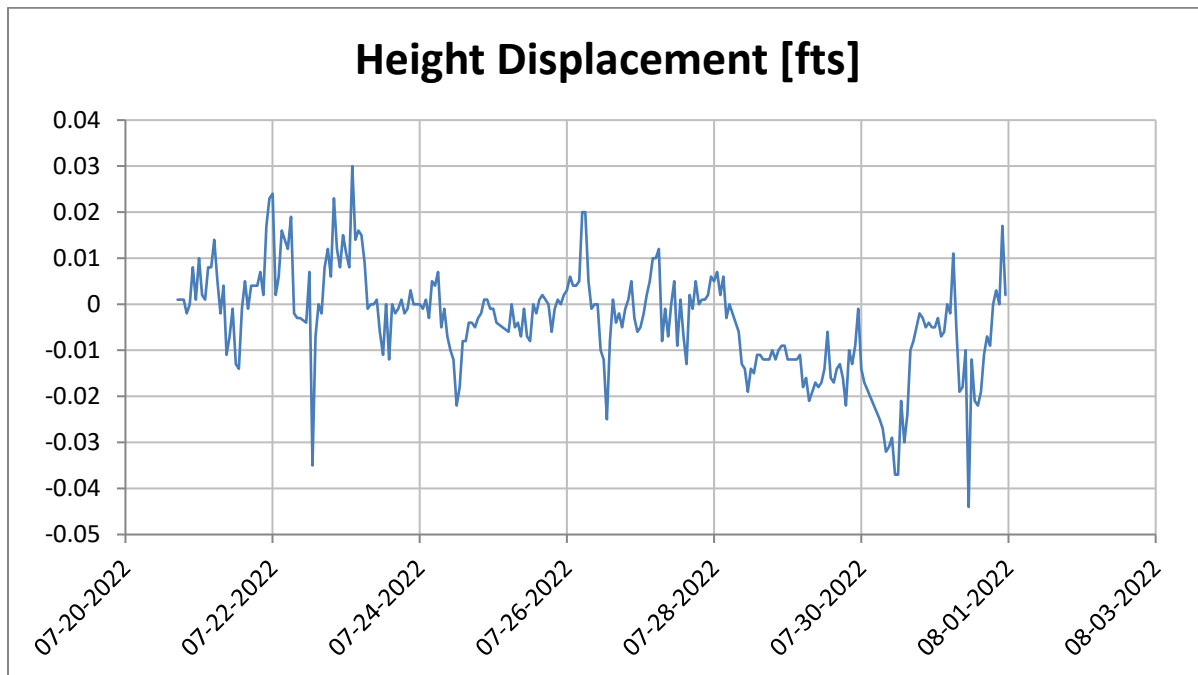
## Prism TOE5

1. Survey accuracy is  $\pm 0.016$  feet.
2. Alarm threshold is  $\pm 0.35$  feet.
3. Transverse displacement is in the horizontal direction. Positive direction means closer to the robotic station.
4. Height displacement is in the vertical direction. Positive direction means higher in elevation.
5. Prism records slope creep movements with slow velocity.
6. Prism reading for 7/20/22 through 7/30/22.

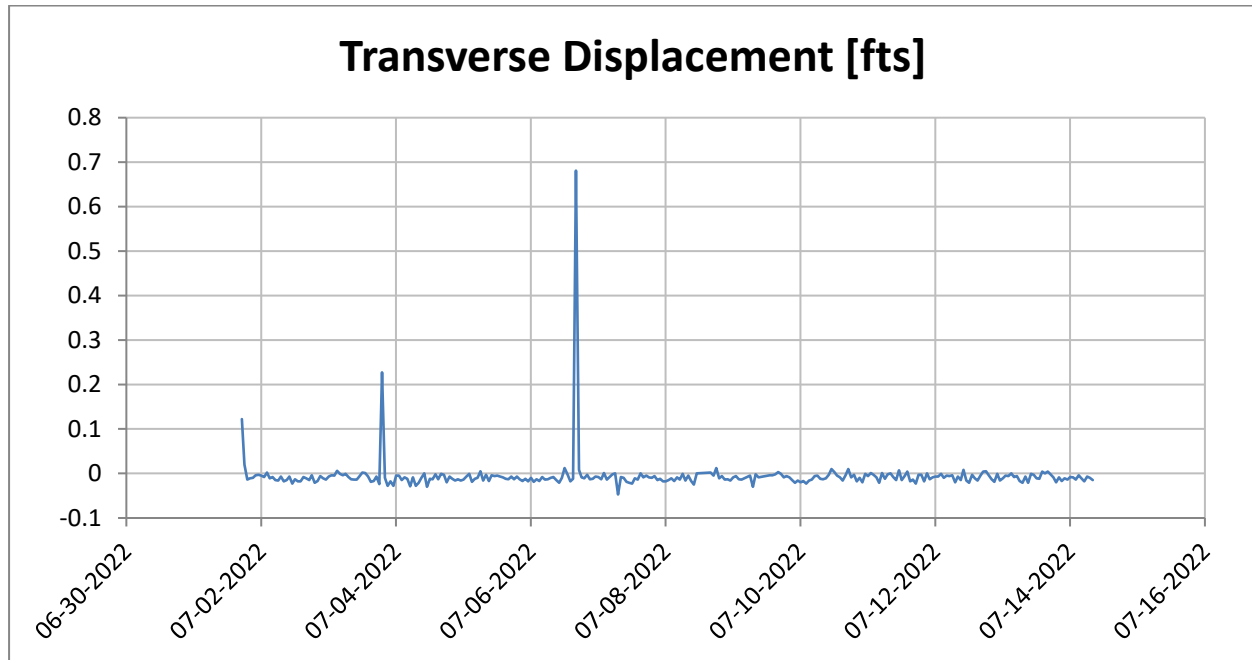
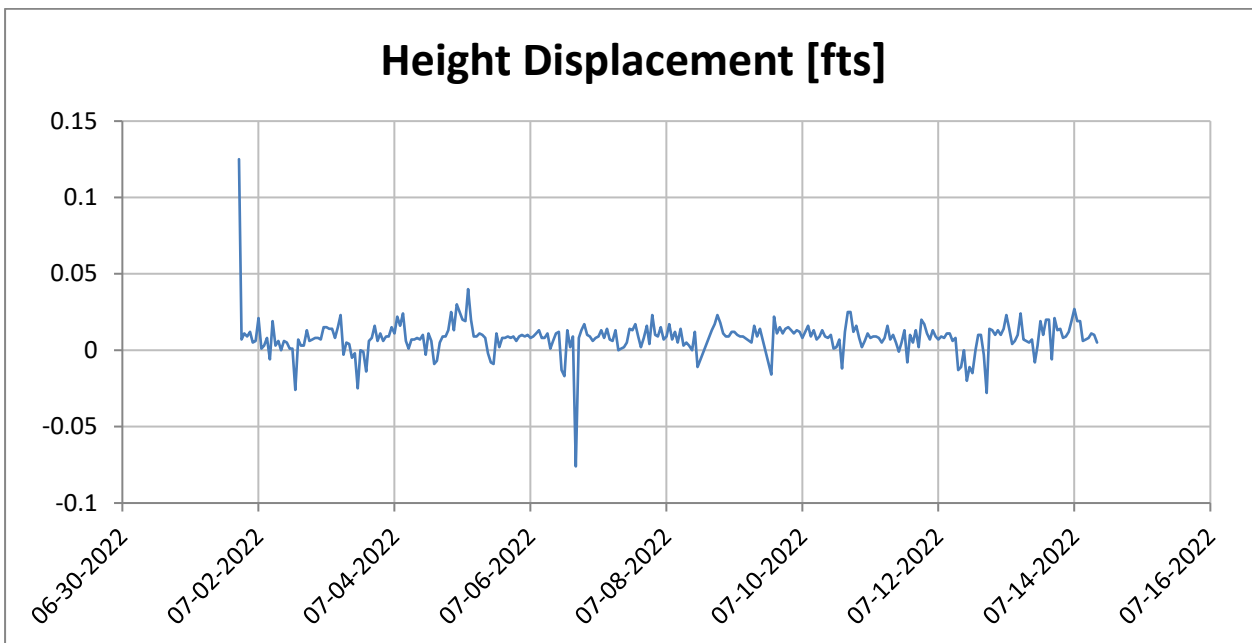
## Prism TOE6

1. Survey accuracy is +/-0.016 feet.
2. Alarm threshold is +/-0.35 feet.
3. Transverse displacement is in the horizontal direction. Positive direction means closer to the robotic station.
4. Height displacement is in the vertical direction. Positive direction means higher in elevation.
5. Prism previously known as TOE3.
6. Prism was removed 7/14/2022.
