MINERALS PROGRAM INSPECTION REPORT
PHONE: (303) 866-3567

MINE NAME: Turnpike Mining Resource	MINE/PROSPECTING ID#: M-2004-009	MINERAL: Sand and gravel	COUNTY: Weld
INSPECTION TYPE: Monitoring	INSPECTOR(S): Eric Scott	INSP. DATE: August 24, 2022	INSP. TIME: 11:30
OPERATOR: Asphalt Specialties Co., Inc.	OPERATOR REPRESENTATIVE: Greg Geras/David King	TYPE OF OPERATION: 112c - Construction Regular Operation

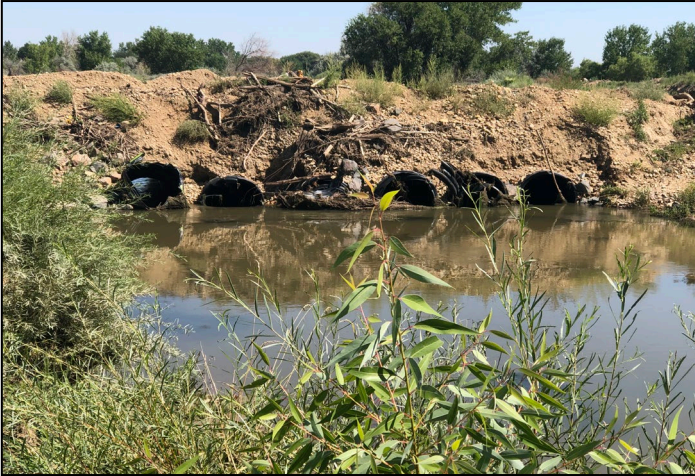
PROBLEM/POSSIBLE VIOLATION: Problem: Partial Blockage to the permitted "low water crossing" across Boulder Creek caused backup of water during a storm event onto the site. A portion of this flow eventually migrated off-site and likely contributed to standing water on an adjacent pastureland located north of the permit area.

On August 24, Eric Scott and Michael Cunningham of DRMS met with Greg Geras and David King of Asphalt Specialties at the Turnpike site at approximately 11:00. DRMS inspected the area around the low water crossing, documented its condition (photo 1), and observed a previous dewatering discharge point on the west bank of Boulder Creek where water had entered the site (photo 2). There was very little standing water observed on the site during the inspection. Asphalt Specialties stated that dewatering of the previously flooded excavation was initiated the morning after the flooding, although one of the two pumps remained submerged at the time of the inspection. DRMS noted that during the flooding event, water likely also flowed north into adjacent properties near the pumping discharge point (photos 3 and 4). This may have contributed, in part, to flooding on the adjacent properties. The corrective actions listed in this report, in addition to continued proper maintenance of the low water crossing and spillway by the permittee, are intended to prevent this issue in the future.

Photo 1 – Condition of Boulder Creek low water crossing culverts on upstream side at time of inspection.

- 1) Remove any obstructions to the low water crossing culverts and repair any damage so that this feature is fully functional as designed.
- 2) Repair the previous dewatering discharge point on the west bank of Boulder Creek immediately upstream of the low water crossing so that water cannot easily migrate from creek onto the mine site during storm events.
- 3) Maintain vegetation where possible along the banks of Boulder Creek to prevent future obstructions to the low water crossing during storm events.

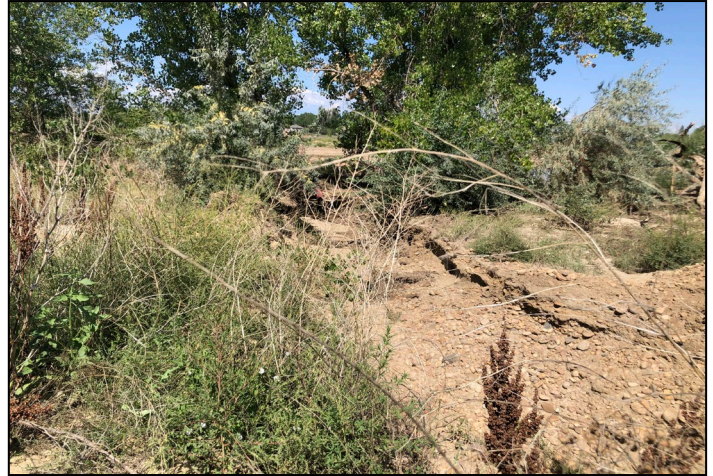
Photo 2 – Incised former dewatering discharge point on west bank of creek immediately upstream of crossing where water overflowed into site.

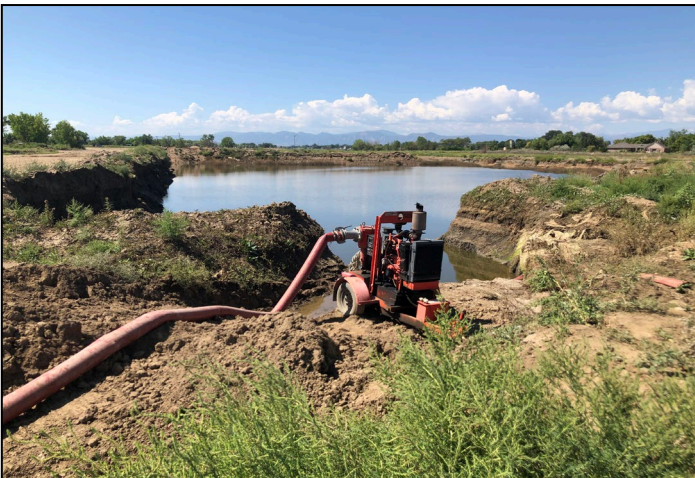
Photo 3 – Pumping discharge point on north end of remaining excavation where water exited site.

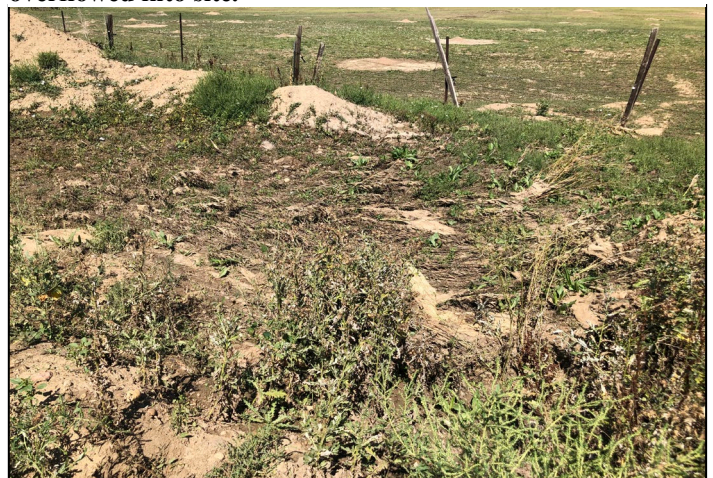
Photo 4 – Property line on north end of site near pumping discharge point where water appears to have flowed off-site.

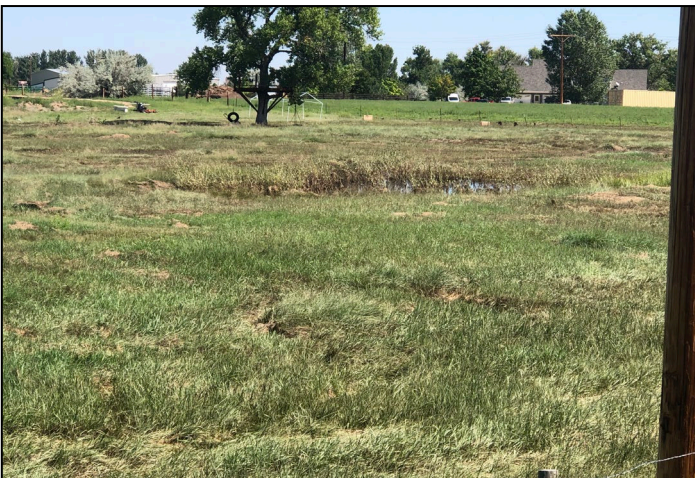
From the permittee's property, DRMS observed the condition of the adjacent Kingery pasture. Vegetation was left behind on the lower strand of the property fencing in the SE corner of the pasture. This appeared to be the lowest point of the property, where surface water would have left the pasture flowing back to Boulder Creek. This indicates that water had reached a depth of approximately 12 inches at some point, although no standing water was present at the time of the inspection. DRMS also noted that the pasture area of the Kingery property has a small area of persistent standing water within it which was also observed in historic air photos (photo 5), and that the ground surface of the pasture area is very near in elevation to the groundwater pond located immediately to the south. This indicates that the normal static water levels are very near the ground surface in this area. The pasture area of the Kingery property is also within the current floodplain and the revised regulatory floodway of Boulder Creek, and lies within an area that has been classified as having a >4%-10% chance of annual flooding as shown on the <https://coloradohazardmapping.com/> website.

Photo 1 – Persistent standing water area in Kingery pasture. No other standing water at time of inspection.
