MINERALS PROGRAM INSPECTION REPORT

MINE NAME: MMM Partnership Gravel Pit	MINE/PROSPECTING ID#: M-2006-042	MINERAL: Sand, gravel and bor for construction	COUNTY: Logan
INSPECTION TYPE: Monitoring	INSPECTOR(S): Nikie Gagnon	INSP. DATE: August 4, 2022	INSP. TIME: 09:00
OPERATOR: MMM Partnership, LLP.	OPERATOR REPRESENTATIVE:	TYPE OF OPERATION: 112c - Construction Regular Operation	
REASON FOR INSPECTION: Normal I&E Program	BOND CALCULATION TYPE: Full	BOND AMOUNT: \$67,200.00	
DATE OF COMPLAINT: NA	POST INSP. CONTACTS: None	JOINT INSP. AGENCY: None	
WEATHER: Clear	INSPECTOR'S SIGNATURE:

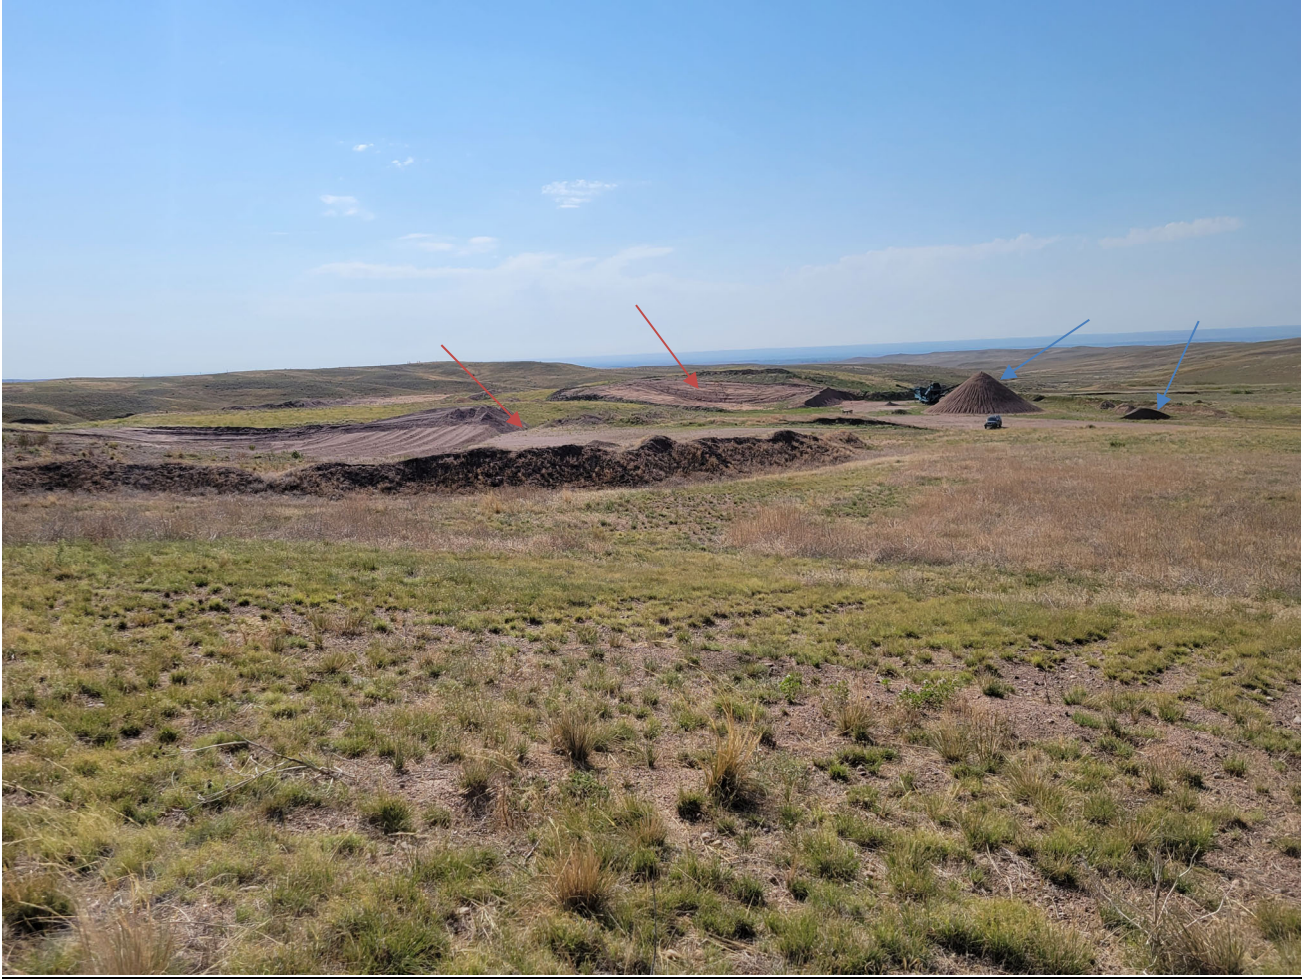
Looking southeast across the permit area.
Red arrows point to the two areas of active mining. Stockpiles are marked by blue arrows.

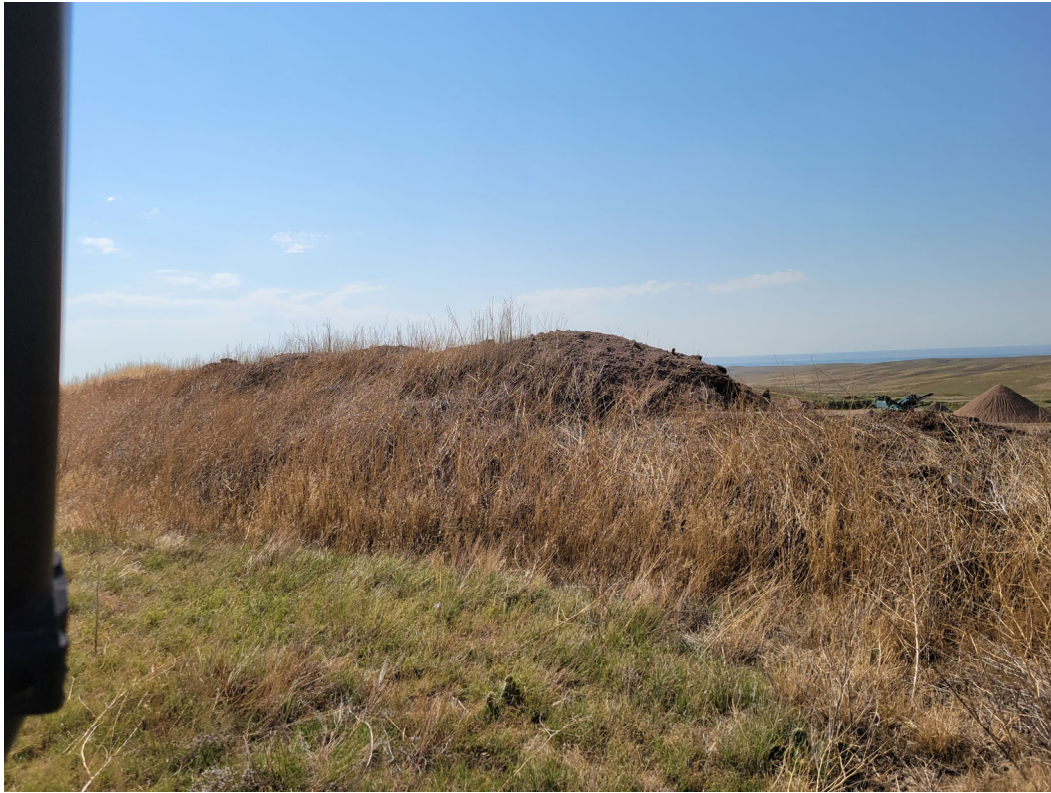
Topsoil stored above the pit along the northern permit boundary.

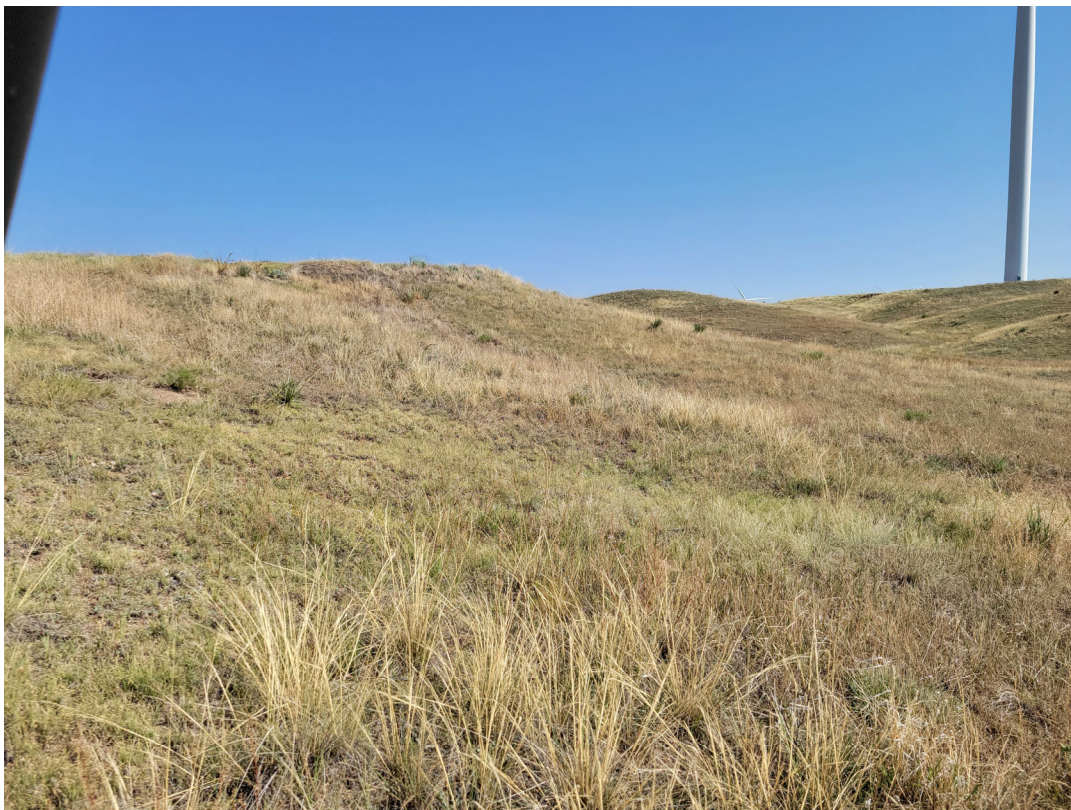
Revegetation: Native vegetation is established in areas previously disturbed and reclaimed. No off-site damage was evident during the inspection.

Previously disturbed and reclaimed slopes.

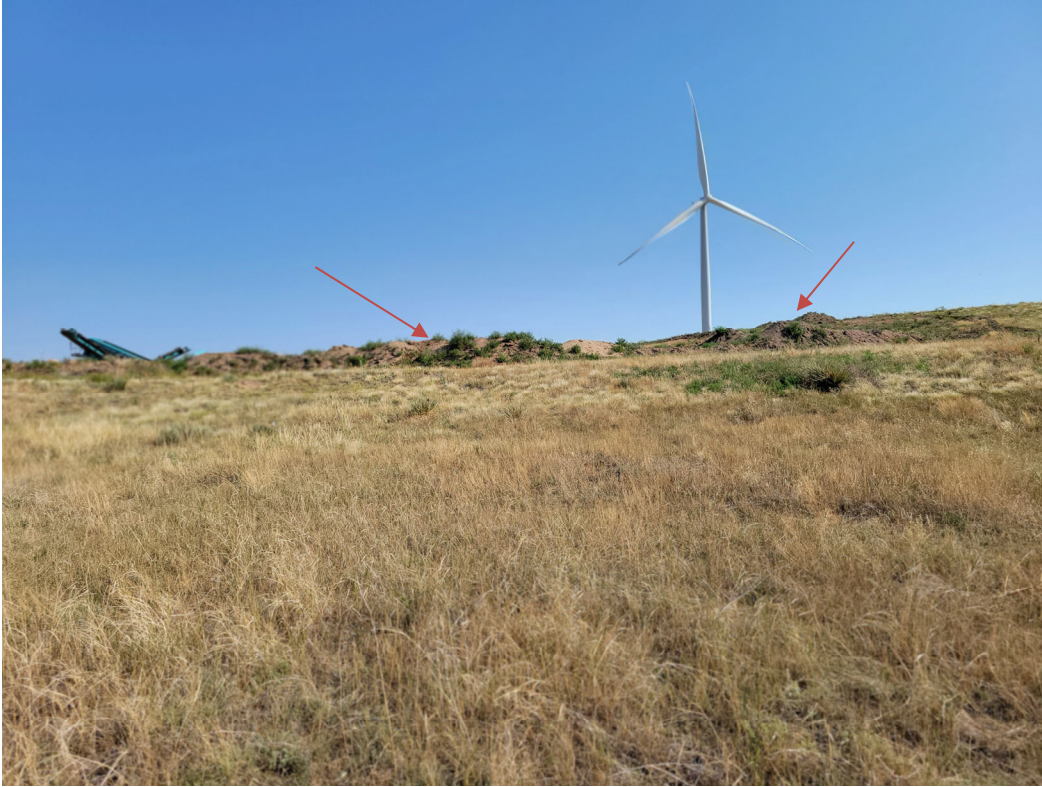
Hydrologic Balance: The pit area was dry during the inspection. Berms along the southeastern area of active mining keep sediment contained within the active mining area and control stormwater runoff.

Soil berms keeping sediment and runoff within the pit area.

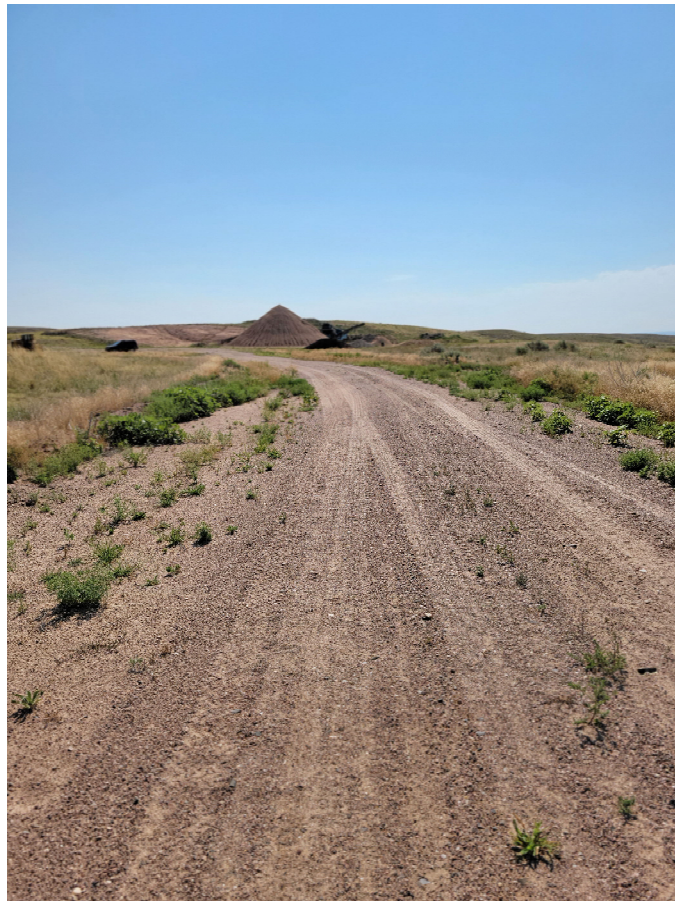
Roads: The access road to the site was graded and maintained.

Gravel access road into pit.

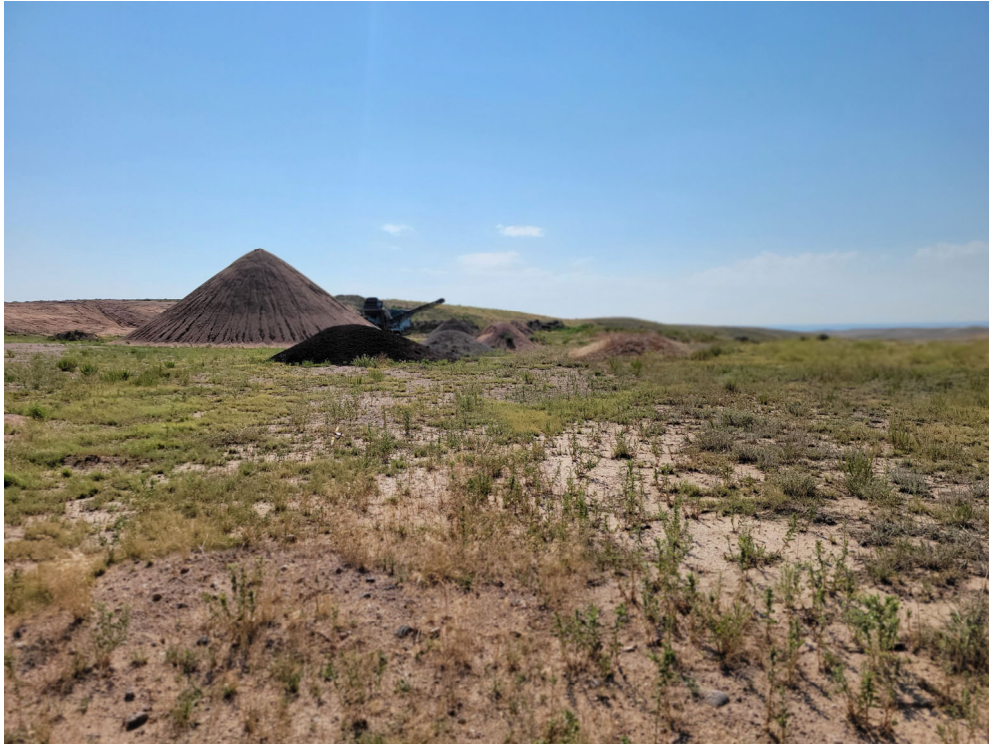
Stockpiled product and mulch in the bottom of the pit area.

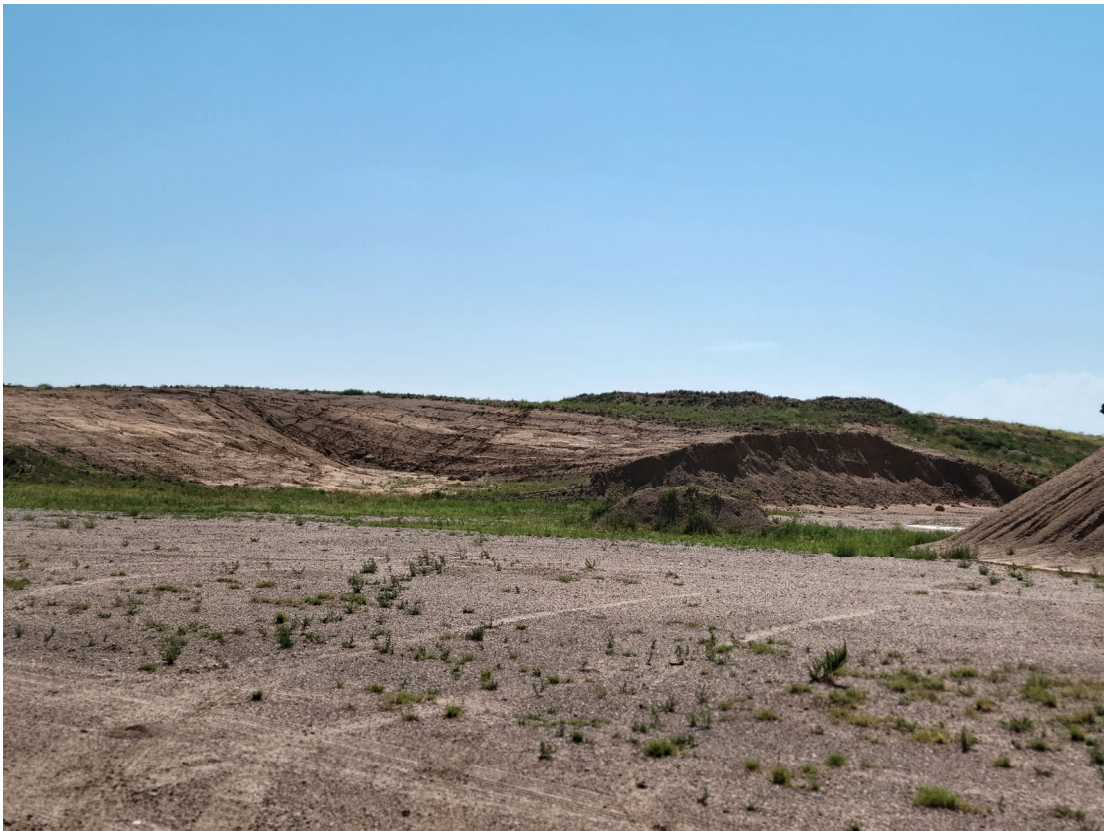
Mining at the site has created two active mining areas in the northwestern and northeastern portions of the permit area. Mr. Kokes indicated mining is nearing completion in the eastern area which was recently graded from the top down to a vertical 15-20 foot tall highwall at the base. The western highwall is also approximately 15 feet tall and nearly vertical at the top and gradually slopes towards the center of the pit.

Looking northeast at the eastern highwall.

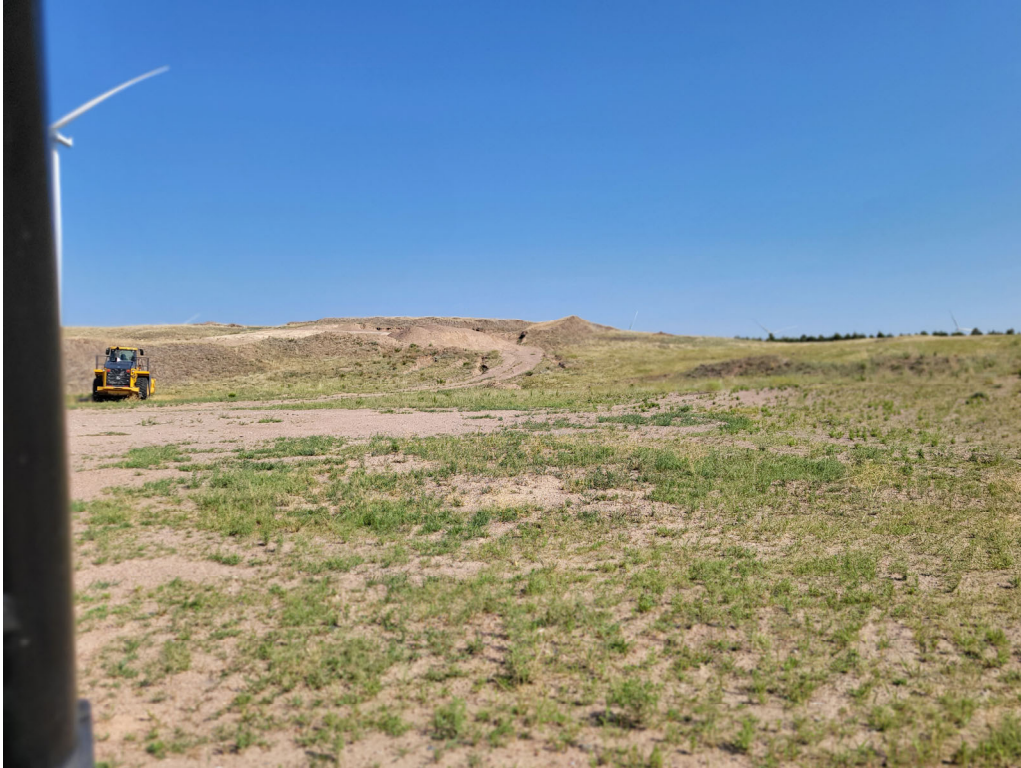
Looking northwest at the western highwall.
