**Re: 5 Dam Seepage Return Line Leak – Climax Mine Permit No. M-1977-493**

# Five day reporting form

# Incident Map

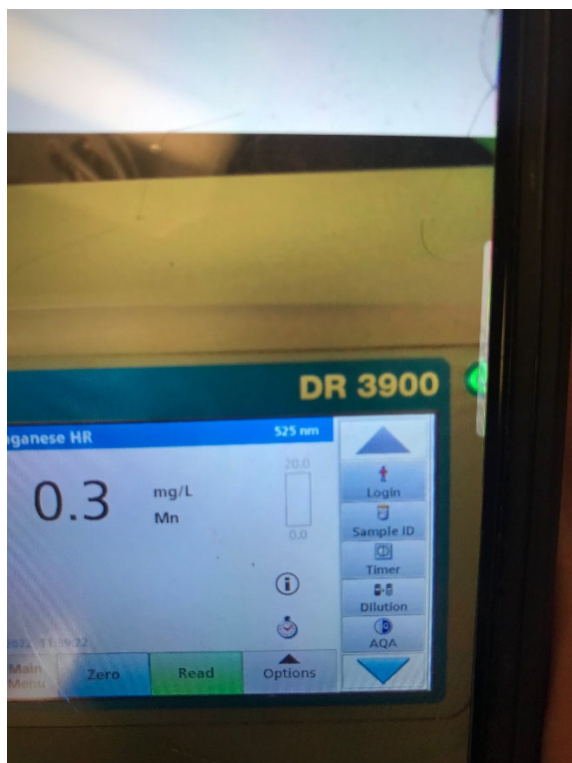
Sample results from Climax's onsite lab on August 5, 2022

*Climax Response: Onsite lab analysis showed that the pH at Outfall 001A was 7.7 and the Mn concentration was 300ug/L. Attached in recorded data and screen shot of the analyzer. The data from the other sample sent offsite has not been received yet and will be sent as soon as it is received.*

Roger Stauffer  
time taken: 12:45  
pH: 7.7  
mgn: 0.3  
time analyzed: 13:00
