MINERALS PROGRAM INSPECTION REPORT

MINE NAME: May Day Idaho Mine Complex	MINE/PROSPECTING ID#: M-1981-185	MINERAL: Gold and silver	COUNTY: La Plata
INSPECTION TYPE: Monitoring	INSPECTOR(S): Dustin Czapla	INSP. DATE: August 16, 2022	INSP. TIME: 13:00
OPERATOR: Sunrise Mining LLC	OPERATOR REPRESENTATIVE: None	TYPE OF OPERATION: 112d-2 - Designated Mining Operation

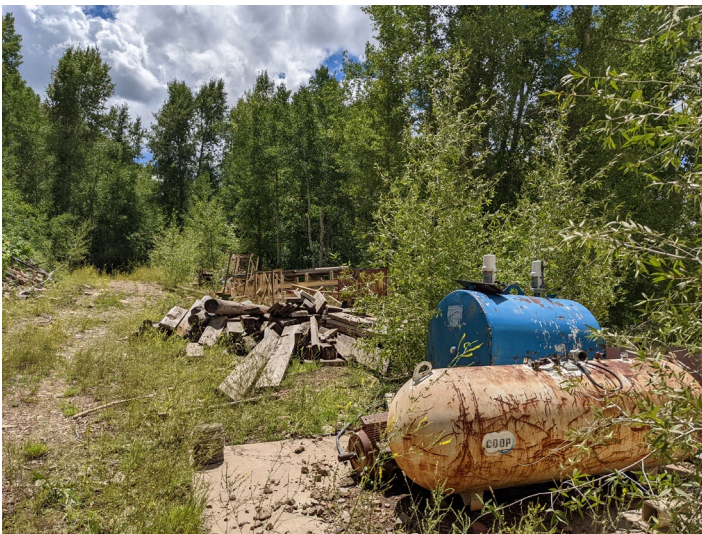
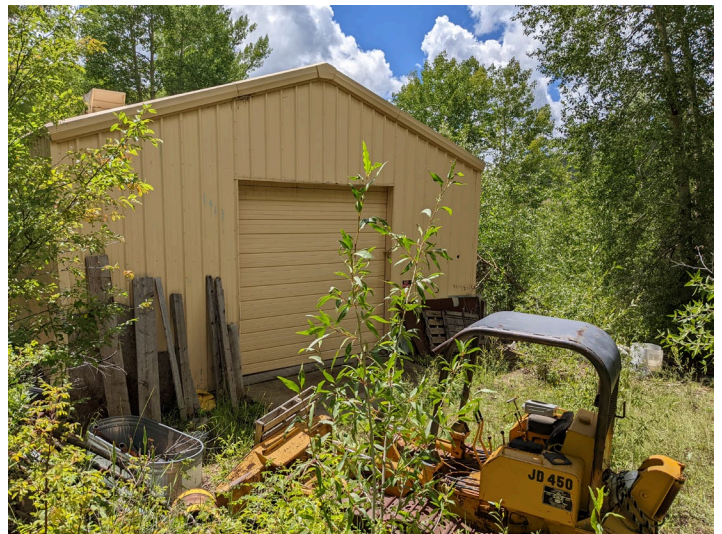
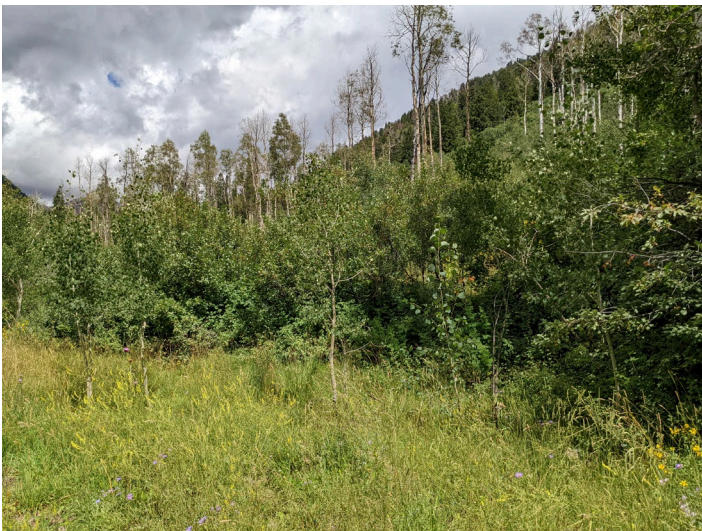
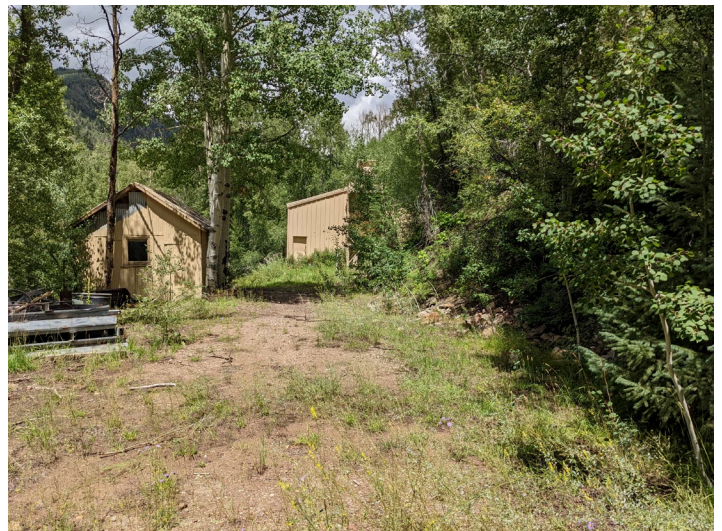
Conditions at the Idaho Area are unchanged from previous inspections. Equipment and debris are stored in an orderly fashion around the building. No problems or violations were noted in this area.

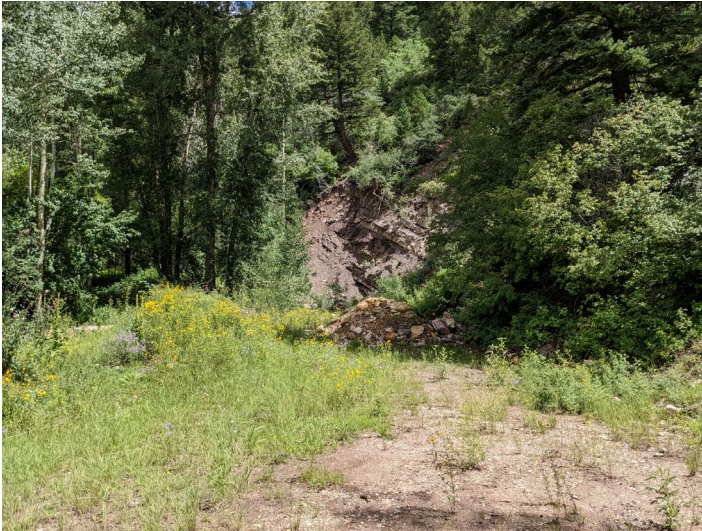
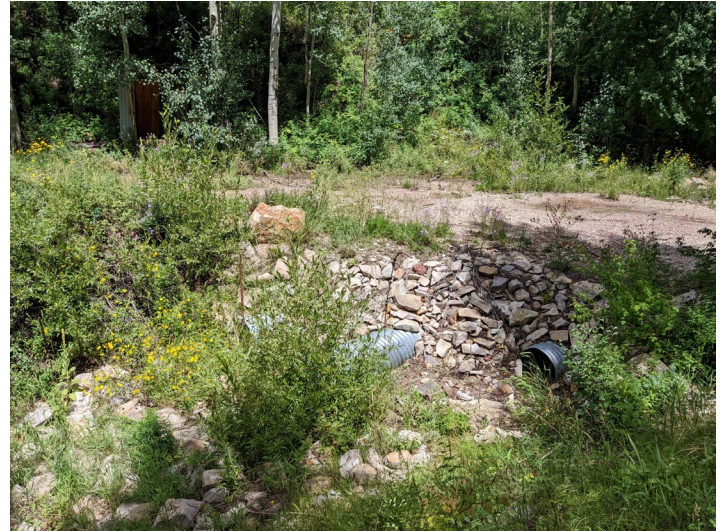
Conditions at the May Day 2 Area are unchanged from previous inspections. The culvert system located in Little Deadwood Gulch appears to be functioning as designed. The portal remains collapsed. No problems or violations were noted in this area.

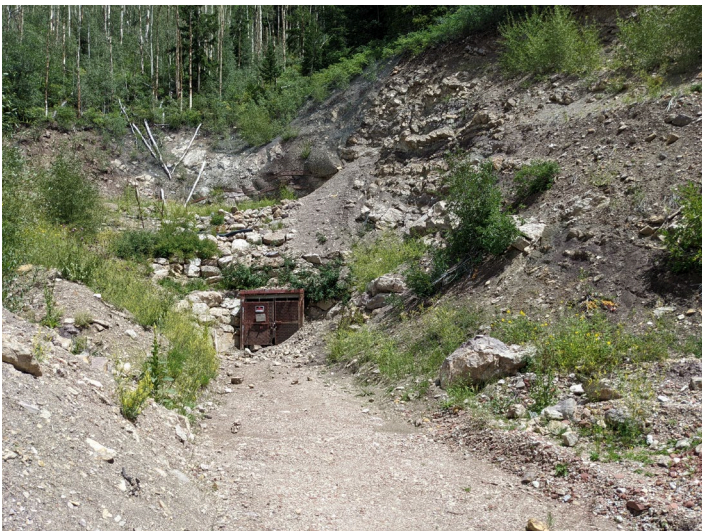
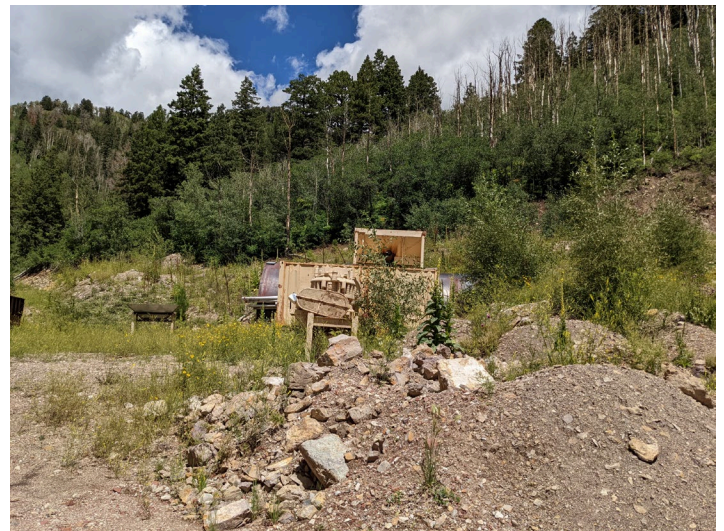
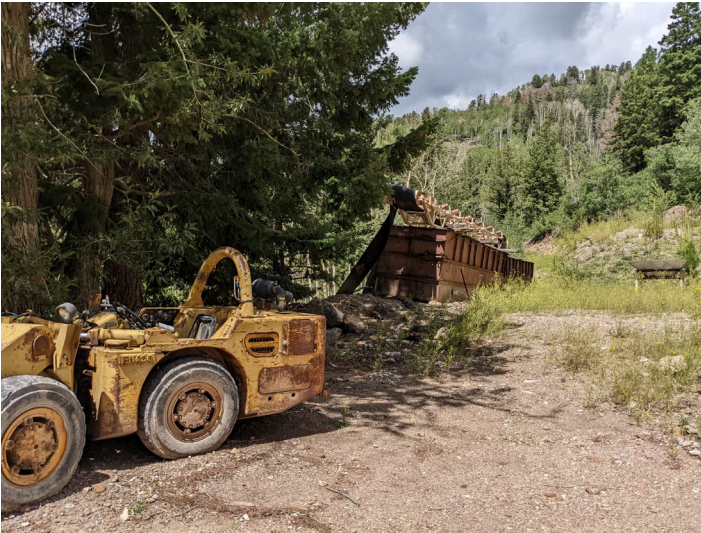
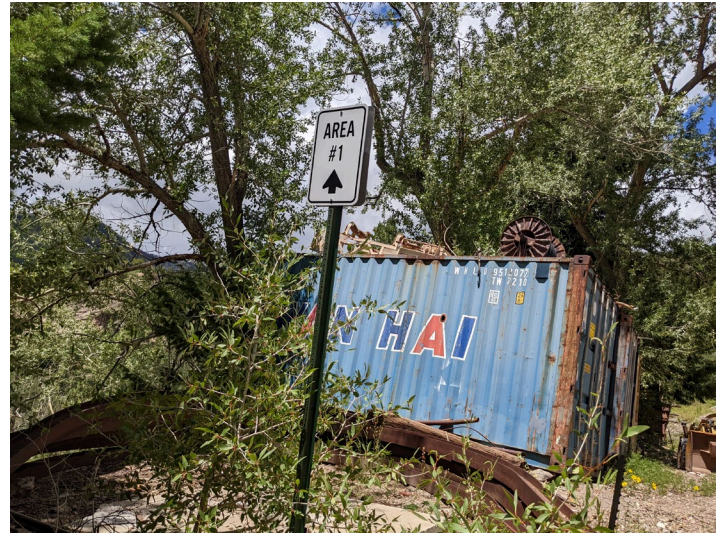
Conditions at the May Day 1 Area are unchanged from previous inspections. Evidence of any recent activity was not observed in this area. The portal is secured with a locked gate. Wire mesh and rock bolts used to stabilize the highwall above the portal appear to be functioning effectively. The milling equipment that was removed from the collapsed mill portal is still located on the May Day 1 pad, along with several shipping containers. No problems or violations were noted in this area.

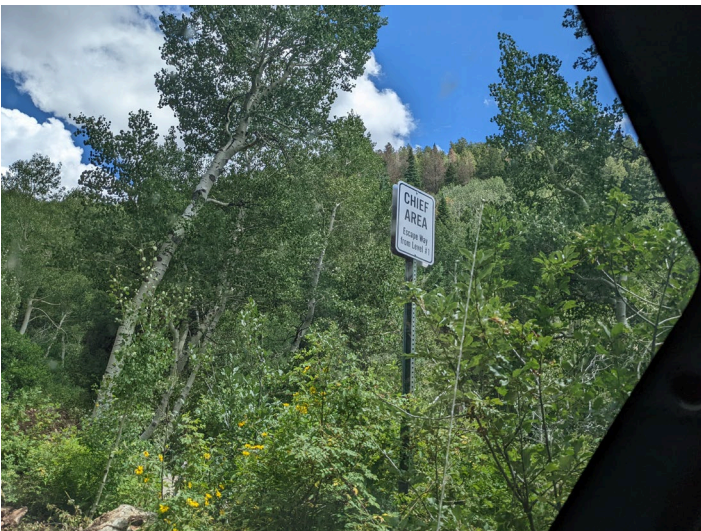
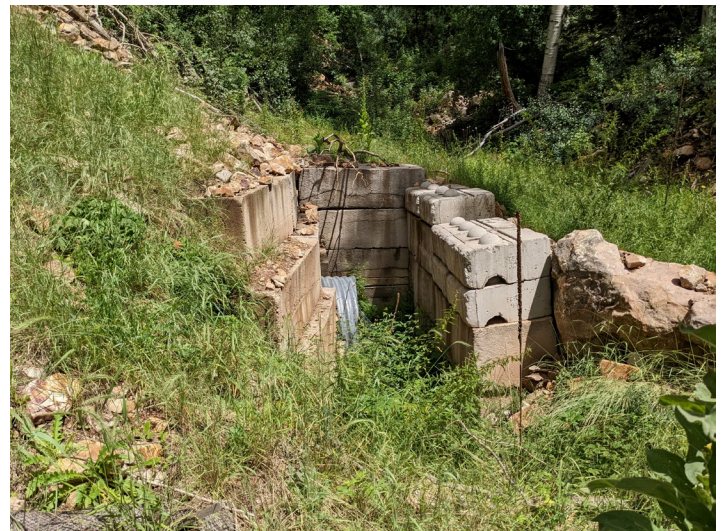
Conditions at the Chief Tunnel area are unchanged from previous inspections. The Chief Portal is designed to function as a secondary escape way and underground access point. All backfilled areas appear to be stable and in good condition. No evidence of settling, slumping or subsidence was observed. Areas where the vegetation matting was installed are well vegetated and stable. The secondary escape / emergency access has been further buttressed with the restoration of Little Deadwood Gulch. The portal is temporarily secured by wire fencing. No problems or violations were noted in this area.
