MINERALS PROGRAM INSPECTION REPORT
PHONE: (303) 866-3567

MINE NAME: Greer Pit	MINE/PROSPECTING ID#: M-1985-115	MINERAL: Sand and gravel	COUNTY: La Plata
INSPECTION TYPE: Monitoring	INSPECTOR(S): Dustin Czapla	INSP. DATE: August 16, 2022	INSP. TIME: 16:30
OPERATOR: J Pat and Lila N Greer	OPERATOR REPRESENTATIVE: None	TYPE OF OPERATION: 110c - Construction Limited Impact	
REASON FOR INSPECTION: Normal I&E Program	BOND CALCULATION TYPE: Complete Bond	BOND AMOUNT: \$12,721.00	
DATE OF COMPLAINT: NA	POST INSP. CONTACTS: None	JOINT INSP. AGENCY: None	
WEATHER: Clear	INSPECTOR'S SIGNATURE:

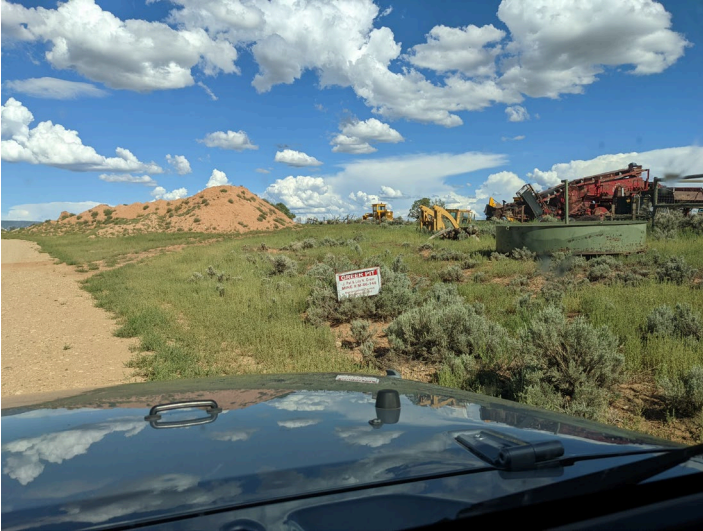
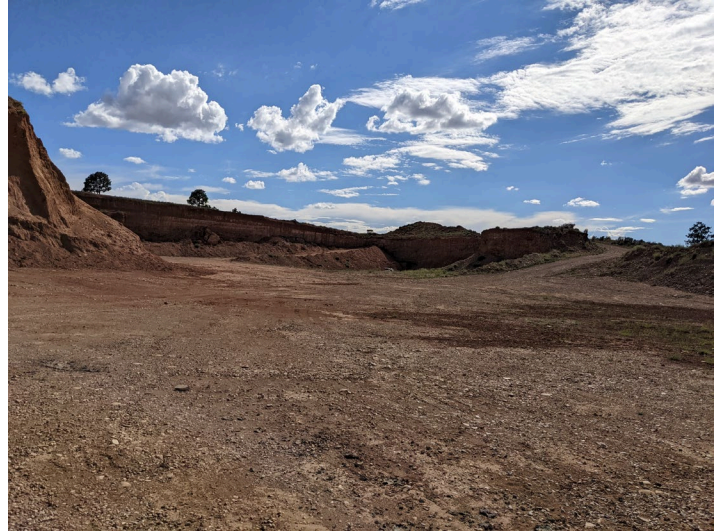
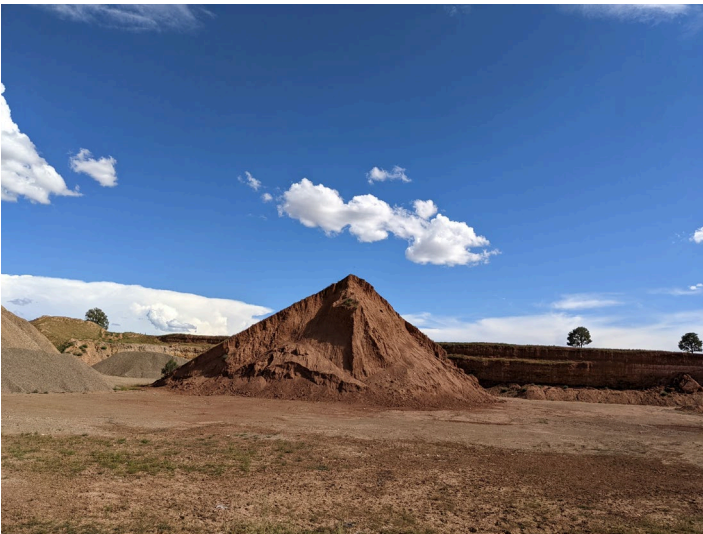
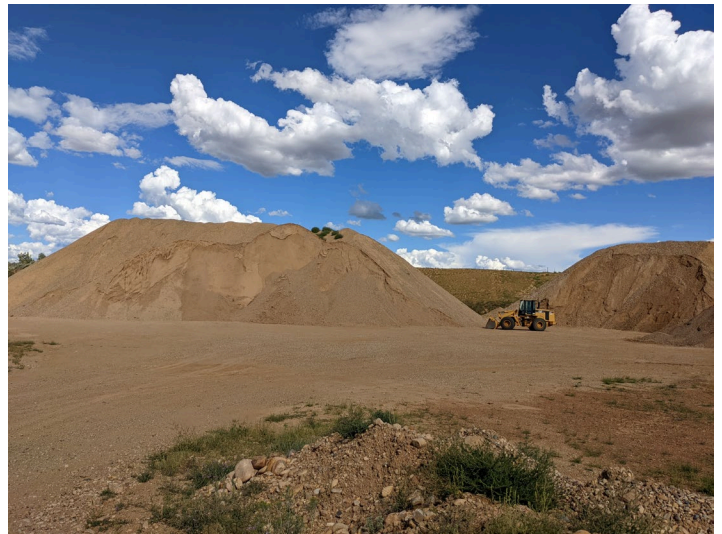
Most of the permit area has been disturbed by mining. Reclamation grading has occurred on the east highwall. The pit daylights to the north. Mining is continuing in the south highwall area where limited reserves remain. The highwall is approximately 30 feet high and near vertical. Topsoil is stockpiled in the pit and above the west highwall. Processed materials stockpiles are located in the pit.
