**MINERALS PROGRAM INSPECTION REPORT**  
**PHONE: (303) 866-3567**

<b>MINE NAME:</b> Incas Mine	<b>MINE/PROSPECTING ID#:</b> M-1986-076	<b>MINERAL:</b> Gold and silver	<b>COUNTY:</b> La Plata
<b>INSPECTION TYPE:</b> Monitoring	<b>INSPECTOR(S):</b> Dustin Czaplá	<b>INSP. DATE:</b> August 16, 2022	<b>INSP. TIME:</b> 14:00
<b>OPERATOR:</b> Mayday Livery LLC	<b>OPERATOR REPRESENTATIVE:</b> Aaron Taylor	<b>TYPE OF OPERATION:</b> 110d - Designated Limited Impact	
<b>REASON FOR INSPECTION:</b> Normal I&E Program	<b>BOND CALCULATION TYPE:</b> Complete Bond	<b>BOND AMOUNT:</b> \$29,902.68	
<b>DATE OF COMPLAINT:</b> NA	<b>POST INSP. CONTACTS:</b> None	<b>JOINT INSP. AGENCY:</b> None	
<b>WEATHER:</b> Clear	<b>INSPECTOR'S SIGNATURE:</b>

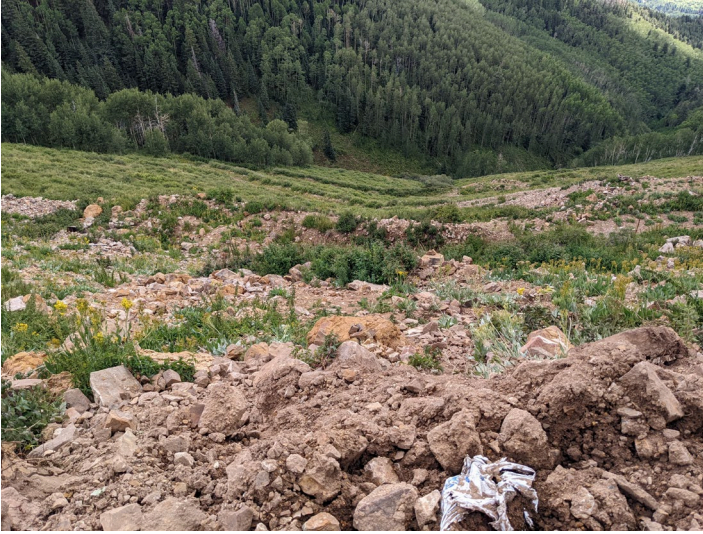
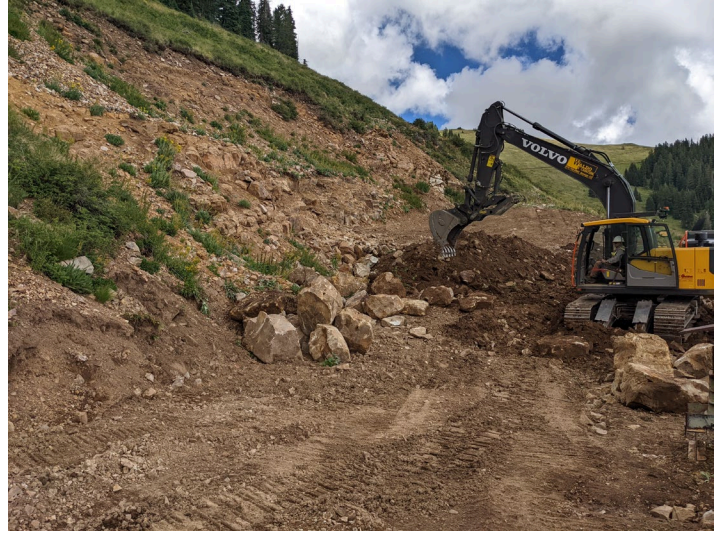
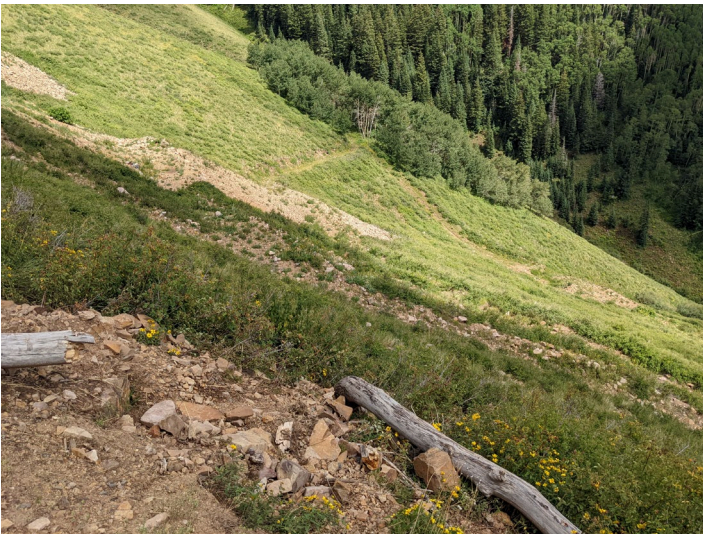
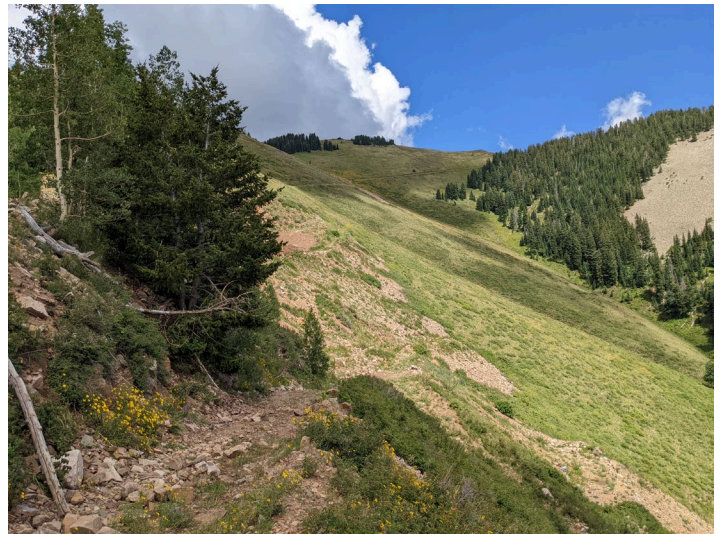
The mine site is in the final stages of reclamation. Final grading of the main excavation area was nearing completion during this inspection. Previous mining operations utilized several portals at various levels throughout the site to gain access to the underground workings. All portals have been backfilled, are secure and appeared stable at the time of the inspection. No signs of settling, slumping or erosion of the earthen backfill material was noted. The mill building was being converted to a cabin structure for the landowner's personal use.
