MINERALS PROGRAM INSPECTION REPORT

MINE NAME: Kokes Gravel Pit	MINE/PROSPECTING ID#: M-1978-249	MINERAL: Sand and gravel	COUNTY: Logan
INSPECTION TYPE: Monitoring	INSPECTOR(S): Nikie Gagnon	INSP. DATE: August 4, 2022	INSP. TIME: 09:30
OPERATOR: Logan County	OPERATOR REPRESENTATIVE: Jeff Reeves	TYPE OF OPERATION: 112c - Construction Regular Operation

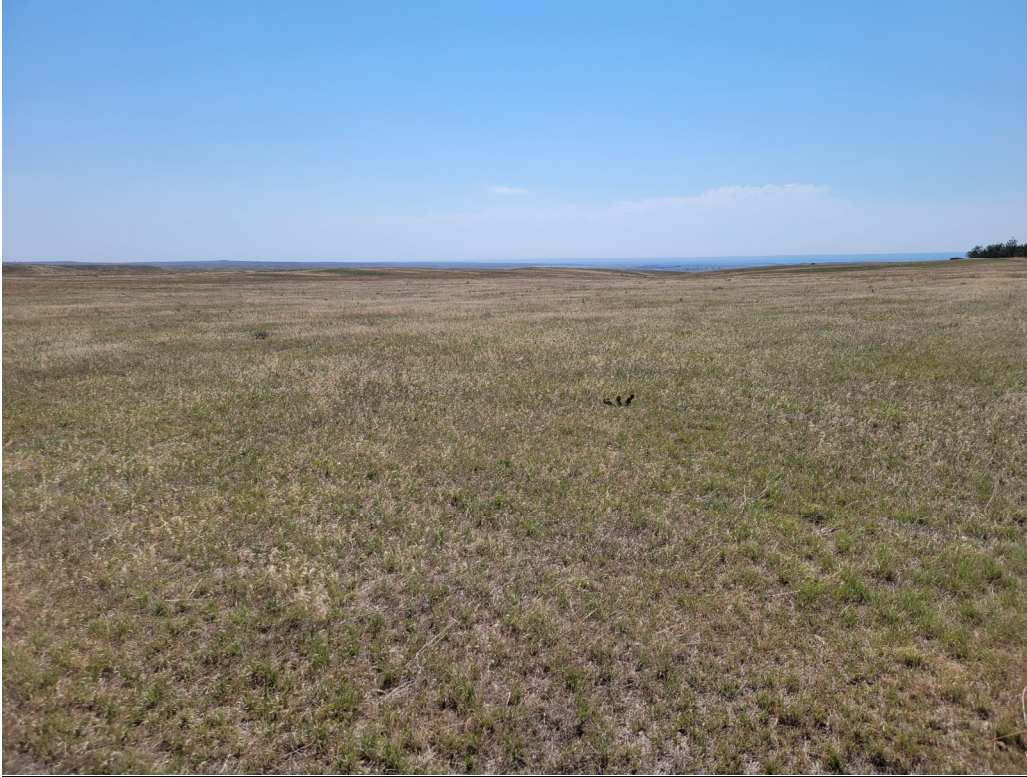
Looking south near the entrance to the permit area.

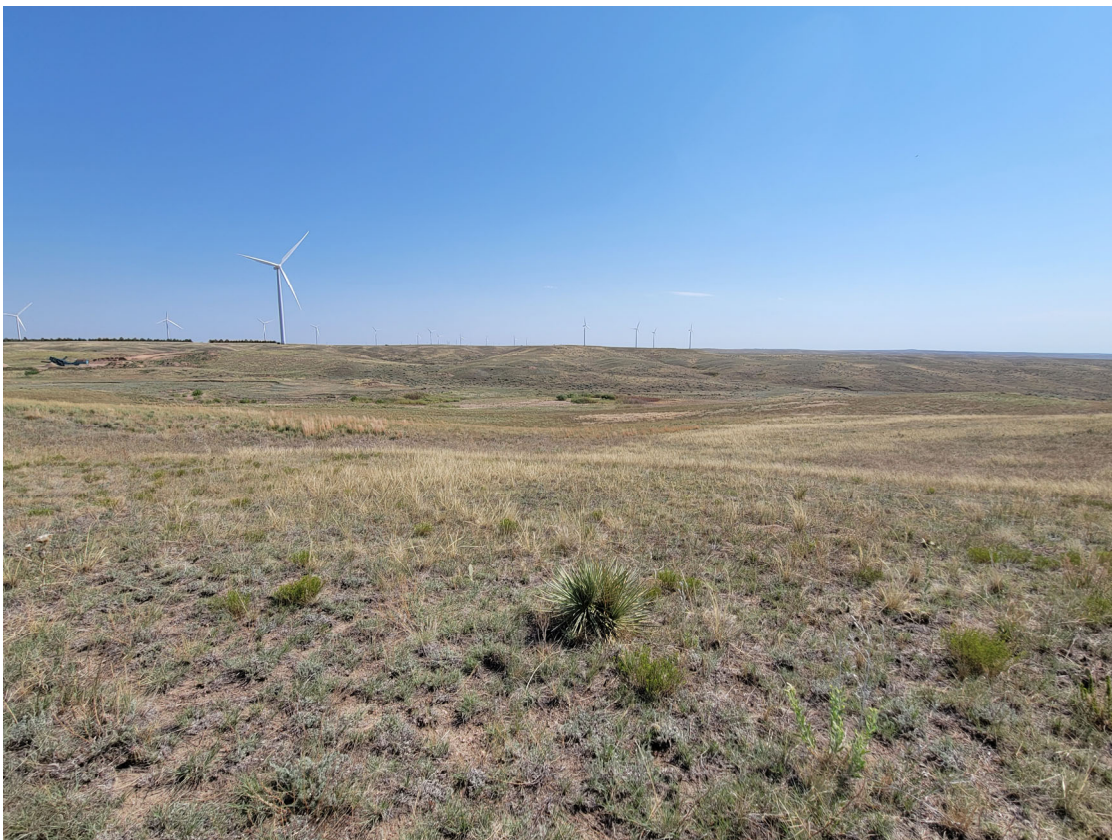
Looking east across the permit area.

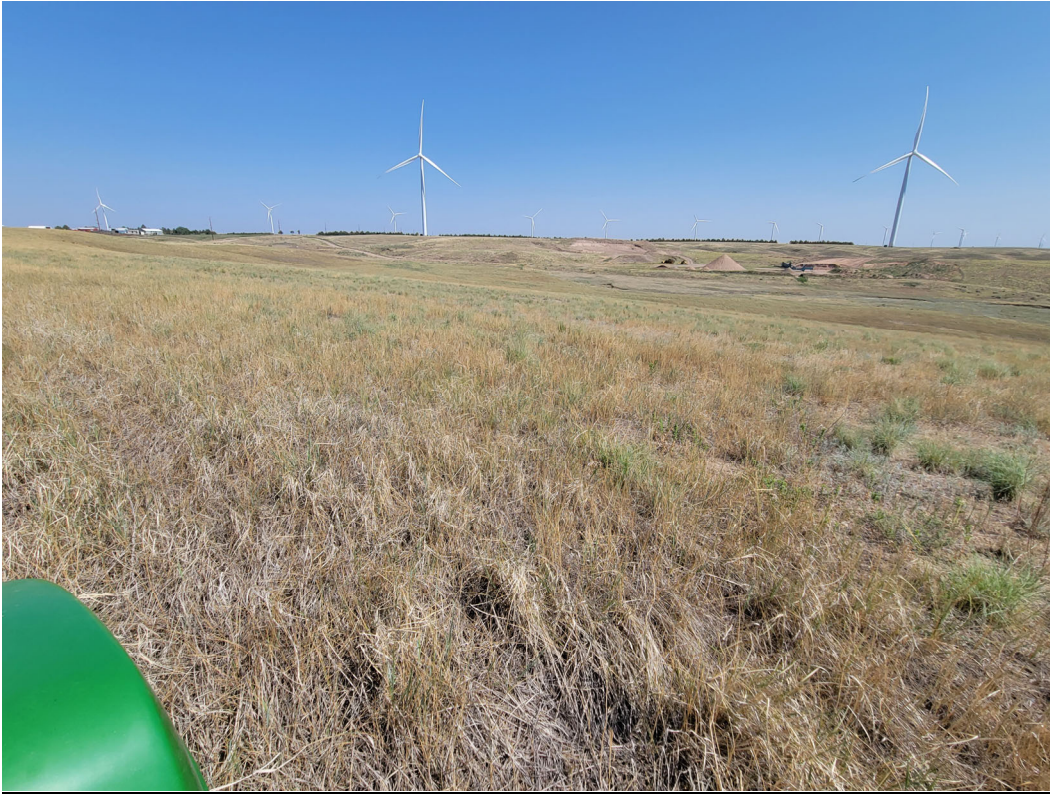
The desired vegetation is established across the majority of the permit area. The western slope of the permit area was seeded in 2017. Native grasses now cover the slope. There is a small area where the grass is patchy and bare ground is exposed. A few annual weeds were noted in this area, however native grass predominates. No rills were evident on the side slopes.

Looking north along the western slope of the permit area. Area reseeded in 2017.

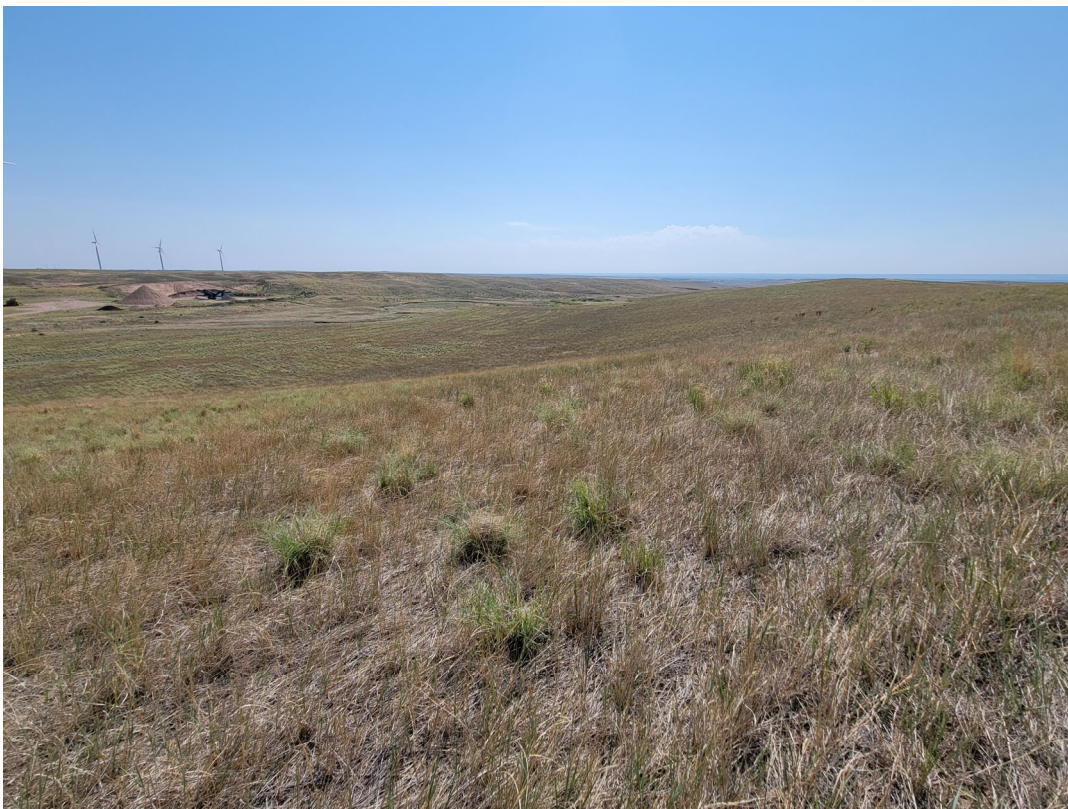
Looking southeast from the western slope of permit area.

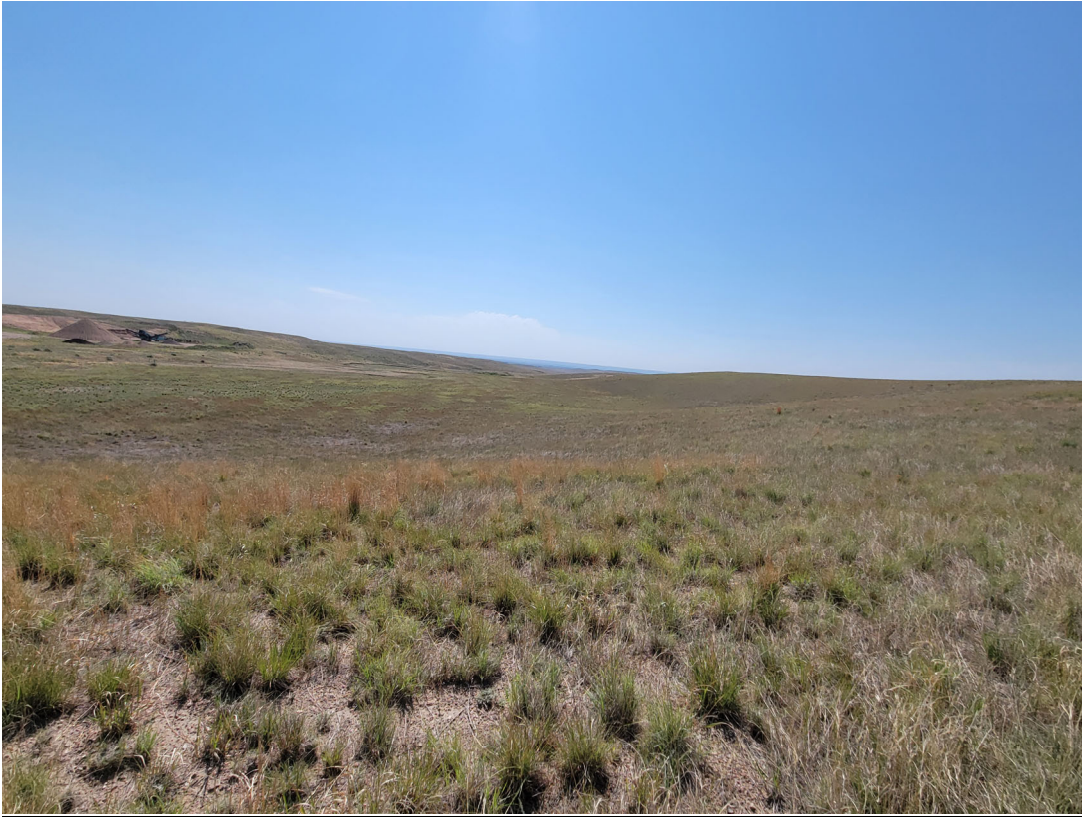
Reclamation has been completed. The site has been backfilled and graded and the topography blends into the surrounding area.

Looking southeast across reclaimed pit area.

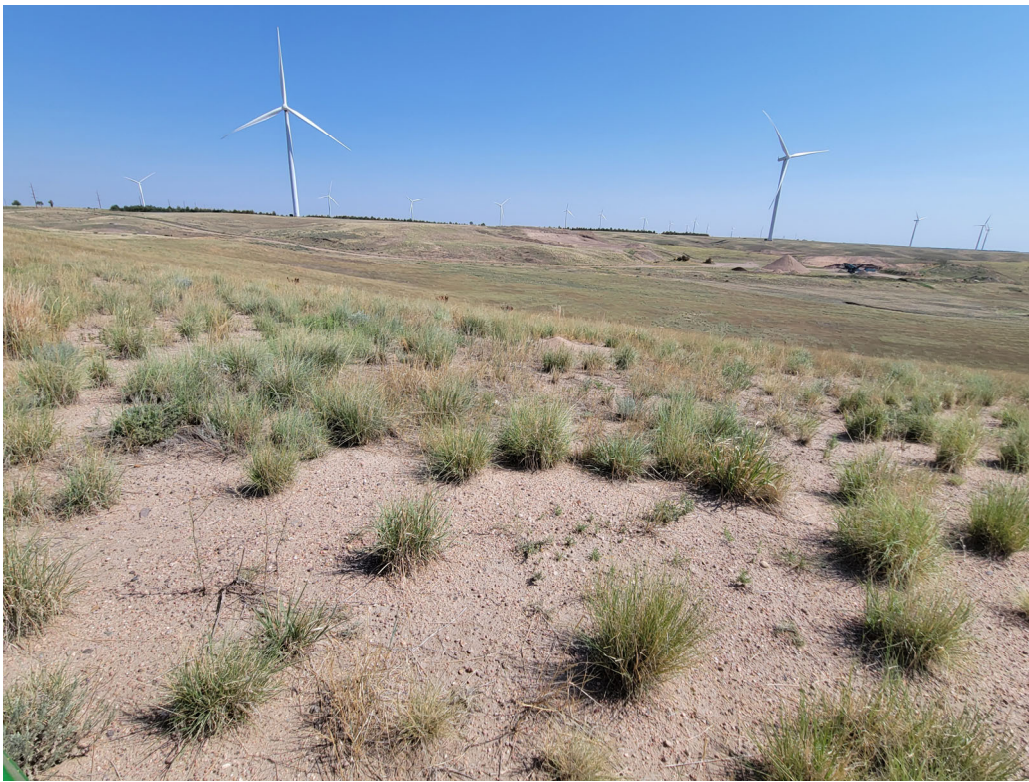
Small area of patchy grass on the top of the western slope, reseeded in 2017.

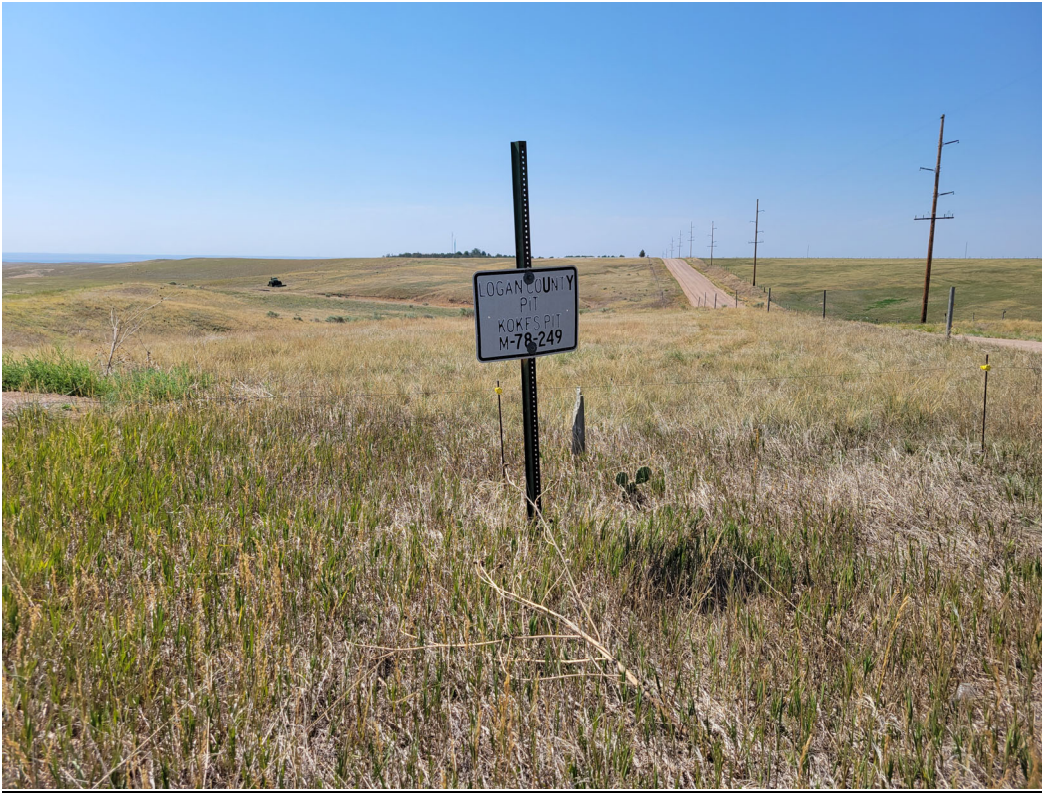
Signs and Markers: The mine identification sign was posted at the entrance and the permit boundary is clearly marked with posts.

Looking south at mine sign posted at the entrance to the pit.

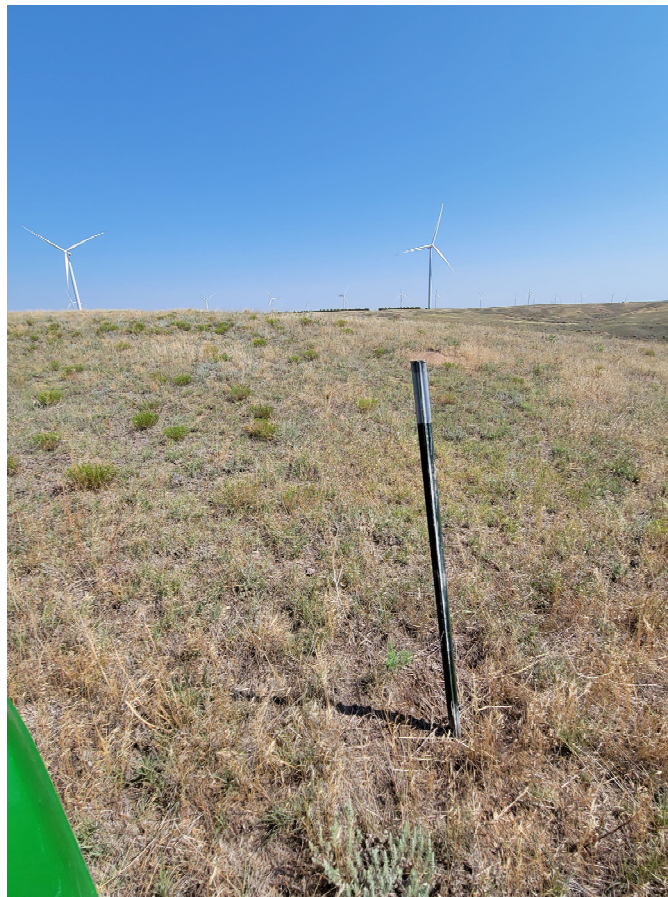
Northern permit boundary marker.
