MINERALS PROGRAM INSPECTION REPORT
PHONE: (303) 866-3567

MINE NAME: Irwin/Thomas Mine	MINE/PROSPECTING ID#: M-2016-054	MINERAL: Sand and gravel	COUNTY: Boulder
INSPECTION TYPE: Surety-Related Inspection	INSPECTOR(S): Patrick Lennberg	INSP. DATE: August 26, 2022	INSP. TIME: 12:30
OPERATOR: Holcim - WCR, Inc.	OPERATOR REPRESENTATIVE: None	TYPE OF OPERATION: 112c - Construction Regular Operation

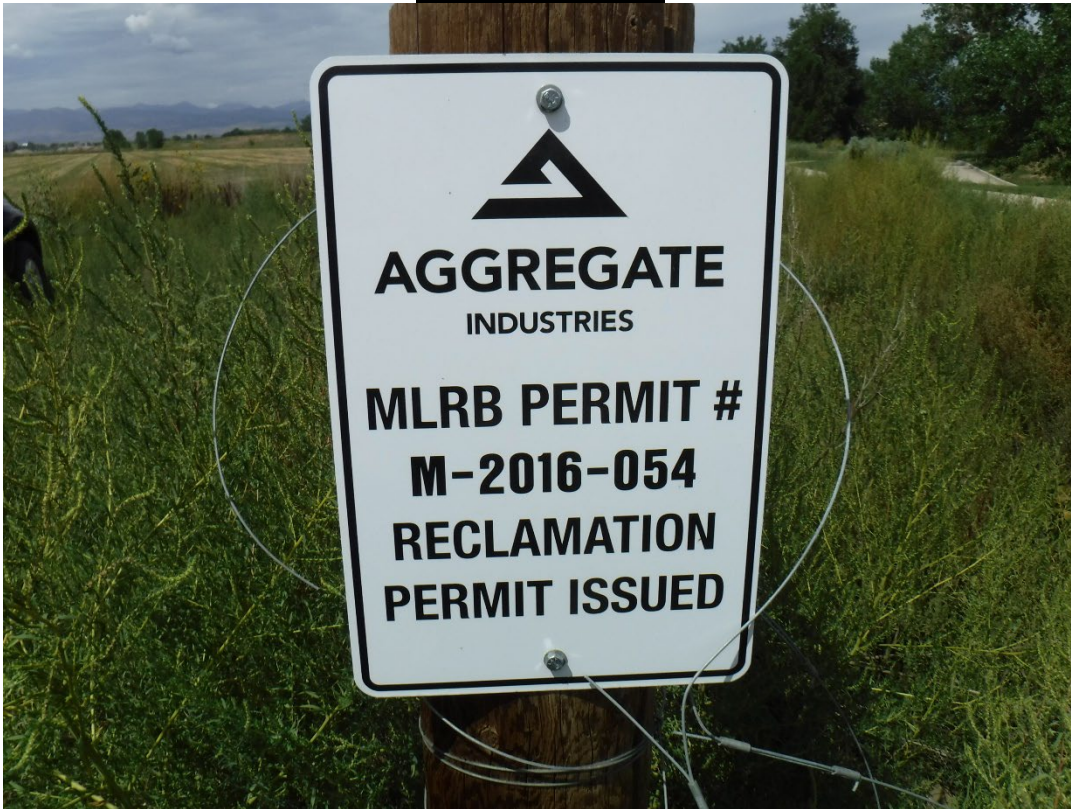
The Irwin/Thomas Mine is located in Boulder County at the southeastern edge of Longmont, Colorado and is accessed from the northeast off N 119th Street. The site is situated at the confluence of Left Hand Creek and St. Vrain Creek. The approved post-mining land use is agriculture. A mine sign was observed at the entrance to the mine as required by Rule 3.1.12. It should be noted the mine sign needs to be updated to reflect the new permittee.

Photo 1: Mine sign at entrance to permit

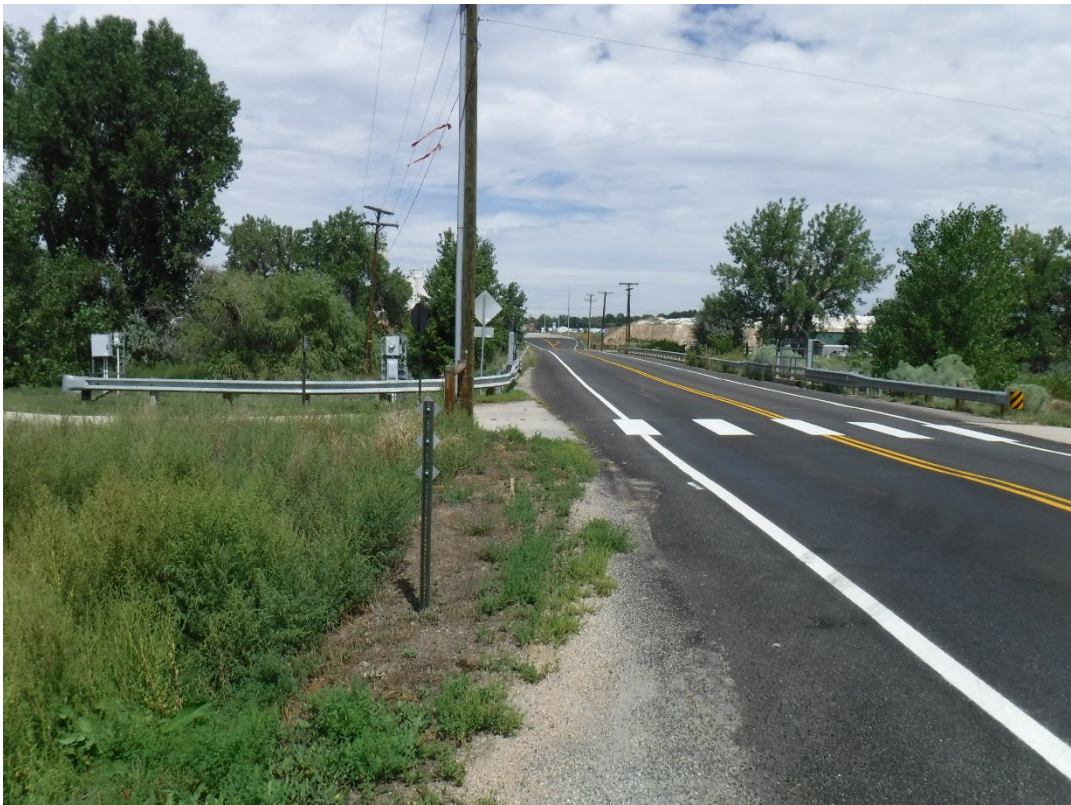
Photo 2: Looking north along N 119th St towards the intersection of Hwy 119

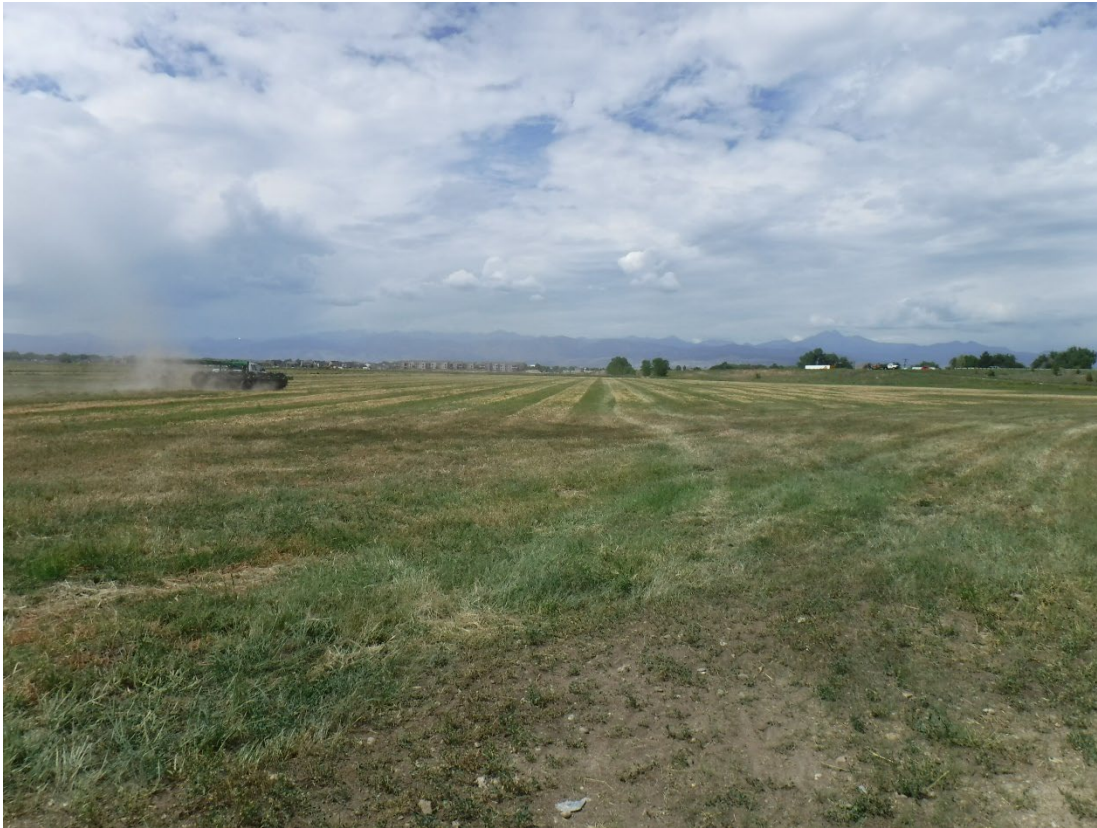
Photo 3: Looking west across the Mining Area 1 currently a cultivated field

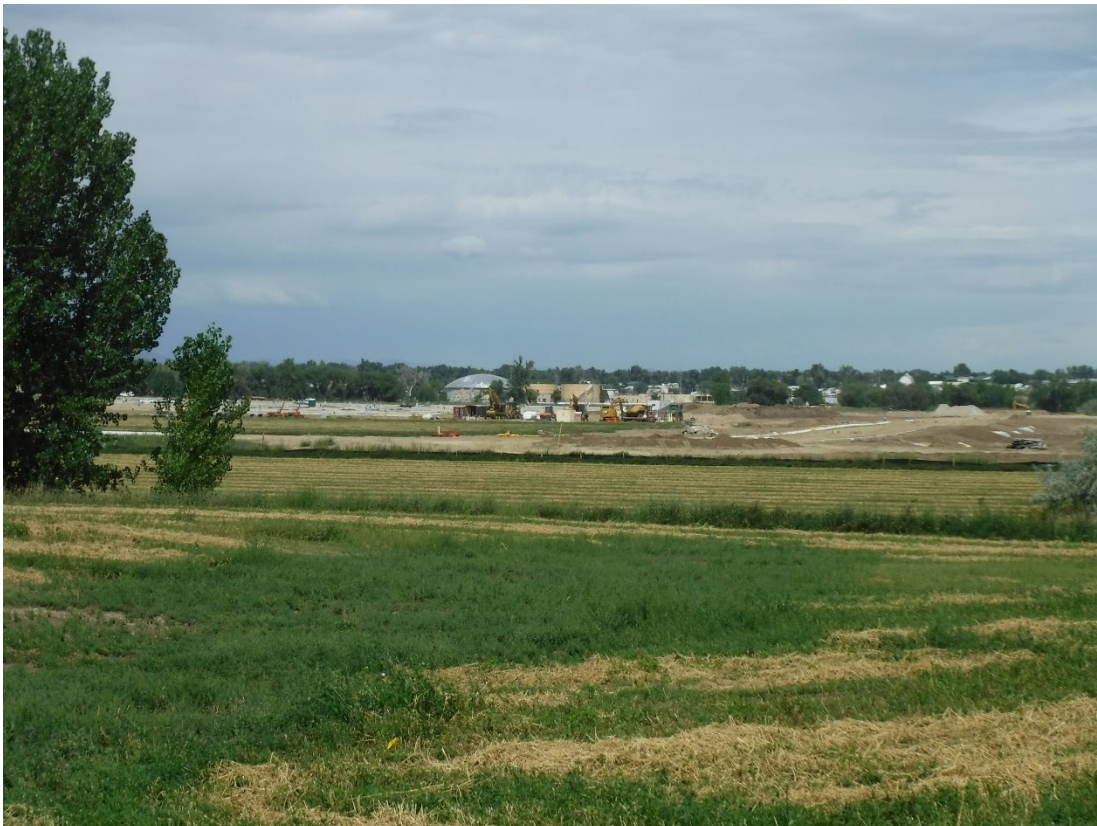
Photo 4: Looking north from Quail Rd at the ongoing construction of a Costco located in the northwestern corner of Mining Area 1

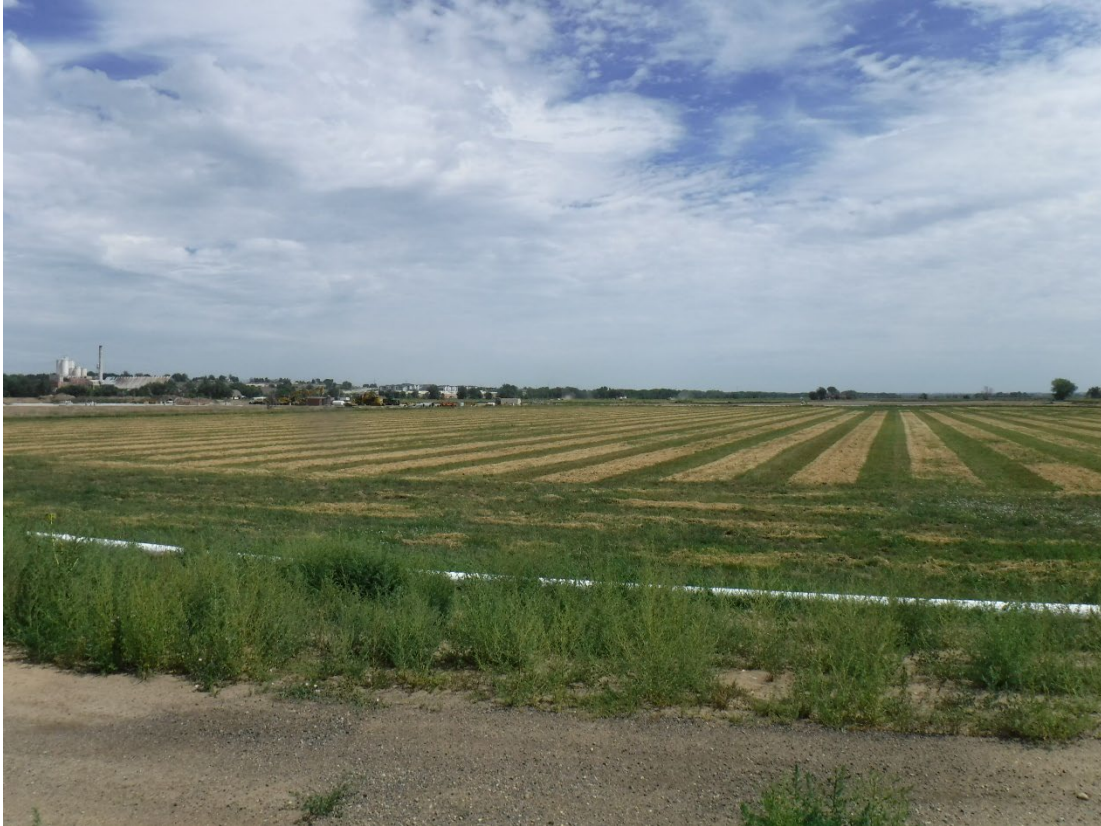
Photo 5: Looking northeast from S Marin Rd at the Costco construction

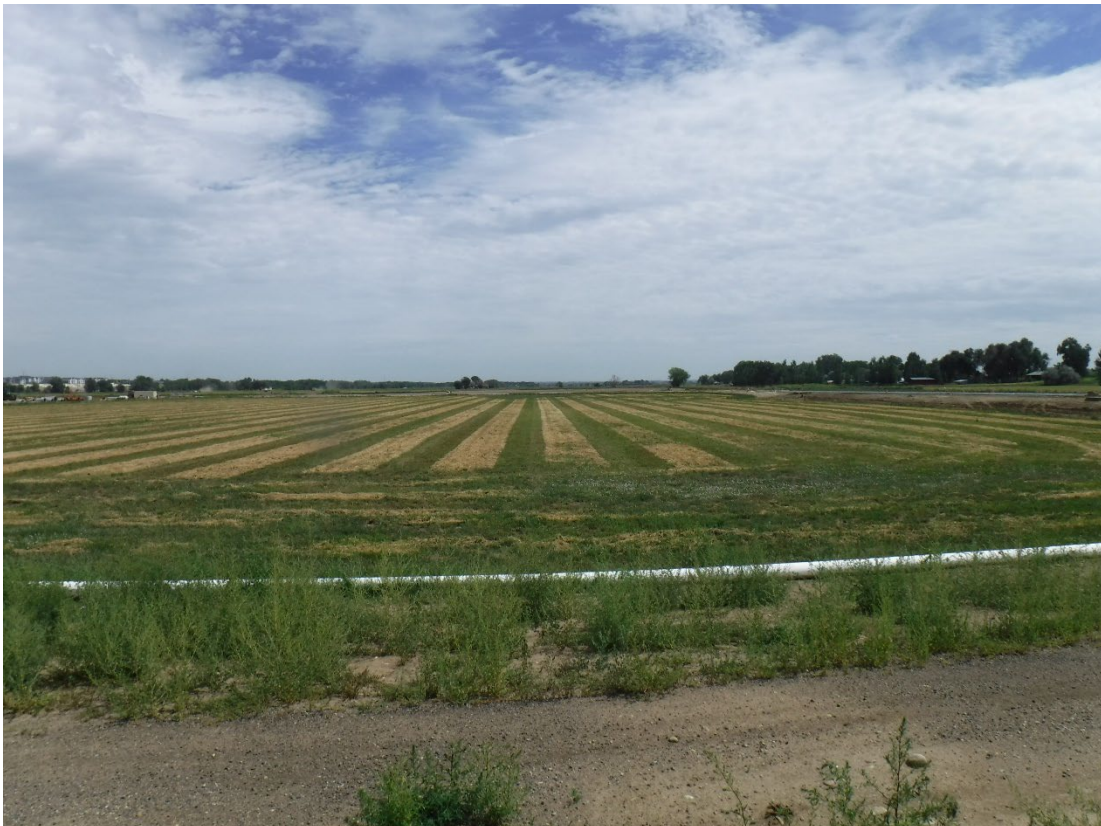
Photo 6: Looking east from S Marin Rd along the western permit boundary of Mining Area 1
