**PERMIT INFORMATION**

<b>Permit Number:</b> C-1981-028 <b>Mine Name:</b> Keenesburg Strip Mine <b>Operator:</b> Coors Energy Company <b>Operator Address:</b> Mr. Ben Moline PO Box 4030 Golden, CO 80402	<b>County:</b> Weld <b>Operation Type:</b> Surface <b>Permit Status:</b> Permanent Cessation <b>Ownership:</b> Private
	<b>Operator Representative Present:</b>  Ben Moline
<b>Operator Representative Signature: (Field Issuance Only)</b>

**INSPECTION INFORMATION**

<b>Inspection Start Date:</b> August 29, 2022 <b>Inspection Start Time:</b> 09:00 <b>Inspection End Date:</b> August 29, 2022 <b>Inspection End Time:</b> 12:45		<b>Inspection Type:</b> Coal Partial Inspection <b>Inspection Reason:</b> Surety Release Requested <b>Weather:</b> Clear	
<b>Joint Inspection Agency:</b>  None		<b>Joint Inspection Contacts:</b>  	
<b>Post Inspection Agency:</b>  None		<b>Post Inspection Contacts:</b>  	
<b>Inspector(s):</b>  Robert Zuber, P.E.	<b>Inspector's Signature:</b>  <i>Robert D. Zuber</i>		<b>Signature Date:</b>  8/30/2022

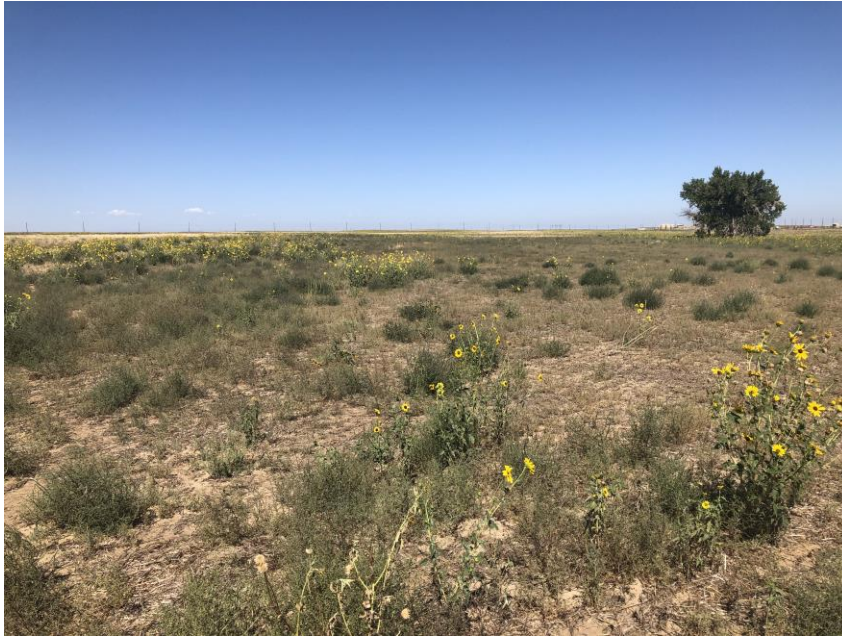
**Area 37, east end, looking north**

- Within Areas 35, 43, and 44, the general drainage pattern is to the northeast. On the west side of these areas, however, there is a swale that drains to the north and then east across the north portion of Area 43.
- Areas 36 and 37 drain to the northeast.
- Most of Area 42 is essentially flat. The “steepest” portion, the reclaimed road west of the Dugout Pond, drains to the north at approximately a 1% slope.
- The ditch in Area 45 drains to the southeast and then east to Sediment Pond 2.

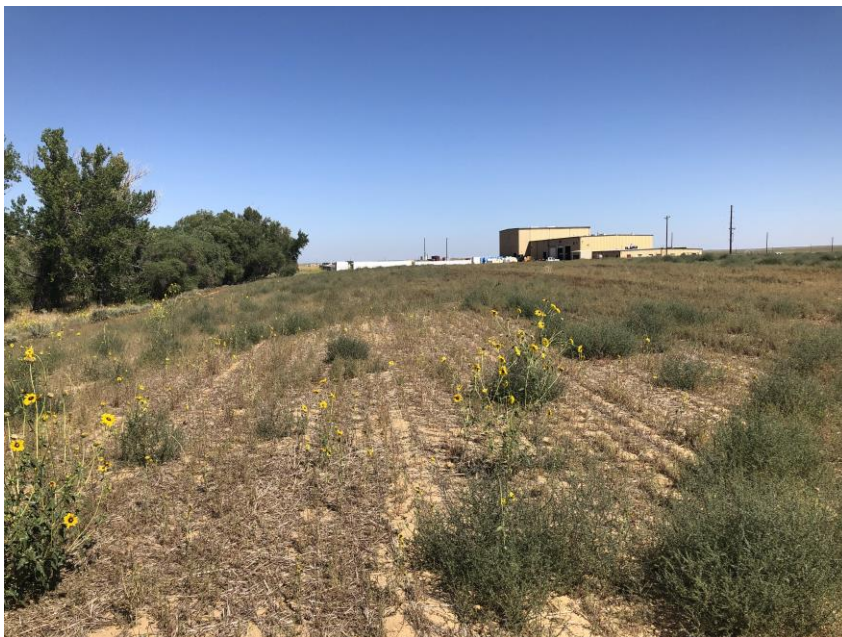
**Area 38, looking north toward facilities**

Area 38, the possible exception to the paragraph above, requires further discussion between DRMS and CEC. This will be part of the adequacy review for SL-11.

- The Area 35 slope to the northeast (approximately transect A-A' in the application) of approximately 5% is somewhat above the slope indicated on the cross-section in the application, approximately 3%.
- Area 38 slopes to the southwest (approximately transect B-B' in the application) at 1.8%. A comparison cannot be made to the application data at this time. Details on the topography of Area 38 need to be developed during the adequacy portion of the review of this application.
- The portion of Area 42 that is due west of the Dugout Pond slopes to the north at 1.3%. This is close to the slope of 1.1% estimated from the map in the application.
- Area 44 slopes to the northeast at approximately 3.3%. This is close to the slope of 2.6% estimated from the map in the application.

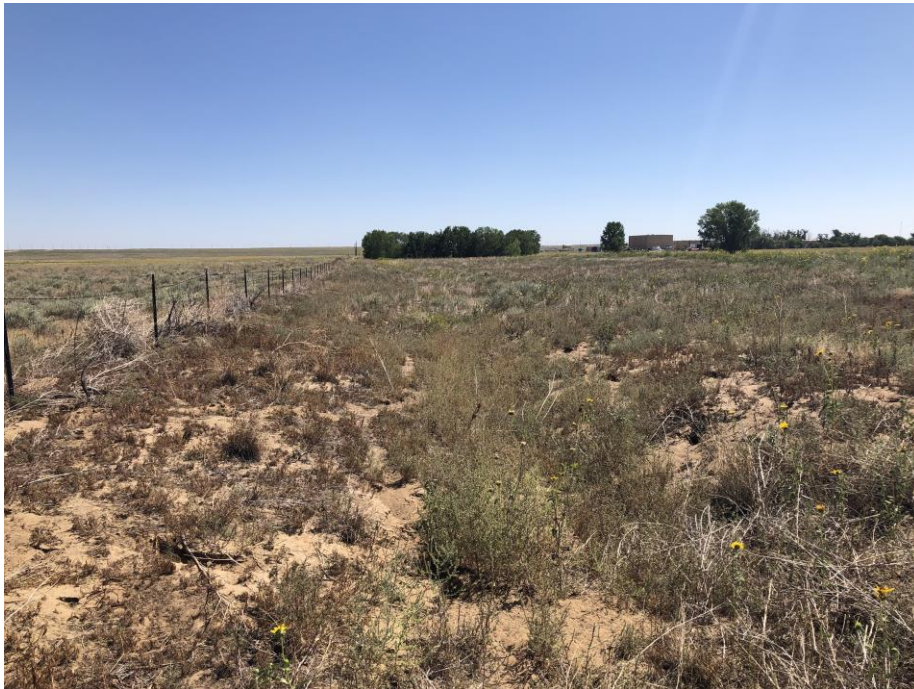
**Area 45, looking east toward Sediment Pond 2**

No problems were identified with erosion at any of the eight areas. The channel in Area 45 appears to be functioning well, as there is no sign of water flowing over the banks, and years of inspecting this channel have not indicated problems.
