MINERALS PROGRAM INSPECTION REPORT

MINE NAME: Tellier Gravel Pit	MINE/PROSPECTING ID#: M-1998-058	MINERAL: Sand and gravel and material for construc	COUNTY: Routt
INSPECTION TYPE: Monitoring	INSPECTOR(S): Tabetha Lynch	INSP. DATE: July 28, 2022	INSP. TIME: 13:00
OPERATOR: Oldcastle SW Group, Inc. dba United Compa	OPERATOR REPRESENTATIVE: Todd Clark	TYPE OF OPERATION: 112c - Construction Regular Operation	
REASON FOR INSPECTION: Normal I&E Program	BOND CALCULATION TYPE: Complete Bond	BOND AMOUNT: \$80,000.00	
DATE OF COMPLAINT: NA	POST INSP. CONTACTS: None	JOINT INSP. AGENCY: None	
WEATHER: Clear	INSPECTOR'S SIGNATURE:

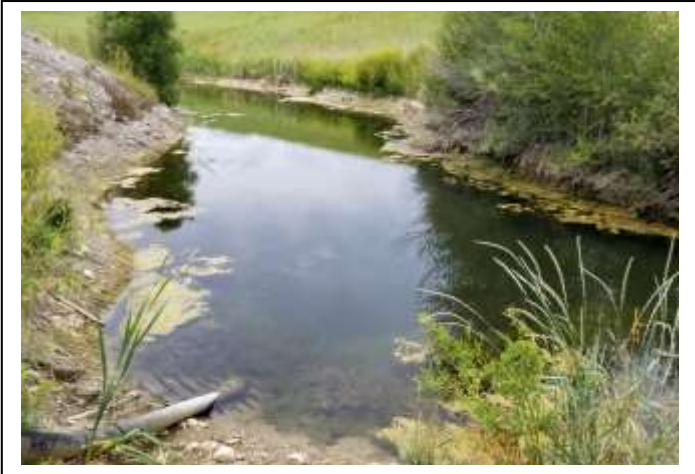
Pond at edge of South pit

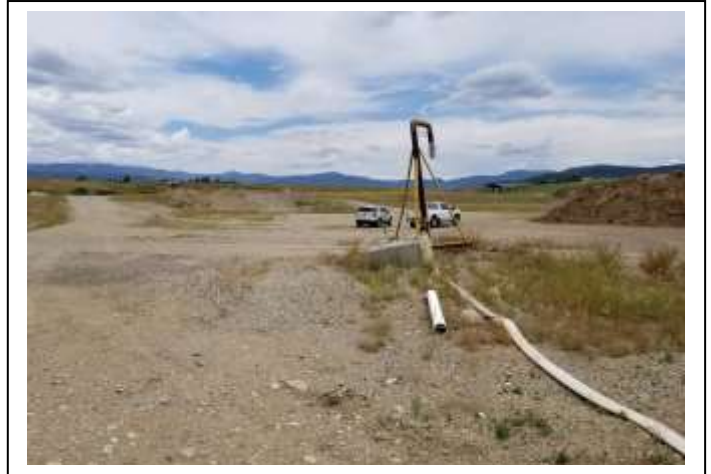
It was indicated that this site has completed mining and has begun final reclamation. One pile of product was remaining on site. The other piles were identified as being for reclamation. Slopes appear to have been graded to a 3:1 and 4:1. Both the north and south pit floors will require topsoil.

Pit floor, product stockpile and reclamation material pile

Compacted areas such as the pit floors and any roads to be removed will need to be ripped prior to topsoil replacement. In the north pit there is a topsoil stockpiles that acts as a visual berm. The other topsoil pile is to the west of the south pit. Some weeds were observed however it was indicated that they had been sprayed twice this year.

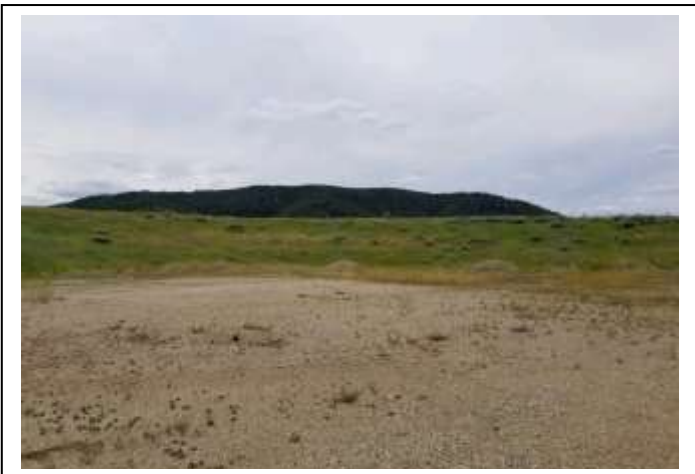
Reclaimed slope, recently sprayed for weeds

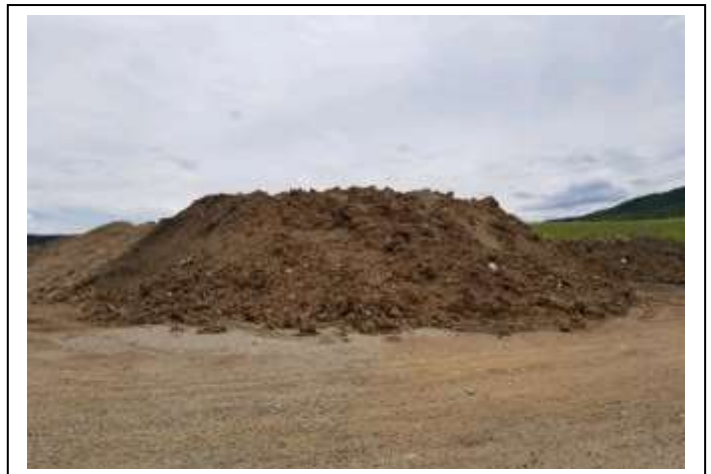
Stockpile material in South pit
