## MINERALS PROGRAM INSPECTION REPORT

<b>MINE NAME:</b> Hogue/River Pit	<b>MINE/PROSPECTING ID#:</b> M-1992-066	<b>MINERAL:</b> Gravel	<b>COUNTY:</b> Routt
<b>INSPECTION TYPE:</b> Monitoring	<b>INSPECTOR(S):</b> Tabetha Lynch	<b>INSP. DATE:</b> July 28, 2022	<b>INSP. TIME:</b> 08:00
<b>OPERATOR:</b> Duckels Construction, Inc. dba Yampa Aggre	<b>OPERATOR REPRESENTATIVE:</b> Fred Duckel	<b>TYPE OF OPERATION:</b> 112c - Construction Regular Operation	
<b>REASON FOR INSPECTION:</b> Normal I&E Program	<b>BOND CALCULATION TYPE:</b> Complete Bond	<b>BOND AMOUNT:</b> \$74,319.00	
<b>DATE OF COMPLAINT:</b> NA	<b>POST INSP. CONTACTS:</b> None	<b>JOINT INSP. AGENCY:</b> None	
<b>WEATHER:</b> Clear	<b>INSPECTOR'S SIGNATURE:</b>

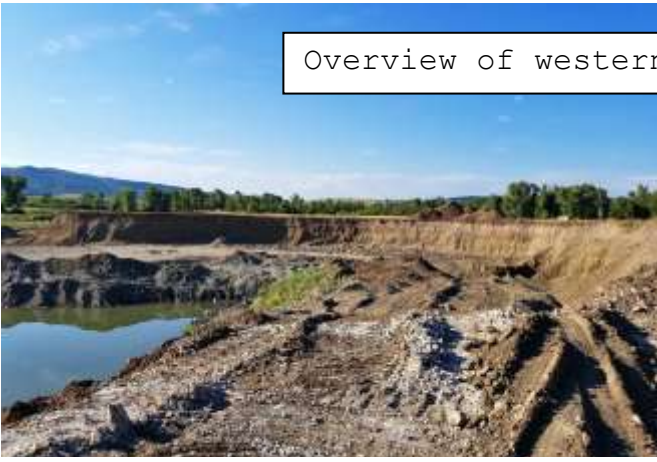
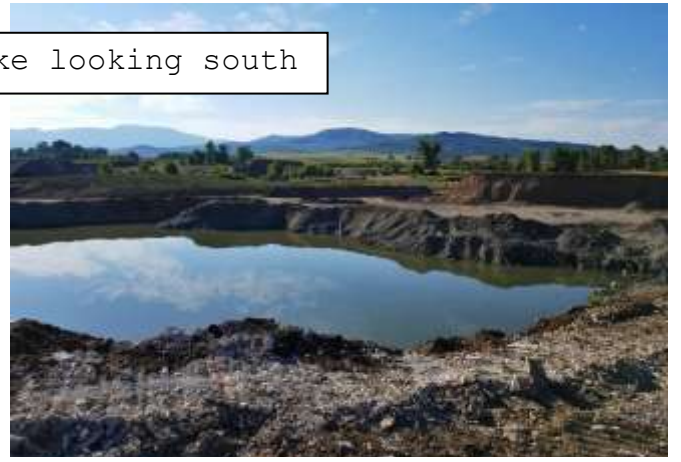
The large western pond appears to be mostly reclaimed. Only areas adjacent to the current mining operation will require additional work. The small sediment pond is also well vegetated and stable. Likewise additional reclamation efforts have been employed on the north and west pit walls adjacent to Hwy 40. Highwalls have been backfilled to a 2:1 slope in some portions as mining has progressed. Throughout the site there are several areas where interim reclamation has been implemented.

Overview of western lake looking south

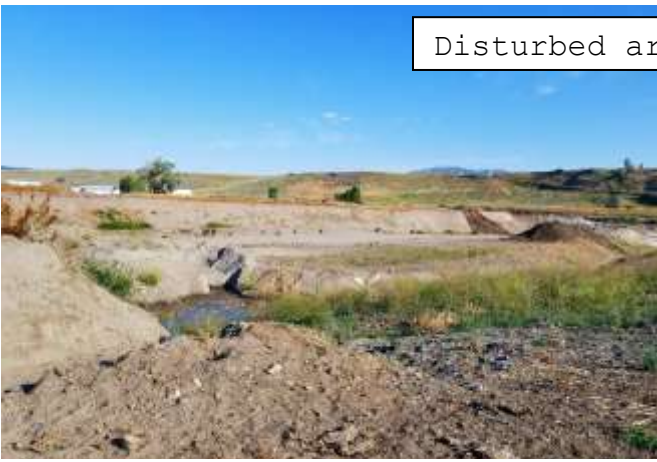
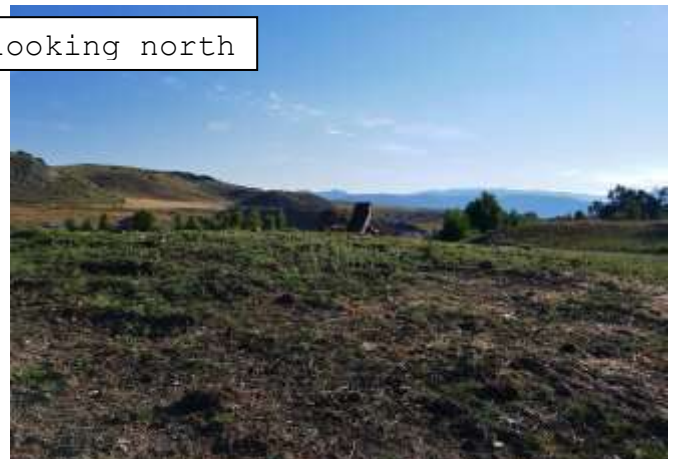
The site was active at the time of the inspection. Material was being hauled to the processing plant. Per the land owners request mining will occur in 200' swaths to limit disturbance. The mining of materials goes down to the underlying shale. Other highwalls throughout the permit boundary have slopes ranging from near vertical to 2:1. Slopes are stable with no visible erosion.

Disturbed area looking north

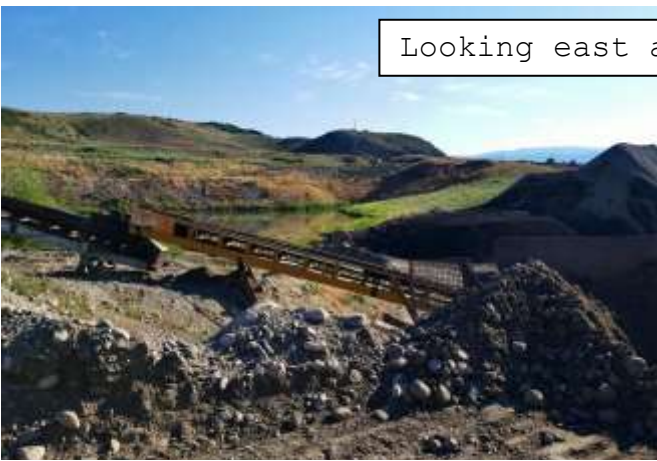
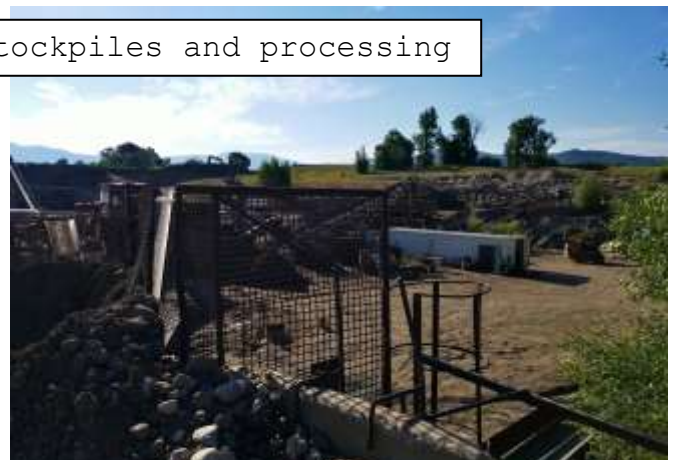
Several piles of various stockpiled material was observed. At this site material is crushed, screened and washed for processing. Cement and asphalt is imported. These products are crushed then resold. There are several visual berms between the site and HWY 40, these are to remain post-reclamation.

Looking east at stockpiles and processing

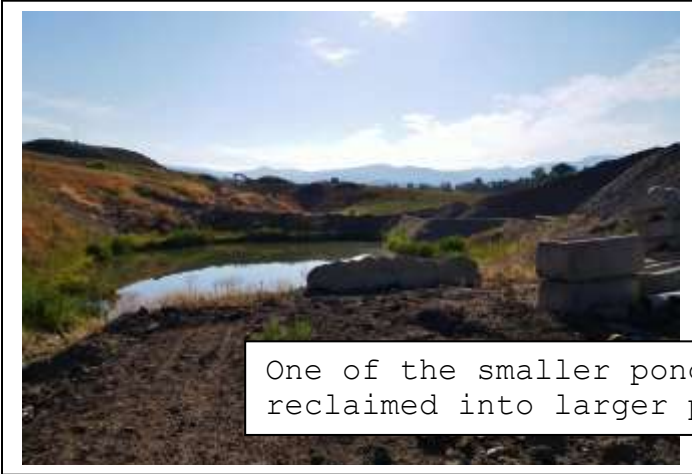
There are five ponds on site at the time of the inspection. Upon final reclamation one pond, approximately 43.5 acres will remain. It is noted that though the operator has the Division of Water Resources approval, the Division does not have a copy of the necessary permit.

One of the smaller ponds that will be reclaimed into larger pond. Looking east
