## MINERALS PROGRAM INSPECTION REPORT

<b>MINE NAME:</b> Bettger Gravel Pit	<b>MINE/PROSPECTING ID#:</b> M-1976-051	<b>MINERAL:</b> Sand and gravel	<b>COUNTY:</b> Routt
<b>INSPECTION TYPE:</b> Monitoring	<b>INSPECTOR(S):</b> Tabetha Lynch	<b>INSP. DATE:</b> July 28, 2022	<b>INSP. TIME:</b> 08:00
<b>OPERATOR:</b> Duckels Construction, Inc.	<b>OPERATOR REPRESENTATIVE:</b> Fred Duckel	<b>TYPE OF OPERATION:</b> 112c - Construction Regular Operation

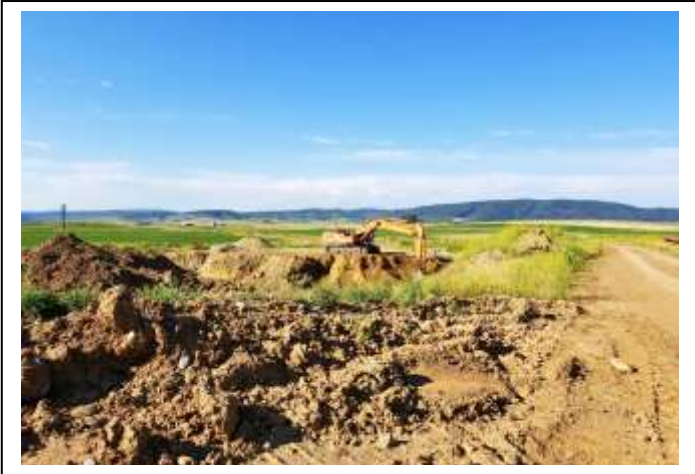
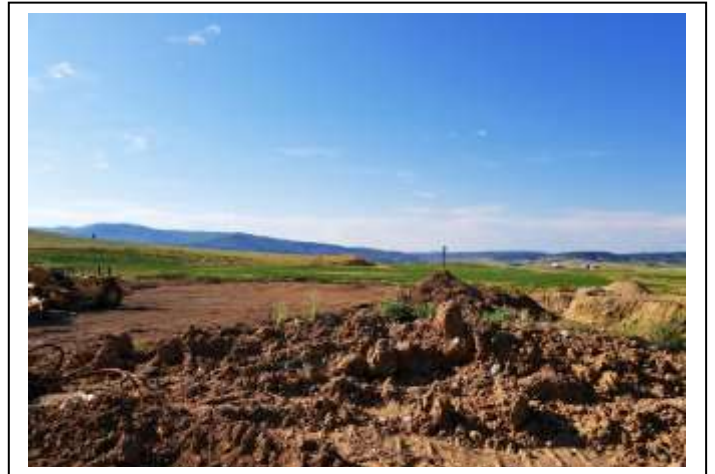
There are several well reclaimed alfalfa fields to the south of the current operation. These areas are properly sloped and appear to meet the requirements of the approved reclamation plan. The Division would like to remind the operator that areas that have successfully complied with the approved reclamation plan may be incrementally released thus releasing that portion of land from DRMS jurisdiction. It also reduces the overall liability of the site.

Overview of the remaining disturbance with reclaimed area in background, which are well established alfalfa fields

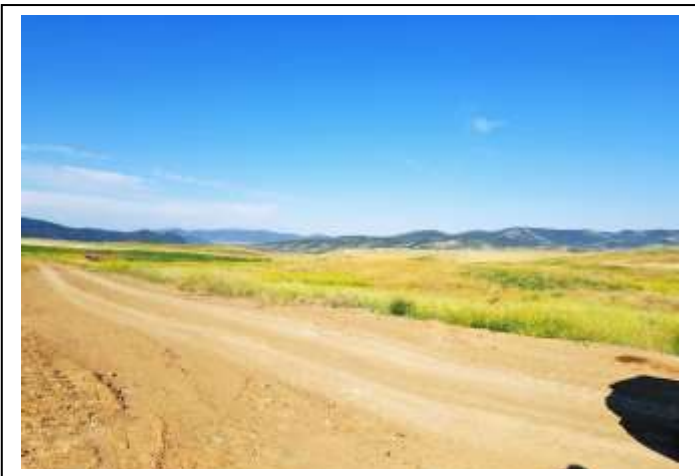
Access road to disturbed area
