MINERALS PROGRAM INSPECTION REPORT
PHONE: (303) 866-3567

MINE NAME: Lyons Quarry	MINE/PROSPECTING ID#: M-1977-141	MINERAL: Quartz (quartzite/qua sandstone)	COUNTY: Boulder
INSPECTION TYPE: Surety-Related Inspection	INSPECTOR(S): Patrick Lennberg	INSP. DATE: August 26, 2022	INSP. TIME: 09:30
OPERATOR: Holcim - WCR, Inc.	OPERATOR REPRESENTATIVE: Wyatt Webster, Jessica Walker	TYPE OF OPERATION: 112c - Construction Regular Operation	
REASON FOR INSPECTION: Surety Related	BOND CALCULATION TYPE: Complete Bond	BOND AMOUNT: \$9,887,461.00	
DATE OF COMPLAINT: NA	POST INSP. CONTACTS: None	JOINT INSP. AGENCY: None	
WEATHER: Clear	INSPECTOR'S SIGNATURE:

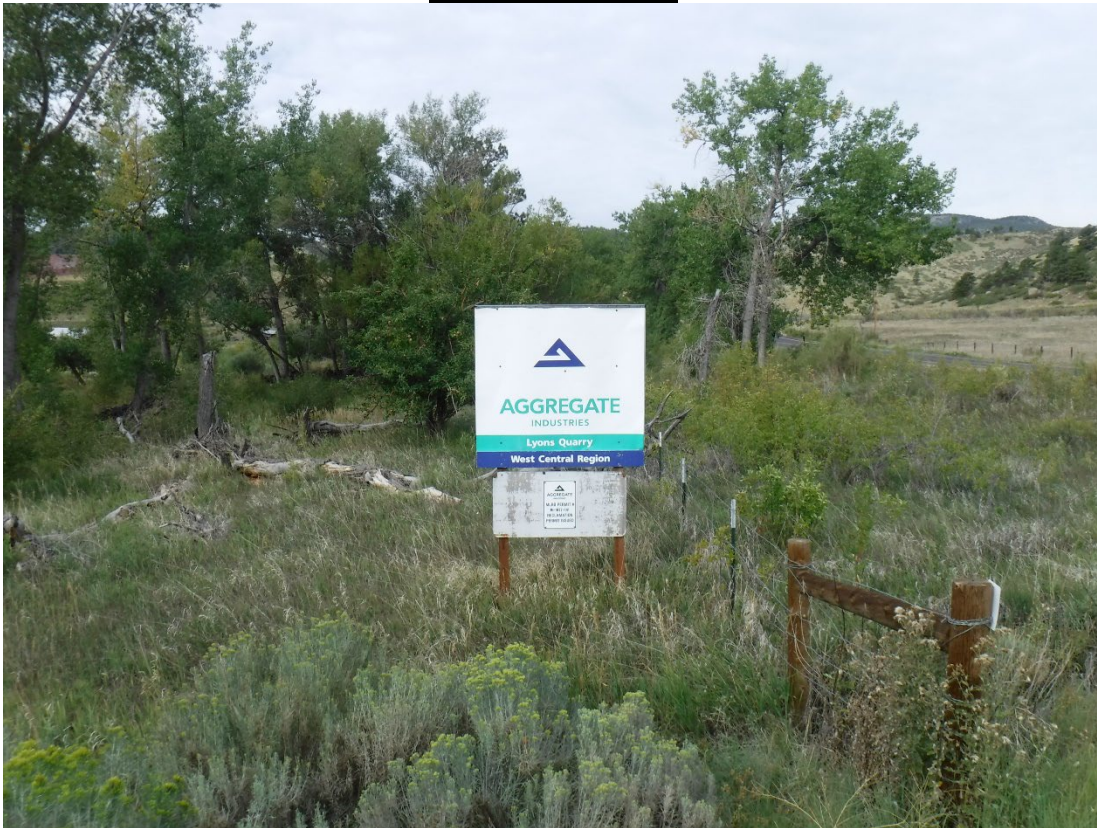
The Lyons Quarry is located in Boulder County approximately 2.25 miles southwest of Lyons, Colorado and is situated south of the South Saint Vrain Creek and Hwy 7. The site is accessed from the east via Old St. Vrain Rd. The affected lands are owned by Boulder County. The approved post-mining land use is rangeland. A mine sign was observed at the entrance to the mine as required by Rule 3.1.12. It should be noted the mine sign needs to be updated to reflect the new permittee.

Photo 1: Mine sign at entrance to permit

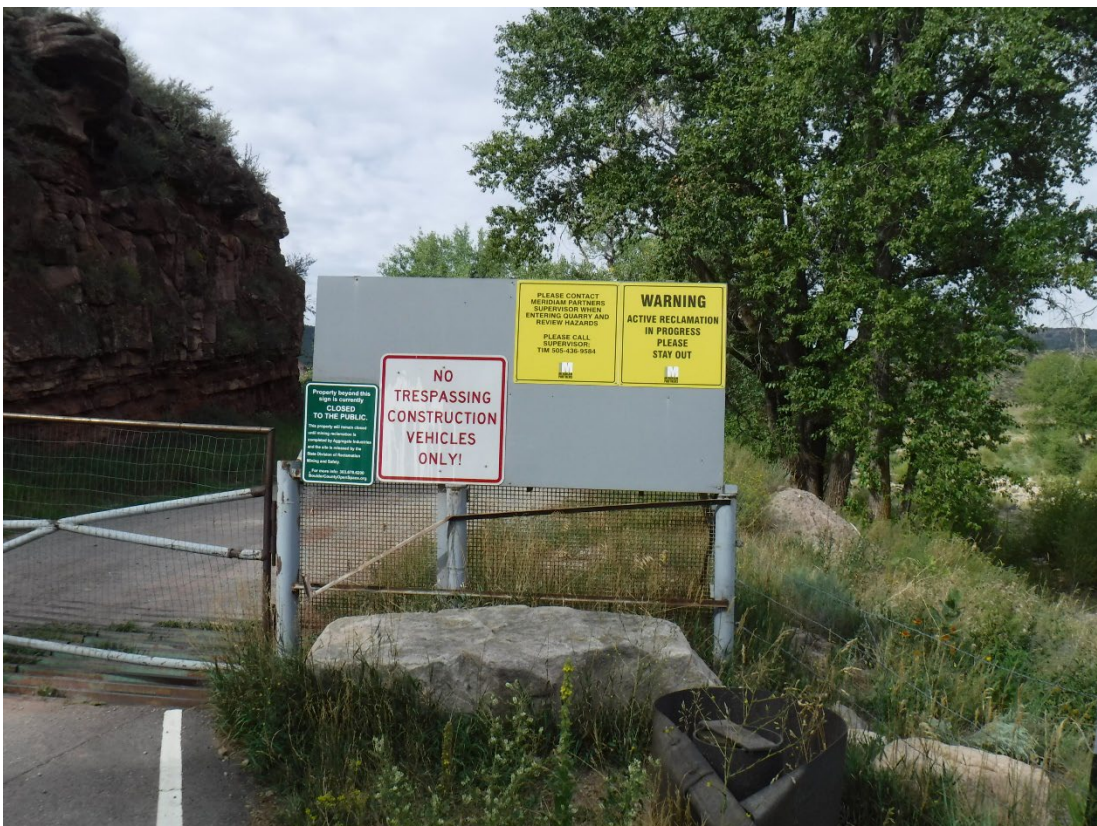
Photo 2: Signage at gated entrance to mine areas

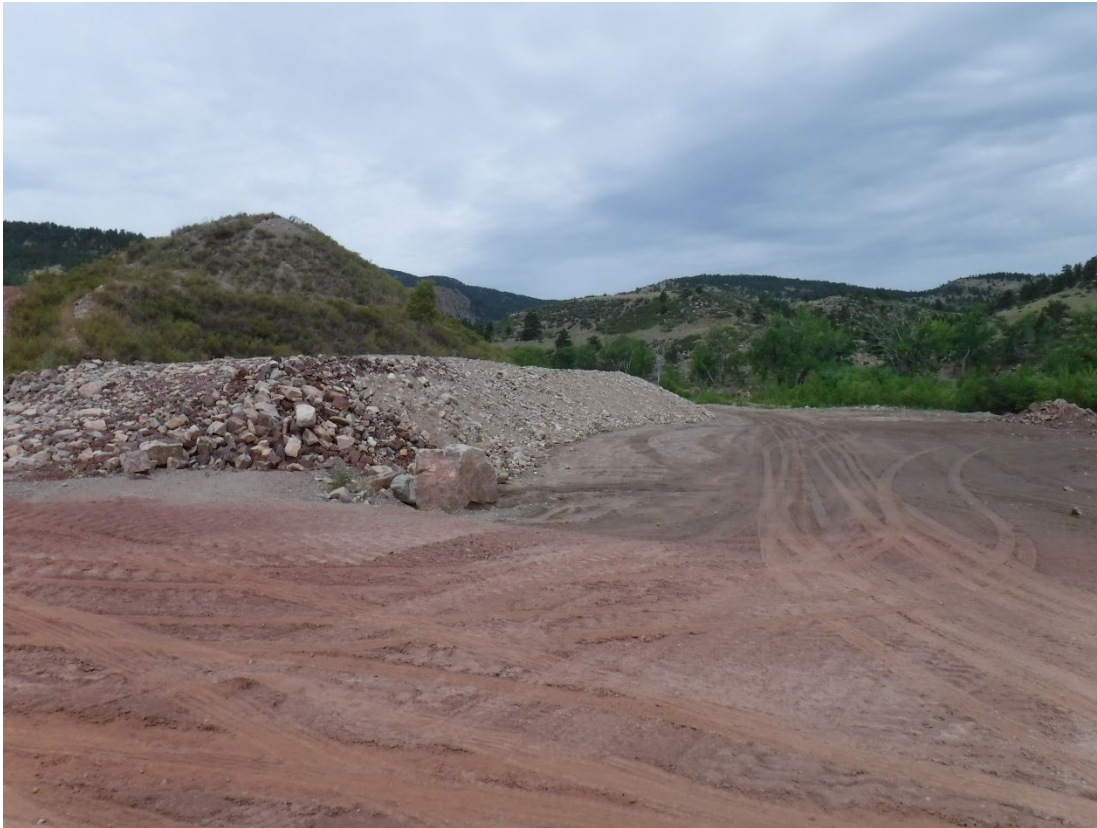
Photo 3: Scour berm in place, partially complete

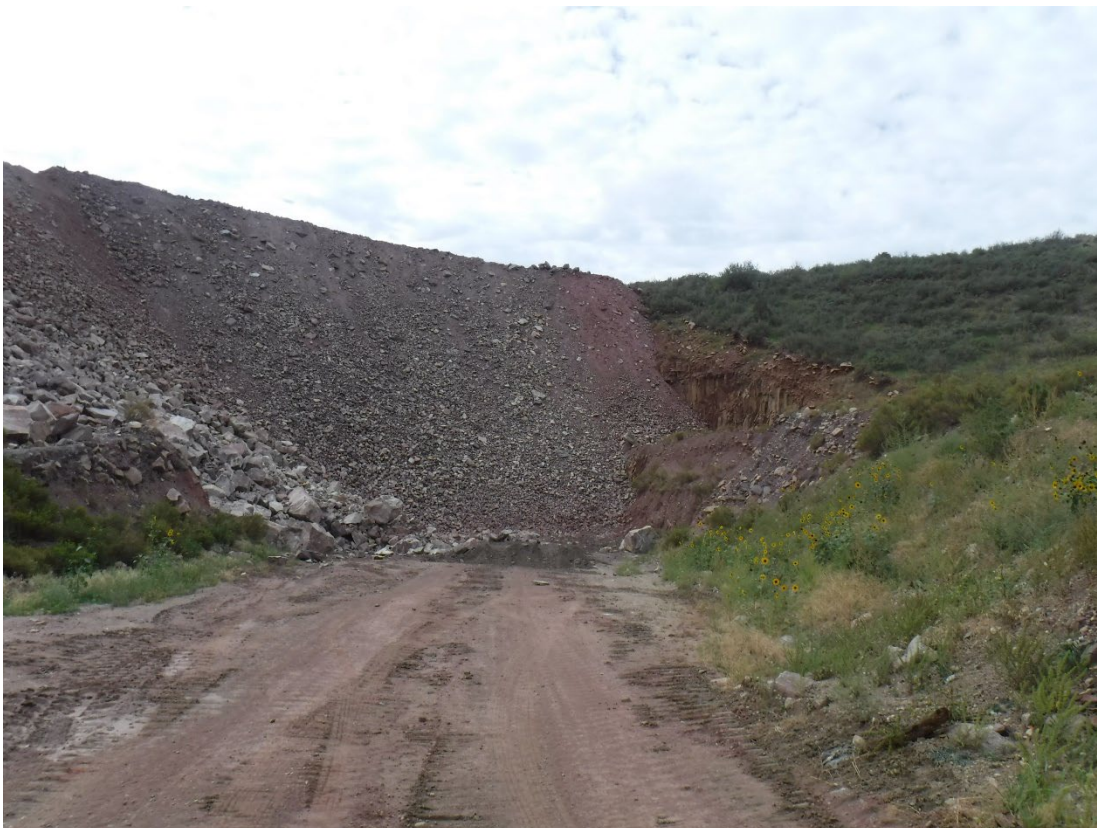
Photo 4: Quarry area 2 backfill progress, ~50% complete

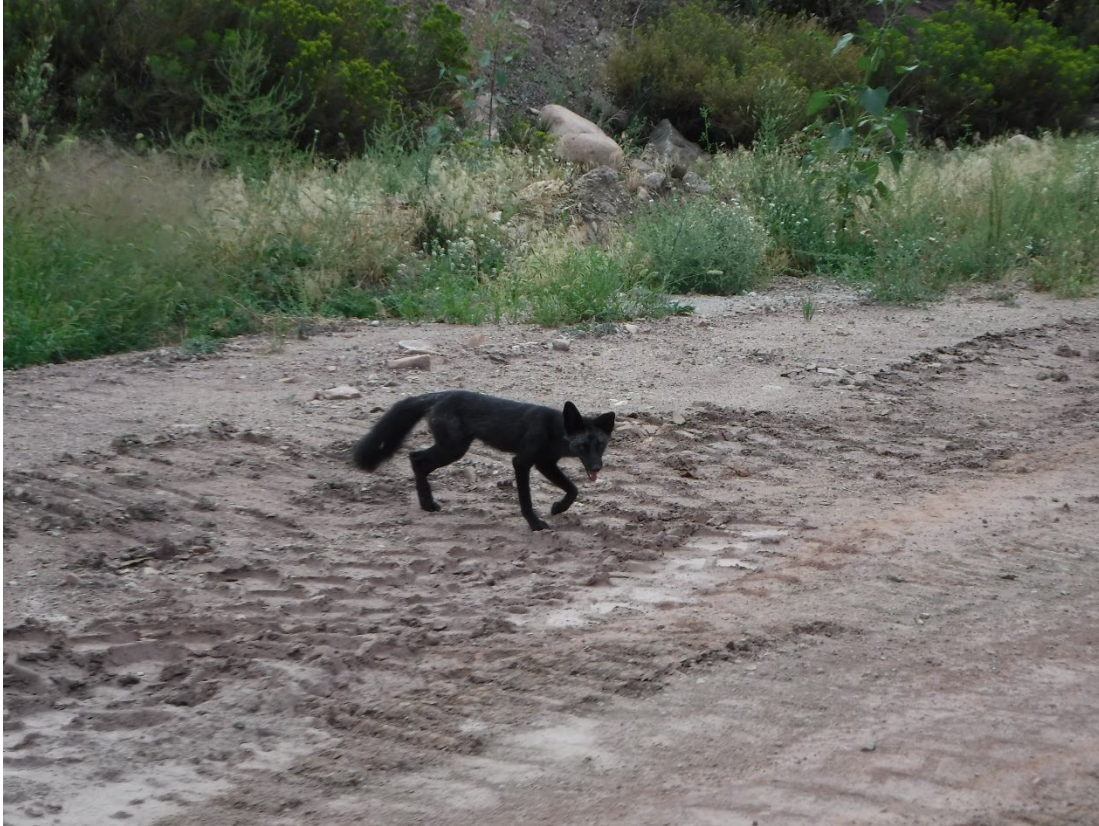
Photo 5: Wildlife present at the site during reclamation activities

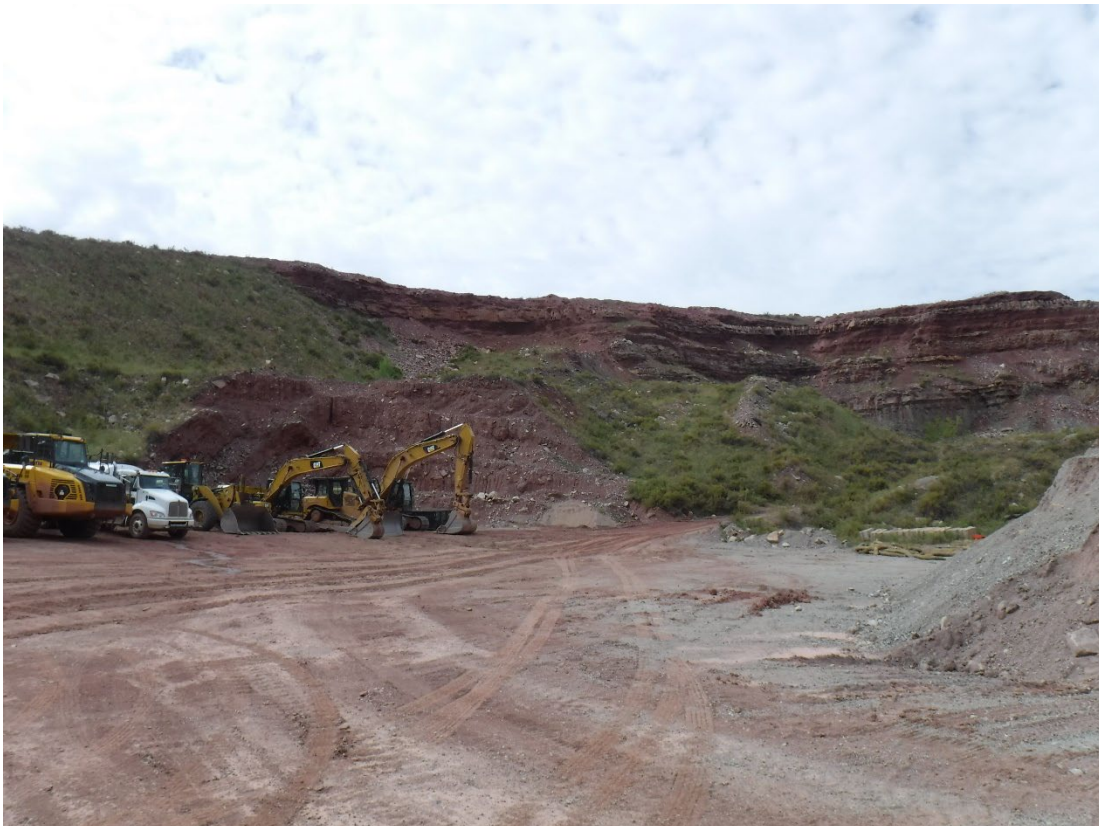
Photo 6: Quarry 1 in the background and the pond has been backfilled and was located under stockpile to right of photo

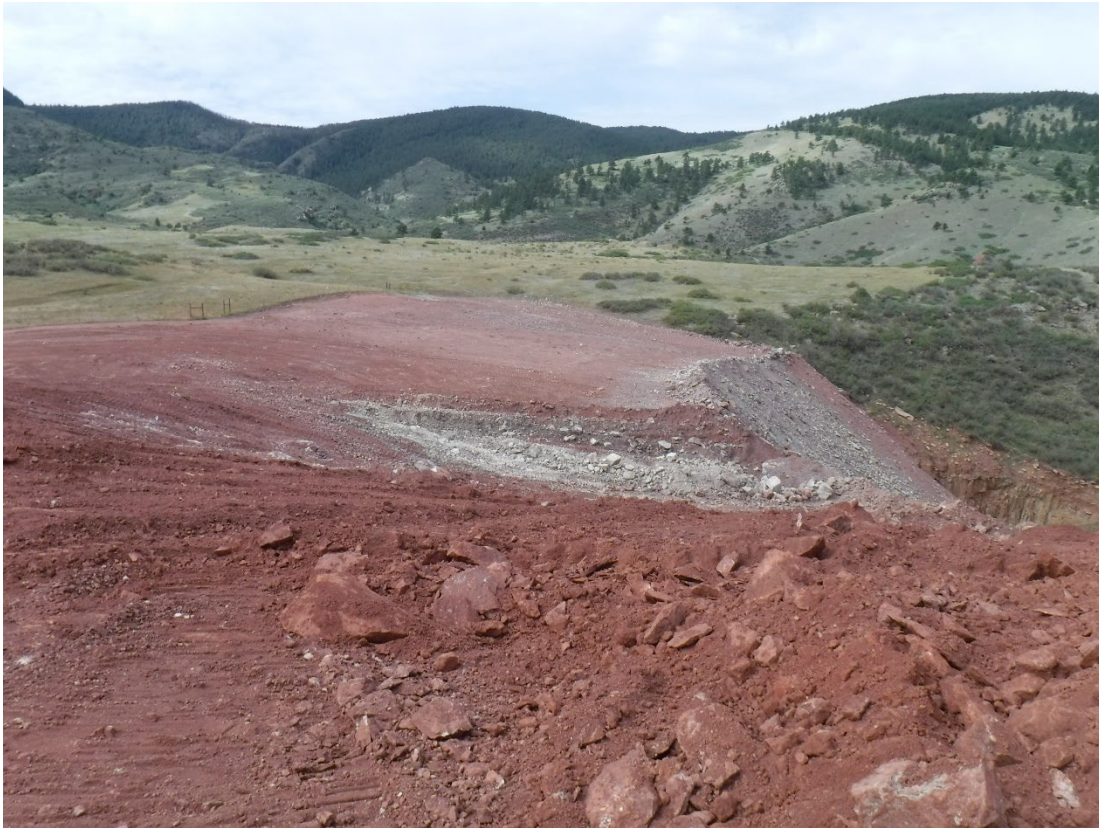
Photo 7: Quarry 2 backfill progress

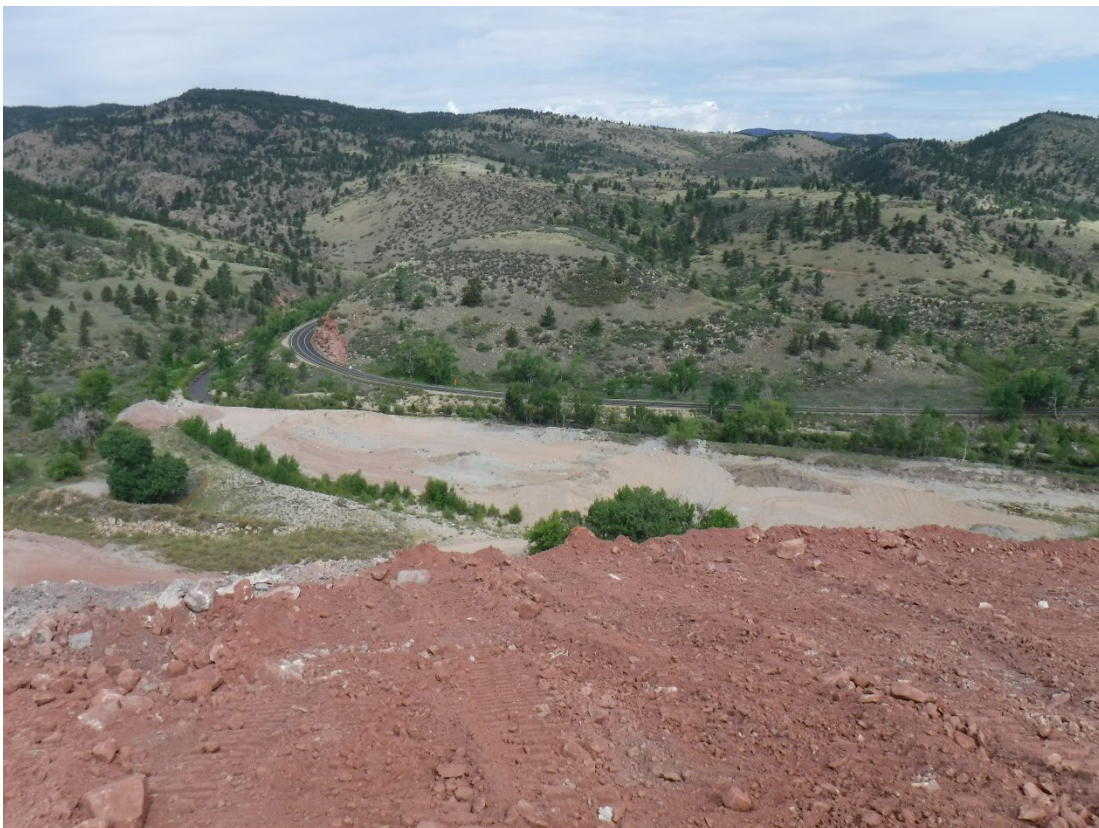
Photo 8: Overview of Reclamation Area 2, looking west

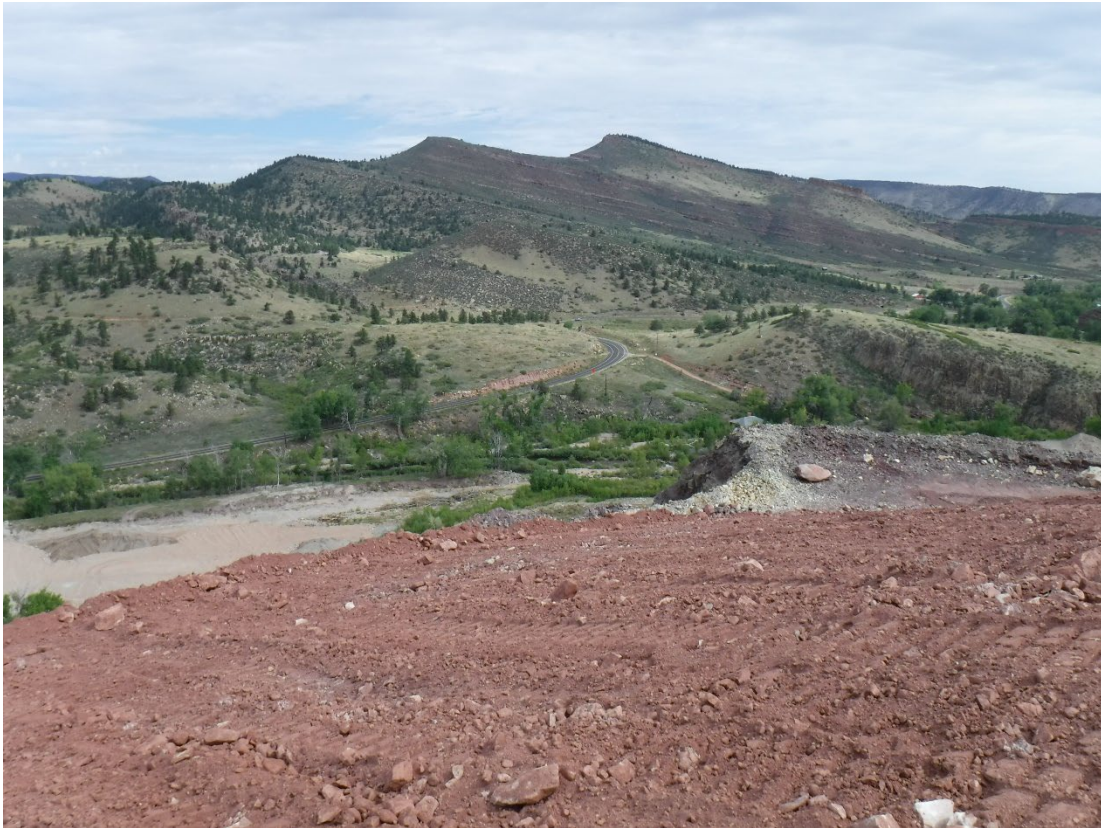
Photo 9: Overview of Reclamation Area 2, looking north

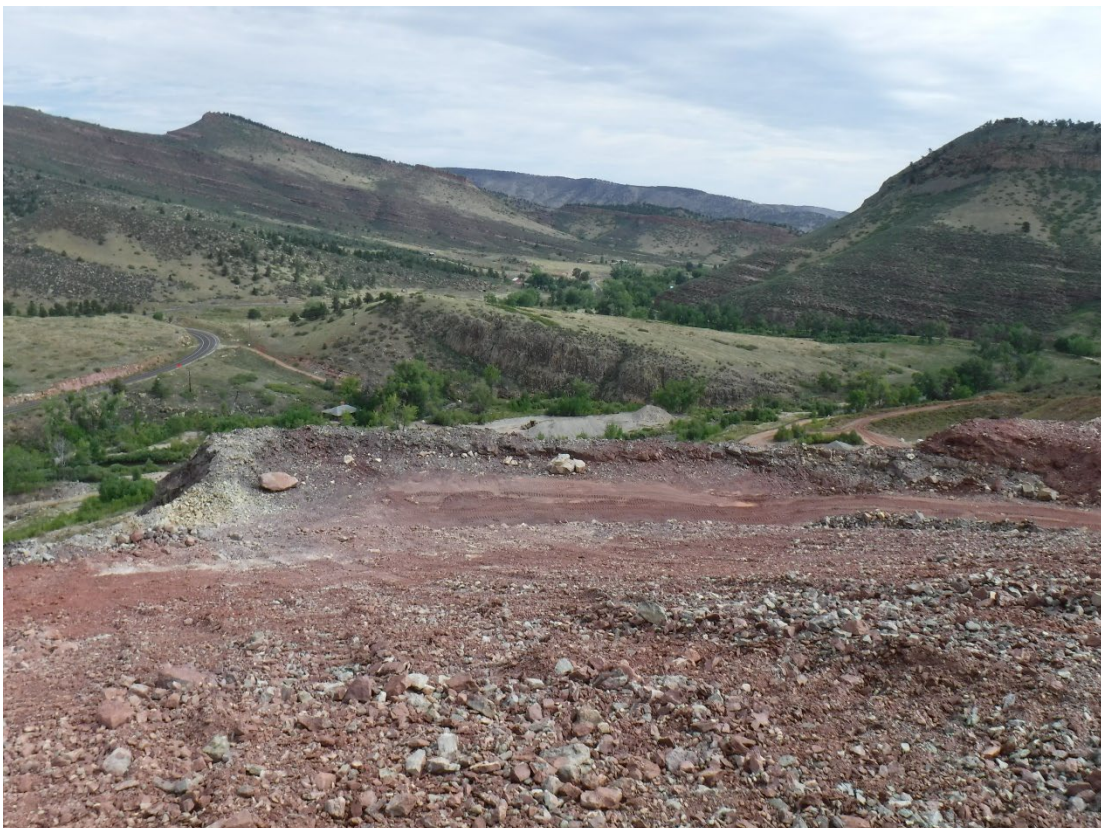
Photo 10: Overview of Reclamation Area 2, looking northeast
