Lorencito Canyon Mine, C-1996-084, Inspection Report

PERMIT INFORMATION

| Permit Number: C-1996-084 |
|---|
| Mine Name: Lorencito Canyon Mine |

| Inspection Start Date: August 23, 2022 Inspection Start Time: 09:15 Inspection End Date: August 23, 2022 Inspection End Time: 13:00 | | | Inspection Type: Coal Complete Inspection Inspection Reason: Normal I&E Program Weather: Clear | |

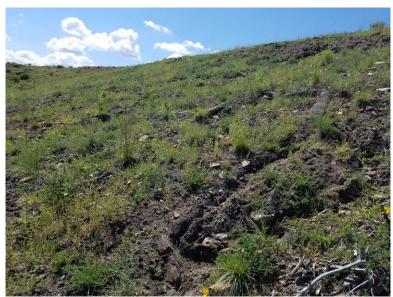
The reclaimed slope above the sediment storage area was observed. Given the recent precipitation that has occurred in the region, desired grasses and forbs have germinated on the steep slope above the sediment storage pile. We observed several species of wheatgrasses, bluestem, side oats grama, blue grama grass. However, Russian thistle has also germinated in this area and accounts for a substantial amount of vegetative cover. While Russian thistle is not desirable, it does provide vegetation cover that assists in stabilizing the slope from erosion. NECC will need to continue to monitor this area and may need to manage the Russian thistle growth if it hinders the development of the desired species. While the vegetation in this area appears better than previously observed by the Division, NECC should still explore actions to stabilize this highly erosive steep slope.

Figure 1. Slope above the sediment storage pile.

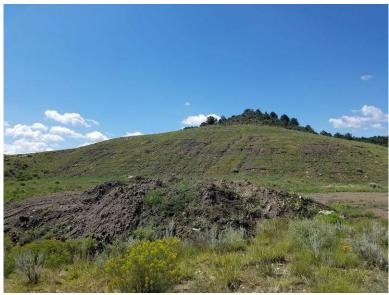
Figure 2. Slope above sediment storage pile.

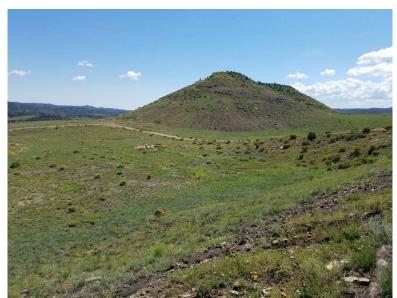
The slopes above Pond 006a are still heavily eroded as well as the slopes around the Knob. Previously noted erosional issues cited by DRMS inspection reports over the last year have not been addressed. According to Nick Mason with NECC, they are working on finding a contractor to conduct the needed repairs at the site. This issue is also noted in the adequacy review for NECC's application to renew the permit for the site (RN5). NECC has been asked to review and evaluate how these areas will be stabilized from erosion in accordance with Rule 4.14.6 as previous attempts have had mixed success.

Figure 3. View of the Knob from above the sediment storage pile.

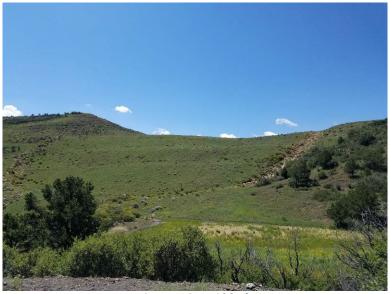
Figure 4. Fill 8.

Fills 8, 7 and 9 were observed. These fills are well vegetated and stable. Signs of instability and structural weakness were not observed.
