MINERALS PROGRAM INSPECTION REPORT
PHONE: (303) 866-3567

MINE NAME: Munroe Gypsum Quarry	MINE/PROSPECTING ID#: M-1977-002-HR	MINERAL: Anhydrite, gypsum	COUNTY: Larimer
INSPECTION TYPE: Monitoring	INSPECTOR(S): Brock Bowles	INSP. DATE: June 30, 2022	INSP. TIME: 12:30
OPERATOR: Colorado Lien Company	OPERATOR REPRESENTATIVE: Dana Mellage	TYPE OF OPERATION: 112c - Construction Regular Operation	
REASON FOR INSPECTION: Normal I&E Program	BOND CALCULATION TYPE:	BOND AMOUNT: \$35,300.00	
DATE OF COMPLAINT: NA	POST INSP. CONTACTS: None	JOINT INSP. AGENCY: None	
WEATHER: Cloudy	INSPECTOR'S SIGNATURE:

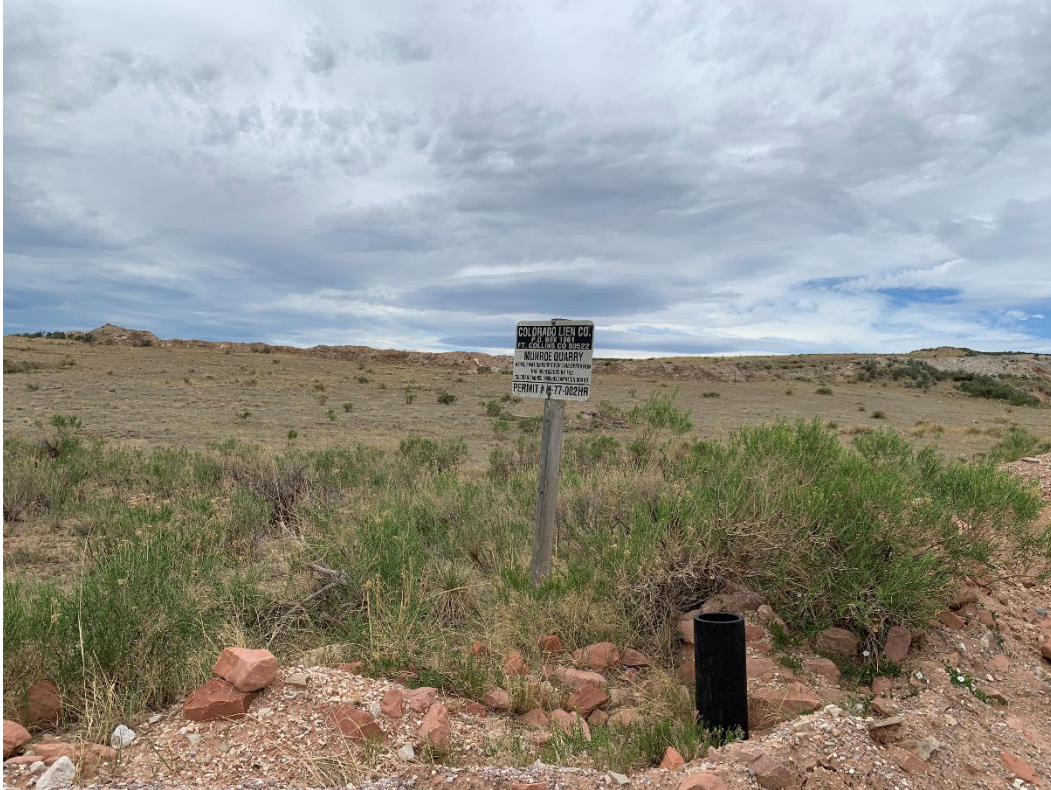
The mine entrance sign was in place along the access road (photo 1). No mining was taking place and no mining equipment was on-site.

Photo 1 – Mine Entrance sign along access road

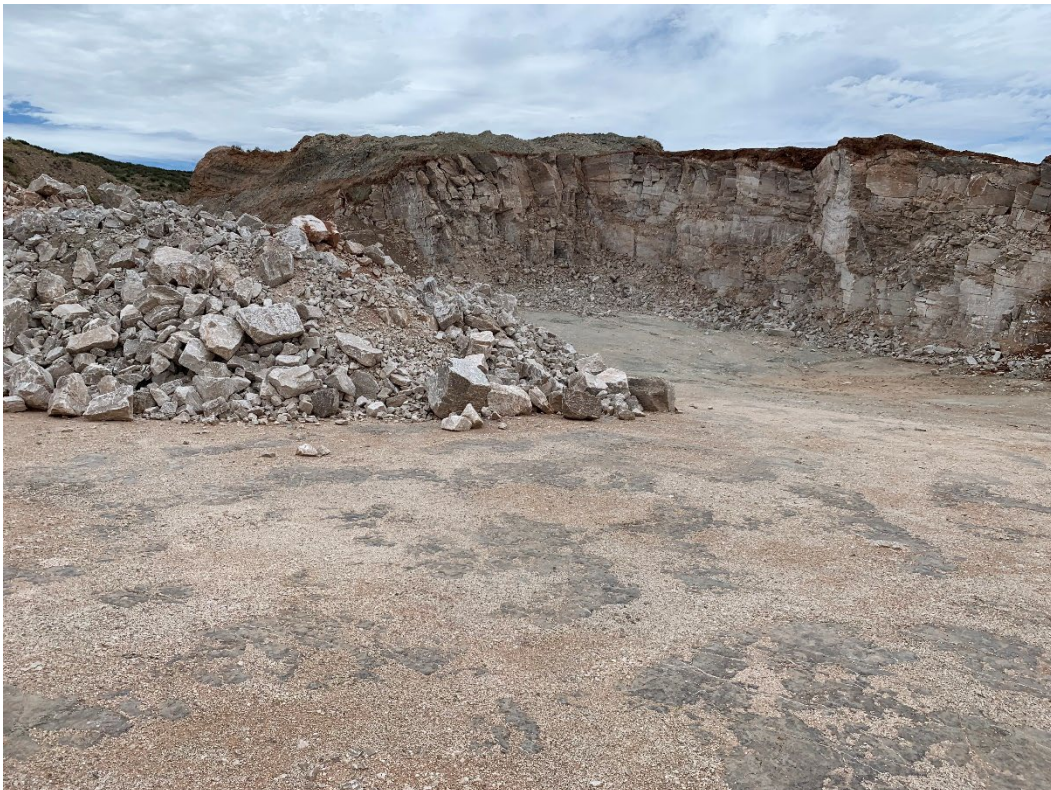
The pit area is about 6 acres in size. The high wall is on the north side of the pit area, is about 1000 feet long with an average height of 35 feet (photo 2). A gypsum stockpile is located in the middle of the pit area and no standing water was seen in the pit. The south side of the pit area is in the process of being backfilled and reclaimed (photo 3).

Photo 2 – Pit area, highwall and stockpile, facing north

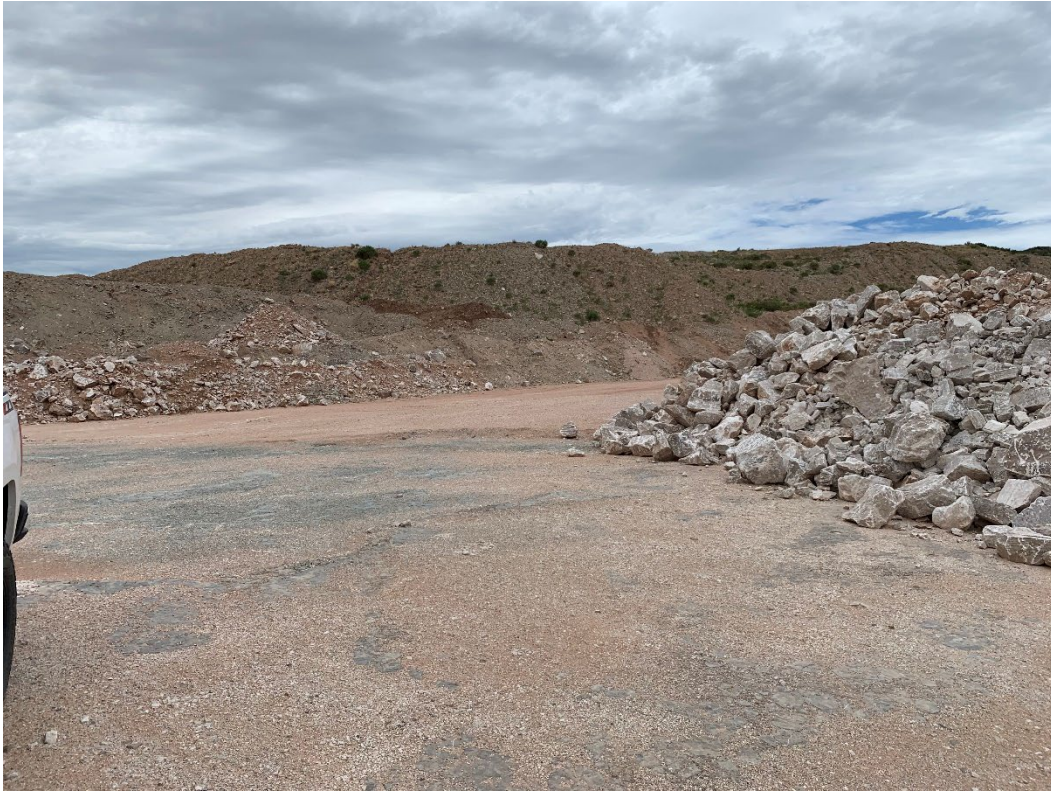
As the pit advances to the north, reclamation is being completed on the south side. The south side of the pit is in various stages of reclamation. The progress is documented on the 2021 Annual Report Map.

Photo 3 – Backfilled areas south of pit area.
