**MINERALS PROGRAM INSPECTION REPORT**  
**PHONE: (303) 866-3567**

<b>MINE NAME:</b> Roberts Quarry	<b>MINE/PROSPECTING ID#:</b> M-1977-301	<b>MINERAL:</b> Limestone (general)	<b>COUNTY:</b> Larimer
<b>INSPECTION TYPE:</b> Monitoring	<b>INSPECTOR(S):</b> Brock Bowles	<b>INSP. DATE:</b> June 30, 2022	<b>INSP. TIME:</b> 11:30
<b>OPERATOR:</b> Pete Lien & Sons, Inc.	<b>OPERATOR REPRESENTATIVE:</b> Dana Mellage	<b>TYPE OF OPERATION:</b> 112c - Construction Regular Operation	
<b>REASON FOR INSPECTION:</b> Normal I&E Program	<b>BOND CALCULATION TYPE:</b>	<b>BOND AMOUNT:</b> \$252,213.00	
<b>DATE OF COMPLAINT:</b> NA	<b>POST INSP. CONTACTS:</b> None	<b>JOINT INSP. AGENCY:</b> None	
<b>WEATHER:</b> Cloudy	<b>INSPECTOR'S SIGNATURE:</b>

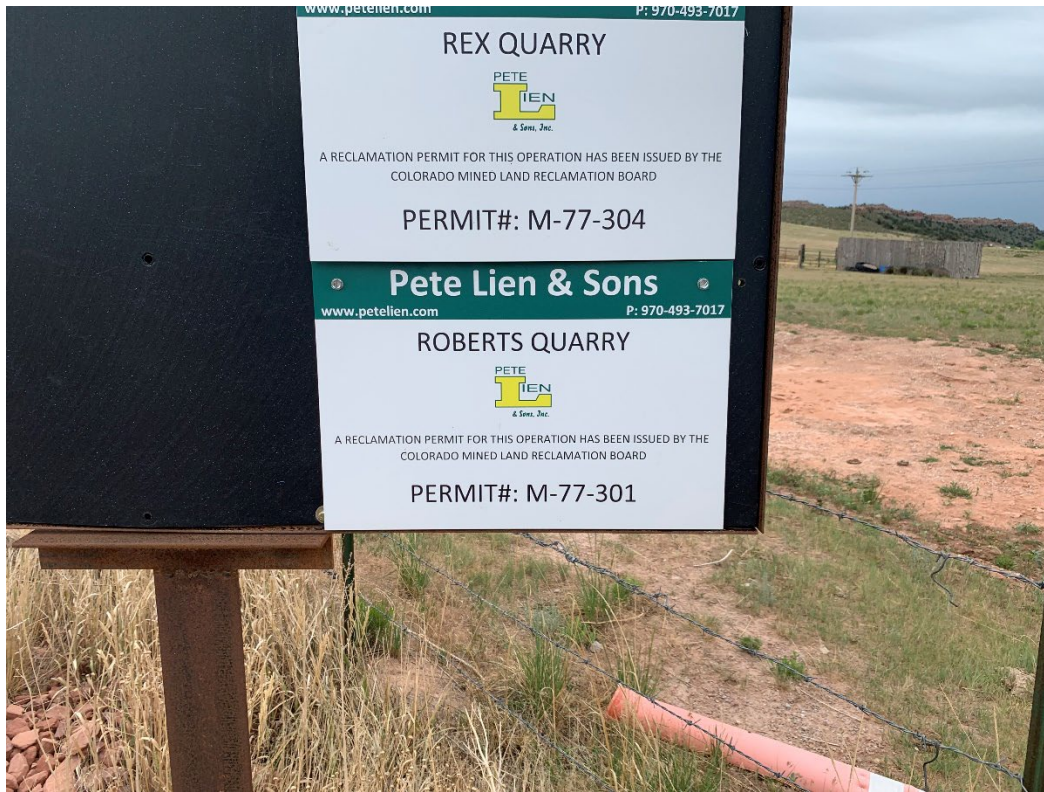
The Roberts Quarry is accessed through the Rex Quarry, M-1977-304, which is also operated by Pete Lien and Sons. The mine entrance sign was in place at the main gate (photo 1). No mining was taking place and no mining equipment was on-site. There is one access road entering the site from the east side of the quarry.

Photo 1 – Mine entrance sign facing Hwy 287

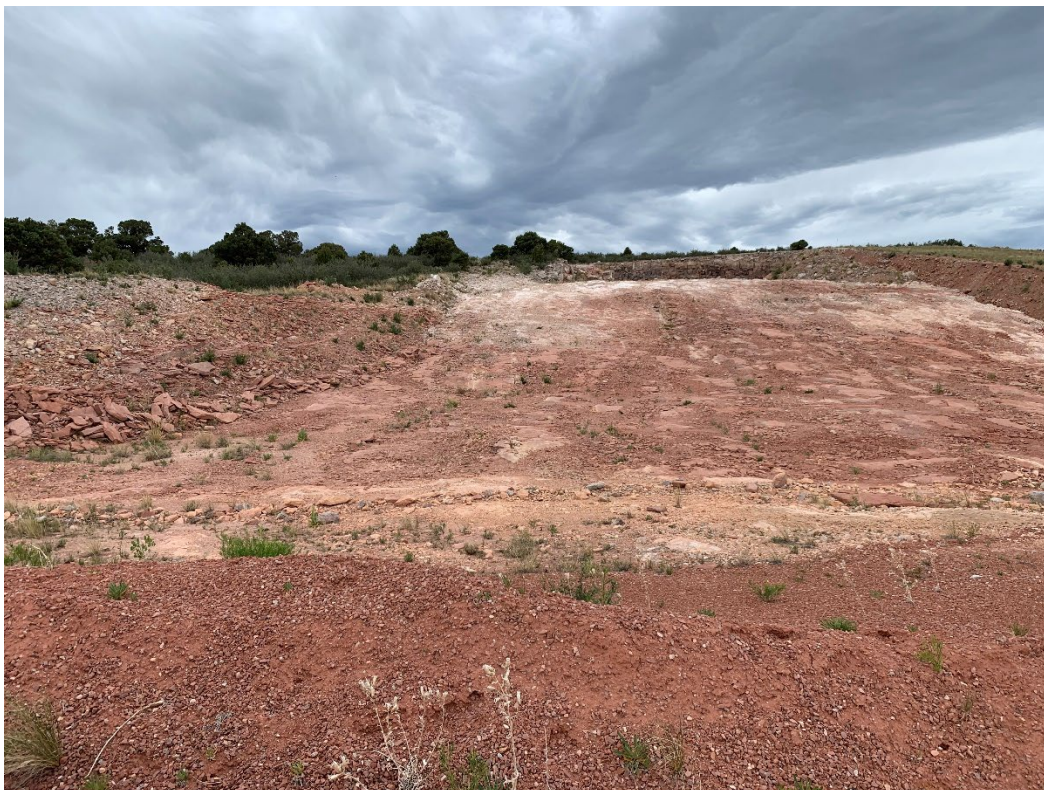
Phase VI is on the south side of the access road. About 2 acres of this area is an open pit (photo 2).

Photo 2- Phase VI pit area on south side of access road.

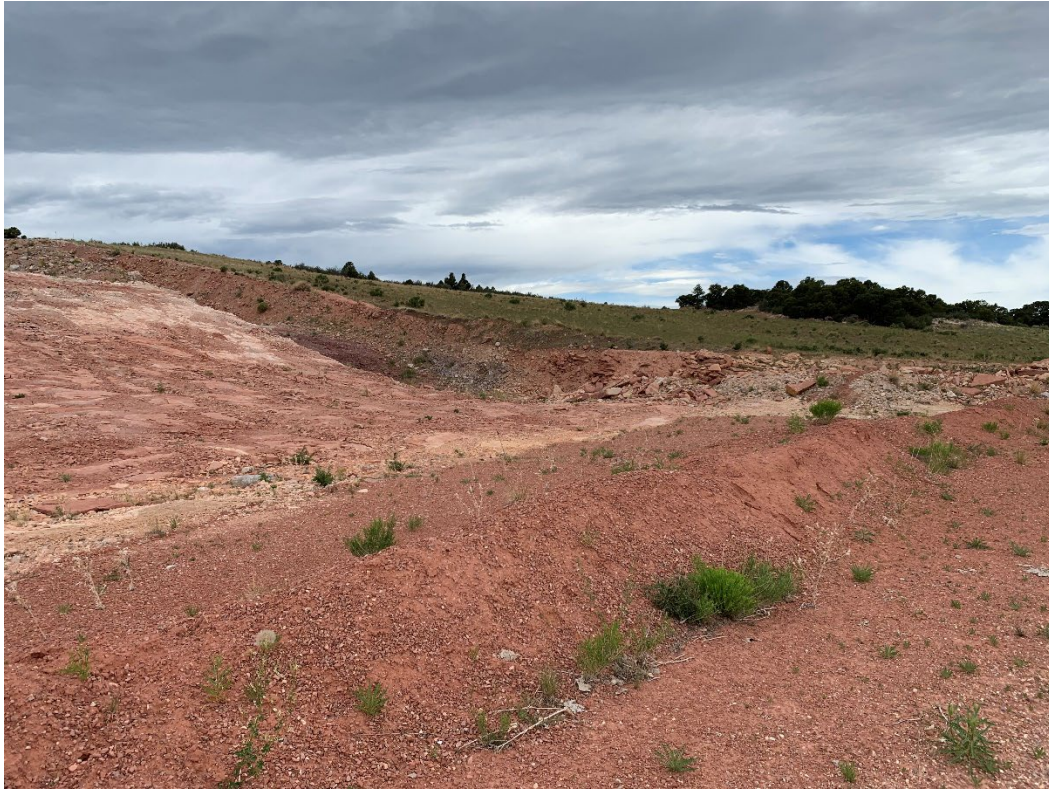
Phase V is the next section west of Phase VI. The area north of the access road has largely not been disturbed with the exception of about .75 acres along the road side. The south of the access road, about 4 acres, has been reclaimed and revegetated (photo 3).

Photo 3 – Revegetated area west of the Phase VI area.

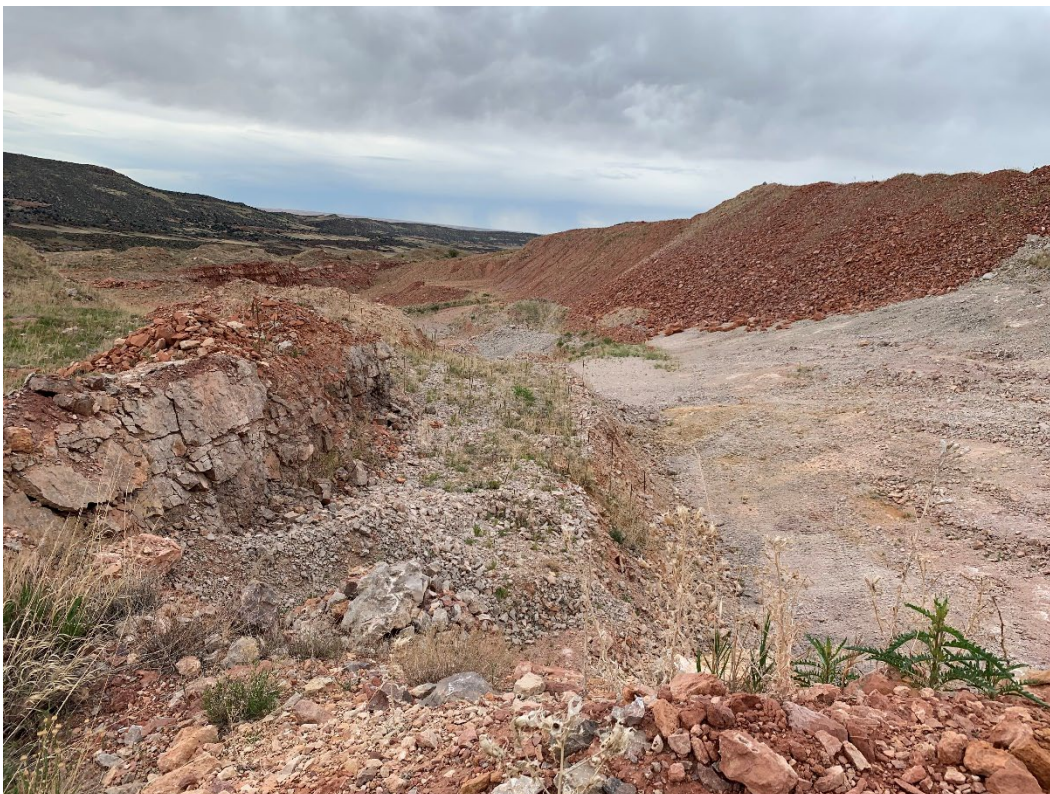
The Phase IV area on the south side of the access road has not been disturbed. The area on the north side of the road is the main pit area which slopes to the north and is about 25 acres. The highwall of the pit is on the north side which contains any potential runoff from leaving the site (photo 4). The topsoil pile is on the western side of the pit area and is well vegetated (photo 5).

Photo 4 – North pit area facing east, highwall on left contains runoff.

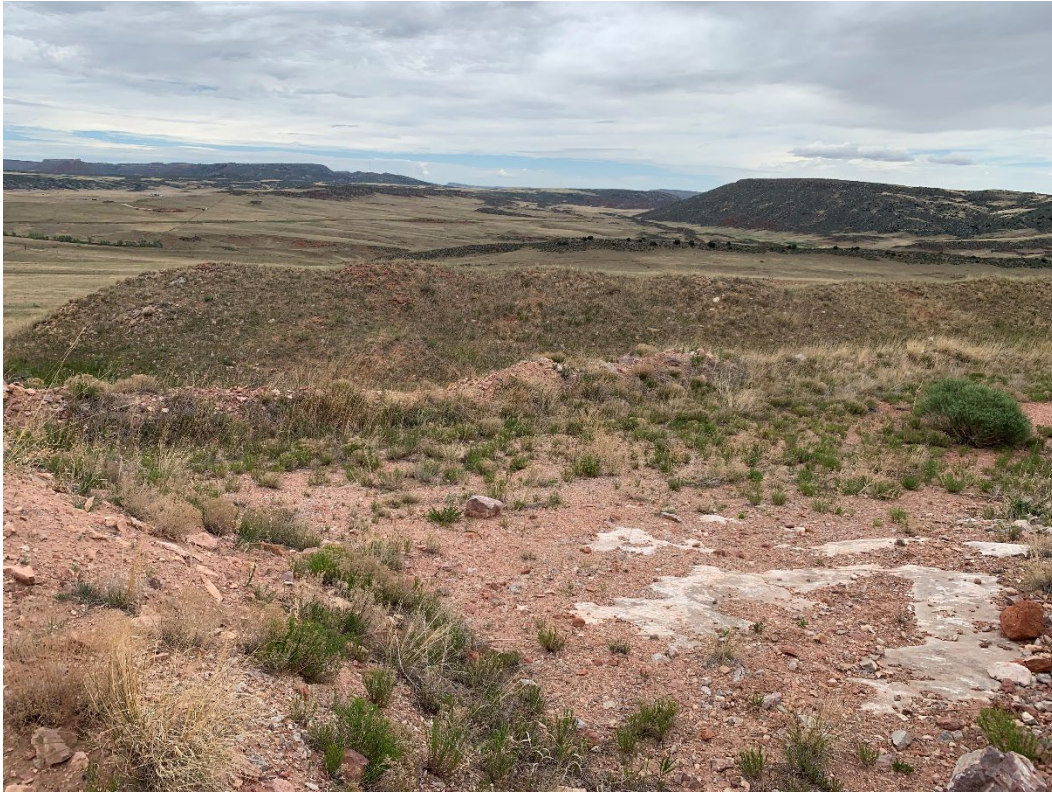
Photo 5 – Topsoil stockpiles
