**MINERALS PROGRAM INSPECTION REPORT**  
**PHONE: (303) 866-3567**

| <b>MINE NAME:</b><br>Schwartzwalder Mine | <b>MINE/PROSPECTING ID#:</b><br>M-1977-300 | <b>MINERAL:</b><br>Uranium | <b>COUNTY:</b><br>Jefferson |
| <b>INSPECTION TYPE:</b><br>Monitoring | <b>INSPECTOR(S):</b><br>Amy Eschberger | <b>INSP. DATE:</b><br>August 22, 2022 | <b>INSP. TIME:</b><br>09:00 |

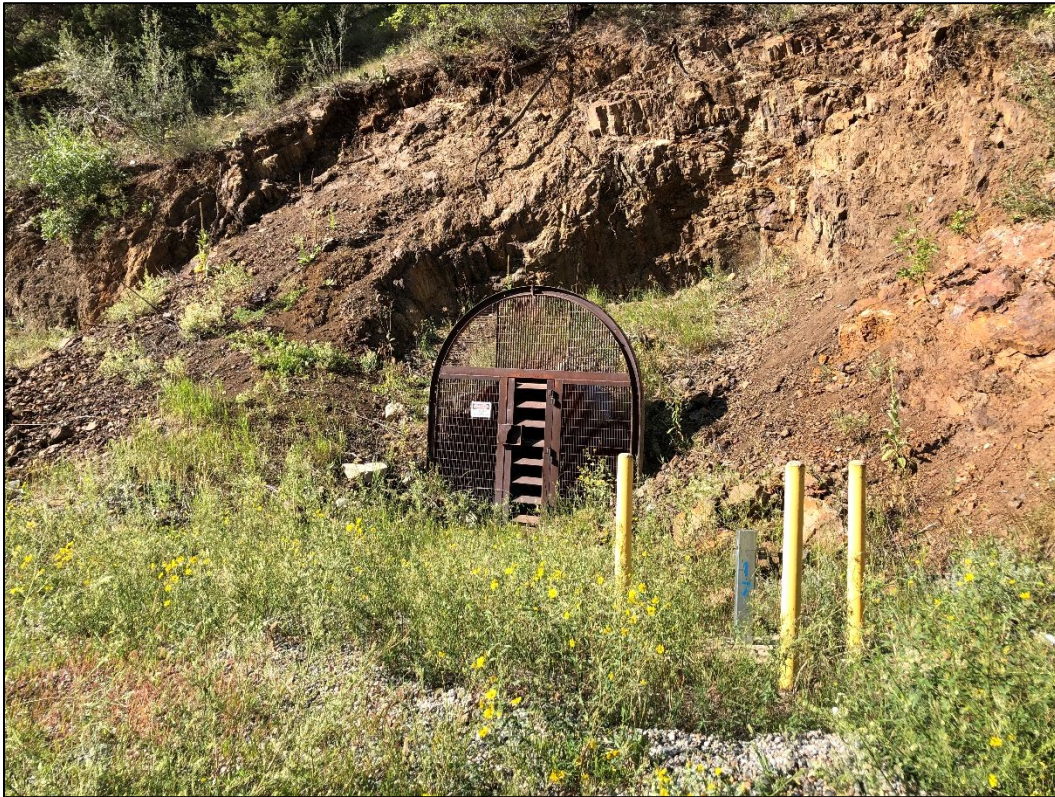
**Photo 1.** View looking south at groundwater monitoring well MW-17, installed near Pierce Adit (along road to mesa with water treatment plant).

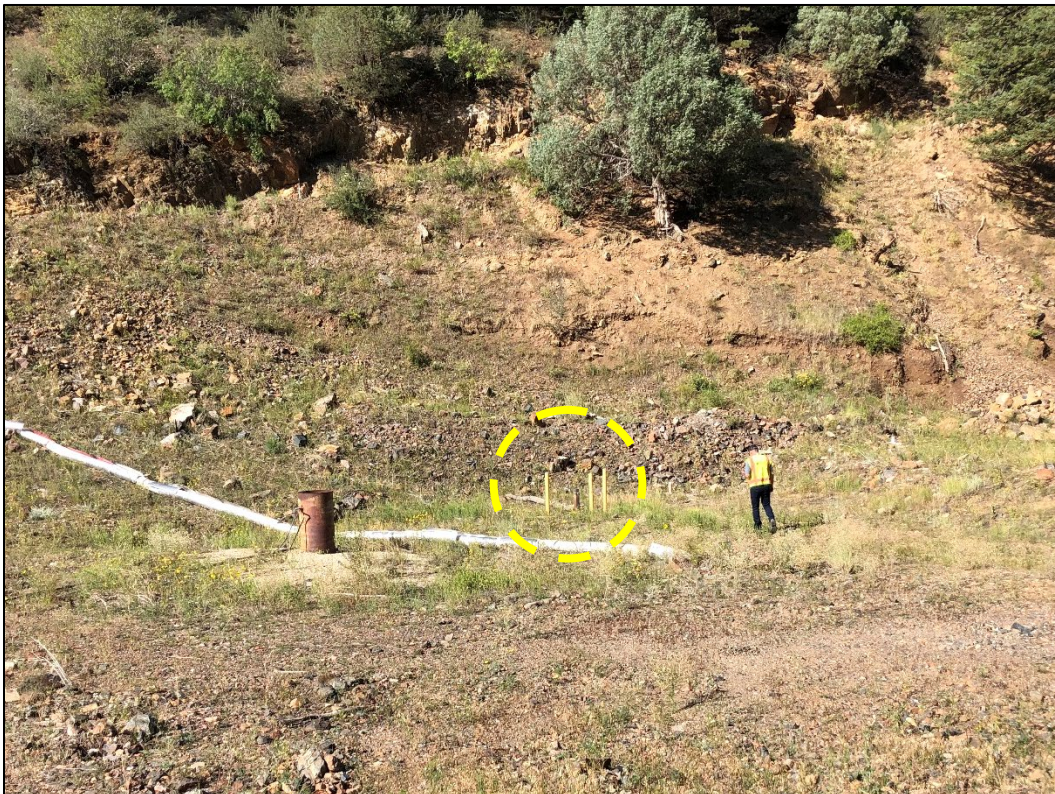
**Photo 2.** View looking south at groundwater monitoring well MW-18 (circled), installed at southern edge of valley (northwest of mesa with water treatment plant).

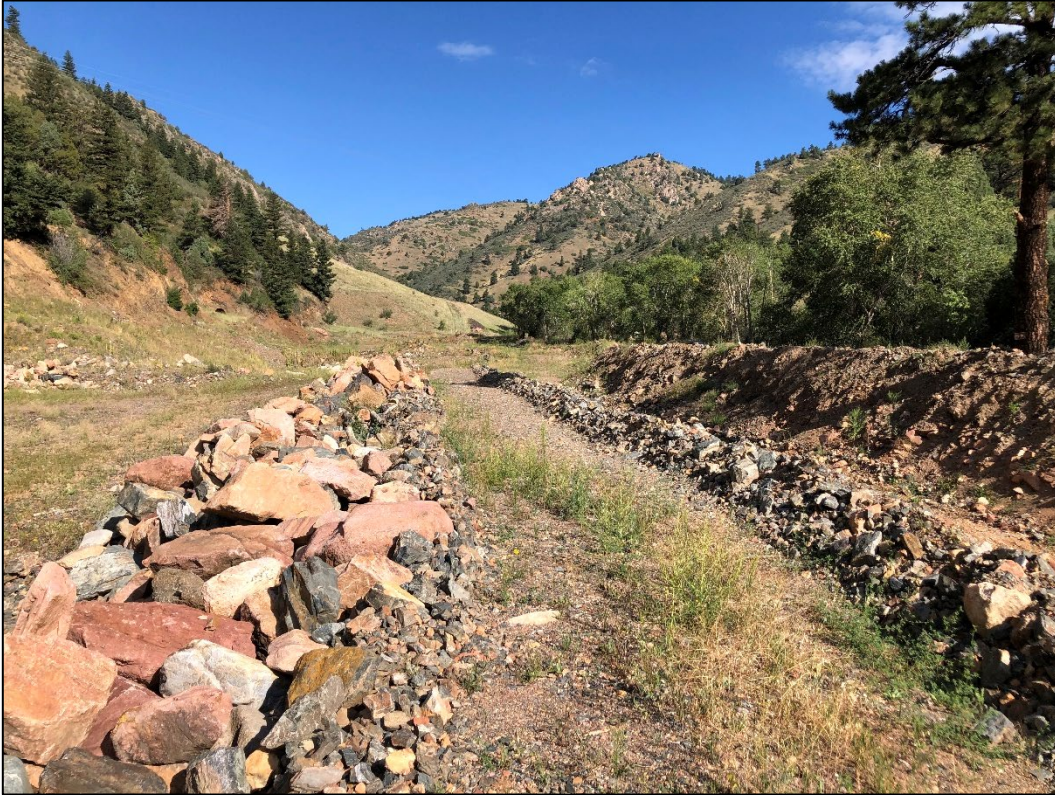
The valley excavation project in which radionuclide-impacted alluvial valley soils are excavated and disposed of underground (on site) had not recommenced. This project has been on hold since December 2021, after the Black Forest Mine reached capacity (for disposal of excavated material) and the main portal was partially backfilled in accordance with Amendment No. 5 (AM-5; approved on January 13, 2021). In Amendment No. 6 (AM-6; currently under review), the operator is proposing to place any additional excavated material at the southeastern edge of the existing South Waste Rock Pile (SWRP). This material will be tied into the adjacent Black Forest Mine backfill area and "capped" with a minimum of one foot of growth medium and revegetated with a grass and wildflower seed mixture. The Division observed the proposed SWRP expansion area during the inspection. In its August 2, 2022 adequacy review #4 for AM-6, the Division requested additional information for this proposal, including a description of the type of cover material to be used to "cap" the contaminated soils, a description of the material to be used in the expansion area compared with existing material in the SWRP, and a description of how stormwater from the two natural drainages above the expansion area will be managed.

**Photo 3.** View looking northwest across central portion of valley excavation project. This project has been suspended since December 2021.

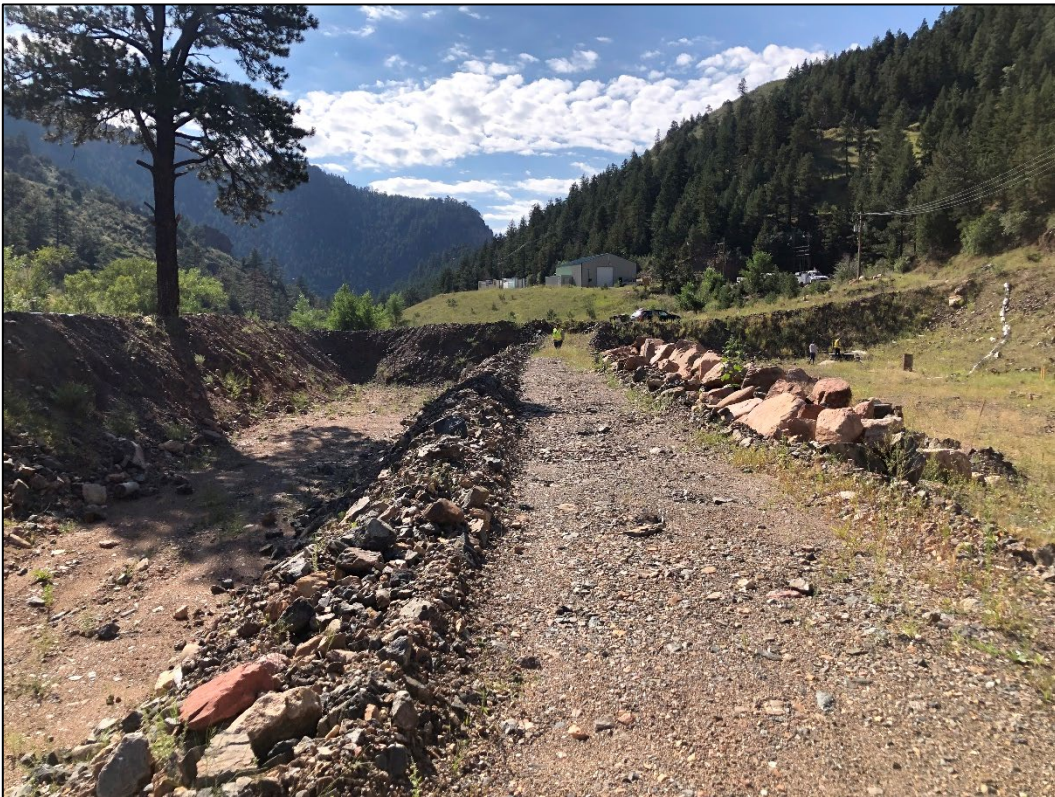
**Photo 4.** View looking southeast across central portion of valley excavation project. This project has been suspended since December 2021.

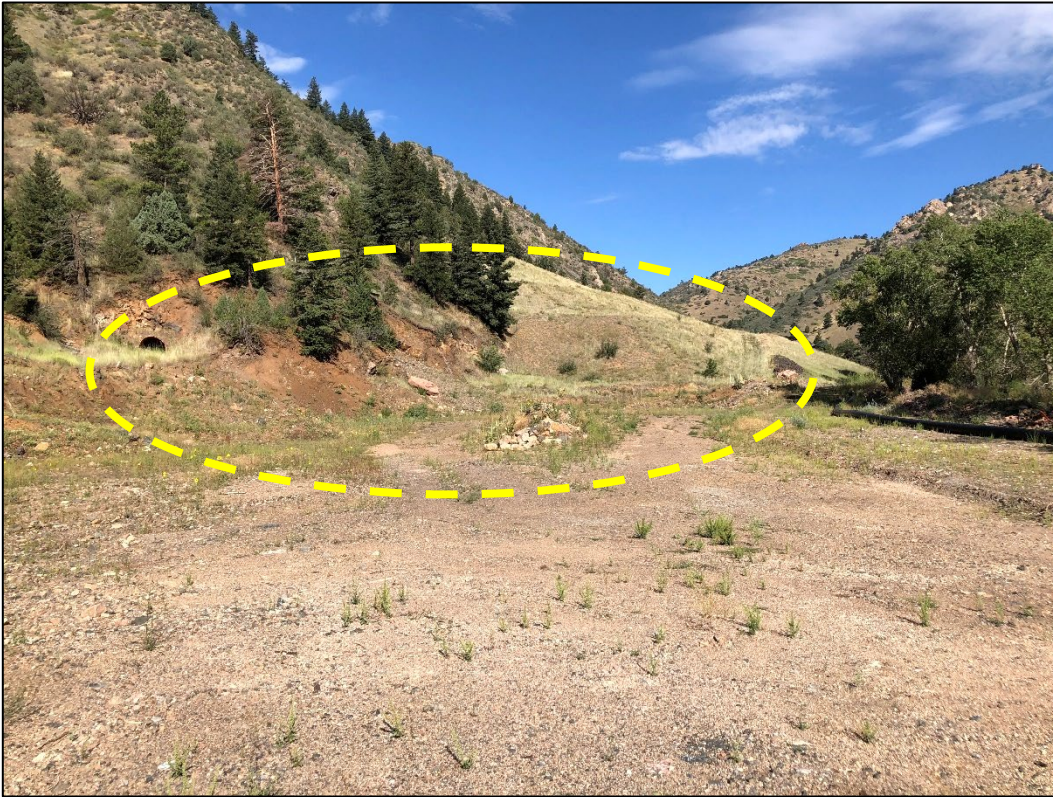
**Photo 5.** View looking northwest across northern portion of valley excavation project. AM-6 proposes placing additional excavated material on southeastern edge of SWRP and tying this material into the Black Forest Mine backfill. Approximate location of proposed SWRP expansion is circled.

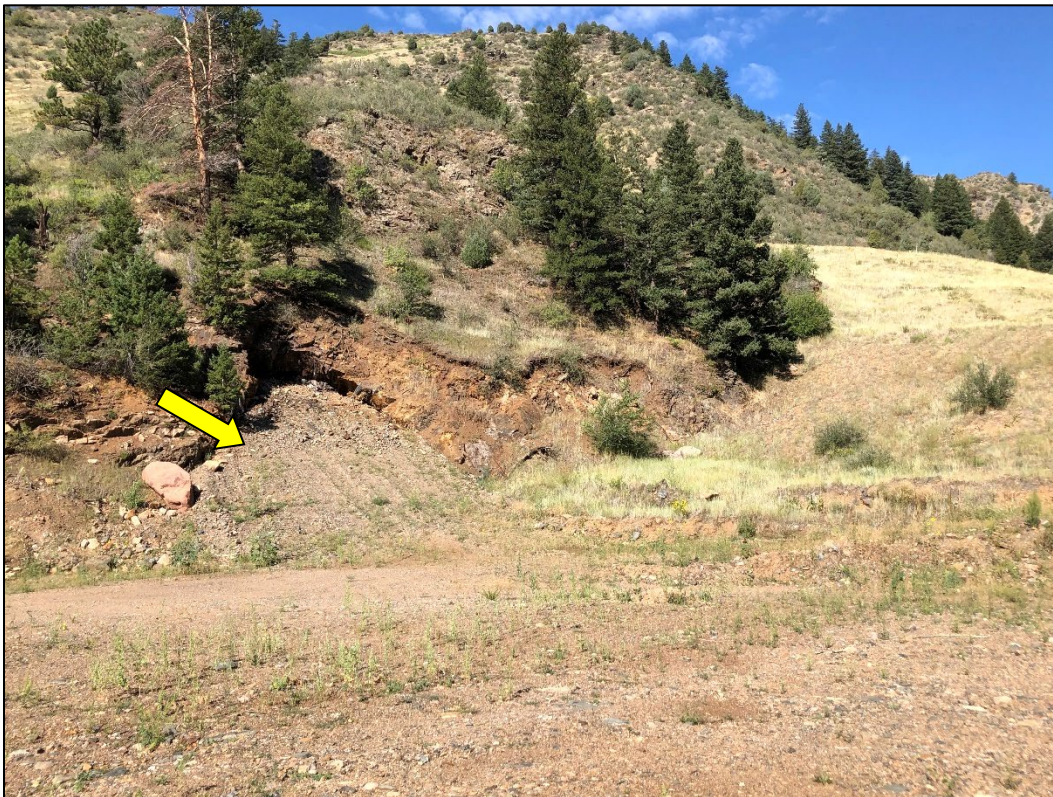
**Photo 6.** View looking west at main portal of Black Forest Mine (indicated), which was partially backfilled in December 2021. This area is included in the proposed SWRP expansion. Note southwestern edge of SWRP at far right.

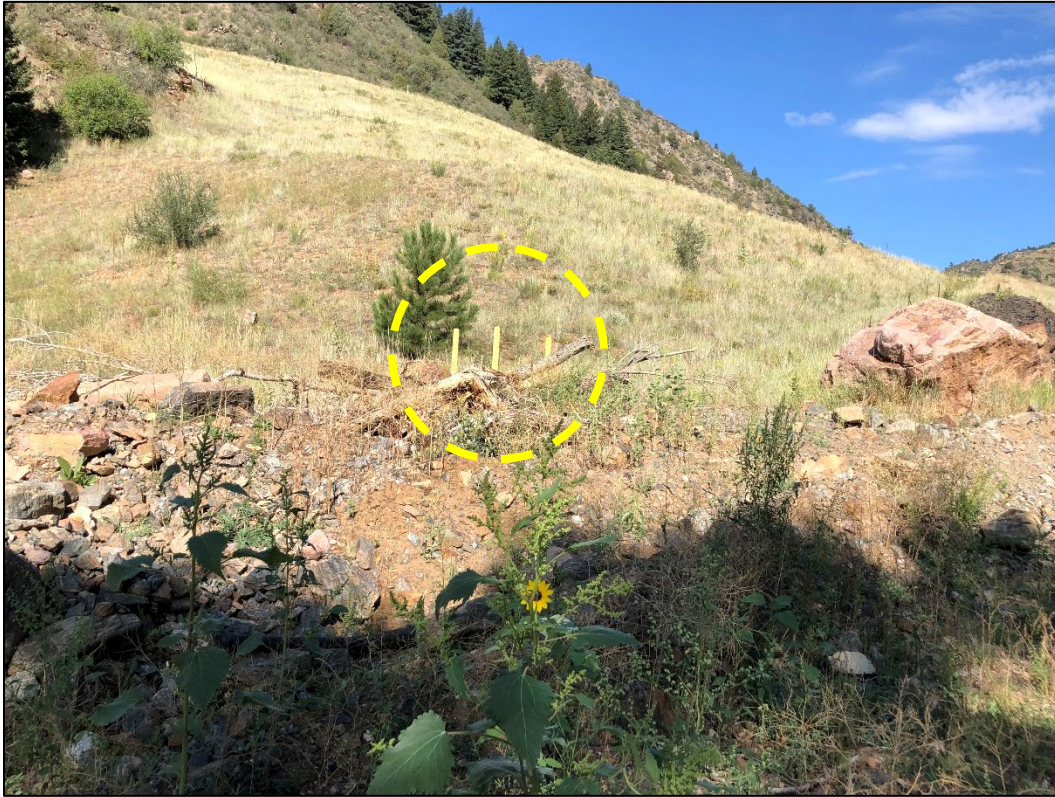
**Photo 7.** View looking north/northwest at southeastern portion of SWRP, showing location of monitoring well MW-19 (circled). The proposed SWRP expansion would leave access to this well from the adjacent road.

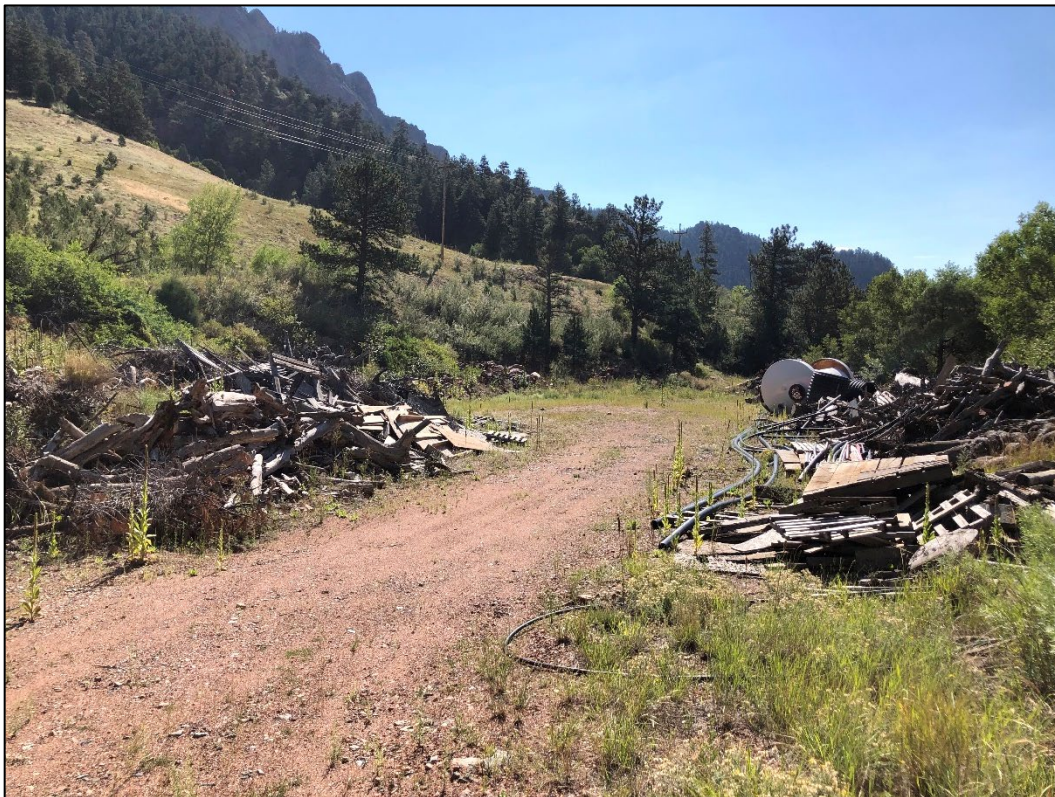
**Photo 8.** View looking southeast across storage area located north of creek. Several items have been removed from this area since it was inspected in November 2021, including empty storage tanks and old mining equipment. This area will be completely cleared out and revegetated for final reclamation.

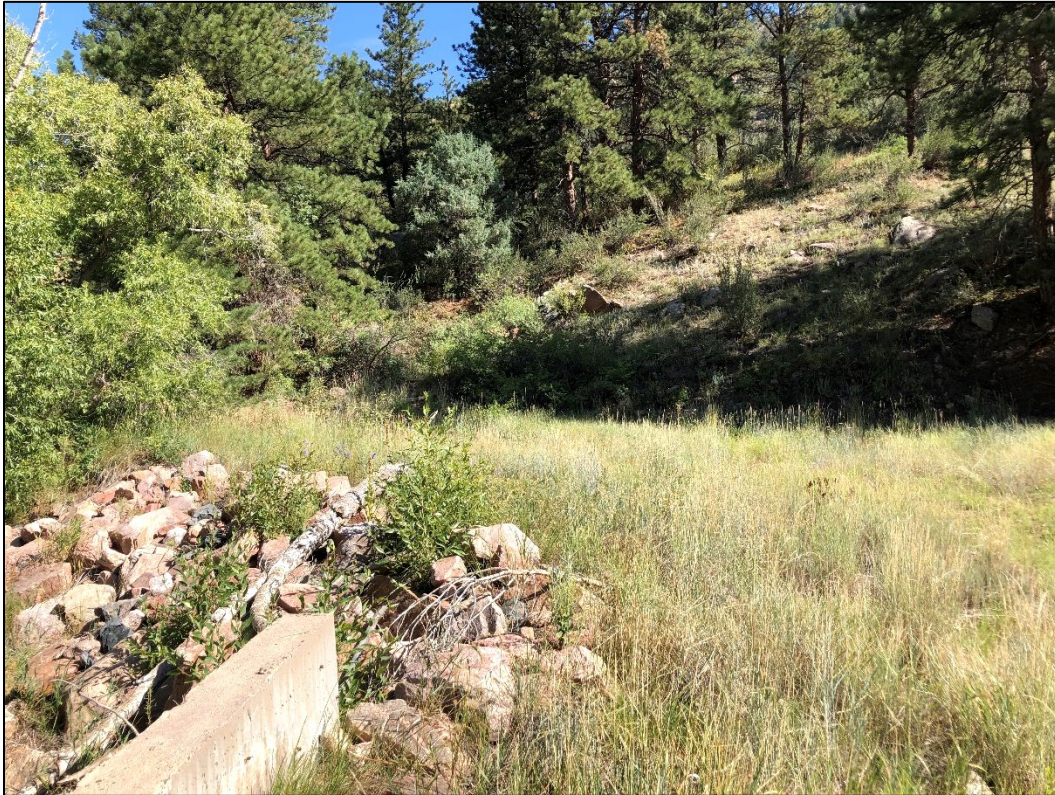
**Photo 9.** View looking northwest across northern portion of storage area located north of creek. The small shed and empty storage tank observed in this area in November 2021 have been removed.

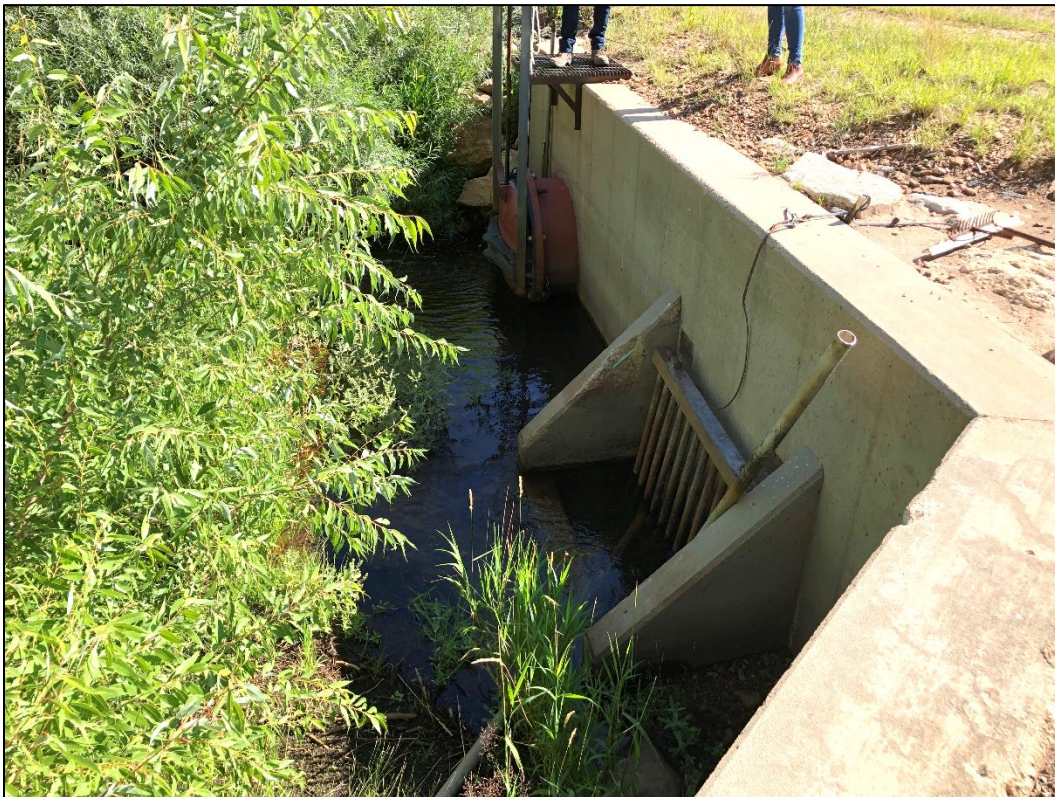
During the inspection, creek flows were being captured above the upgradient cutoff wall and routed around the mine site via the bypass pipeline. In AM-6, the operator is proposing to re-establish creek flows across the mine site, after the alluvial valley excavation project (and other surface reclamation) has been completed. The

**Photo 10.** View of upgradient cutoff wall/headgate in Ralston Creek, showing creek flowing upstream of cutoff wall. Upgradient flows were being routed around the mine site via the bypass pipeline.

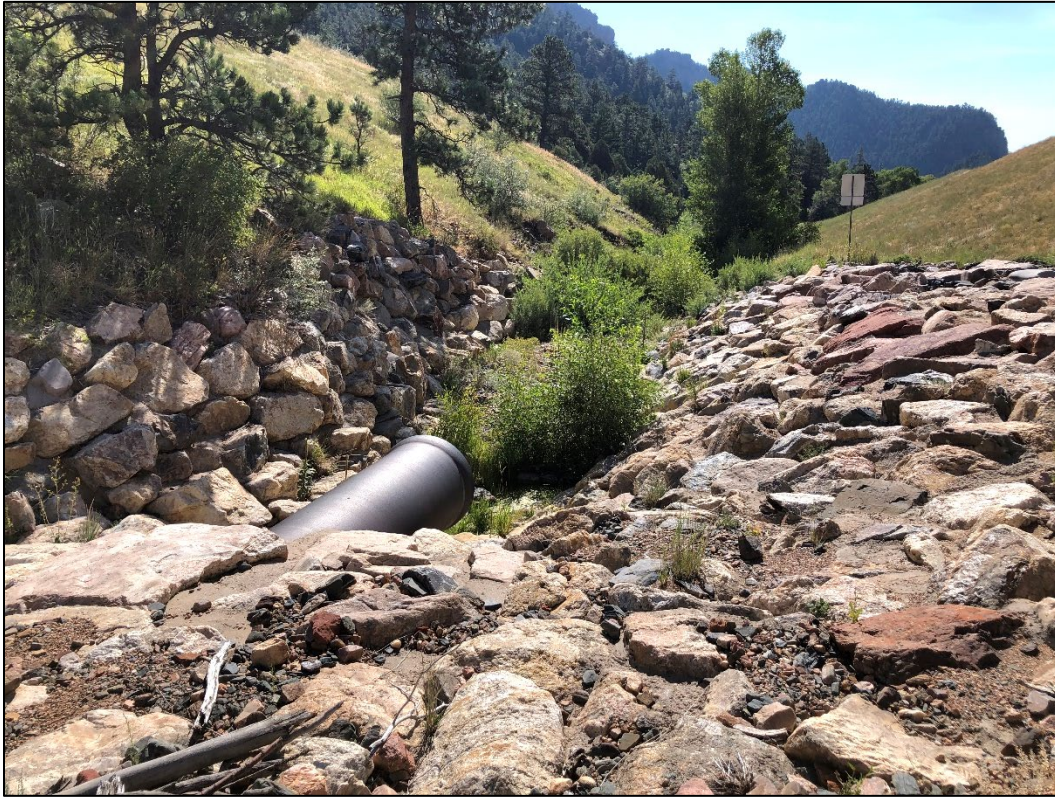
**Photo 11.** View looking downstream from upgradient cutoff wall/headgate in Ralston Creek, showing creek channel dry downstream of cutoff wall.

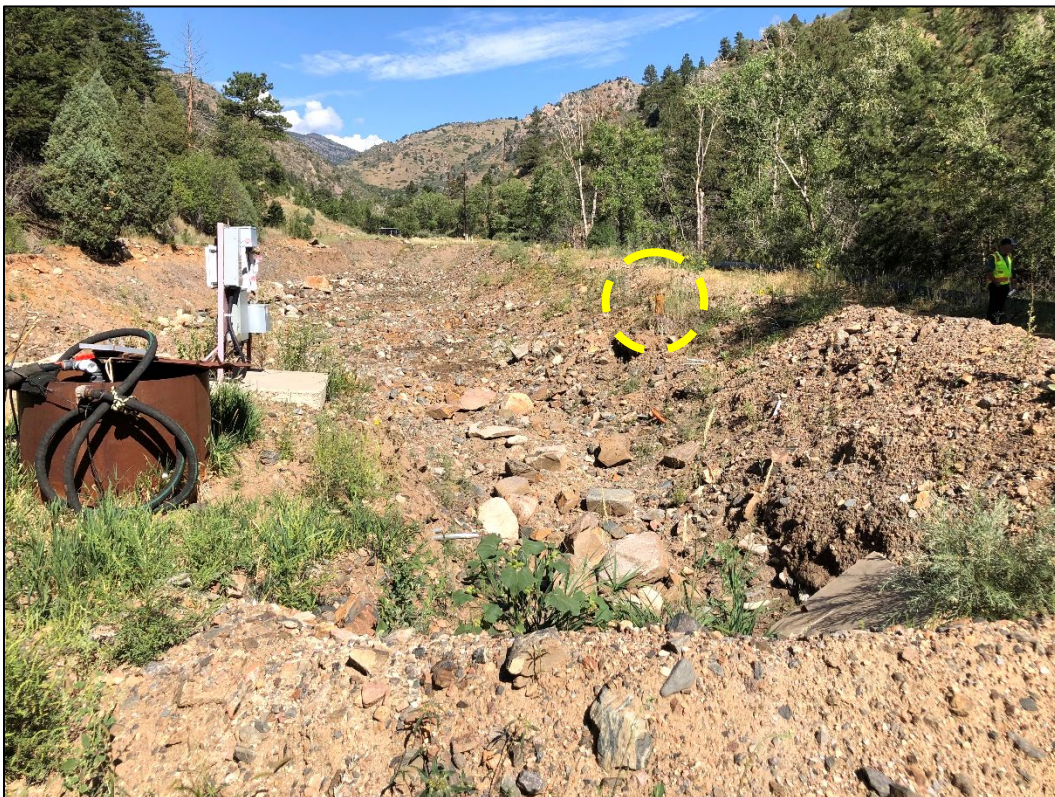
The Division observed the area of the existing alluvial groundwater monitoring wells MW-6, MW-7, and MW-12, located at the southeastern edge of the mine site. As mentioned in previous inspection reports, these wells have been or will be impacted by the valley excavation project, and will therefore, need to be formally removed from the approved groundwater monitoring plan. In its adequacy review #4, the Division suggested the operator install an additional bedrock groundwater monitoring well south of the creek, between wells MW-7 and MW-12. During the inspection, the operator indicated they believe the area between wells MW-6 and MW-7 would be a more appropriate location for the new well, given the additional space available in this portion of the valley. The Division agreed that anywhere between wells MW-6 and MW-12 could suffice for the new well location, as long as it is south of the creek, and west of the groundwater divide illustrated in AM-6 (on Figure E-4). Given the excavation activities still underway in the area of these wells, the operator will not be able to install the new bedrock well until the excavation project is complete. A Technical Revision will need to be submitted within 30 days of installation of the new well, including a final construction report and an updated groundwater monitoring plan and map that incorporate the new well.

**Photo 12.** View looking northwest across southern portion of valley excavation project. Note master sump #1 and monitoring well MW-7 (circled) installed in this area. These features have been rendered inoperative due to the excavation project and will need to be removed from the monitoring plan.

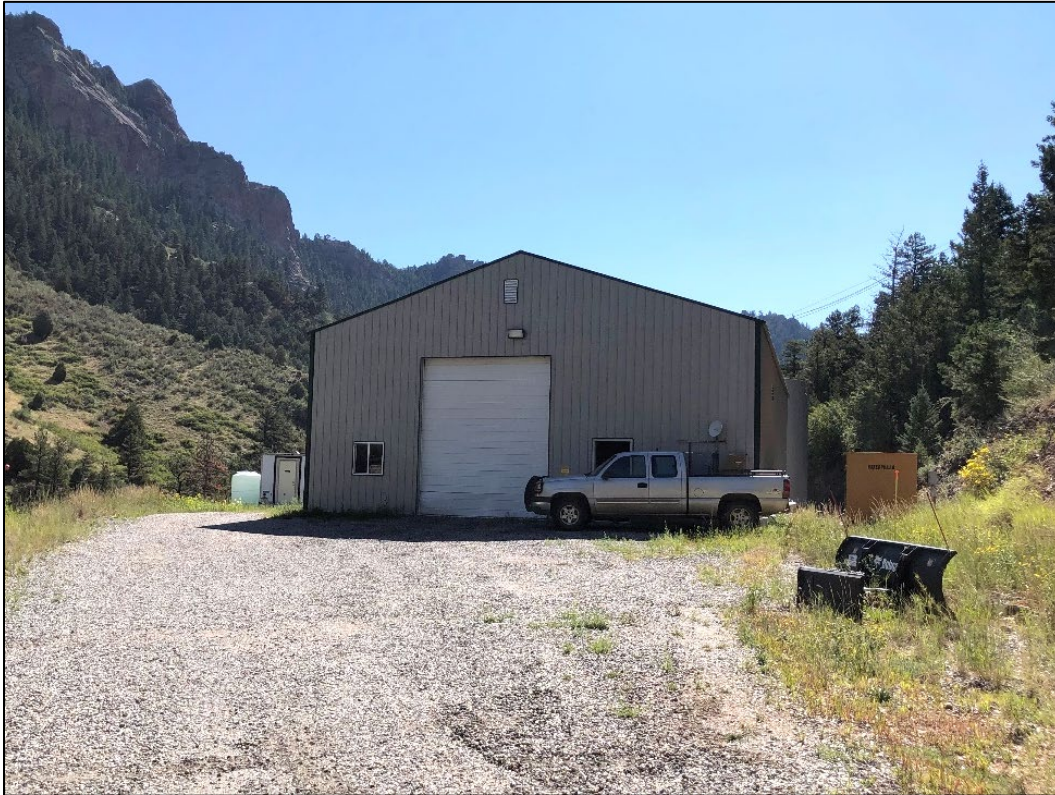
**Photo 13.** View looking southeast at northwestern side of water treatment plant (on top of mesa).

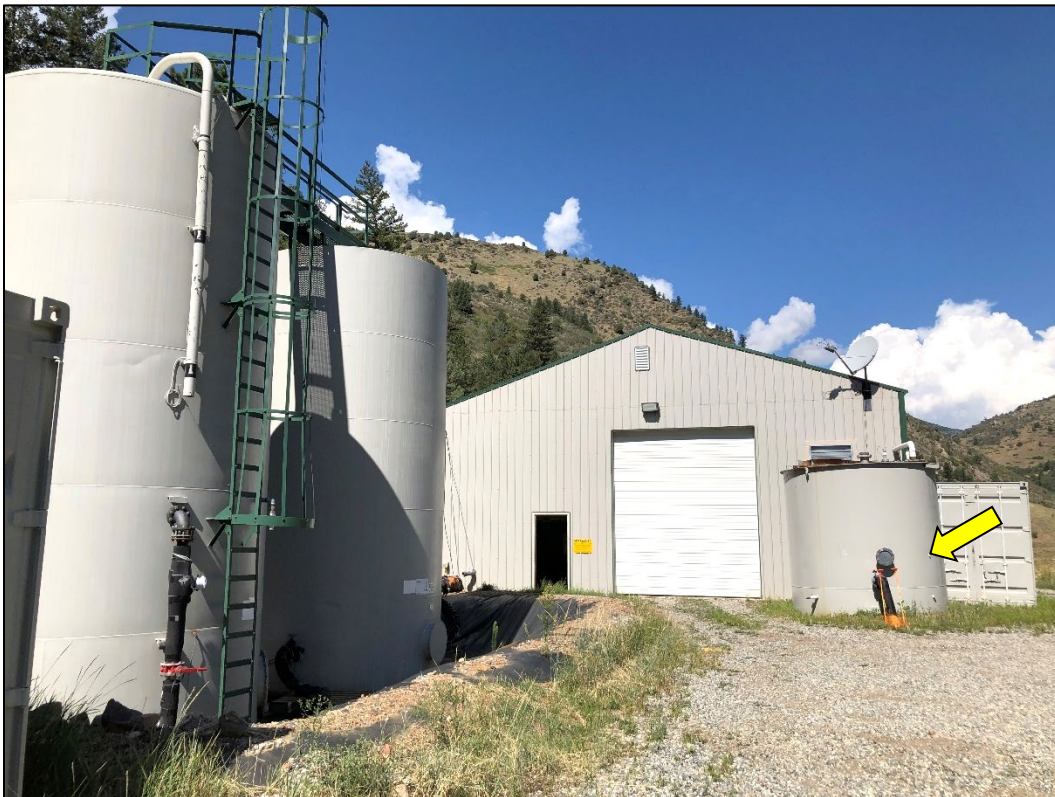
**Photo 14.** View looking northwest at southeastern side of water treatment plant (on top of mesa). Note reactor tank and backfill slurry tank (in foreground) which sit inside a lined secondary containment basin, and clean water tank (indicated in background).

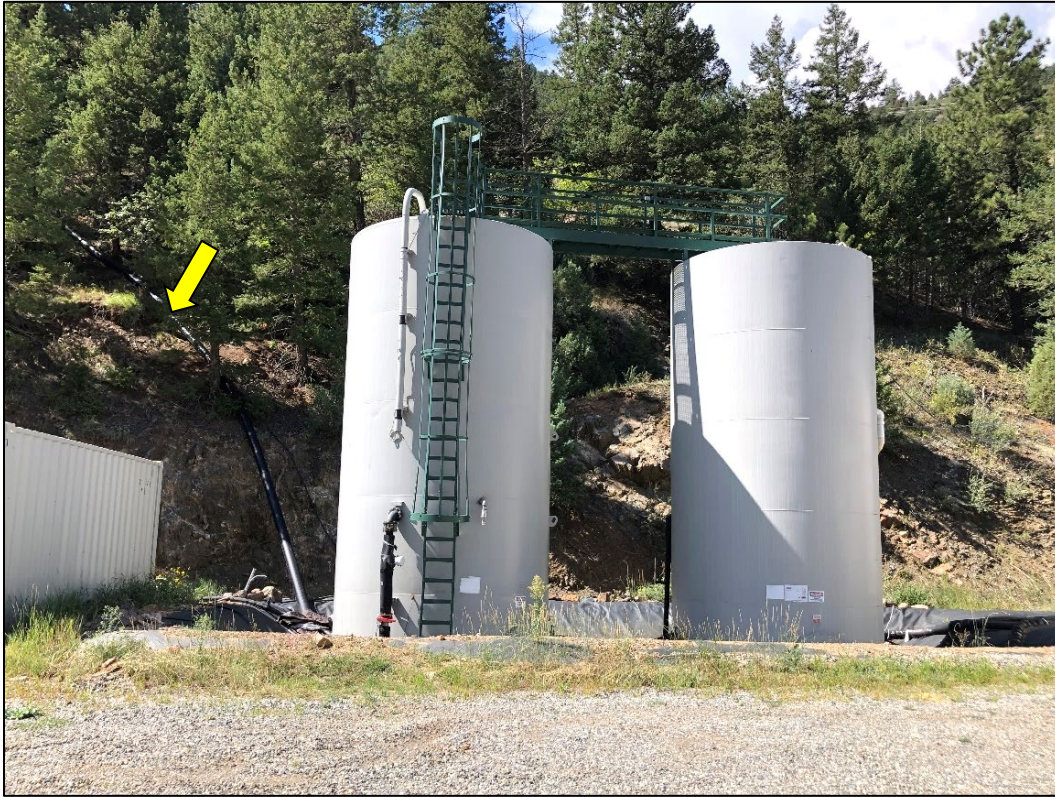
**Photo 15.** View looking west at reactor tank and backfill slurry tank which sit inside a lined secondary containment basin. Note pipeline (indicated) which runs from dewatering pump inside Jeffrey Air Shaft (located uphill from plant) for approx. 250 feet down to tanks.

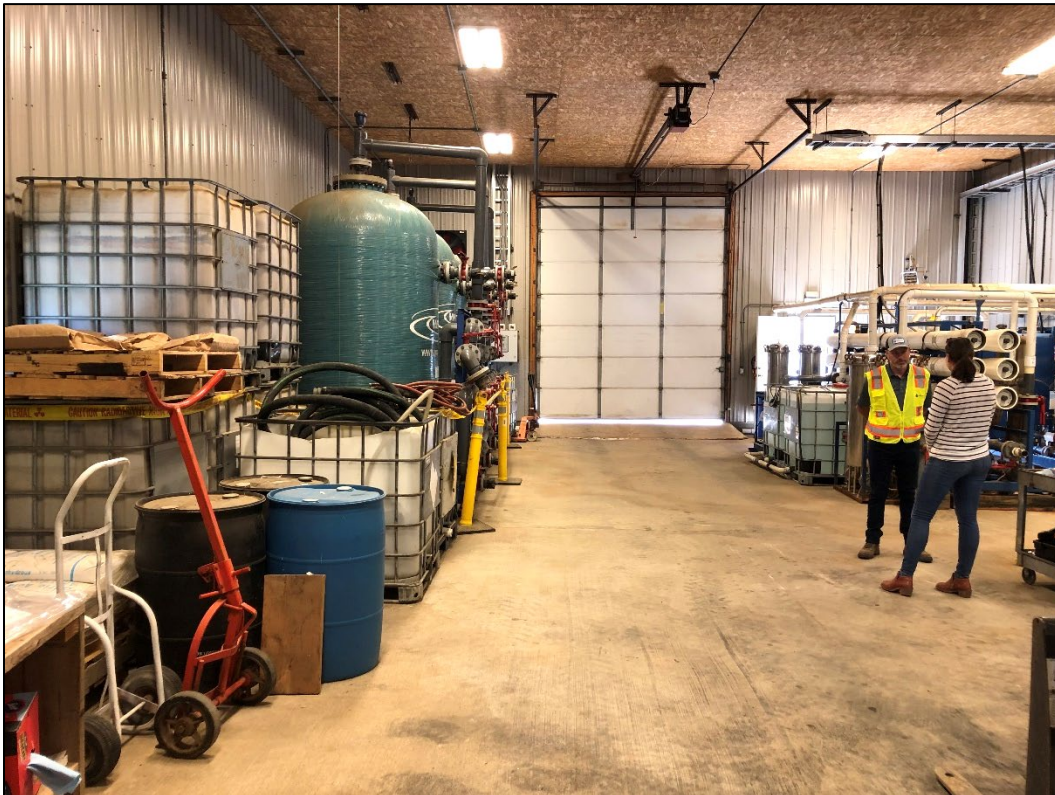
**Photo 16.** View looking southeast inside water treatment plant, showing IX system and resin storage area (at left) and RO system (at right). Note approx. 12 foot x 17 foot garage door at end of building, with concrete floor ramp.

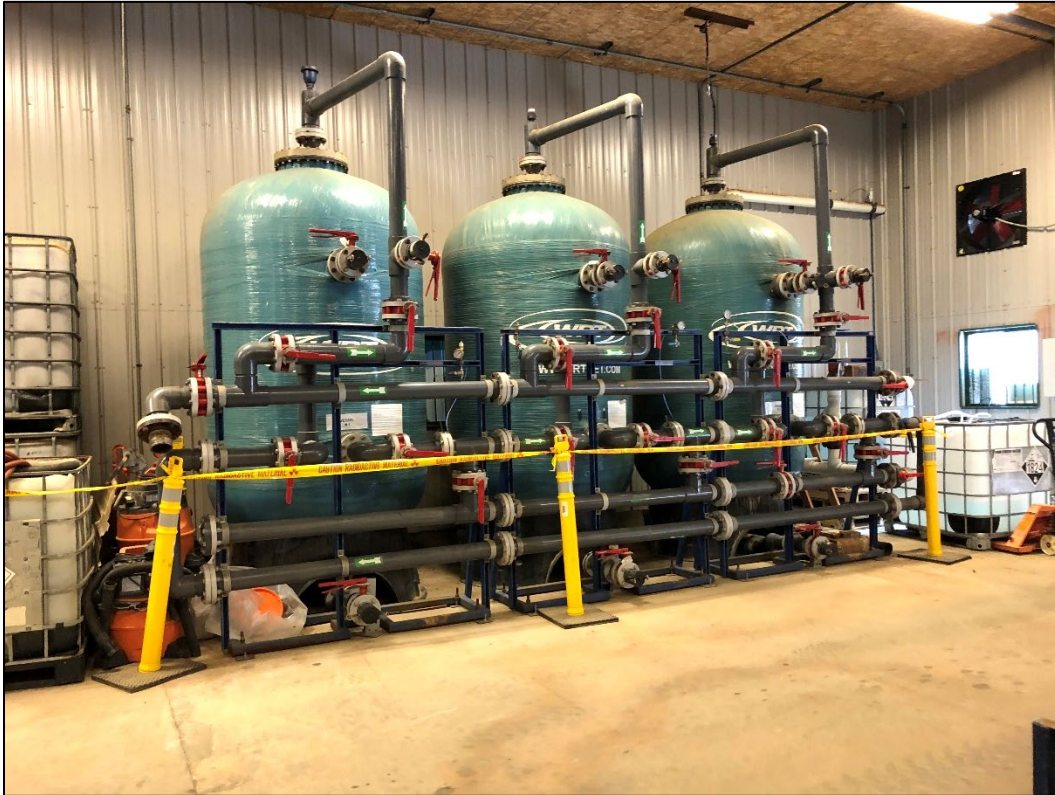
**Photo 17.** Closer view of IX treatment system inside water treatment plant (along northern wall), consisting of 3 tanks. According to operator, only one tank is typically used at this time, mainly for polishing after primary treatment through RO system.

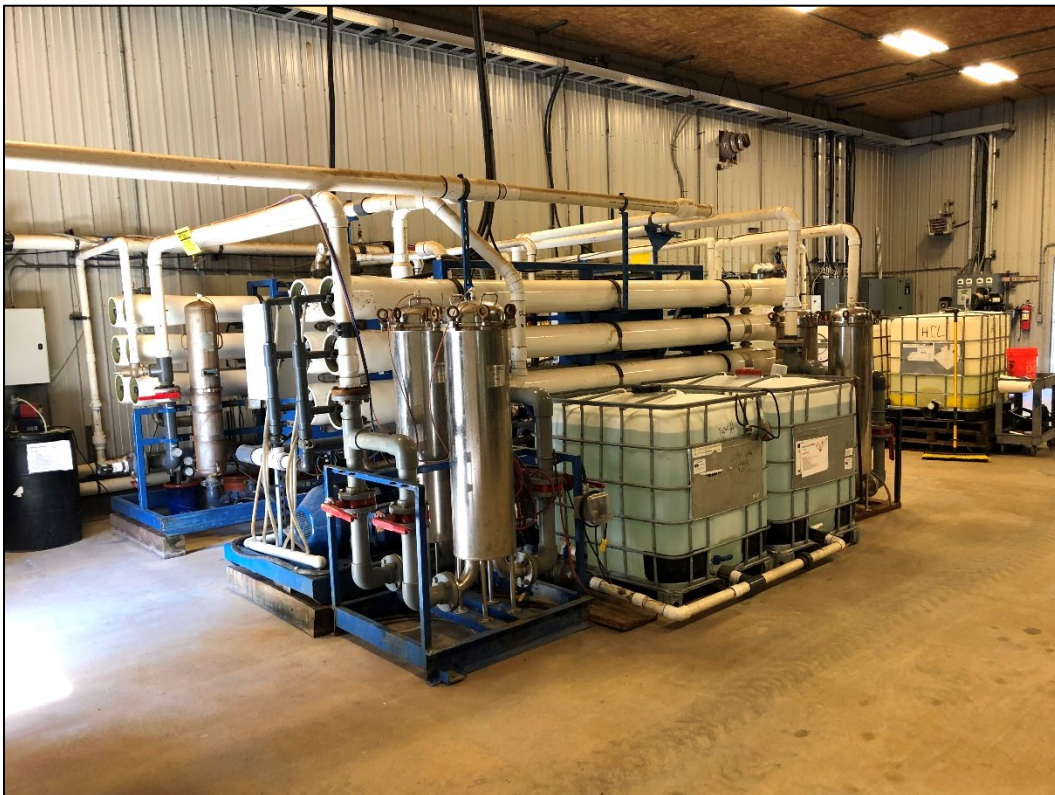
**Photo 18.** Closer view of RO treatment system inside water treatment plant (along southern wall). This is the primary treatment system for water pumped from the mine workings.

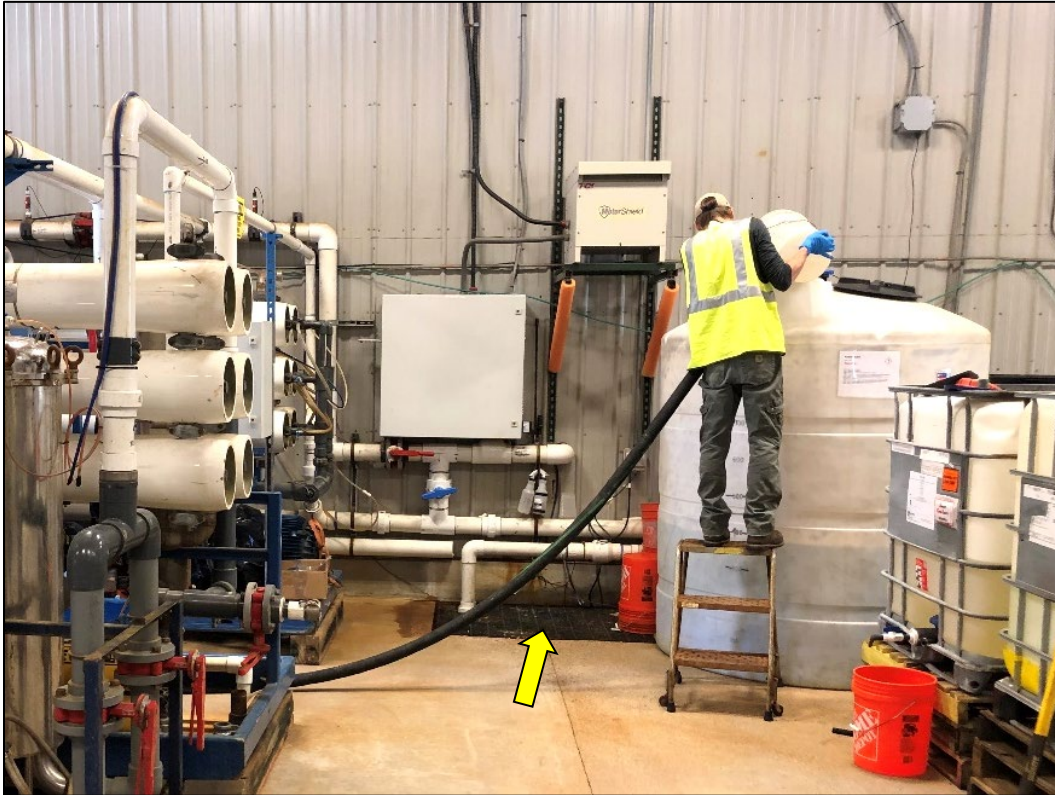
**Photo 19.** View of mine pump (at center), anti-scale tank (at right), and sump drainage area (indicated) inside water treatment plant (along southern wall). Any fluids captured by sump system are directed to mine workings.

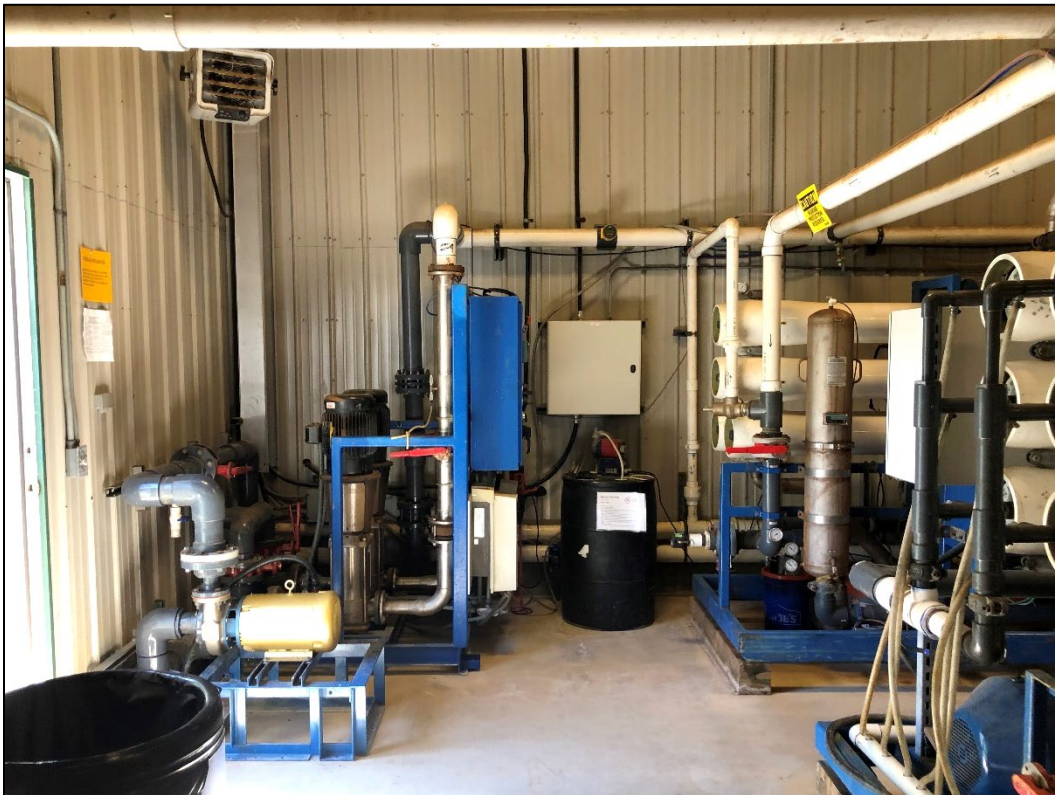
**Photo 20.** View of backfill pump, booster pumps, backfill pump VFD, and barium chloride drum (at center) located in southern corner of water treatment plant. Note portion of RO system visible at right.

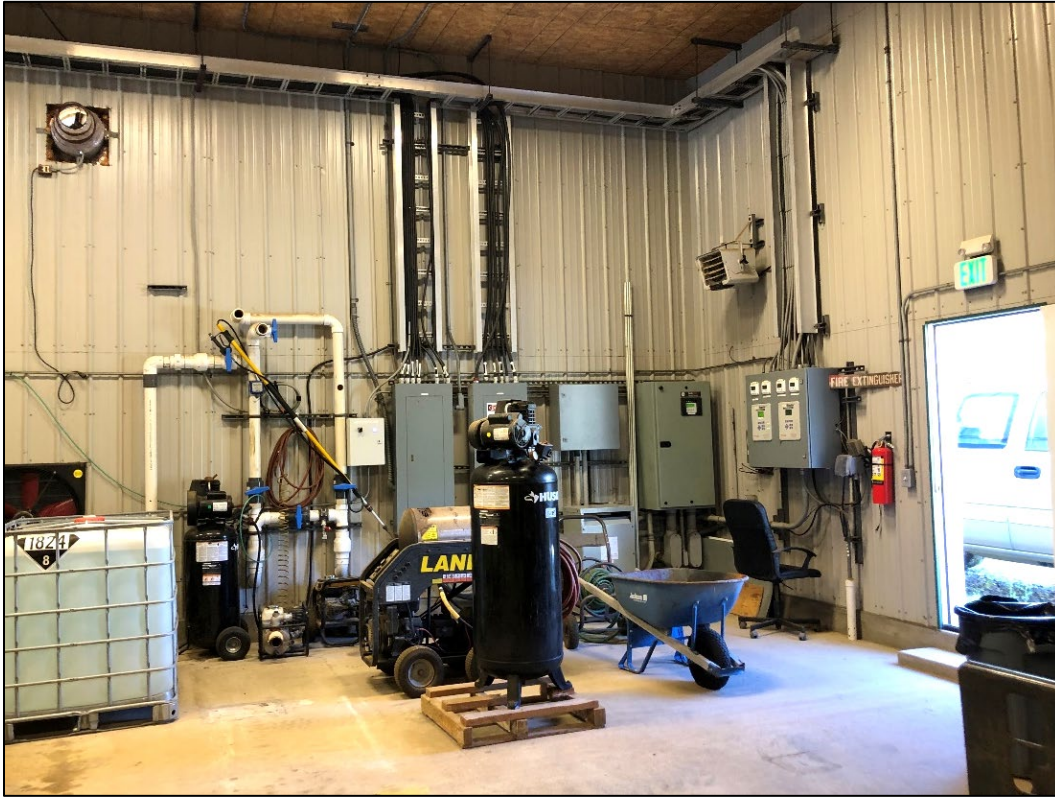
**Photo 21.** View of main electrical panel located in western corner of water treatment plant.

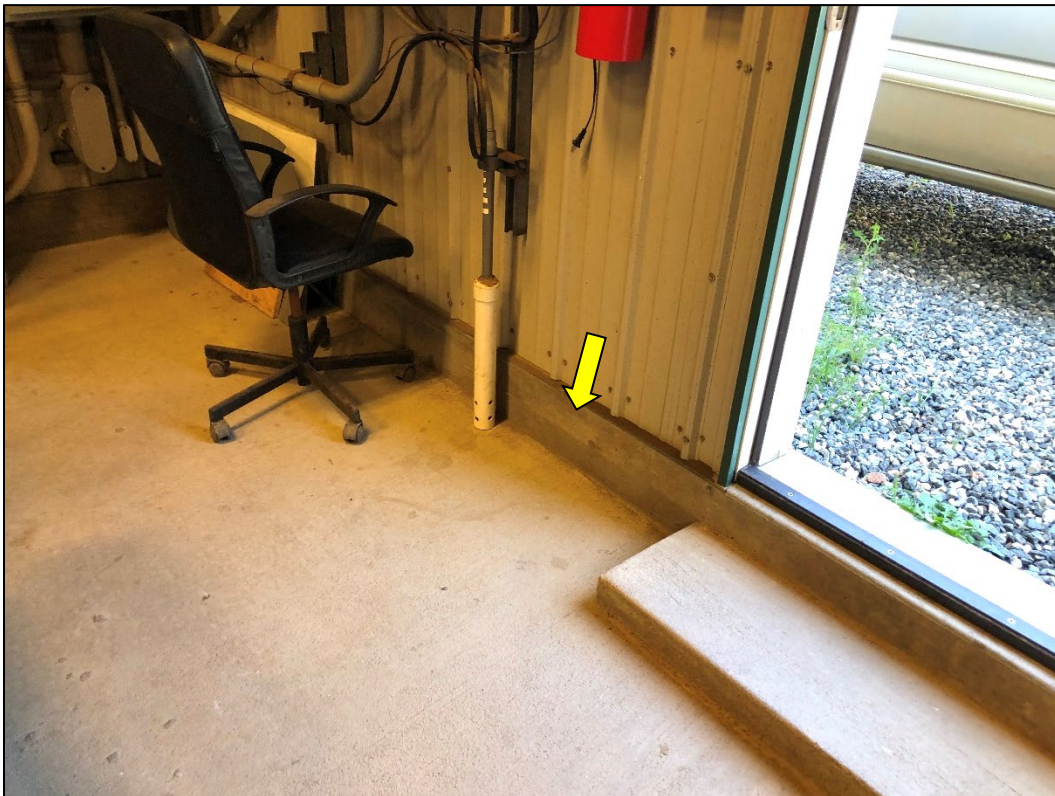
**Photo 22.** Closer view of floor of water treatment plant, showing 8 inch high concrete berm (indicated) installed around edge of floor. This berm serves as secondary containment for the plant, to contain at least 110% of the maximum storage capacity of all primary containers inside the building holding hazardous chemicals.
