MINERALS PROGRAM INSPECTION REPORT

MINE NAME: Simla Highway Pit	MINE/PROSPECTING ID#: M-1995-095	MINERAL: Gravel	COUNTY: El Paso
INSPECTION TYPE: Monitoring	INSPECTOR(S): Timothy Cazier, P.E.	INSP. DATE: May 4, 2022	INSP. TIME: 13:50
OPERATOR: Hill Top Gravel LLC	OPERATOR REPRESENTATIVE: Blake Tope	TYPE OF OPERATION: 110c - Construction Limited Impact	
REASON FOR INSPECTION: Normal I&E Program	BOND CALCULATION TYPE: Partial Bond	BOND AMOUNT: \$14,462.00	
DATE OF COMPLAINT: NA	POST INSP. CONTACTS: None	JOINT INSP. AGENCY: None	
WEATHER: Cloudy	INSPECTOR'S SIGNATURE:

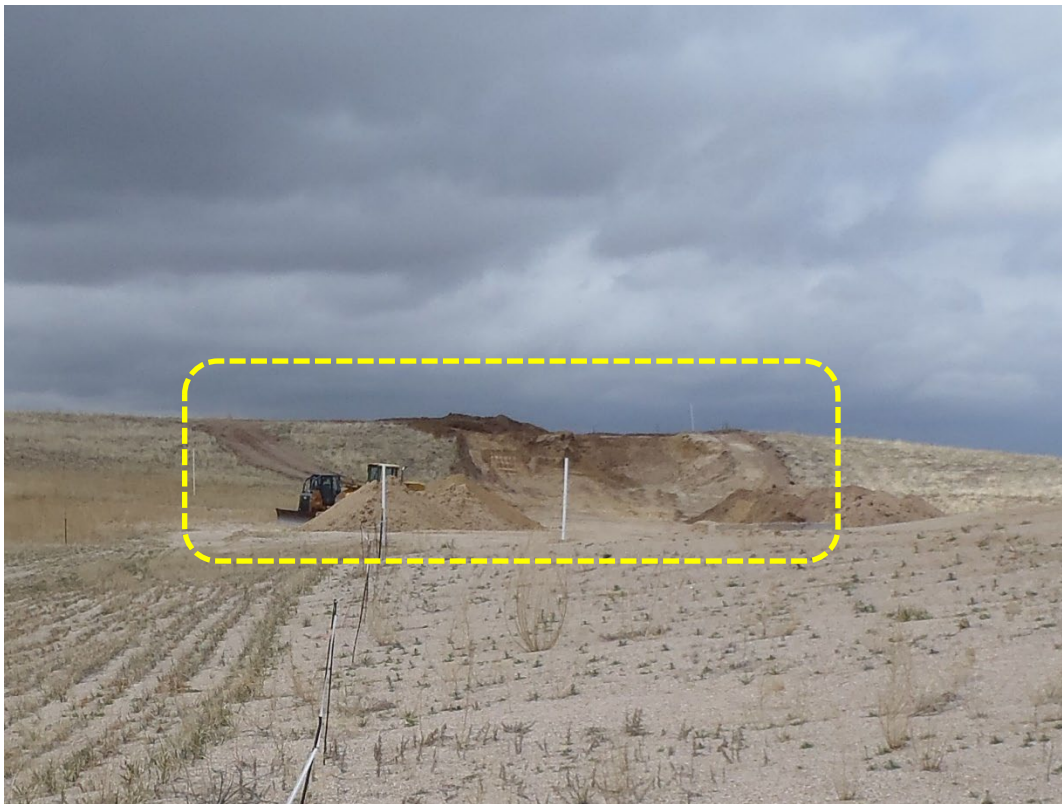
include a minor earthwork task to move 400 cubic yards to flatten a small amount of working highwall (*reference SI-1 bond estimation*). Sufficient backfill material appeared to be available for the small active highwall (see **Photo 1**) on the north within the TR-2 expansion area.

Signs and Markers: Mr. Tope explained the permit sign had been shot up and a new one was on order. [Please send the DRMS a phot of the new sign properly posted.](#) The affected area boundaries were well marked (see **Photos 1** and **4**).

Photo 1. Active working area on north end of pit (looking north, note numerous boundary markers).

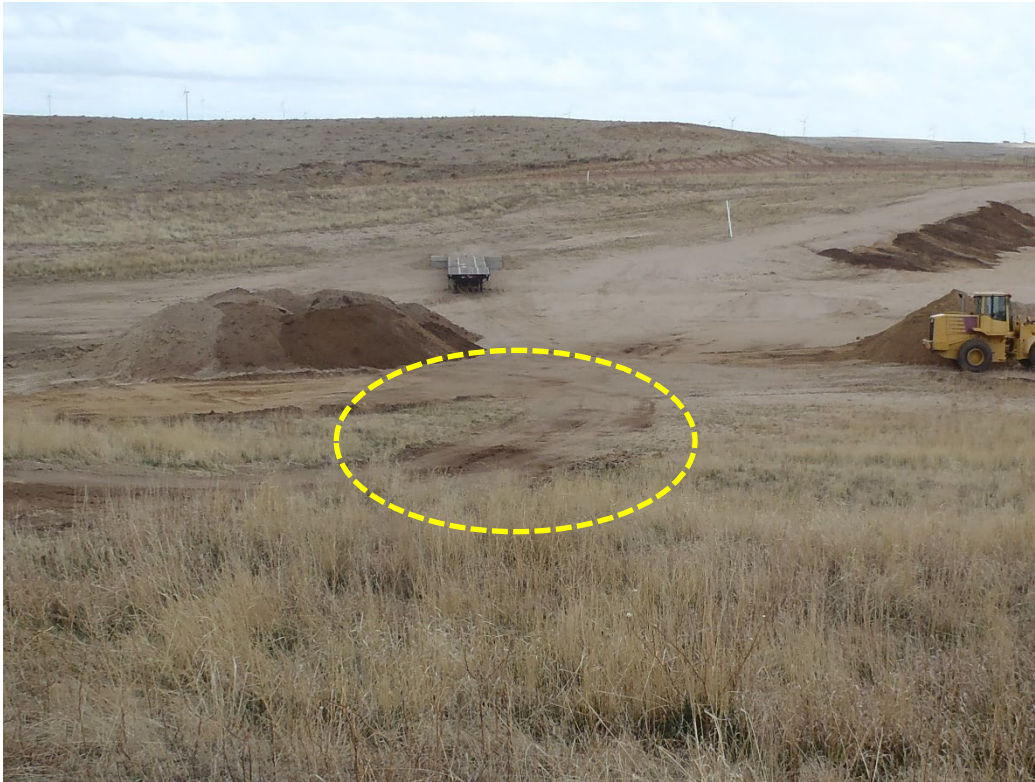
Gen. Compliance with Mine Plan: The operation appeared to be in compliance with the approved mine plan at the time of the inspection. The maximum allowed disturbed area for the purpose of bonding is 2.65 acres (which includes the one-acre sediment pond as long as no grading is involved). An additional bond is held for four acres that have been revegetated, but are still in the permit [*assuming a 25% failure rate – or for one equivalent acre of seeding*]]. There is a short segment between the sediment pond and the new active mining area that is not technically covered under the TR-2 approval (see **Photo 2** dashed redline on **Figure 1**). As neither the new active mine area or the topsoil stockpile have reached their approved maximum area (shown on **Figure 1**), there is sufficient bond. [However, future permit revisions should be sure to incorporate haul/access roads.](#)

Photo 2. Small access road shown on Figure 1 as a dashed red line.

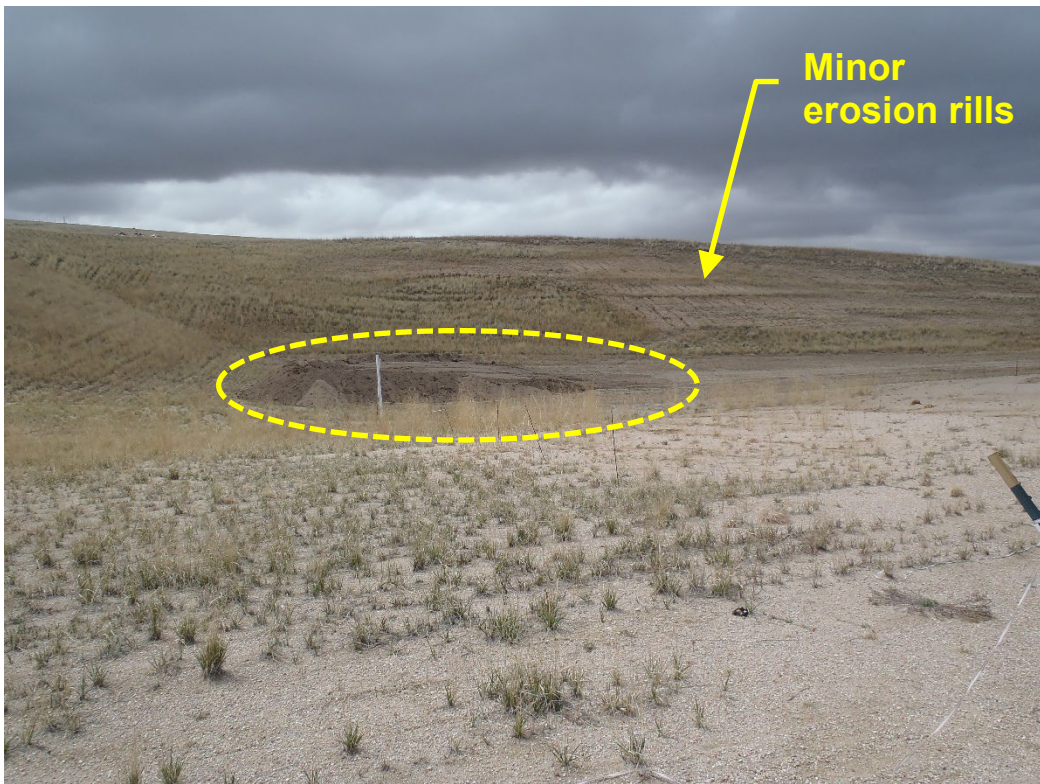
Sediment Control: Only minor erosion was observed (see **Photo 3**) and no BMPs were needed at the time of the inspection.

Topsoil: A topsoil stockpile is in the south end of the pit (see **Photo 3**).

Photo 3. Temporary topsoil stockpile (circled, south end, looking west, note minor erosion).

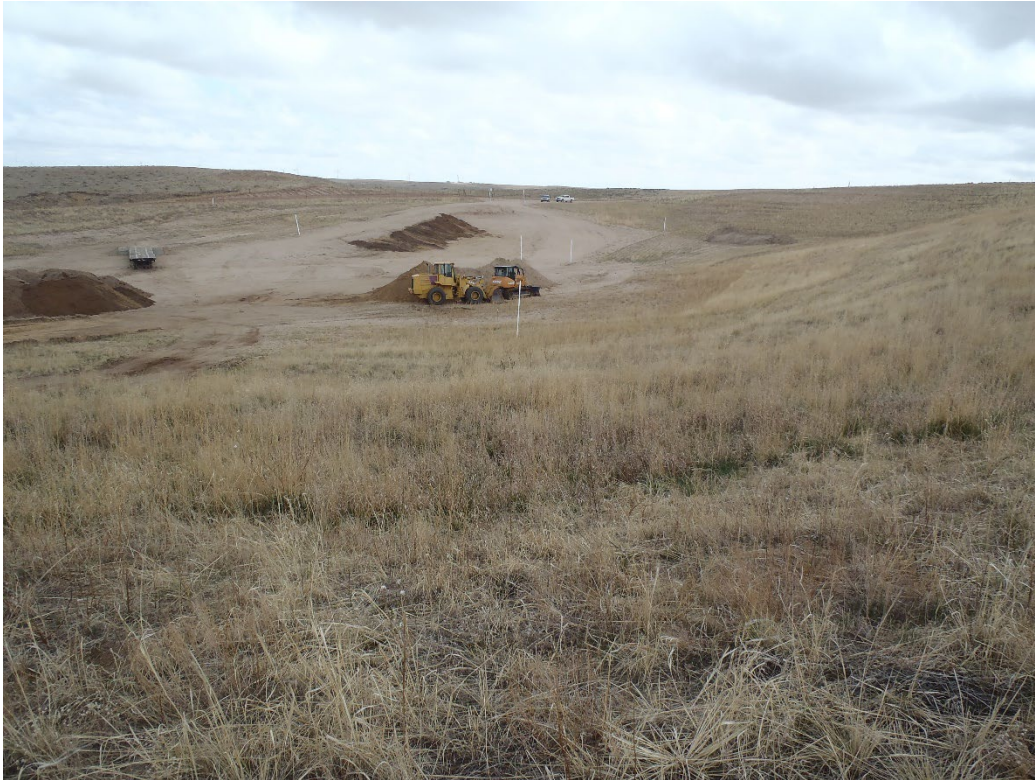
Support Facilities On-site: A Cat 624H loader and a Case dozer were observed on site (see **Photo 4**).

Photo 4. Cat 624H loader and a Case dozer (looking south, note white boundary markers and revegetated east facing slopes).

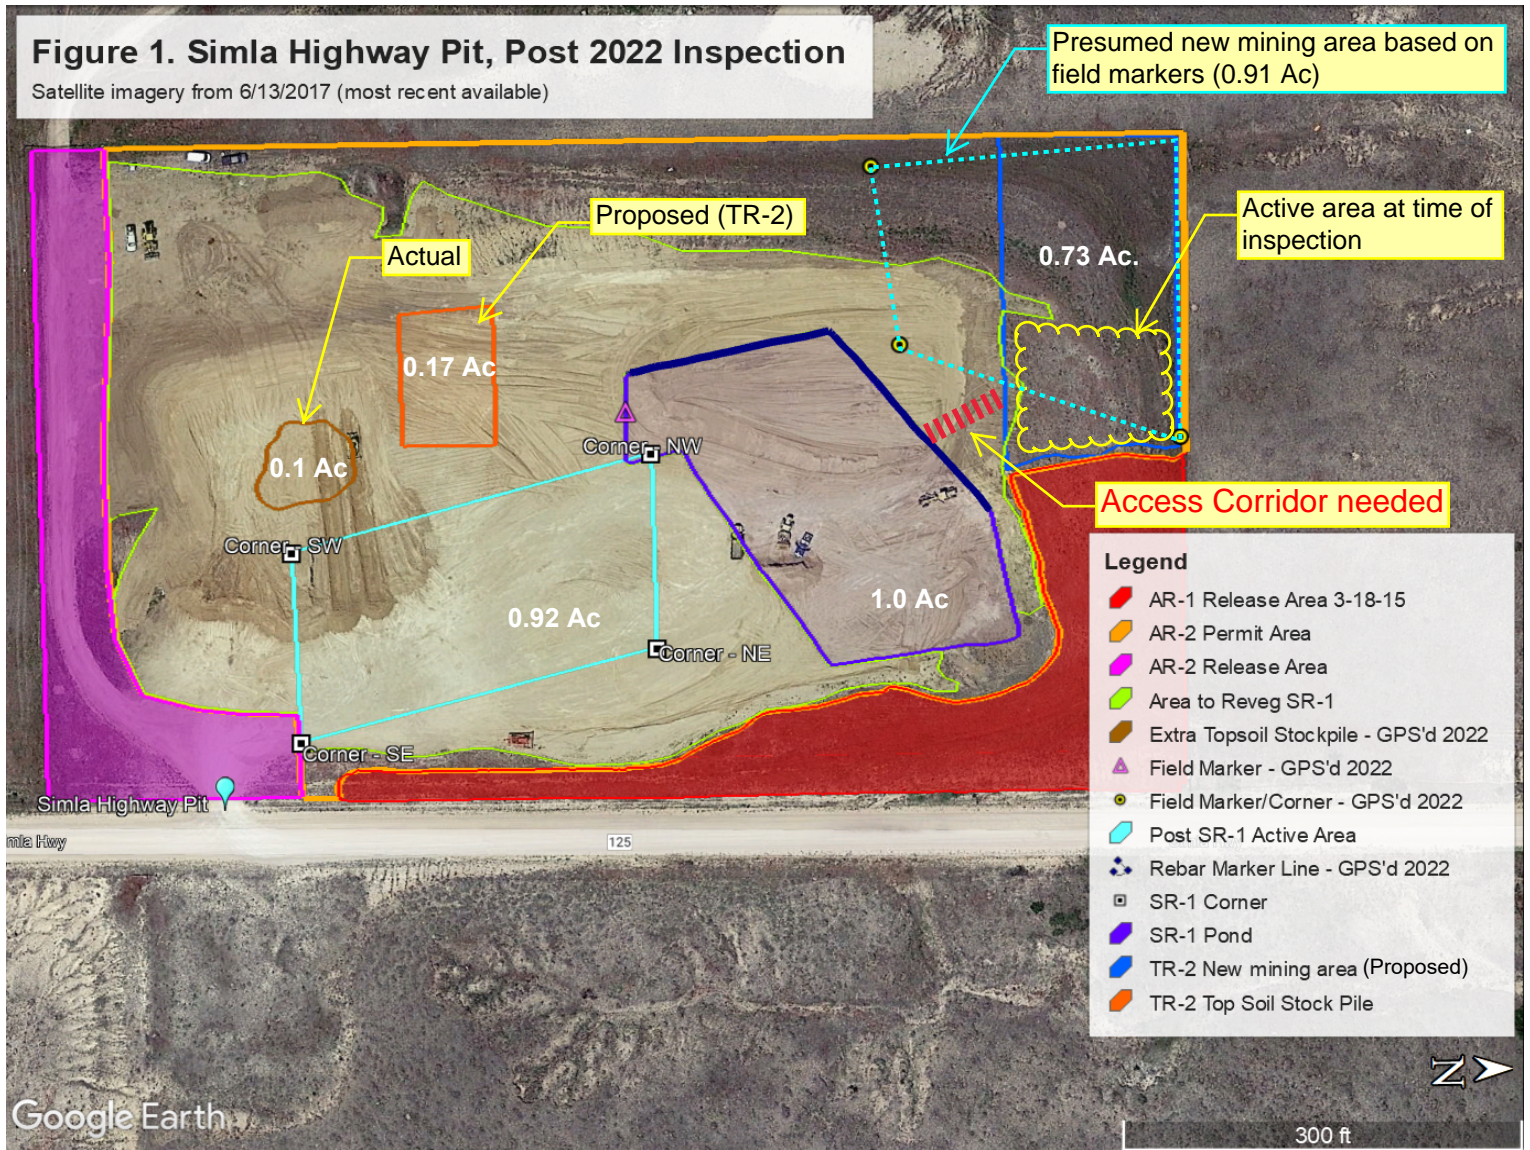
Figure 1. Simla Highway Pit, Post 2022 Inspection

- **AR-1**, approved April 2015 – Acreage Release of a 1.18-acre “L” shaped area in the NE corner of the permit, reducing the permit area to 8.72 acres (red shaded area on **Figure 1**)

- **AR-2**, approved May 2018 – Acreage Release of a 0.83-acre “L” shaped area in the SE corner of the permit (magenta shaded area on **Figure 1**) where the access road is to remain per TR-1, reducing the permit area to 7.89 acres;

Hill Top Gravel has been working on expanding the pit area while limiting re-disturbance of previously reclaimed areas within the 7.89 acre permit. It should be noted the DRMS Rules consider all area within 110c permits to be affected area, for which a bond is required. However, special circumstances surrounding the SR-1 and SO-2 allowed this practice to be temporarily suspended. The DRMS is working with the Permittee to restore this bonding practice. See **Figure 1** for delineated areas.

Post Inspection Meeting: The DRMS brought an outdated map to the inspection. This initiated some discussion regarding the new mining area on the north end and the DRMS agreed to review this upon returning to the office and retrieving the current map subsequent to the inspection. Figure 1 shows the results of the post inspection review of the disturbances at the time of the inspection. The only area not technically within the TR-2 approved disturbance is the access road between the sediment pond and the new mining area. This area is very small, well within the permit area and with minimal impact to the bond – as observed at the time of the inspection. The DRMS is concerned about the potential of creating significant disturbance not covered by the currently held bond, if the area south of the TR-2 approved new mining area (blue line on Figure 1) and north of the two field markers used to draw the light blue dashed line on Figure 1 get mined. The Permittee should contact the DRMS prior to mining this area.
