**MINERALS PROGRAM INSPECTION REPORT**  
**PHONE: (303) 866-3567**

<b>MINE NAME:</b> Westhoff Farms	<b>MINE/PROSPECTING ID#:</b> M-1987-166	<b>MINERAL:</b> Borrow material for	<b>COUNTY:</b> Morgan
<b>INSPECTION TYPE:</b> Monitoring	<b>INSPECTOR(S):</b> Brock Bowles	<b>INSP. DATE:</b> July 6, 2022	<b>INSP. TIME:</b> 12:00
<b>OPERATOR:</b> Morgan County	<b>OPERATOR REPRESENTATIVE:</b> John Goodman	<b>TYPE OF OPERATION:</b> 110c - Construction Limited Impact	
<b>REASON FOR INSPECTION:</b> Normal I&E Program	<b>BOND CALCULATION TYPE:</b> None	<b>BOND AMOUNT:</b> \$0.00	
<b>DATE OF COMPLAINT:</b> NA	<b>POST INSP. CONTACTS:</b> None	<b>JOINT INSP. AGENCY:</b> None	
<b>WEATHER:</b> Clear	<b>INSPECTOR'S SIGNATURE:</b>

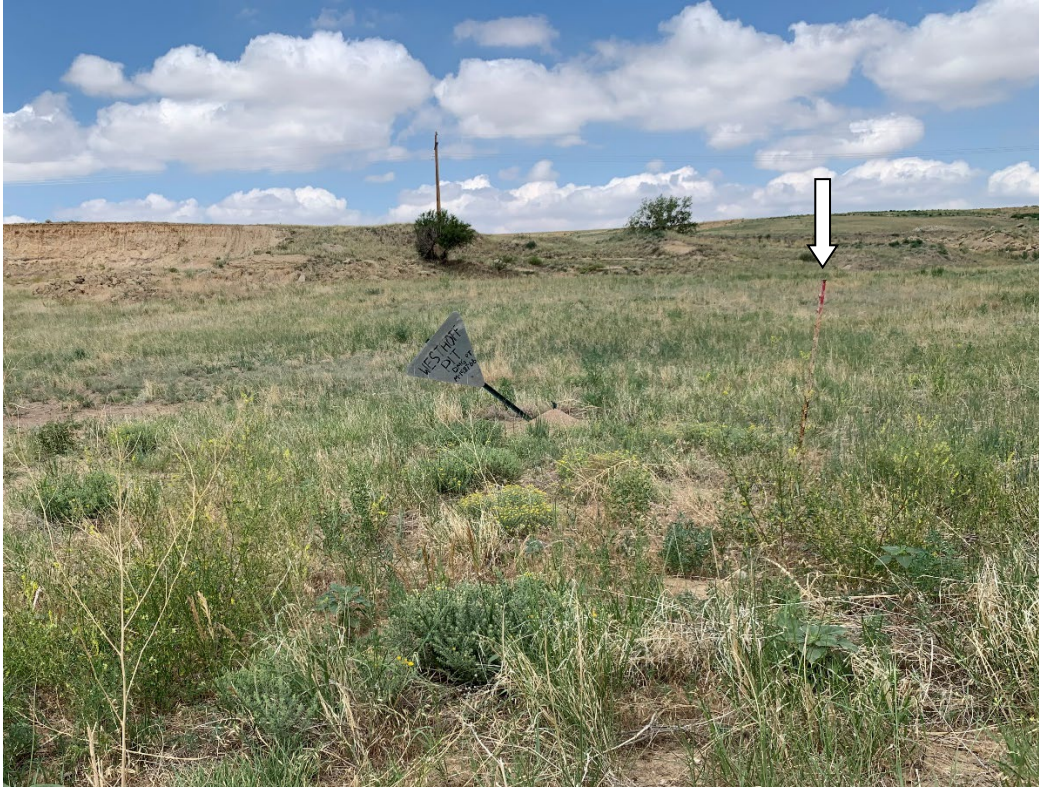
The mine entrance sign was in place facing CR 3 (photo 1). Permit boundary markers were in place. No equipment was onsite and the mine had not been recently mined. This was evident by the amount of vegetation on the pit floor.

Photo 1 – Mine entrance sign and NE permit marker

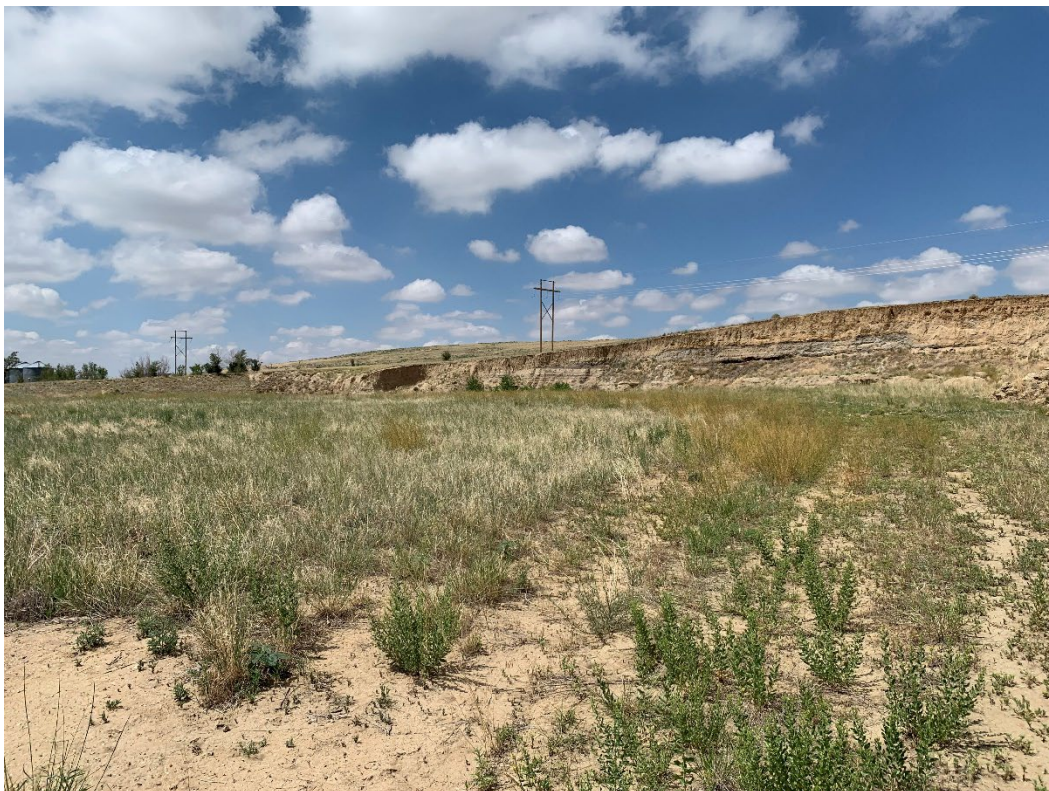
The mine is directly adjacent to CR3. Mining started at the road and went west into the hillside. The pit bottom is level with the road and the surrounding landscape rises which resulted in a 25 foot highwall on the west side of the pit (photo 2).

Photo 1 – Pit area from CR 3 facing west

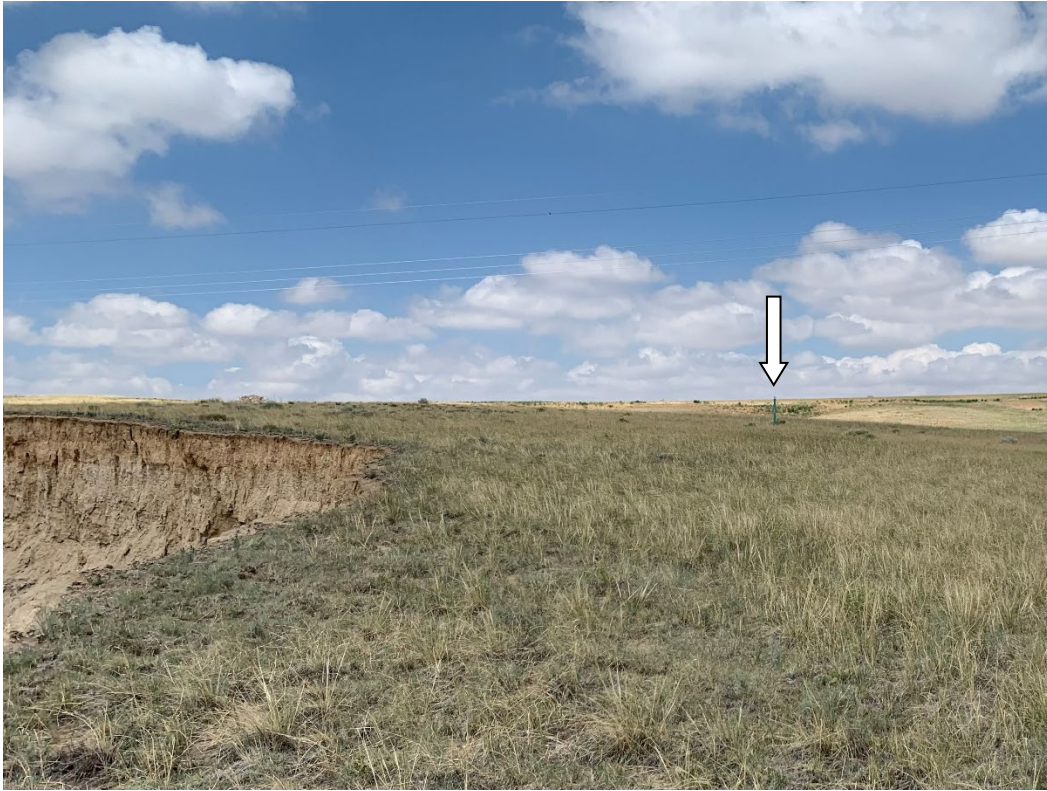
It appears that the mine has been mined out because the highwall is getting too close to the permit boundary (photo 3). The highwall will have to be backfilled or cut and filled to 3h:1v. Backfilling will require material being trucked in and pushed up against the highwall. To cut and fill the slope requires the upper part of the highwall being pushed into the pit area. This creates additional disturbance between the highwall and the permit boundary. The disturbance created above the highwall needs to be within the confines of the permit boundary. The Division recommends that the pit be closed and reclaimed, or submit an amendment application to expand the permit boundary of the pit.

Photo 3 – NW permit boundary marker and top of highwall on left, photo facing west

A topsoil pile was located on the south side of the pit area and was well vegetated. All topsoil above the highwall needs to be salvaged before cut and fill operations.

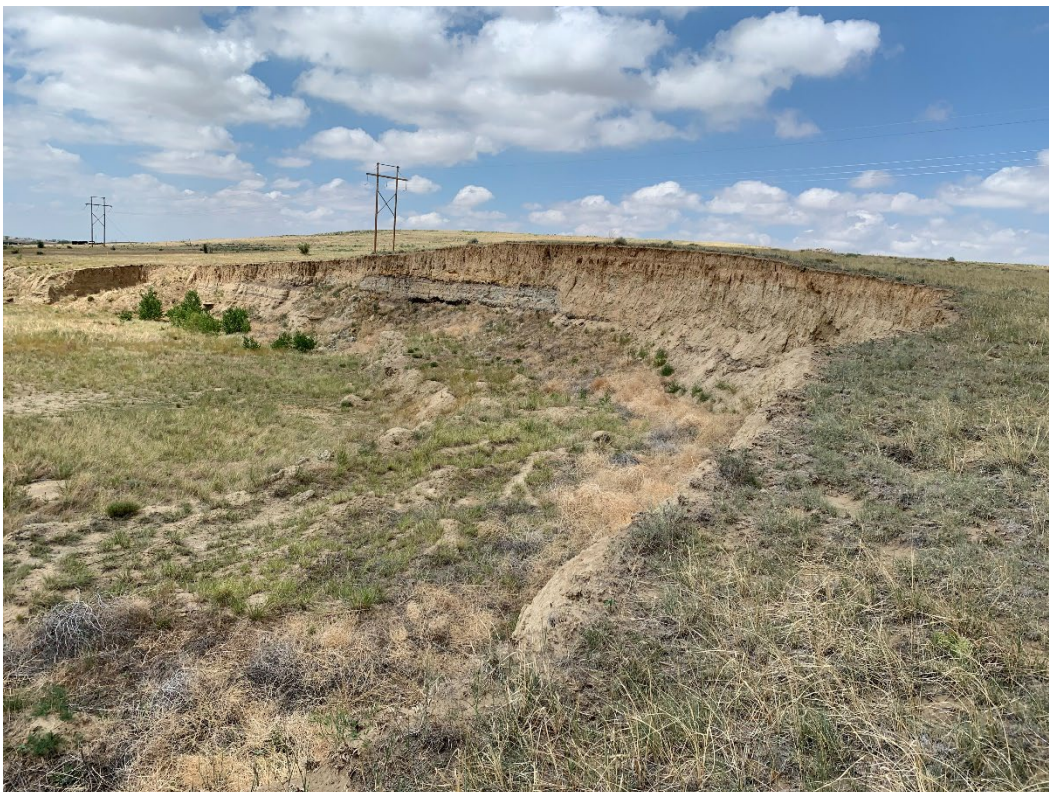
The pit floor area has not been seeded or reclaimed but was well vegetated. No standing water was noted and no noxious weeds were noted.

Photo 4 – Pit area, photo facing southwest
