## Documents in response to the PAR for Fountain Pit

RE: Responses to Preliminary Adequacy Letter on TR3 for Fountain Pit  
Permit M-1982-155

# **Report on the Ecological Condition of 44 Acres of Revegetated Land at the Fountain Pit, permit M-1982-155**

**by Mark A. Heifner, ecologist**

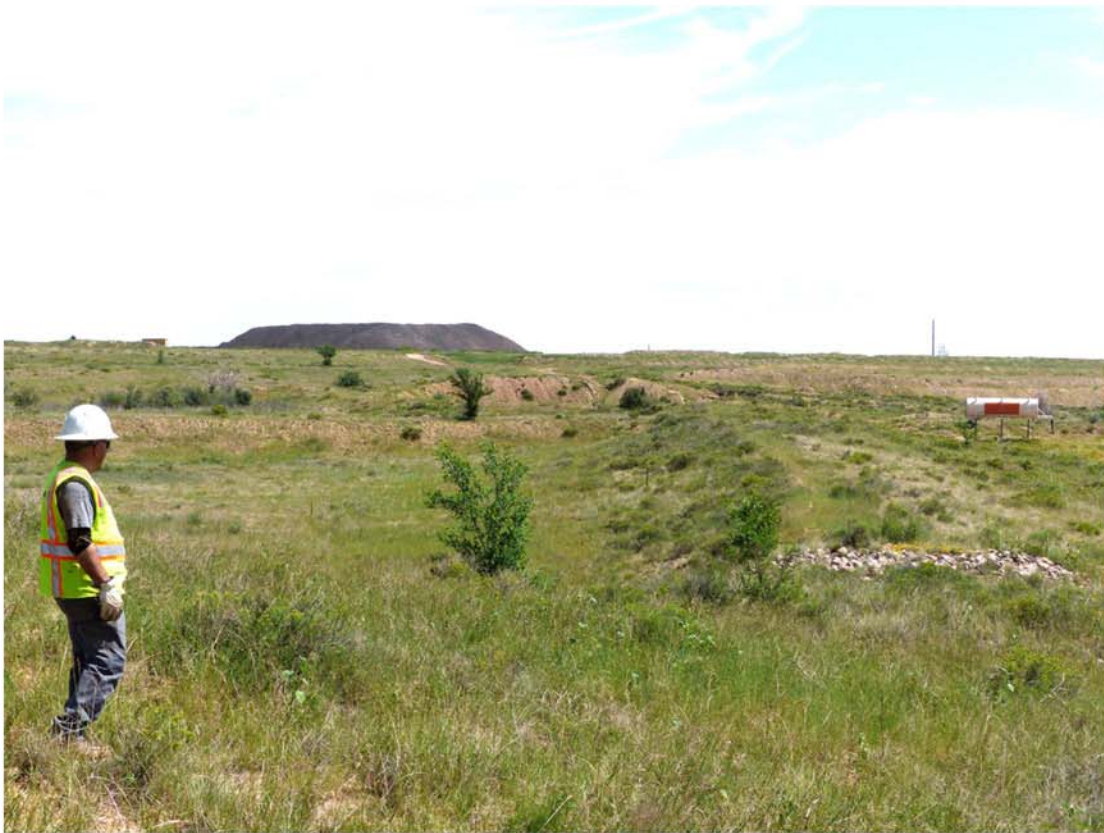
Outer edge of the sediment basins. Essentially a very sturdy dam. Actual sediment basins are on the left. Bare slope in background is on adjacent land and is not part of this area of examination.

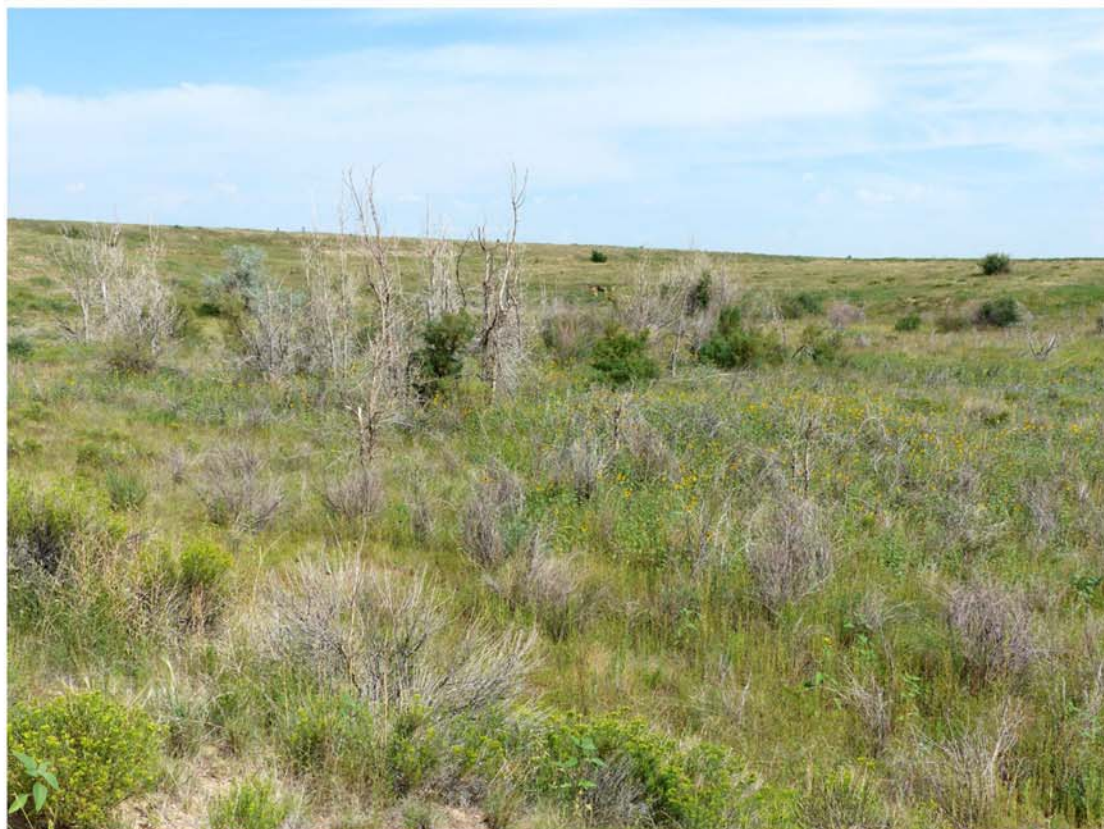
As for the *Tamarix* these, like the willows, are in the process of dying. However, this species is a master at finding water where there is little and persisting for a long time. Checking the ground around the healthier plants showed not a single young plant even though it appears the healthier ones are flowering and seeding. This lack of reproduction will be explained when it comes to discussing the soils in the sediment ponds.

The lack of reproduction of *Tamarix* is most certainly due to the generally dry surface soils. It appears that all the *Tamarix* are old plants and most have dead tops and some with live branches only around the base. This is clear evidence that even the deep water in the dense soils is now scarce. *Tamarix* has a very high water requirement and without frequent replenishment of soil moisture they decline rapidly.

Interior of the east (primary) sediment basin that is now dry. Note the dead trees and shrubs caused by the drying out of the sediment in the basin. A wide variety of grasses and wildflowers have invaded. The slightly blurry trees are *Tamarix* that need to be eradicated.

- 6) The *Tamarix* infestation of the settling ponds unfortunately must be eradicated.
- 7) There are a number of small erosion damages at the toe of some slopes where water collects into stronger and erosive streams. These need to be repaired gently so to not damage the excellent vegetation surrounding these places. Use rubber wheeled equipment operated only when the soil is dry and weigh the appropriateness of using small equipment and taking more trips with using larger equipment and taking fewer trips. Never use tracked equipment or it will do more damage than the erosion has done.

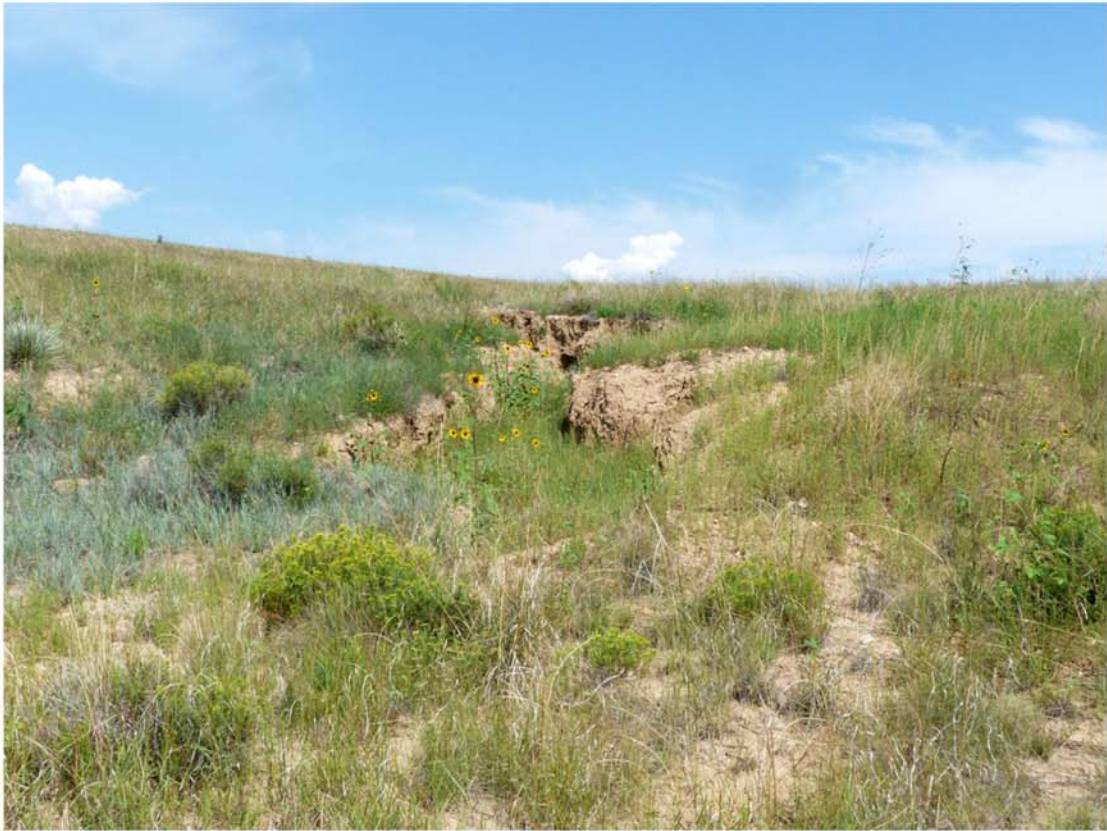
There are a few other similar gullies at the bottom of the long north slope that leads down to the primary sediment basin. Most of the erosion is quite old but deep enough that it will take a considerable amount of time for natural stabilization to occur. These were undoubtedly quite active before the rich vegetation developed on the slopes. As these slopes are primarily composed of overburden which is a gray colored, blocky and firm silty-sandy clay loam, it is apparent that on unprotected slopes this material is quite erodible. That shows that in the use of this material to create final slopes around the gravel pit, protection from severe erosion should be used or the 3:1 slopes are likely to present a considerable maintenance issue until the vegetation is established. It is also clear that any final slopes that are steeper than 3:1 would not have likely succeeded in revegetation without a lot of very good luck. Cooley Gravel's original proposed slopes of 2:1 around the pit would have rarely worked when using this overburden.

Minor gully erosion on lower part of slope leading up hill from sediment basins. Nearly stabilized. Needs some repair.

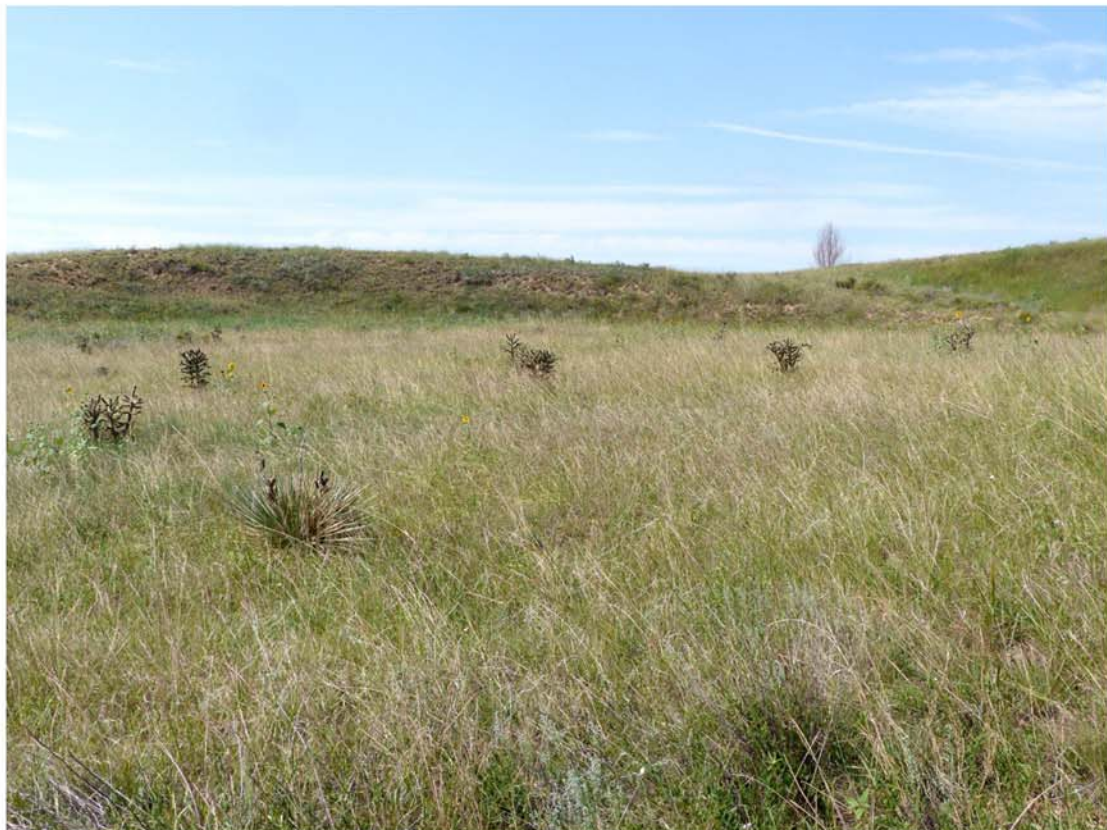
View of vegetation on the north side of the top of the mound of soil/overburden. Most of the grasses are needle grasses and blue grama. Cholla and yucca have also invaded. All vegetation is natural established by invasion.

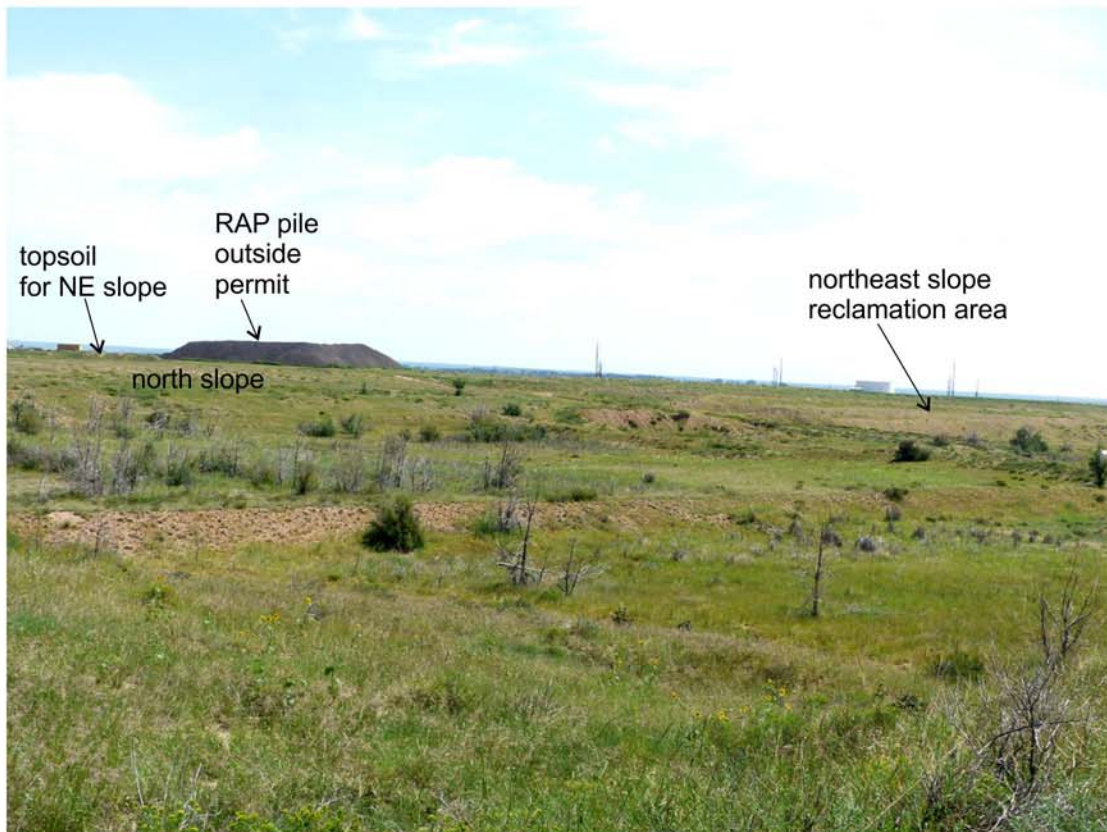
Sediment basins from above showing divider between the two. Most of the trees are *Tamarix*, but no signs of reproduction were seen. All the vegetation is a result of invasion and not planting or seeding. Most species are native.

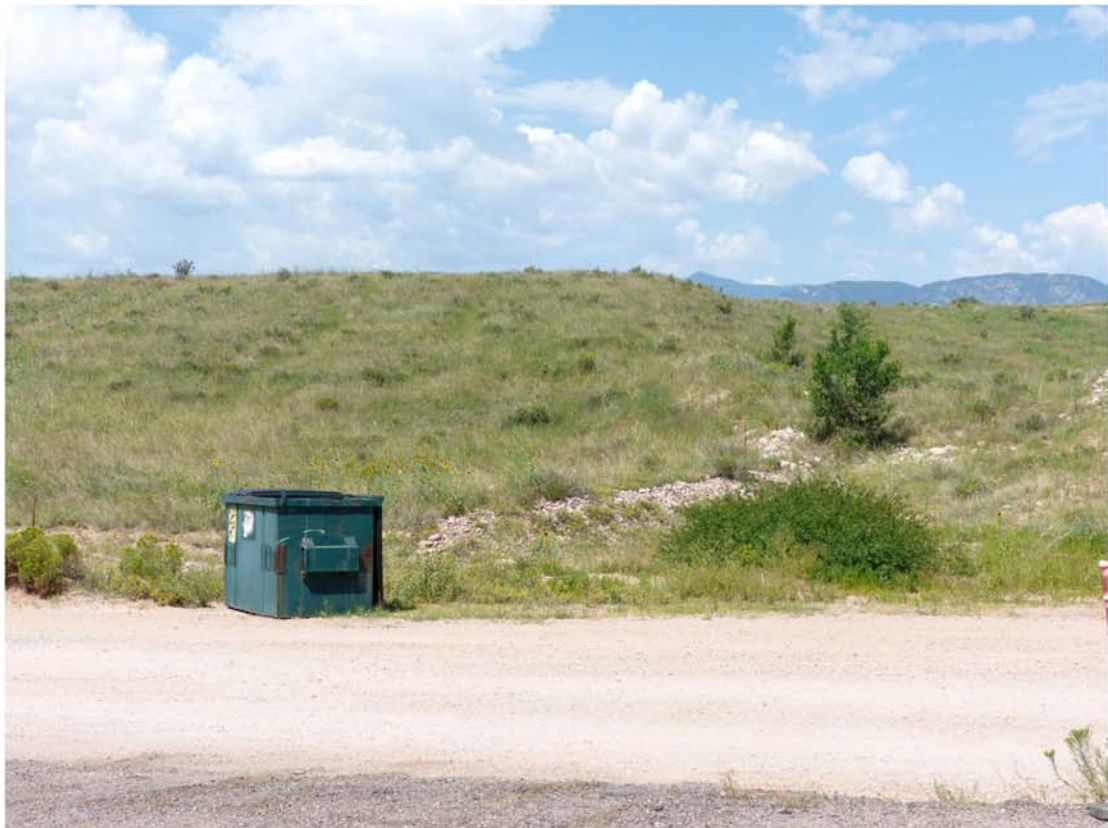
From the scale looking northwest at the south facing slope of the now vegetated soil/overburden stockpile established in the 1980's. Virtually all the vegetation is composed of native plants that invaded this area from surrounding natural land.
