## **OBSERVATIONS**

This was a monitoring inspection of the White Wolf Construction Borrow Pit, Division of Reclamation, Mining and Safety (DRMS or Division) permit number M-2018-029, operated by White Wolf Construction & Landscaping, LLC. I, Connor Drinkard and Jared Ebert with DRMS conducted the inspection. Mr. Bernard (Joe) Montoya with White Wolf Construction & Landscaping, LLC accompanied us during the inspection. Mr. Montoya has indicated he is no longer selling material from the site and is instead transporting it to another location within his property. Mr. Montoya plans to begin reclamation of the site soon. It is expected that the operation will be complete and the excavation will be graded in accordance with the reclamation plan by the end of the year.

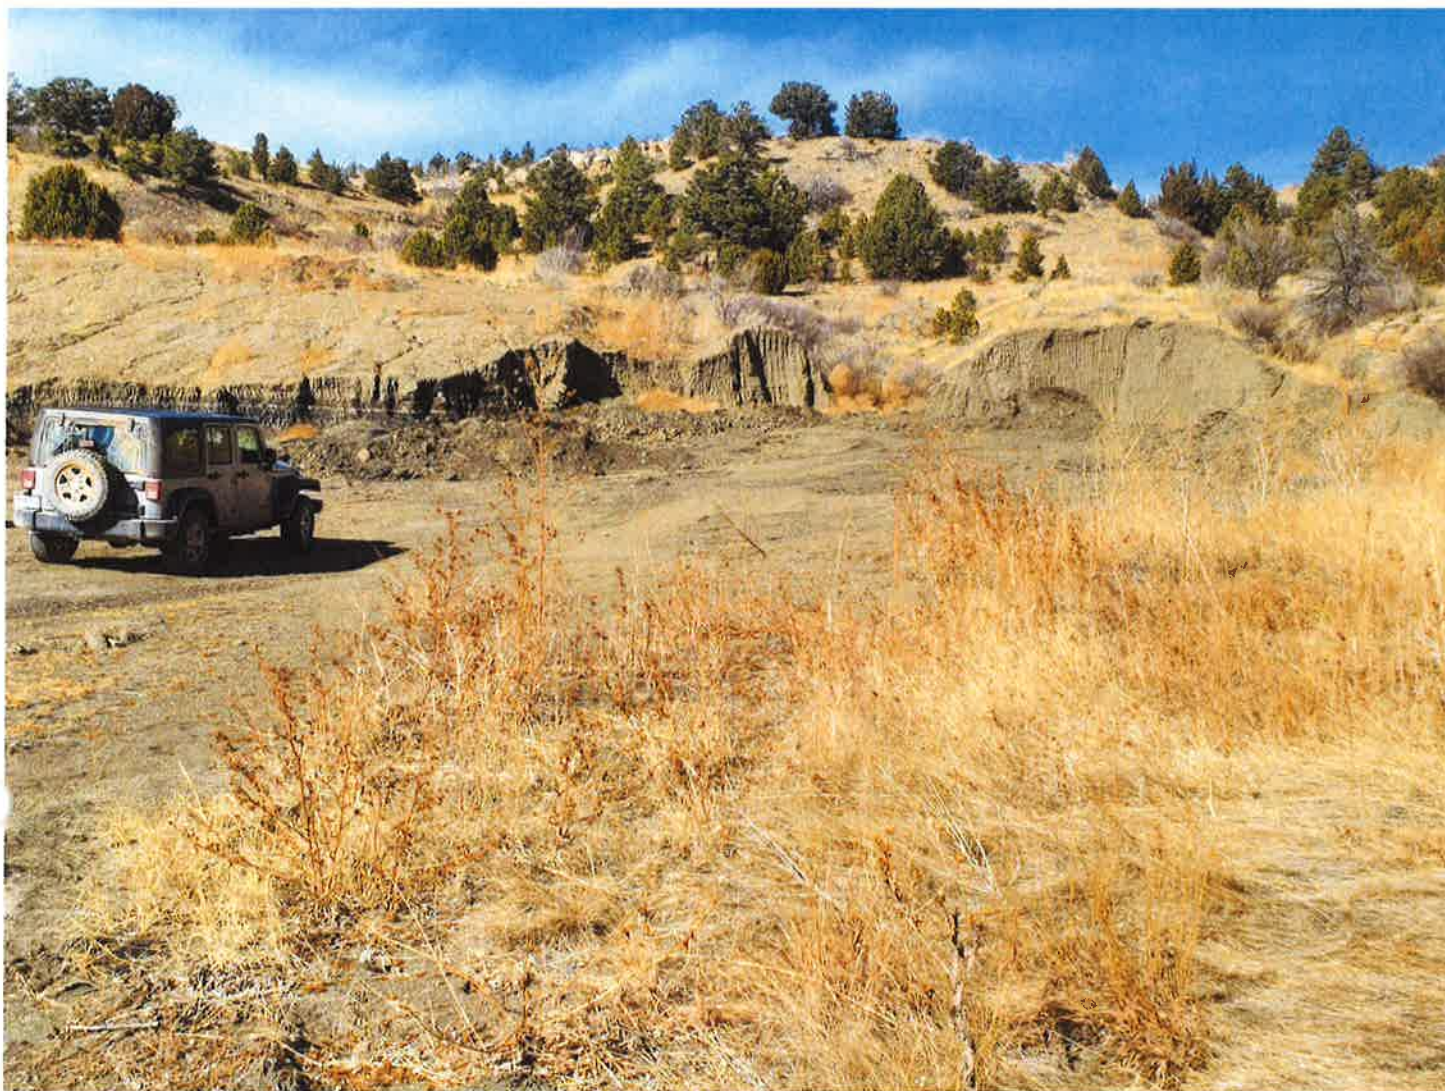
**Figure 1. Affected area looking north from the access road.**

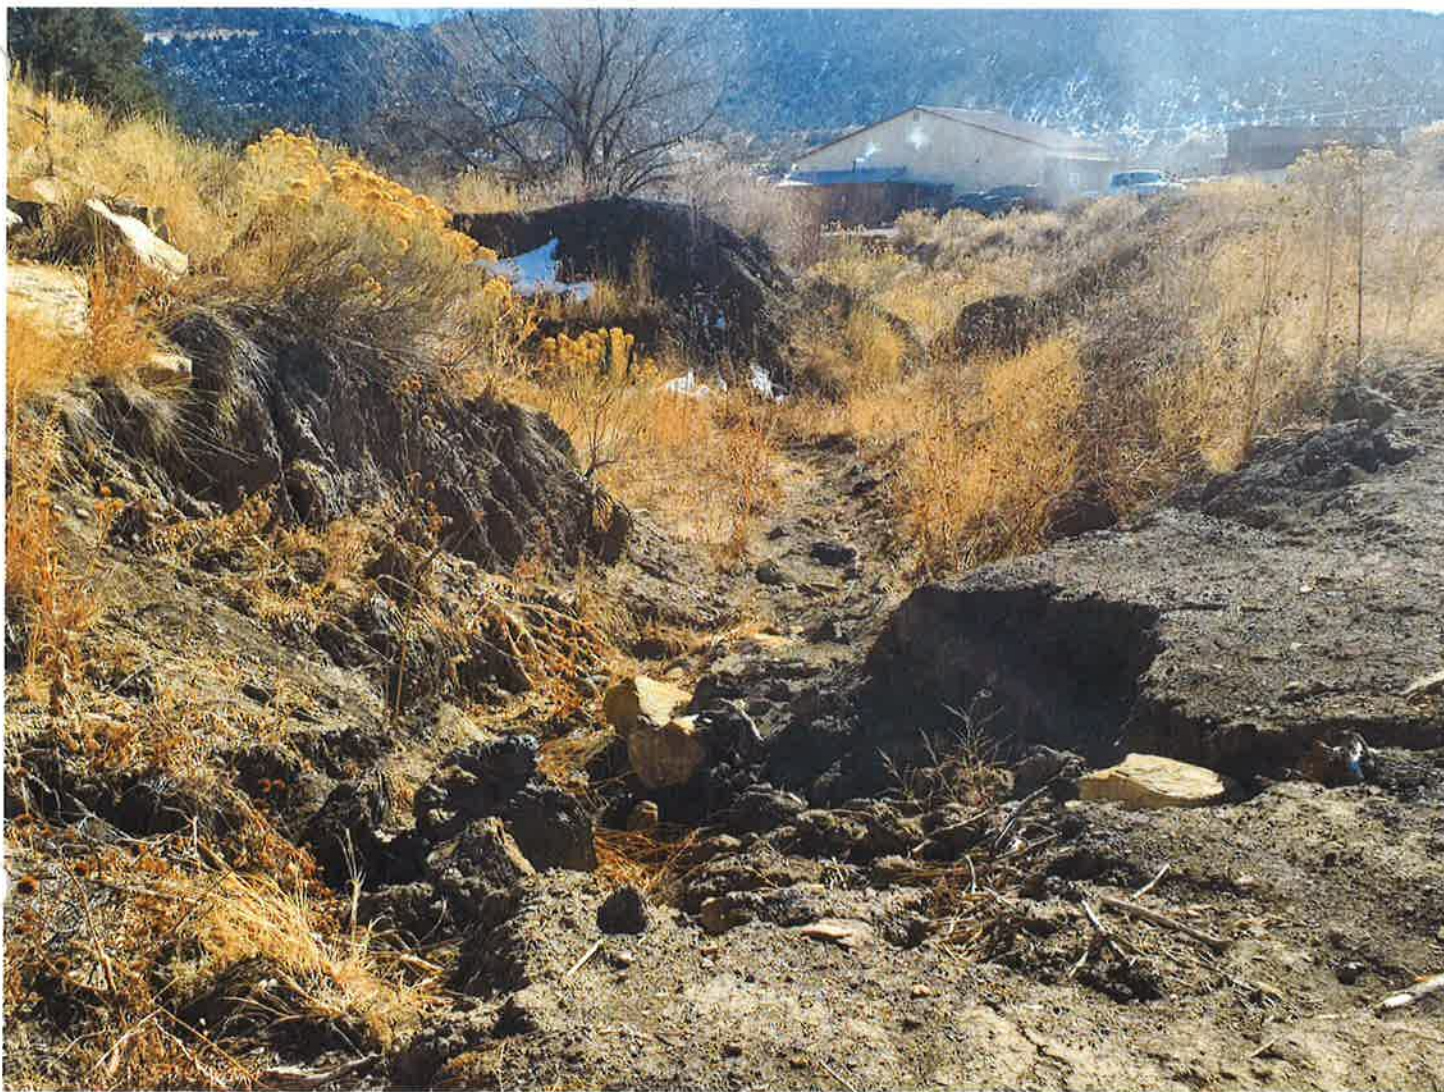
**Figure 2. Where the affected area drains to (looking southeast of the permit area).**

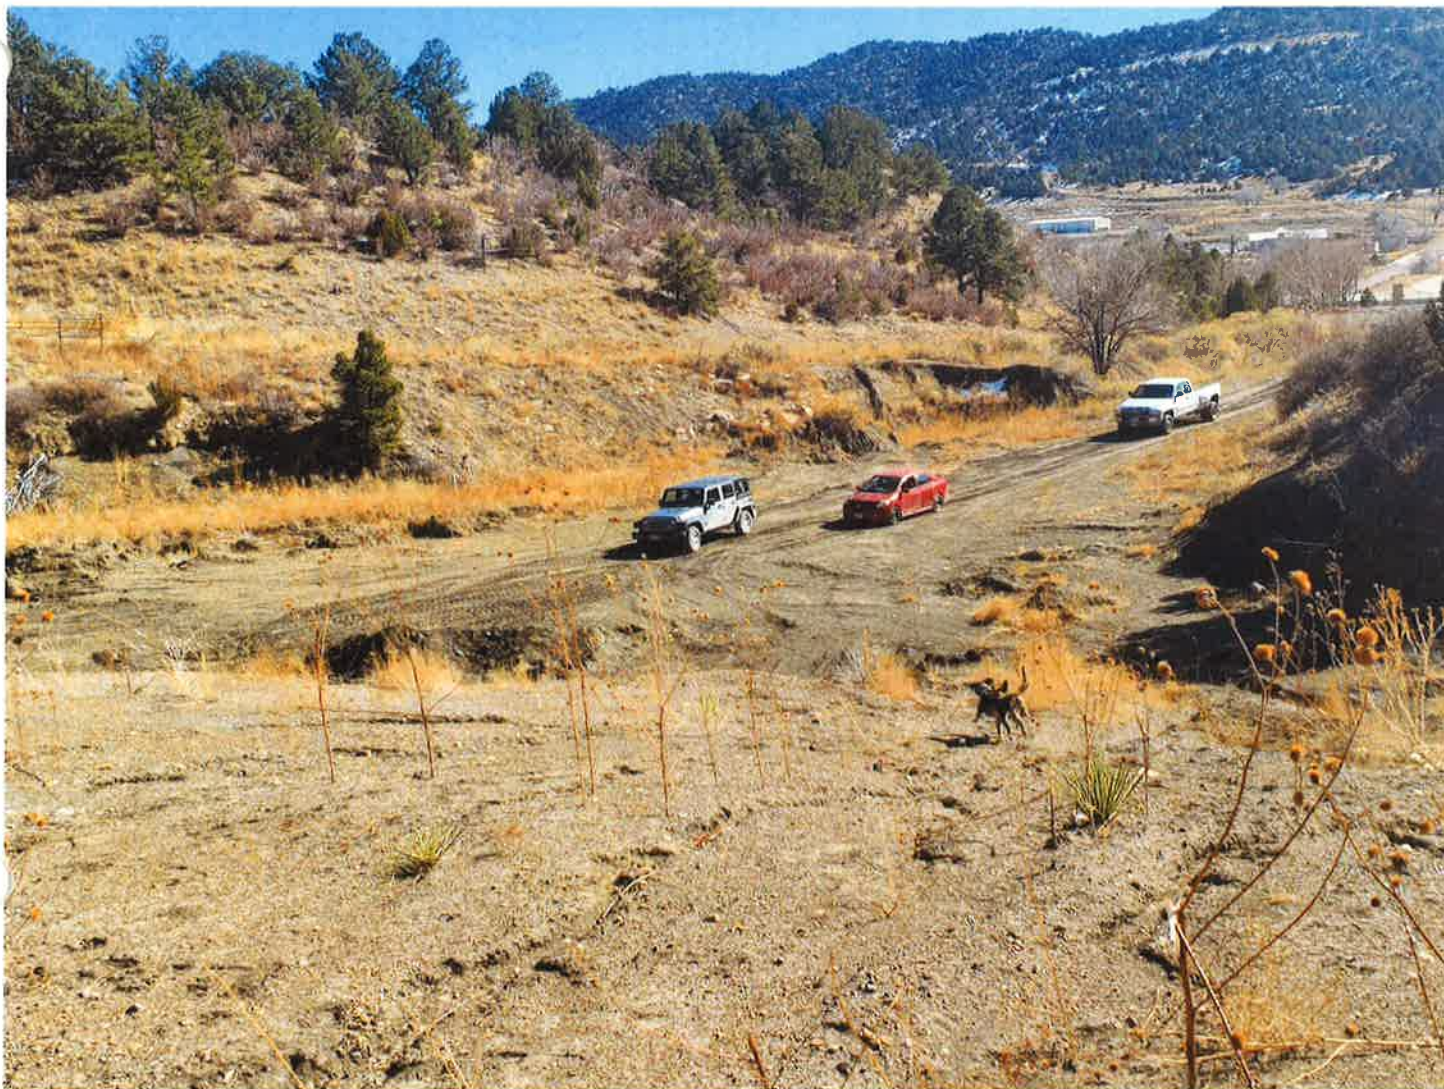
**Figure 3. Permit area looking southeast.**

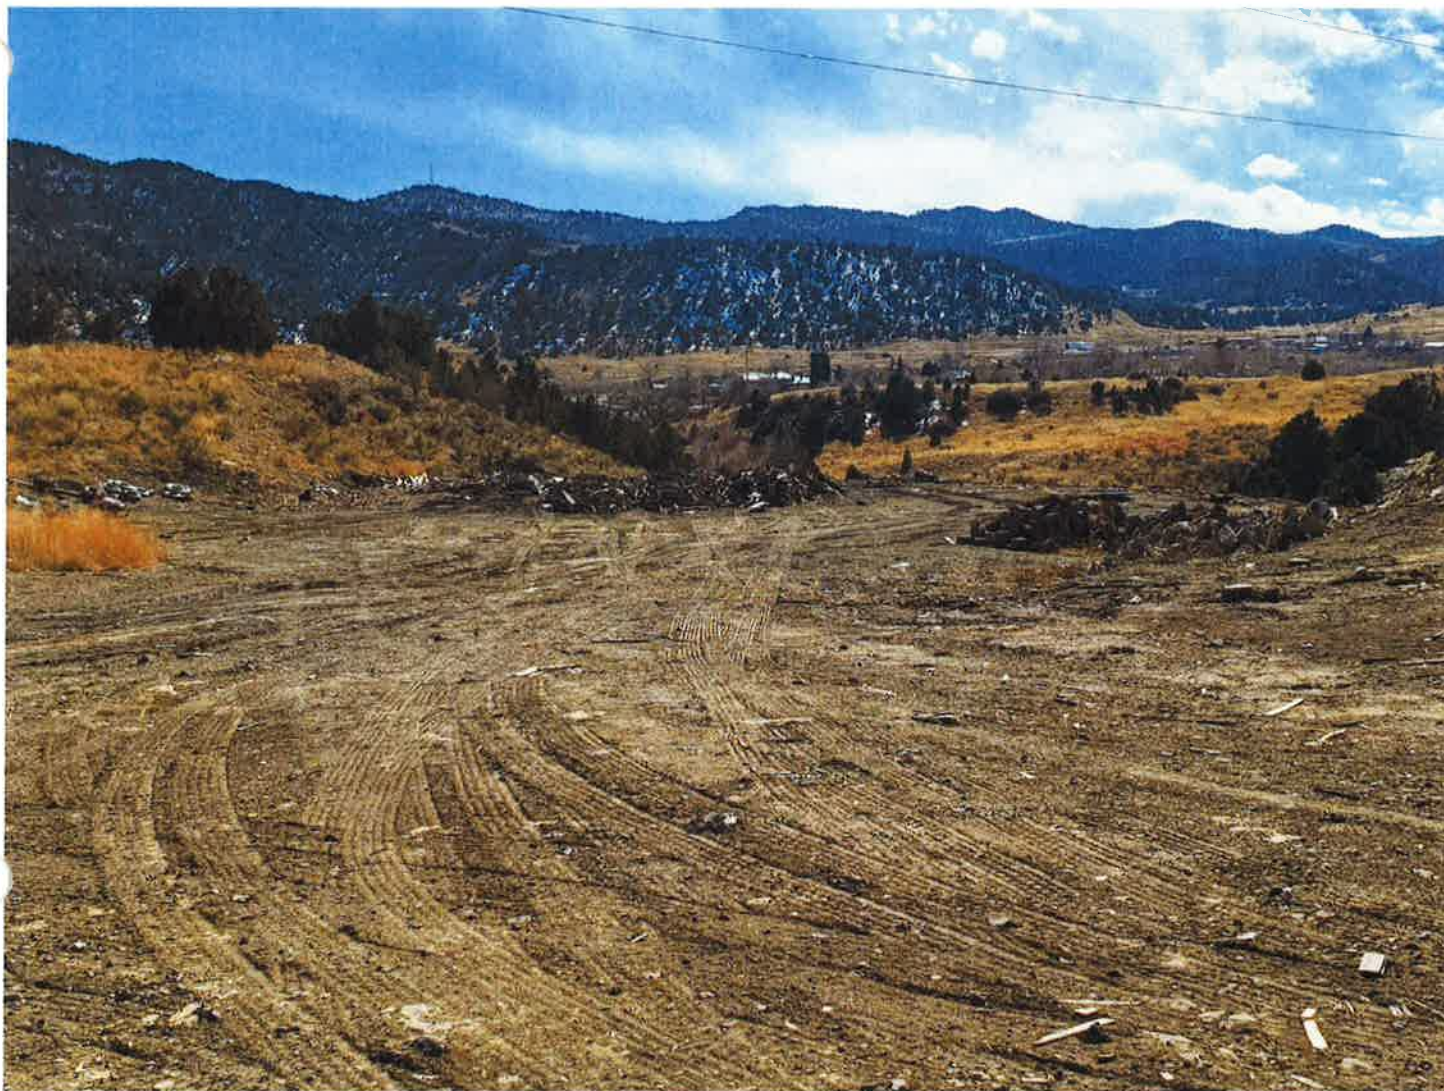
**Figure 4. Where Mr. Montoya indicated the material is being taken to (within his property about .25 miles west of the permit area). Looking south.**
