MINERALS PROGRAM INSPECTION REPORT
PHONE: (303) 866-3567

MINE NAME: Mesa Gravel Pit	MINE/PROSPECTING ID#: M-1982-036	MINERAL: Sand and gravel	COUNTY: Routt
INSPECTION TYPE: Surety-Related Inspection	INSPECTOR(S): Tabetha Lynch	INSP. DATE: August 17, 2022	INSP. TIME: 12:00
OPERATOR: Peabody Sage Creek Mining, LLC	OPERATOR REPRESENTATIVE: Miranda Kawcak	TYPE OF OPERATION: 112c - Construction Regular Operation	
REASON FOR INSPECTION: Surety Related	BOND CALCULATION TYPE: None	BOND AMOUNT: \$132,273.00	
DATE OF COMPLAINT: NA	POST INSP. CONTACTS: None	JOINT INSP. AGENCY: None	
WEATHER: Clear	INSPECTOR'S SIGNATURE:

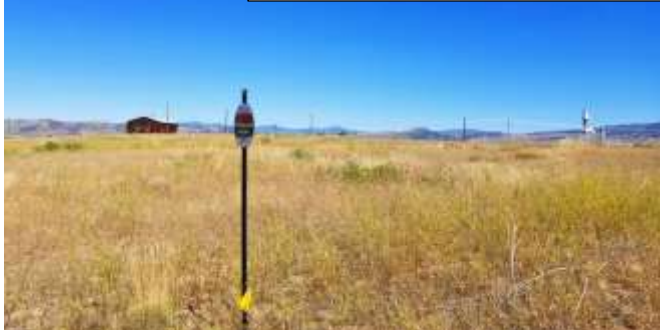
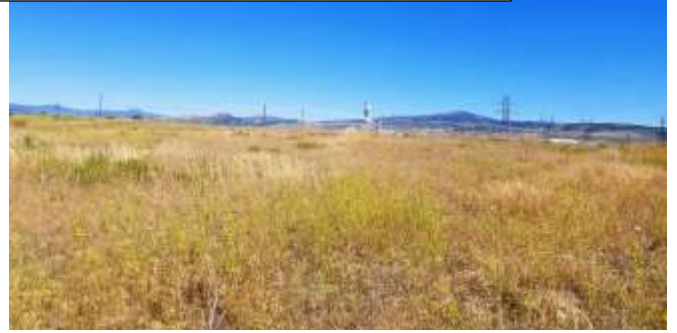
NW corner proposed to be removed, looking north from pipeline marker.

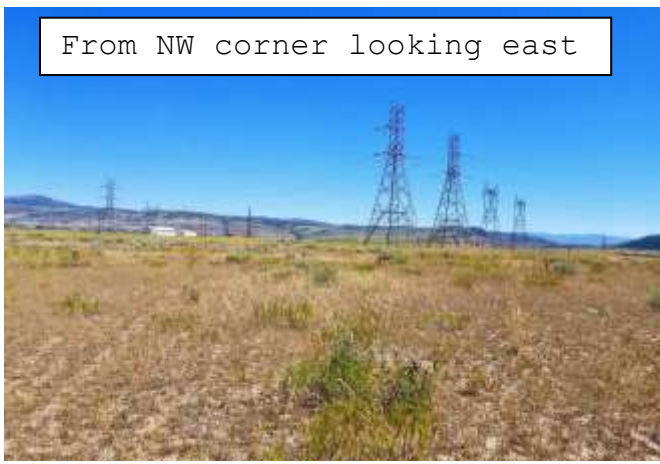
From NW corner looking east

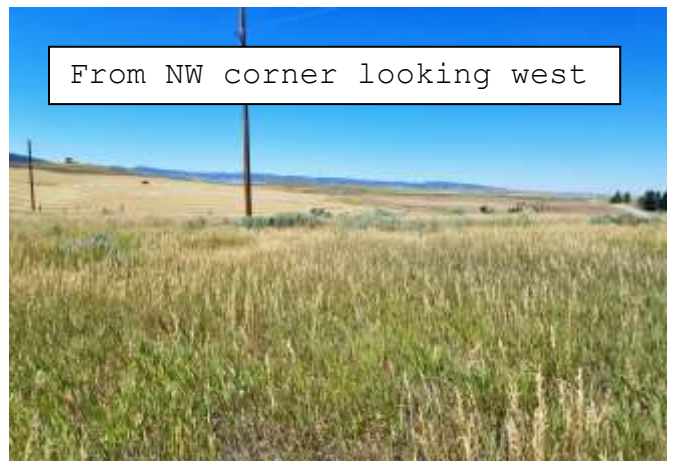
From NW corner looking west

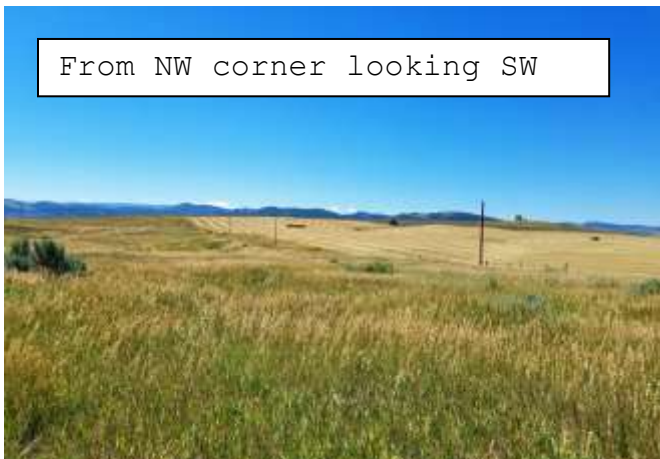
From NW corner looking SW

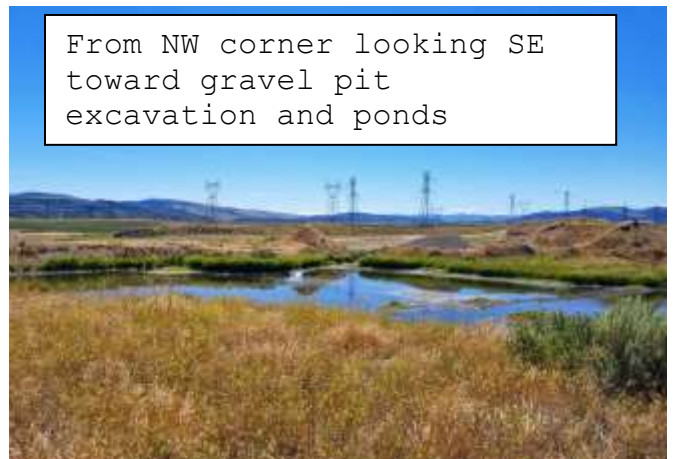
From NW corner looking SE toward gravel pit excavation and ponds
