MINERALS PROGRAM INSPECTION REPORT
PHONE: (303) 866-3567

MINE NAME: Springdale 589 Claim	MINE/PROSPECTING ID#: M-2022-033	MINERAL: NA	COUNTY: Gilpin
INSPECTION TYPE: Illegal(Unpermitted Operation)	INSPECTOR(S): Brock Bowles	INSP. DATE: August 30, 2022	INSP. TIME: 09:00
OPERATOR: NA	OPERATOR REPRESENTATIVE: Keith Mumma	TYPE OF OPERATION: IM - Is it Mining	
REASON FOR INSPECTION: Citizen Complaint	BOND CALCULATION TYPE: None	BOND AMOUNT: No Bond Held	
DATE OF COMPLAINT: NA	POST INSP. CONTACTS: None	JOINT INSP. AGENCY: None	
WEATHER: Clear	INSPECTOR'S SIGNATURE:

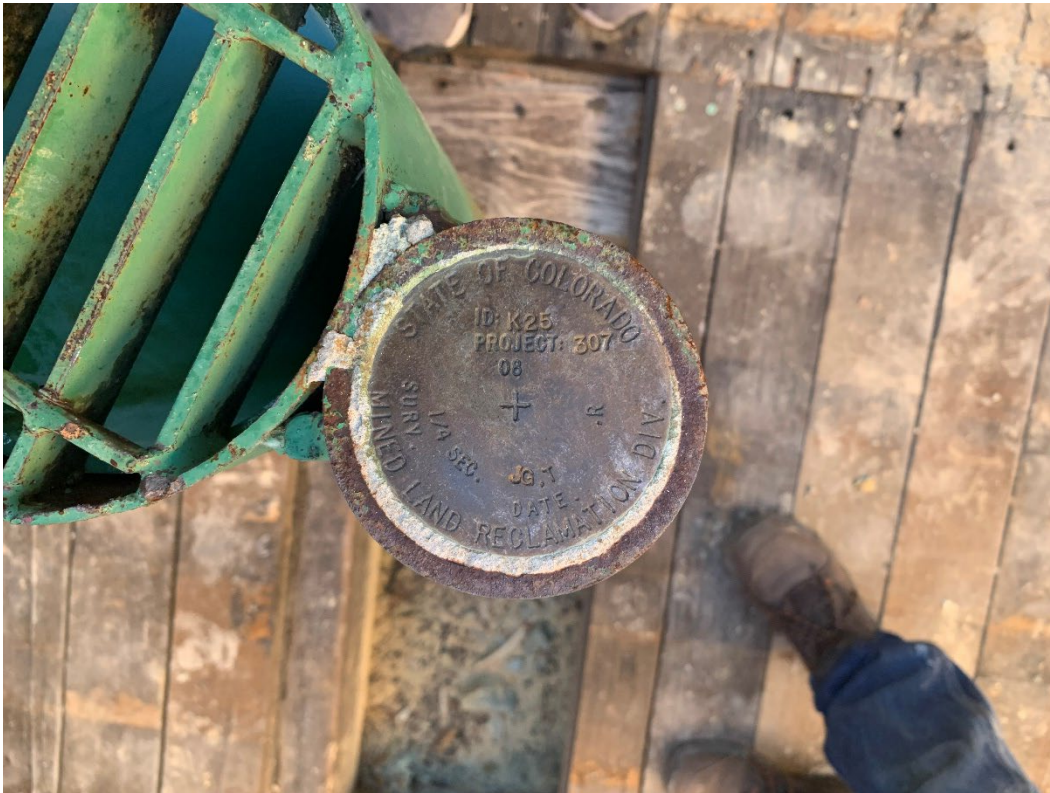
Mr. Mumma explained that on the backside of his claim/property there is an old mine shaft that was sealed off and closed by DRMS. The old shaft is marked by a steel pipe with a brass cap (photo 1) and the steel pipe had been broken off by trespassers. Mr. Mumma constructed/improved a road (photo 4) to the old shaft and claims he moved some of the tailings from around the broken pipe to accommodate repairing the pipe (photo 2). Once the pipe was repaired, Mr. Mumma started constructing a shed around the pipe to protect the pipe from further damage (photo 3).

Photo 1 – Brass cap on shaft marker

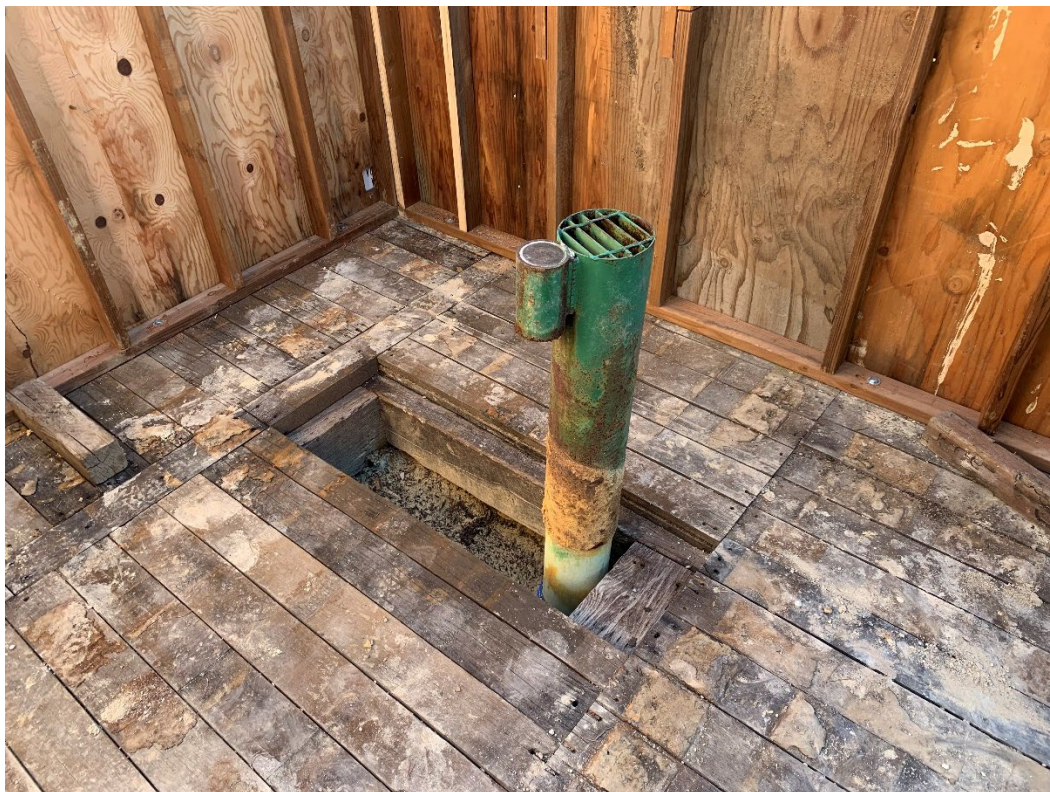
Photo 2 – Pipe identifying and venting the sealed mine shaft.

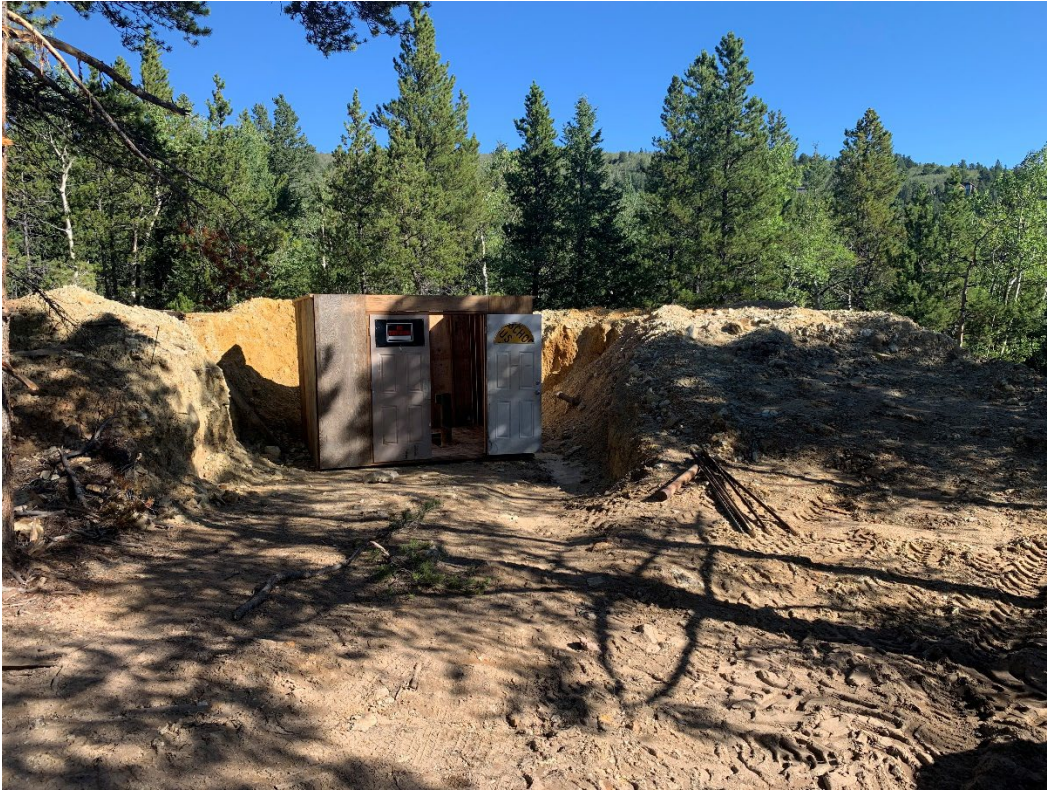
Photo 3 – Shed constructed around the identification/ventilation pipe, facing north.

Please use caution when working around any closed/sealed mine shaft. According to DRMS records, the shaft K-25-Project 307 mentioned in this report is 3'x5' and more than 100' deep. The extent of the mine workings, how close the underground workings are to the surface, and if the mine is connected to other mine workings in the area are all unknown. The shaft was sealed in 2002 with polyurethane foam. The closure method used for this shaft is nonstructural and is not designed to hold weight loads. Please use extreme caution when constructing structures or using heavy machinery in the vicinity of the shaft. Also, the green pipe is a ventilation pipe allowing for pressure equalization between the mine workings and the atmosphere. Please ensure there is plenty of ventilation in the shed to prevent gas accumulation or creating an oxygen deficient confined space.

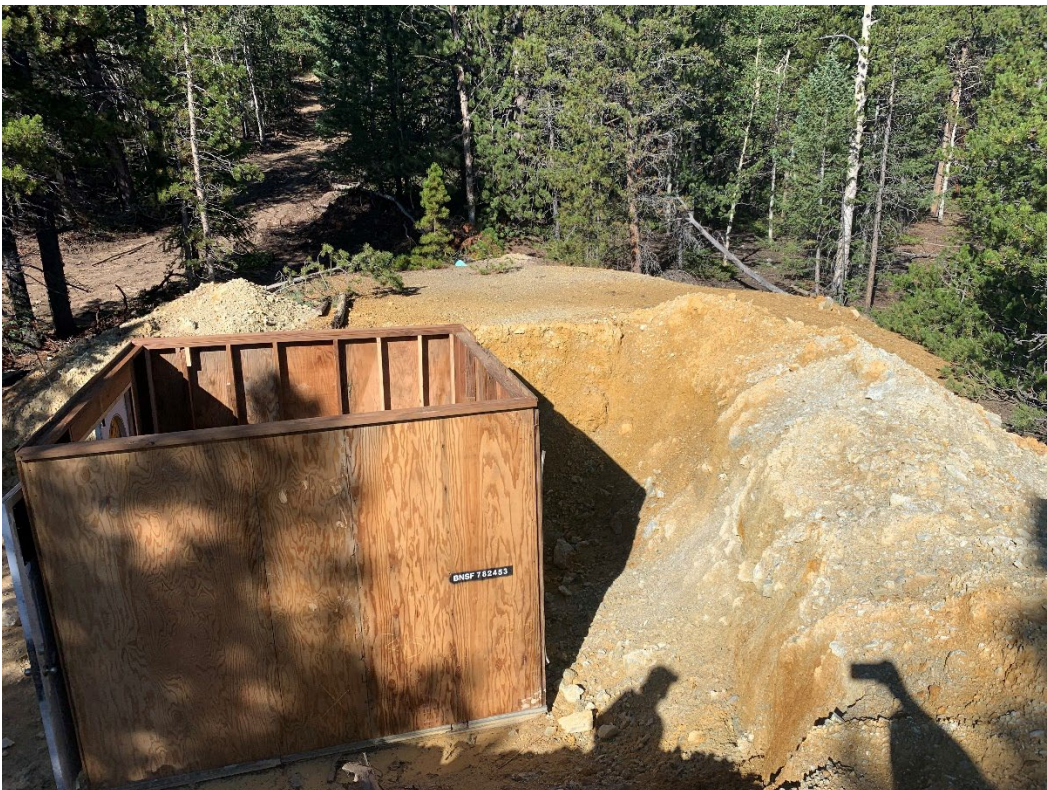
The site conditions observed during the inspection appear to be consistent with Mr. Mumma's story. No mining equipment was onsite, the shaft closure appeared to be undamaged and no other disturbance was noted in the area (photos 4-7). Some tailings were removed from the middle of the pile and placed on the south and east sides of the existing pile.

Photo 4 – Surrounding area, facing west, access road in upper left of photo

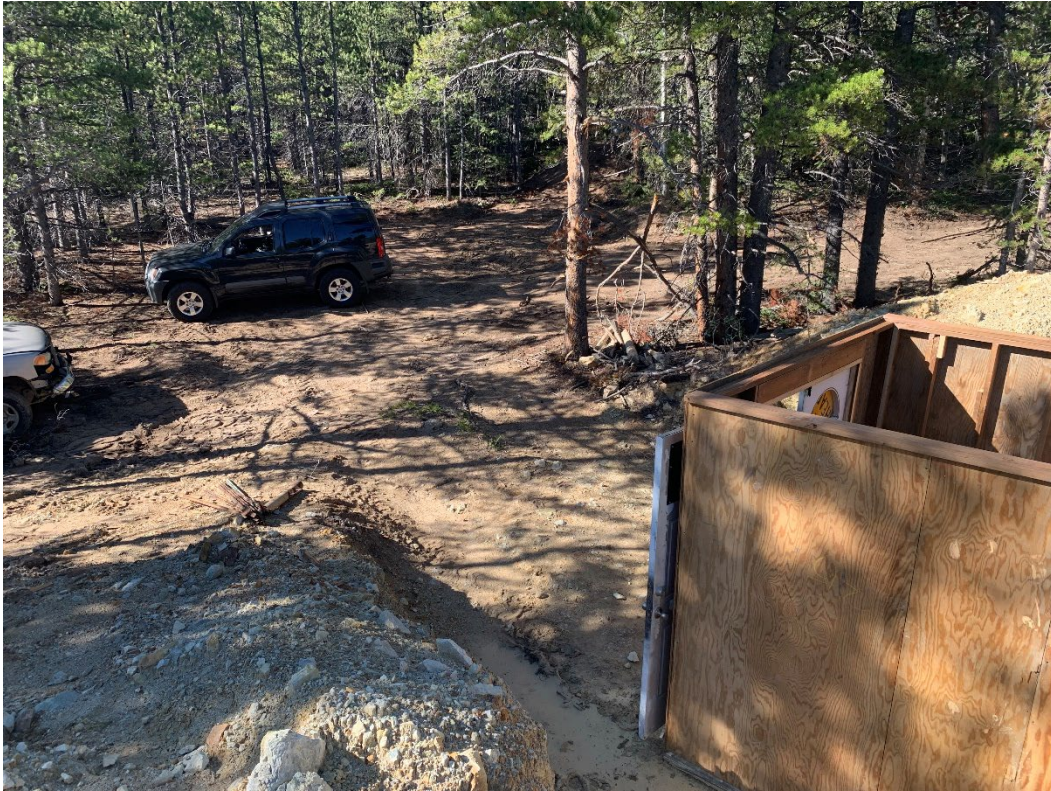
Photo 5 – Surrounding area, facing south

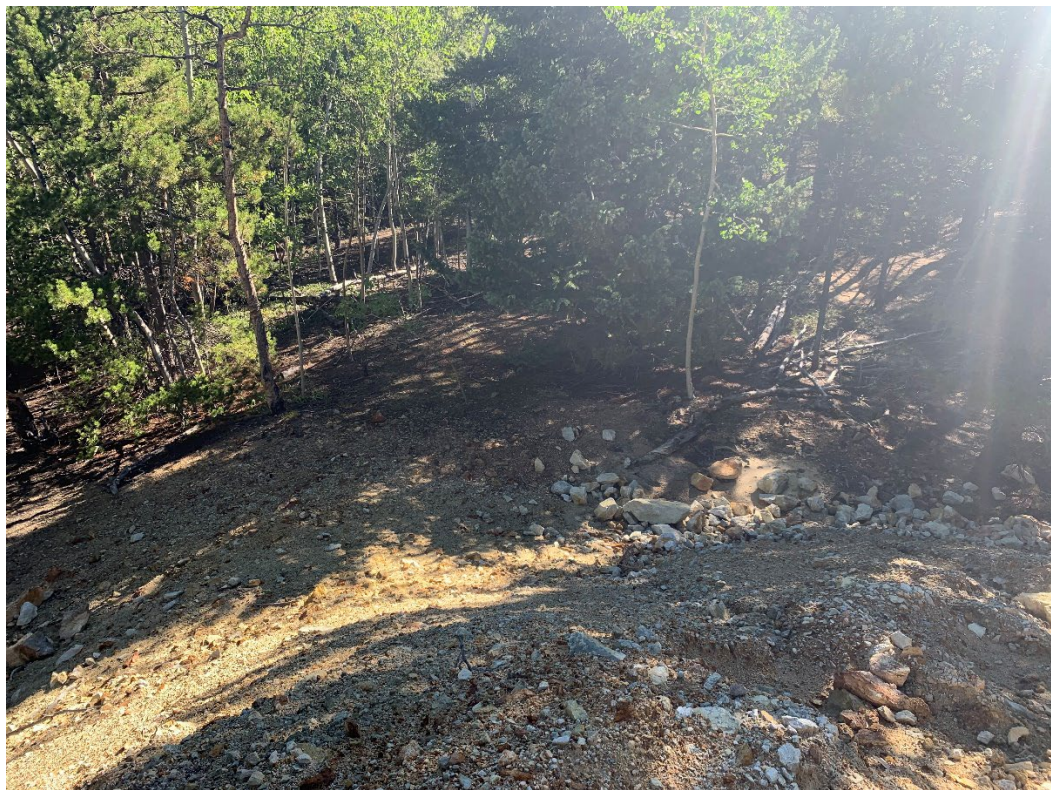
Photo 6 – Surrounding area, facing east

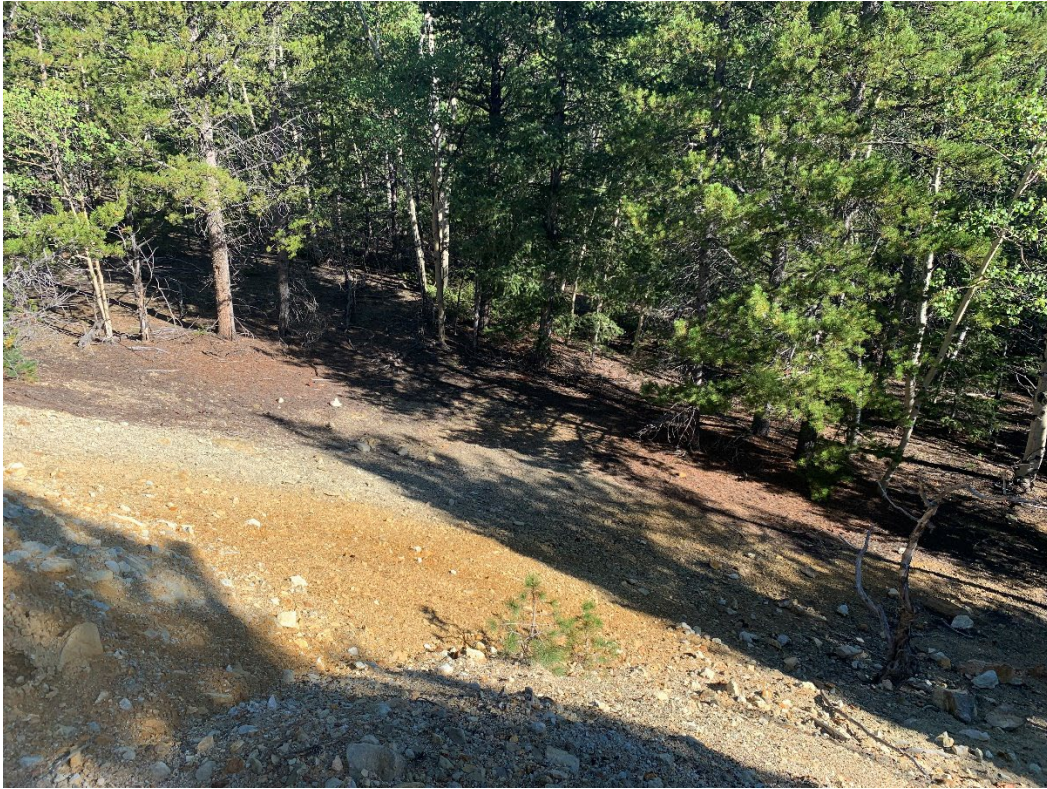
Photo 7 – Surrounding area, facing north
