MINERALS PROGRAM INSPECTION REPORT

MINE NAME: Buss Barrow Pit	MINE/PROSPECTING ID#: M-2019-021	MINERAL: Borrow material for construction	COUNTY: Fremont
INSPECTION TYPE: Surety Release Inspection	INSPECTOR(S): Timothy Cazier, P.E.	INSP. DATES: July 27, 2022 September 8, 2022	INSP. TIMES: 12:00 13:00
OPERATOR: Fremont Paving & Redi-Mix, Inc.	OPERATOR REPRESENTATIVE:	TYPE OF OPERATION: 111 - Construction by Government Agency

REASON FOR INSPECTION: Surety Release Requested	BOND CALCULATION TYPE: Partial Bond	BOND AMOUNT: \$8,376.00
DATE OF COMPLAINT: NA	POST INSP. CONTACTS: None	JOINT INSP. AGENCY: None
WEATHER: Clear	INSPECTOR'S SIGNATURE: 	SIGNATURE DATE: September 9, 2022

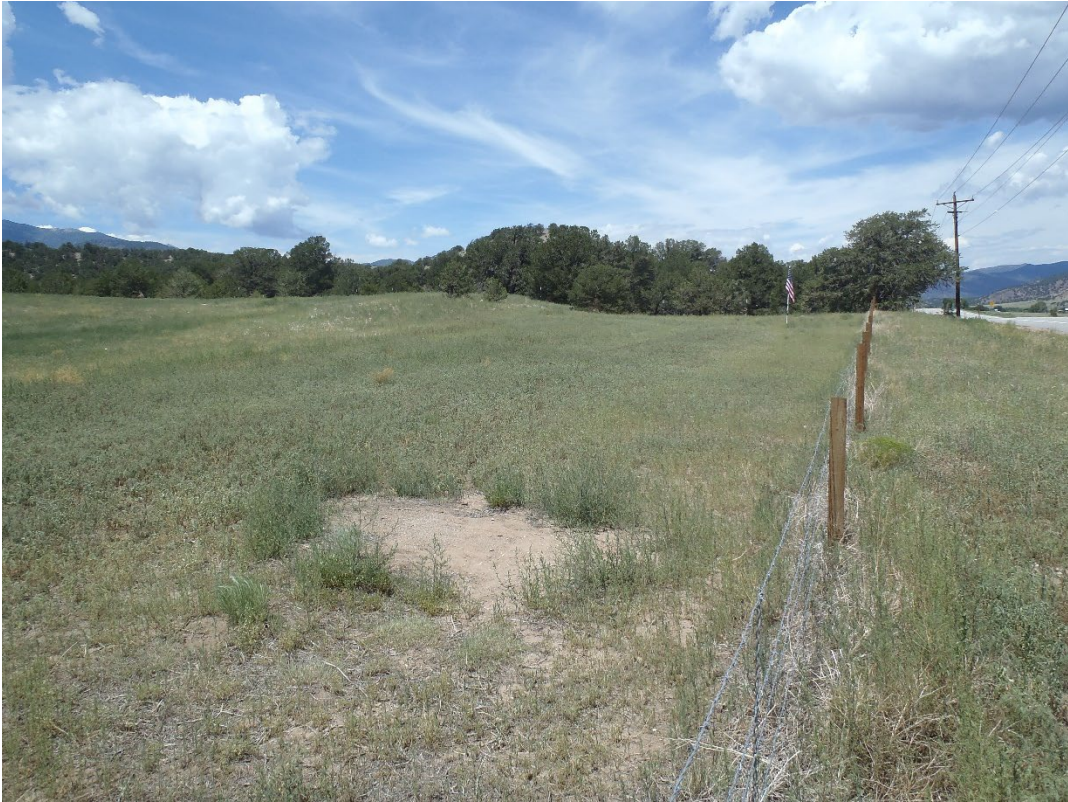
The release request (SL-1) was received by the DRMS the day before the July 27th inspection and this site was added to the inspection itinerary with short notice, allowing little preparation. Upon arrival on July 27th the site access off Hwy 50 had been replaced with a four-strand barbed wire fence (see **Photo 1**). The fence was not climbed due to safety concerns and the tension of the new wire was too high to manually spread far enough to climb through.

Photo 1. Four strand barbed wire fence at Hwy 50 former entrance and nearby kochia (7/27/22-looking NW).

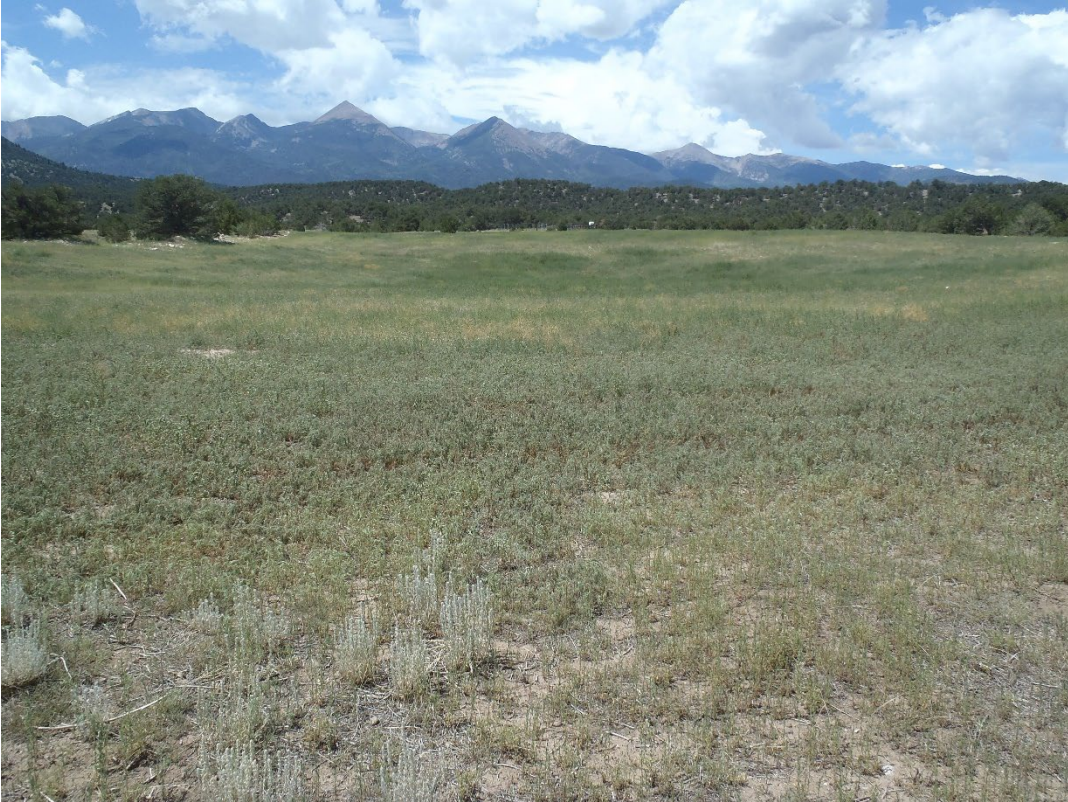
The site was observed to be well vegetated (see **Photo 2**). Kochia was observed near the fence, but what appeared to be grasses were thought to be covering most of the site. The DRMS received an objection to the release request from Darren Buss (landowner) on August 11th. The objection stated there were very few grasses growing and the area was very "thick with weeds". The objection letter included a photo of a large bare spot, along with photos of the weeds, and comparison photos. As a result of the objection letter, a follow-up inspection was scheduled for September 8th. Ms. Schreiber was able to coordinate access to the site from the landowner's property, eliminating the need to cross the aforementioned new barbed wire fence.

Photo 2. Graded pit floor and highwall (7/27/22-looking SW, apparent grasses in middle of photo).

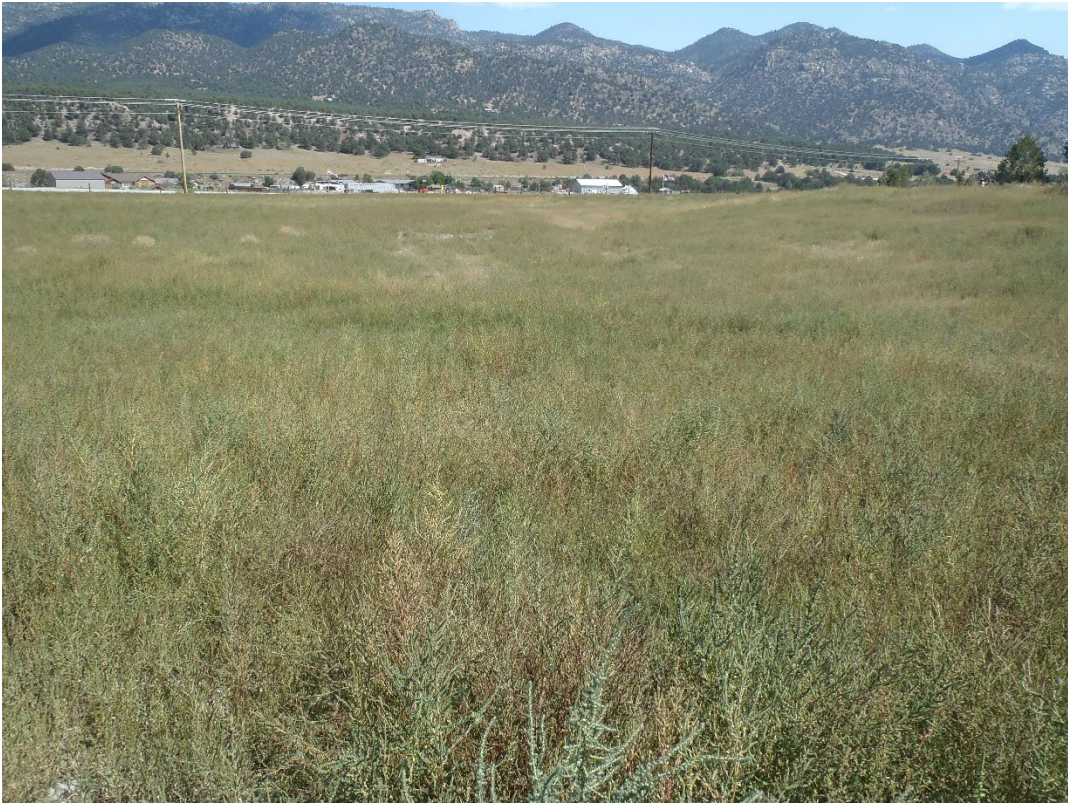
Observations during the September 8th inspection confirmed kochia as the dominant species (see **Photo 3**). A few dormant specimens of grass were found beneath the kochia (see **Photo 4**), but none appeared to be from this season's growth. Kochia is not considered a noxious weed in Colorado, so its presence is not cited as a problem in this report. However, as little to no grasses were found, the observed kochia essentially constitutes a monoculture and it is not commensurate with the approved post-mine land use for rangeland. The bare spot (see **Photo 5**) cited in the objection from Mr. Buss was estimated to be about 40 feet in diameter. It appeared to be on a slightly elevated portion of the reclamation area, where winds may have blown off the straw mulch. No other explanation for the bare spot was evident.

Photo 3. Kochia dominating revegetated area (9/8/22-looking NE at crest of regraded highwall, no grasses).

Summary: The DRMS cannot approve the release of a reclaimed area that consists of a vegetative monoculture (kochia), nor one where the cover is not consistent with the approved post-mine land use (rangeland in this case). The DRMS recommended consulting with the Fremont Conservation District on how to best replace the kochia with the desired grasses. Ms. Schreiber agreed to contact the FCD.

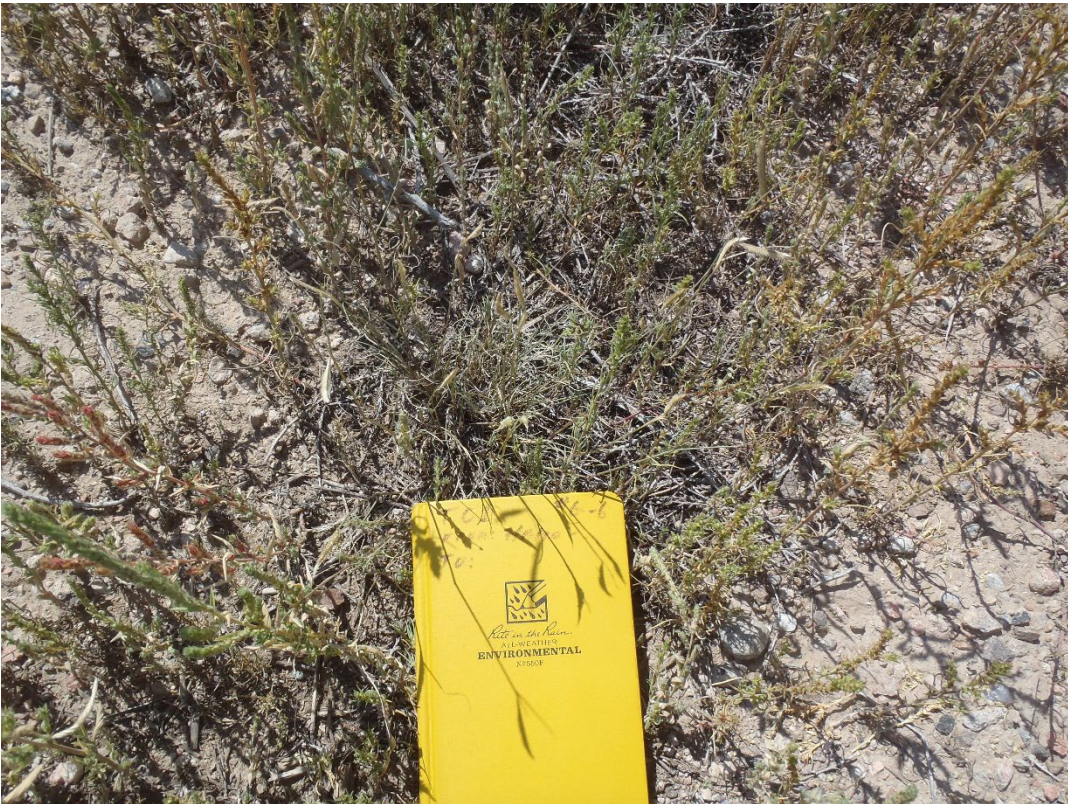
Photo 4. Occasional example of dormant grass below kochia (9/8/22-near bare spot in Photo 5).

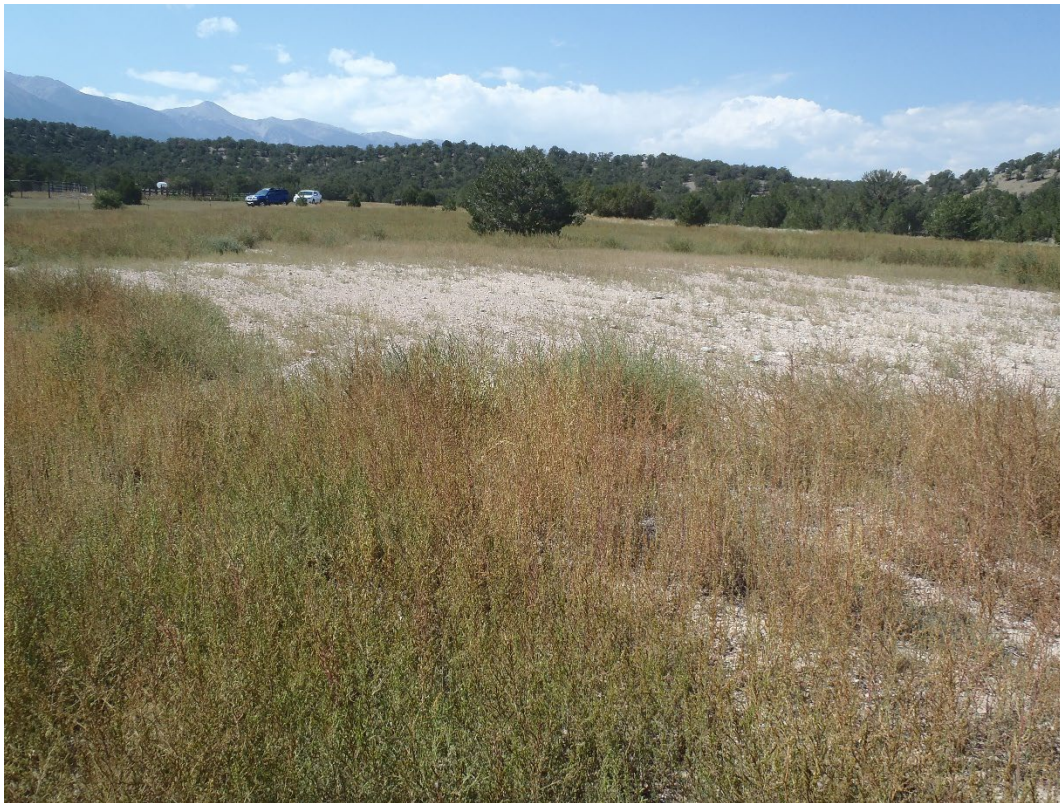
Photo 5. Bare spot above/SW of former highwall (9/8/22-looking SW, approximately 40 ft in diameter).
