## MINERALS PROGRAM INSPECTION REPORT

<b>MINE NAME:</b> Dreher Pit	<b>MINE/PROSPECTING ID#:</b> M-2012-051	<b>MINERAL:</b> Sand and gravel	<b>COUNTY:</b> Yuma
<b>INSPECTION TYPE:</b> Monitoring	<b>INSPECTOR(S):</b> Nikie Gagnon	<b>INSP. DATE:</b> August 11, 2022	<b>INSP. TIME:</b> 09:30
<b>OPERATOR:</b> Yuma County	<b>OPERATOR REPRESENTATIVE:</b> Tom Andersen	<b>TYPE OF OPERATION:</b> 112c - Construction Regular Operation

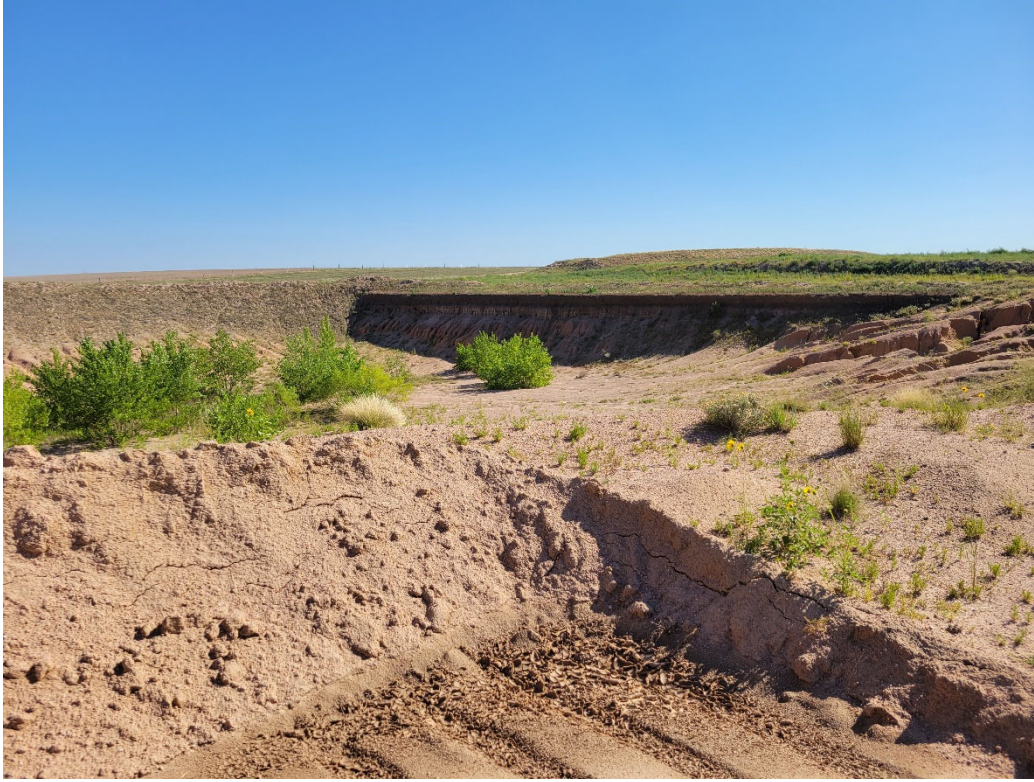
Looking north into the Stage 3 active mining area.

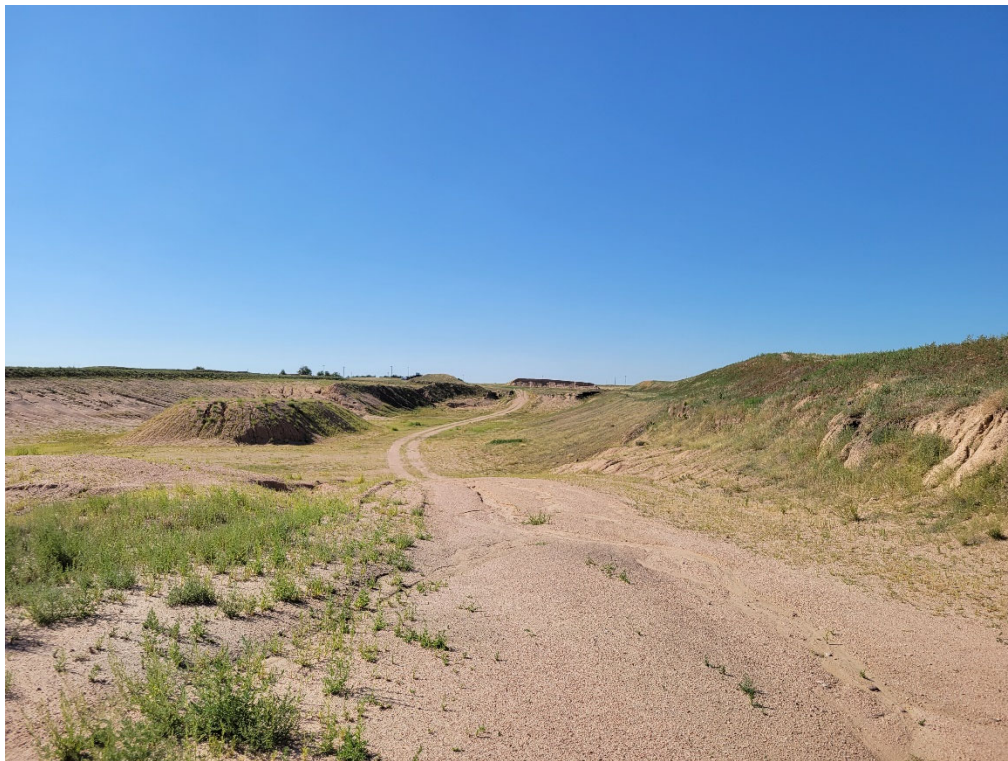
Looking south at the Stage 2 active mining area.

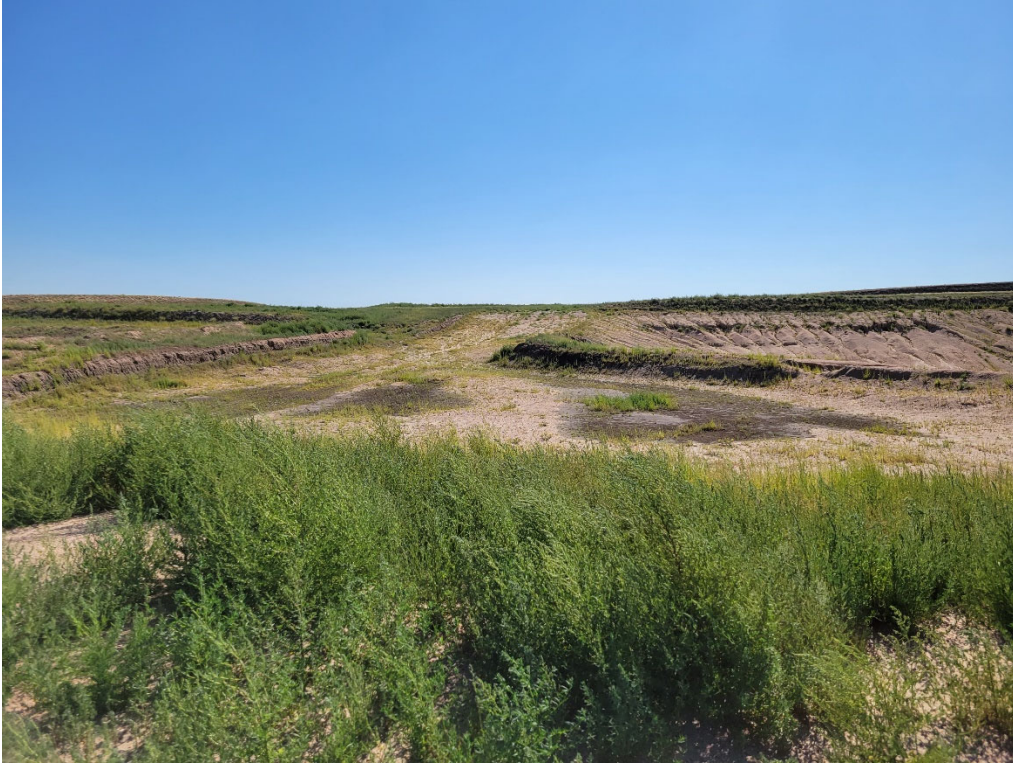
Hydrologic Balance: The pits were dry during this inspection, however Mr. Andersen indicated the County recently pumped stormwater out after a heavy rainstorm that left water in the pits. Some additional care may be needed to prevent excessive runoff from precipitation events from accumulating in the pit.

Looking east into the active mining area from the access road.  
Stormwater flows into the pit here and infiltrates into the ground.

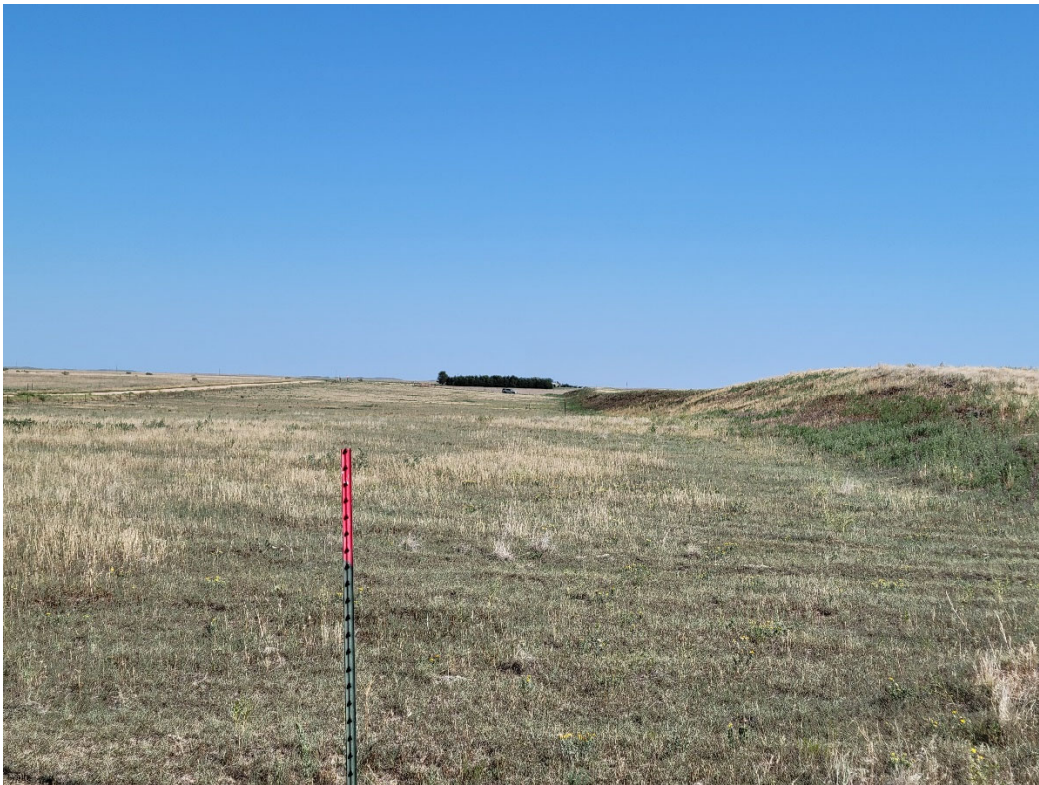
Topsoil: Topsoil and overburden is stockpiled along the western, eastern, and northern sides of the pit. These berms are vegetated and stable. A few rills were noted on the western side of the berm but no obvious signs of erosion was noted along the bottom.

Looking north from southwest corner of permit area. Topsoil berm runs north/south along top of pit.

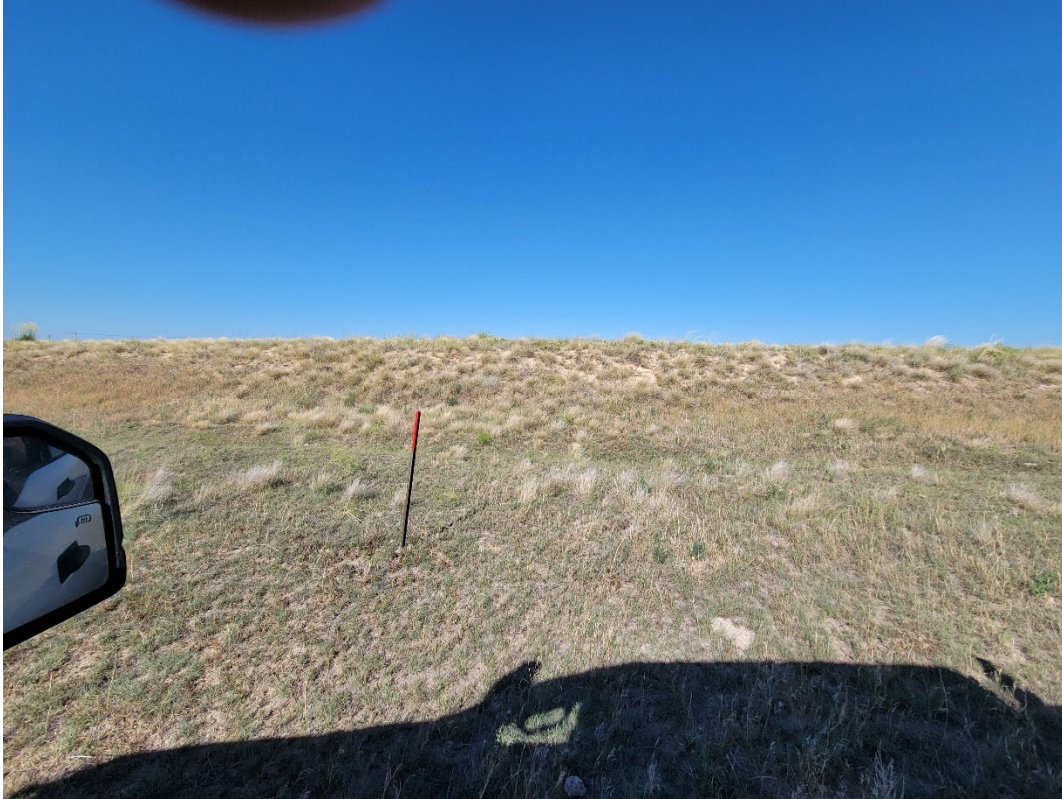
Topsoil and overburden berm along eastern edge of active pit.

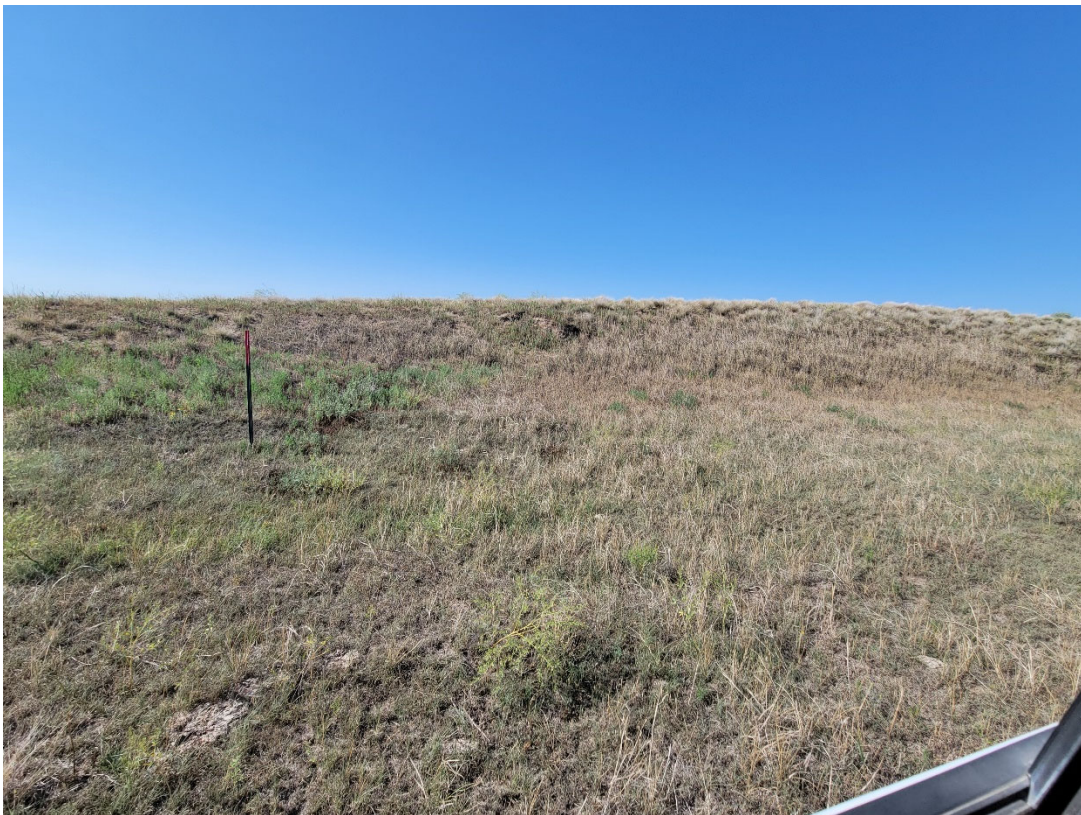
Topsoil and overburden berm along northern edge of the permit boundary

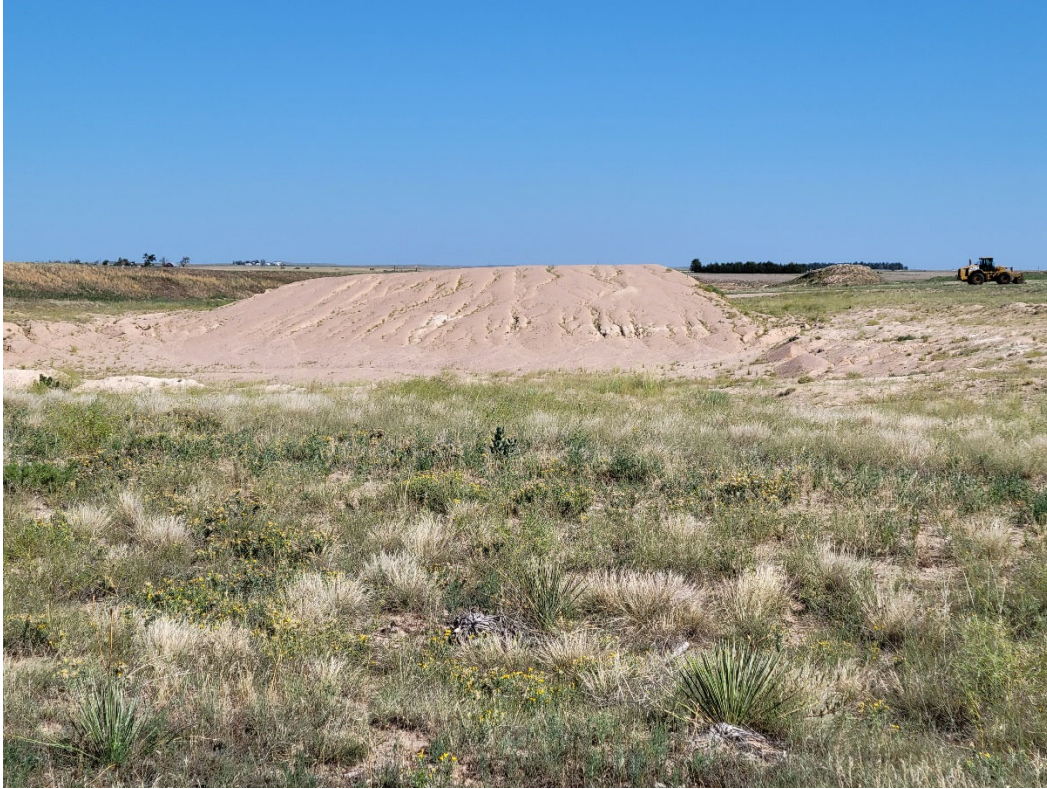
Looking north across interior of main pit. Stockpile of mined material in Stage 1 pit.

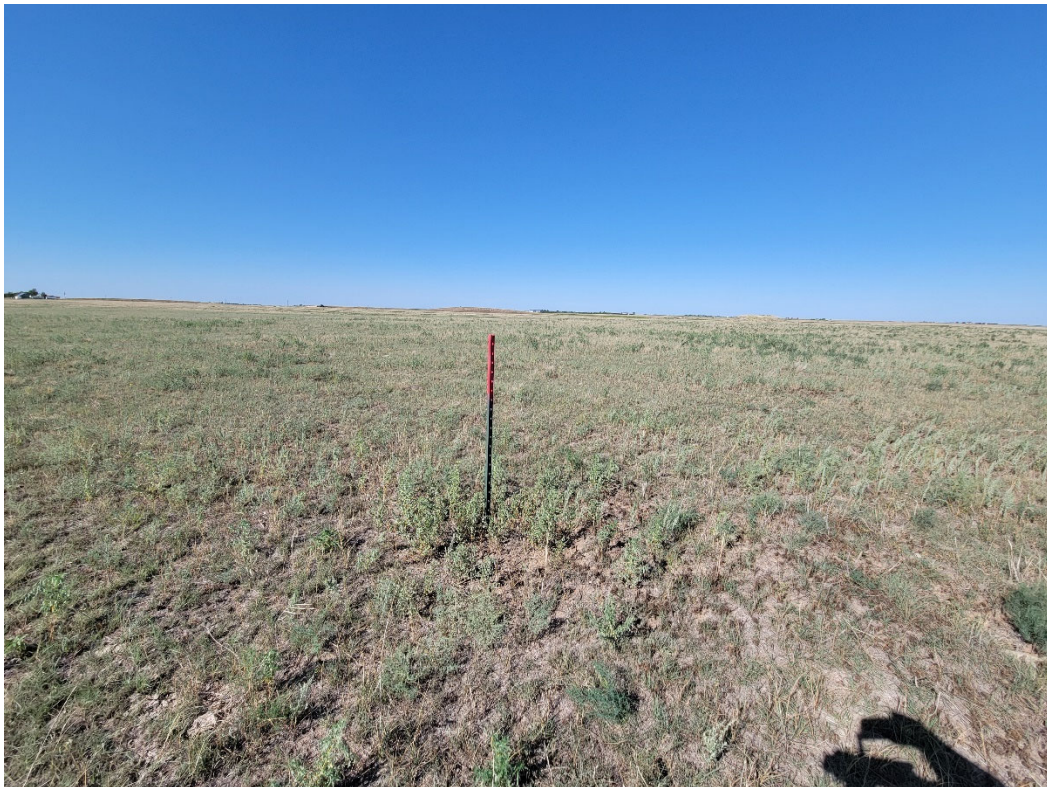
Looking west from southeast corner of permit area.
