MINERALS PROGRAM INSPECTION REPORT
PHONE: (303) 866-3567

MINE NAME: Wagner Pit	MINE/PROSPECTING ID#: M-2010-002	MINERAL: Sand and gravel	COUNTY: Moffat
INSPECTION TYPE: Monitoring	INSPECTOR(S): Zach Trujillo	INSP. DATE: September 1, 2022	INSP. TIME: 09:00
OPERATOR: Wagner Rock LLC	OPERATOR REPRESENTATIVE: None	TYPE OF OPERATION: 110c - Construction Limited Impact	
REASON FOR INSPECTION: Normal I&E Program	BOND CALCULATION TYPE: Complete Bond	BOND AMOUNT: \$13,600.00	
DATE OF COMPLAINT: NA	POST INSP. CONTACTS: None	JOINT INSP. AGENCY: None	
WEATHER: Clear	INSPECTOR'S SIGNATURE:

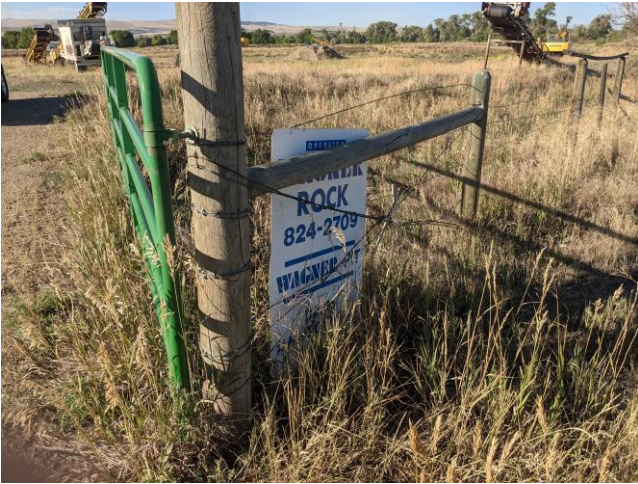
The mine identification sign and affected area boundary markers are in place and in compliance with Rule 3.1.12. The sign is located at the entrance and the entire permit boundary is fenced in.

Mine ID sign.

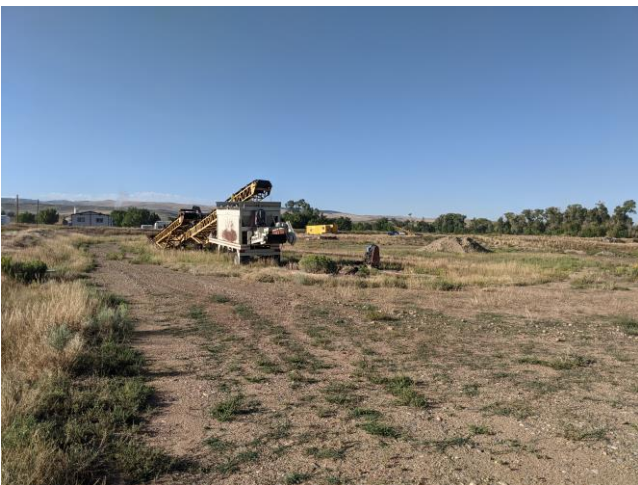
The mine was inactive at the time of the inspection. There is no fuel stored on site. No buildings or other permanent structures have been erected. A crusher and excavator were located on site but the only equipment. There is one small stockpile in the pit and area. No overburden and topsoil stockpiles were observed on site that were noted on previous inspections.

Crusher on site.

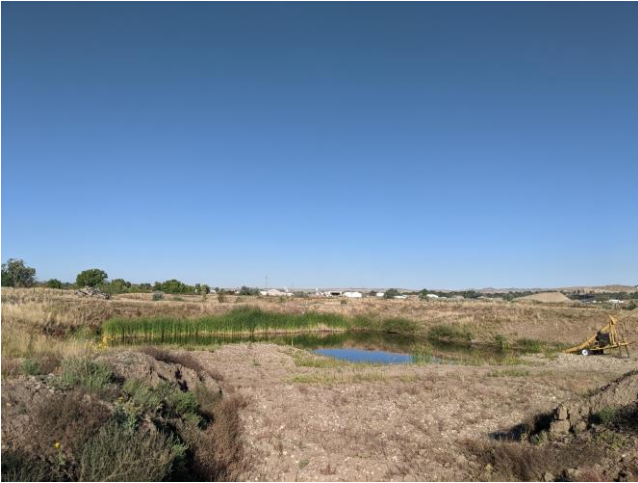
There was one pond on site and was inspected. The pond held minimal water and was not discharging at the time of the inspection. The embankments were stable and vegetated.

Sediment pond.

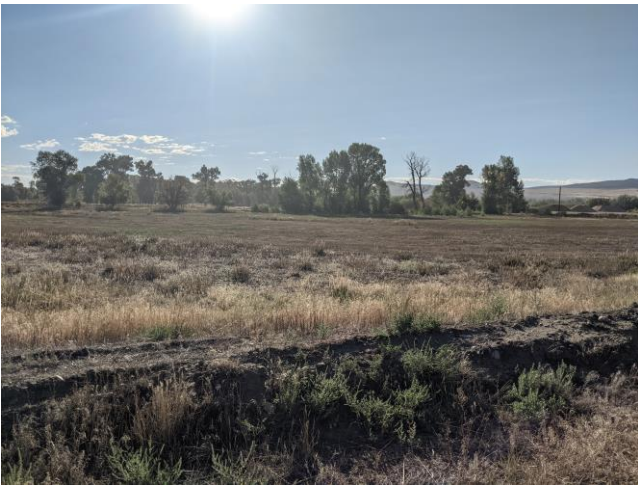
The eastern half of the pit remains undisturbed. It is separated from the active pit area by a berm and is stabilized with well-established grasses. Discussion with the operator prior to the inspection stated that weed spraying had occurred prior to the inspection. No noxious weeds were encountered on the inspection.

Eastern portion of permit.
