**MINERALS PROGRAM INSPECTION REPORT**  
**PHONE: (303) 866-3567**

<b>MINE NAME:</b> State Pit No. 38	<b>MINE/PROSPECTING ID#:</b> M-2006-076	<b>MINERAL:</b> Sand, gravel and clay	<b>COUNTY:</b> Moffat
<b>INSPECTION TYPE:</b> Monitoring	<b>INSPECTOR(S):</b> Zach Trujillo	<b>INSP. DATE:</b> September 1, 2022	<b>INSP. TIME:</b> 11:00
<b>OPERATOR:</b> Moffat County	<b>OPERATOR REPRESENTATIVE:</b> None	<b>TYPE OF OPERATION:</b> 112c - Construction Regular Operation	
<b>REASON FOR INSPECTION:</b> Normal I&E Program	<b>BOND CALCULATION TYPE:</b> None	<b>BOND AMOUNT:</b> \$0.00	
<b>DATE OF COMPLAINT:</b> NA	<b>POST INSP. CONTACTS:</b> None	<b>JOINT INSP. AGENCY:</b> None	
<b>WEATHER:</b> Clear	<b>INSPECTOR'S SIGNATURE:</b>

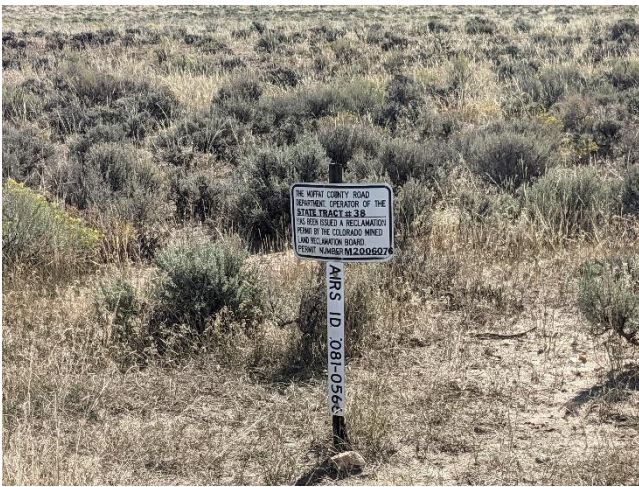
The access road has a locked gate. The mine identification sign and affected area boundary markers are in place and in compliance with Rule 3.1.12. The perimeter was marked with t-posts to clearly delineate permit boundaries. Topsoil and overburden piles were also marked.

Mine ID sign.

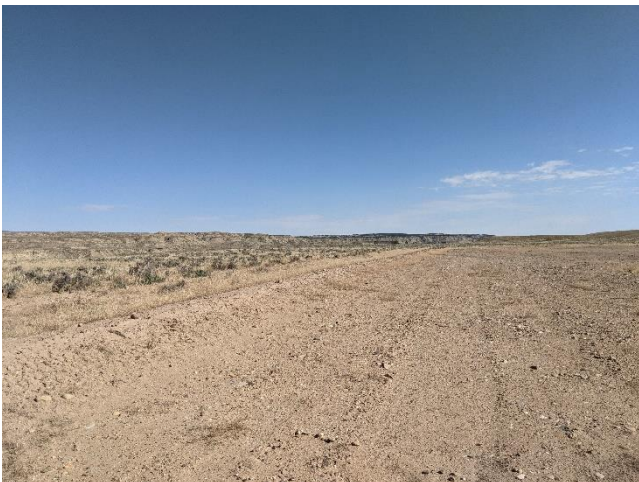
The site was inactive at the time of the inspection. No equipment, fuel or structures were present. There were several stockpiles of previously processed material on site. Stockpiled material is stable with no erosion. The sump located adjacent to zone 1 was dry. The entire site was contained by berms. No erosion or issues were observed within the mined area.

Perimeter containment berm.

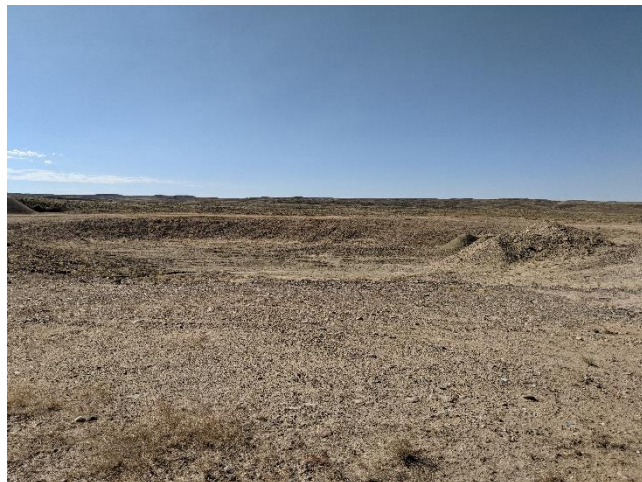
Current pit area.

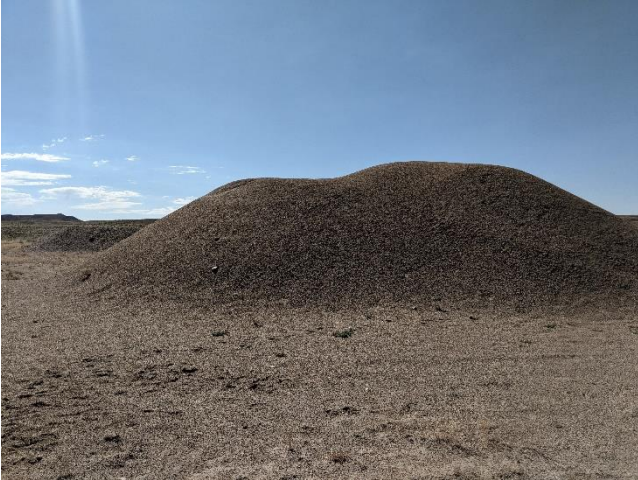
Material stockpiles.

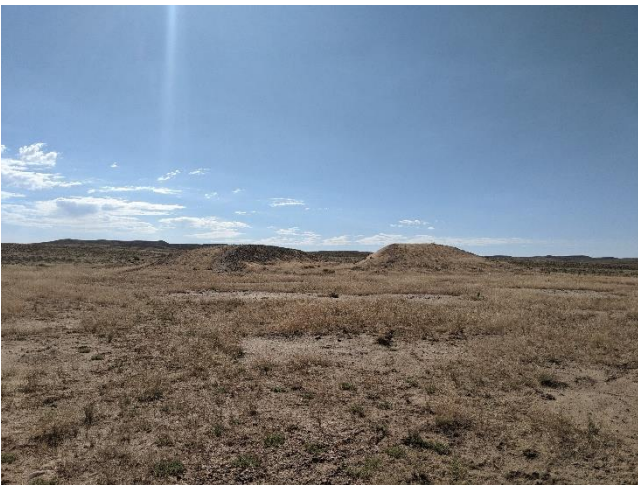
Topsoil and overburden is stored along the east side of the pit. These stockpiles are stabilized with vegetation. Little to no weeds were observed throughout the site.

Topsoil and overburden stockpiles.
