MINERALS PROGRAM INSPECTION REPORT
PHONE: (303) 866-3567

MINE NAME: Raftopoulos Pit #1	MINE/PROSPECTING ID#: M-1998-003	MINERAL: Sand and gravel	COUNTY: Moffat
INSPECTION TYPE: Monitoring	INSPECTOR(S): Zach Trujillo	INSP. DATE: September 1, 2022	INSP. TIME: 13:00
OPERATOR: 3B Enterprises, LLC	OPERATOR REPRESENTATIVE: None	TYPE OF OPERATION: 112c - Construction Regular Operation	
REASON FOR INSPECTION: Normal I&E Program	BOND CALCULATION TYPE: Complete Bond	BOND AMOUNT: \$31,727.00	
DATE OF COMPLAINT: NA	POST INSP. CONTACTS: None	JOINT INSP. AGENCY: None	
WEATHER: Clear	INSPECTOR'S SIGNATURE:

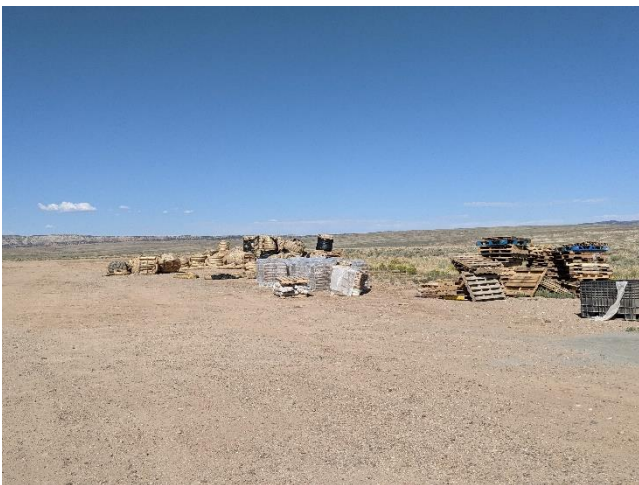
Staw wattles staged.

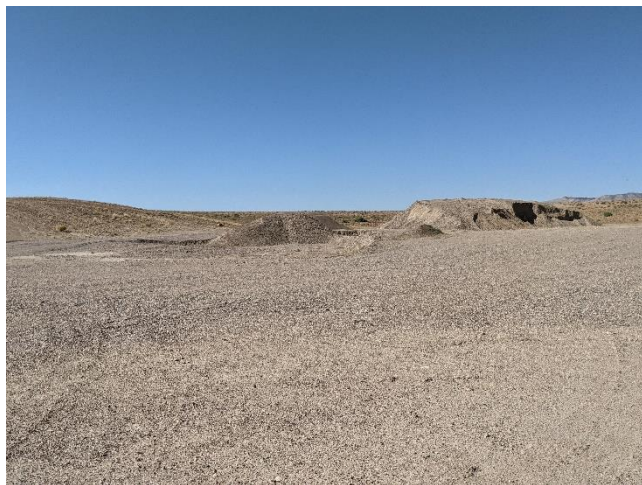
Stockpiles.

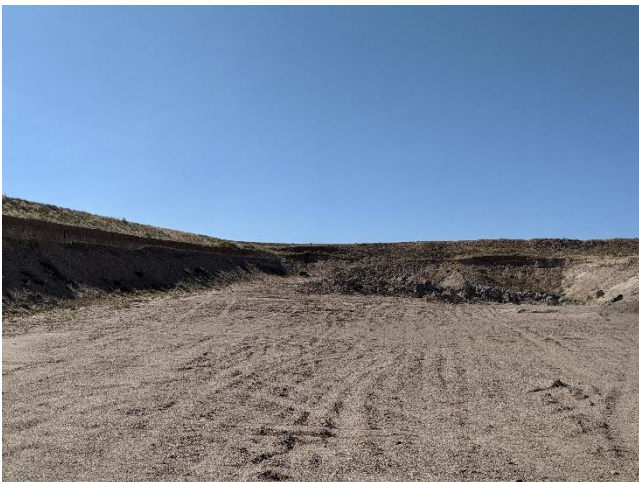
Pit area.
