## MINERALS PROGRAM INSPECTION REPORT

<b>MINE NAME:</b> Revenue Mine	<b>MINE/PROSPECTING ID#:</b> M-2012-032	<b>MINERAL:</b> Lead, silver and gold	<b>COUNTY:</b> Ouray
<b>INSPECTION TYPE:</b> Monitoring	<b>INSPECTOR(S):</b> Lucas West	<b>INSP. DATE:</b> August 25, 2022	<b>INSP. TIME:</b> 09:00
<b>OPERATOR:</b> Ouray Silver Mines Inc.	<b>OPERATOR REPRESENTATIVE:</b> Todd Jesse, Poppy Staub	<b>TYPE OF OPERATION:</b> 112d-1 - Designated Mining Operation	
<b>REASON FOR INSPECTION:</b> Normal I&E Program	<b>BOND CALCULATION TYPE:</b> None	<b>BOND AMOUNT:</b> \$517,219.00	
<b>DATE OF COMPLAINT:</b> NA	<b>POST INSP. CONTACTS:</b> None	<b>JOINT INSP. AGENCY:</b> None	
<b>WEATHER:</b> Clear	<b>INSPECTOR'S SIGNATURE:</b>

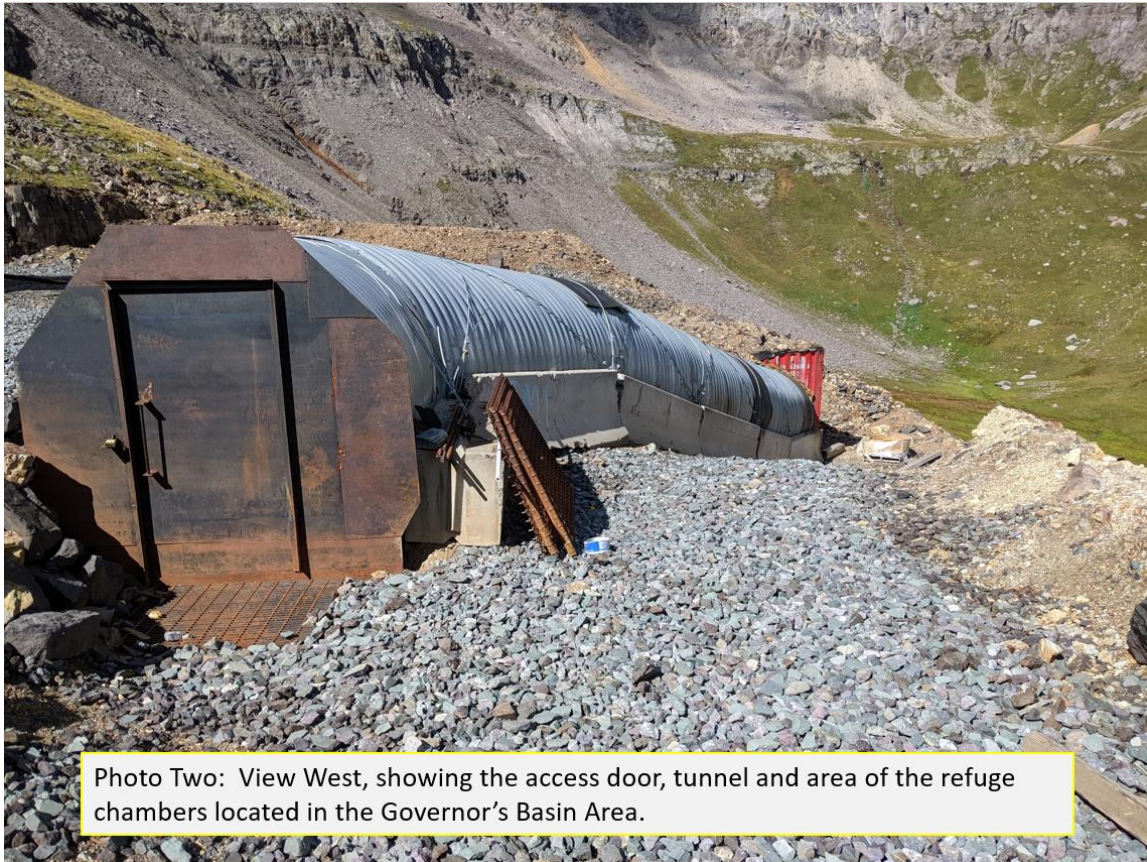
Photo Two: View West, showing the access door, tunnel and area of the refuge chambers located in the Governor's Basin Area.

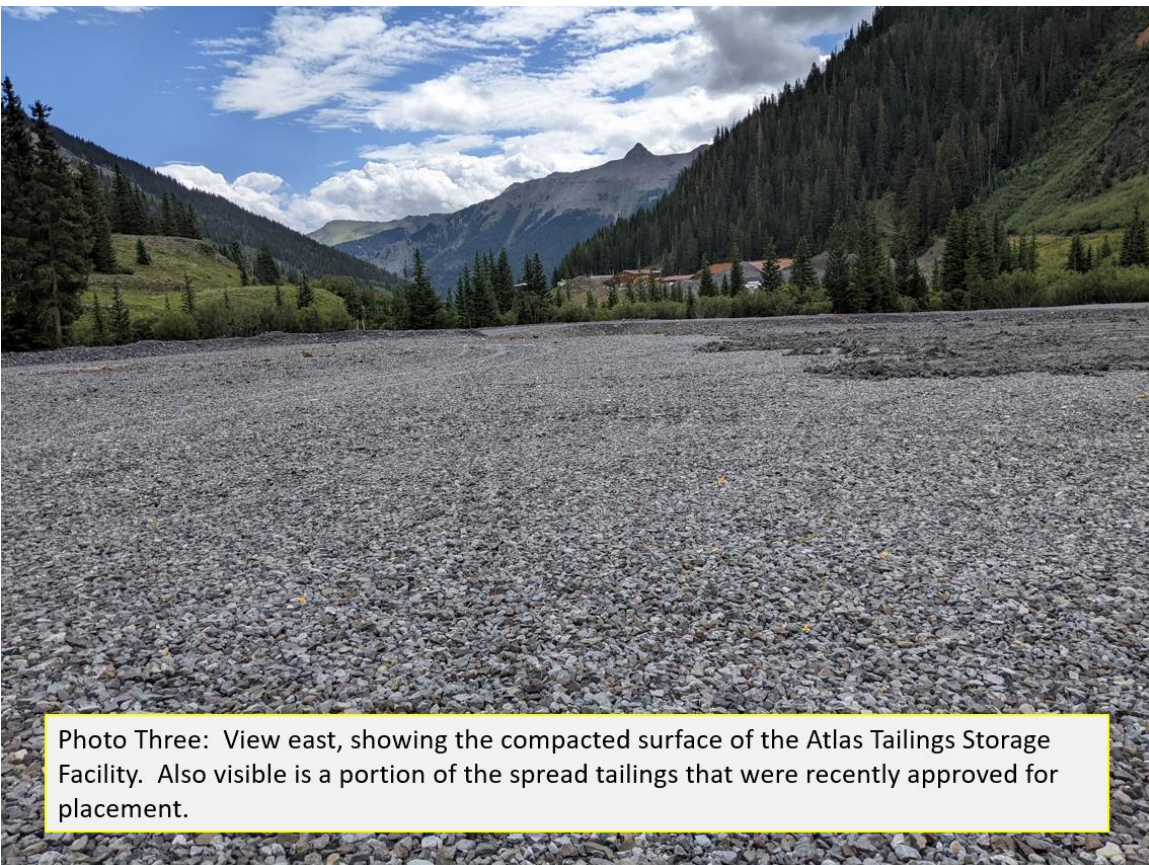
Photo Three: View east, showing the compacted surface of the Atlas Tailings Storage Facility. Also visible is a portion of the spread tailings that were recently approved for placement.

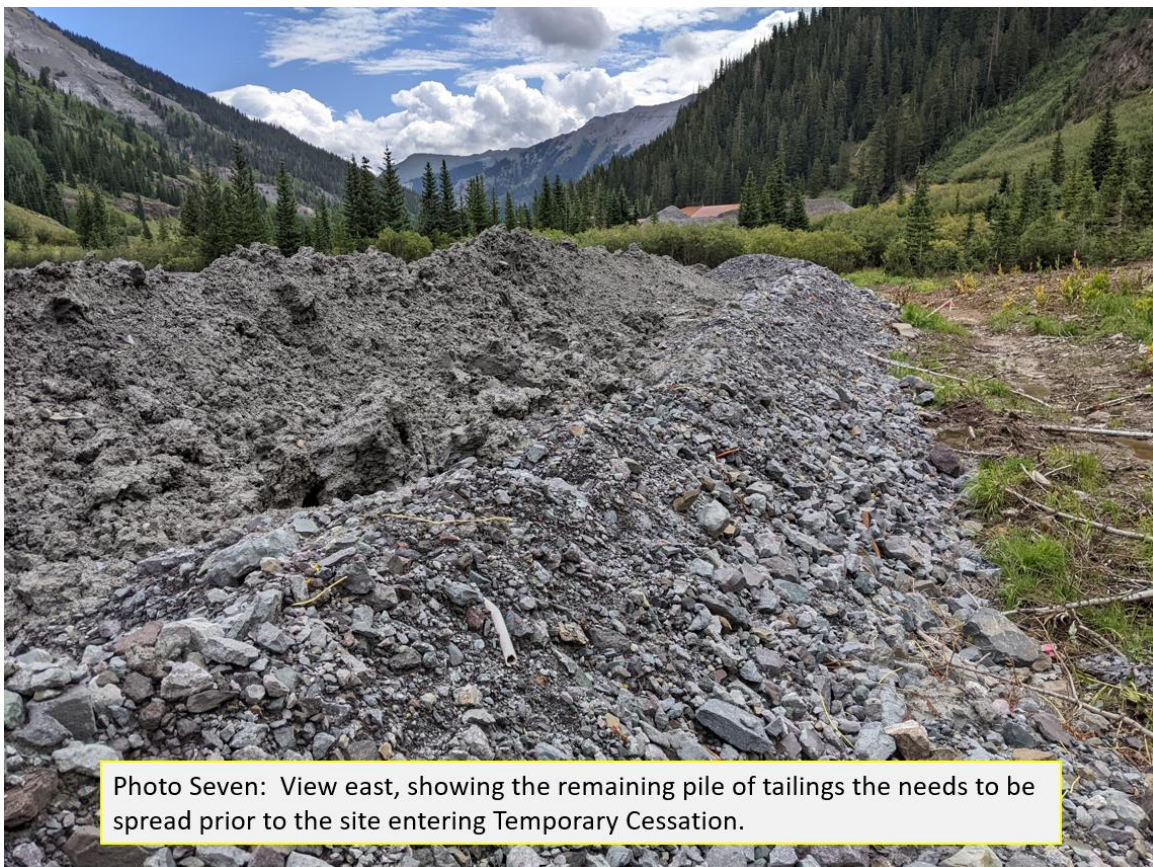
pile can be seen in Photo Seven. As noted previously, the Notice of Temporary Cessation was deemed incomplete due to the small pile of tailings not being spread and the minimal spillage of tailings in the storm water control ditch. These items must be completed prior to the Notice of Temporary Cessation being deemed complete. As noted previously the Division is awaiting photographic documentation that the items have been completed. At such time as the documentation is received, the Notice will be considered complete for filing and processed.

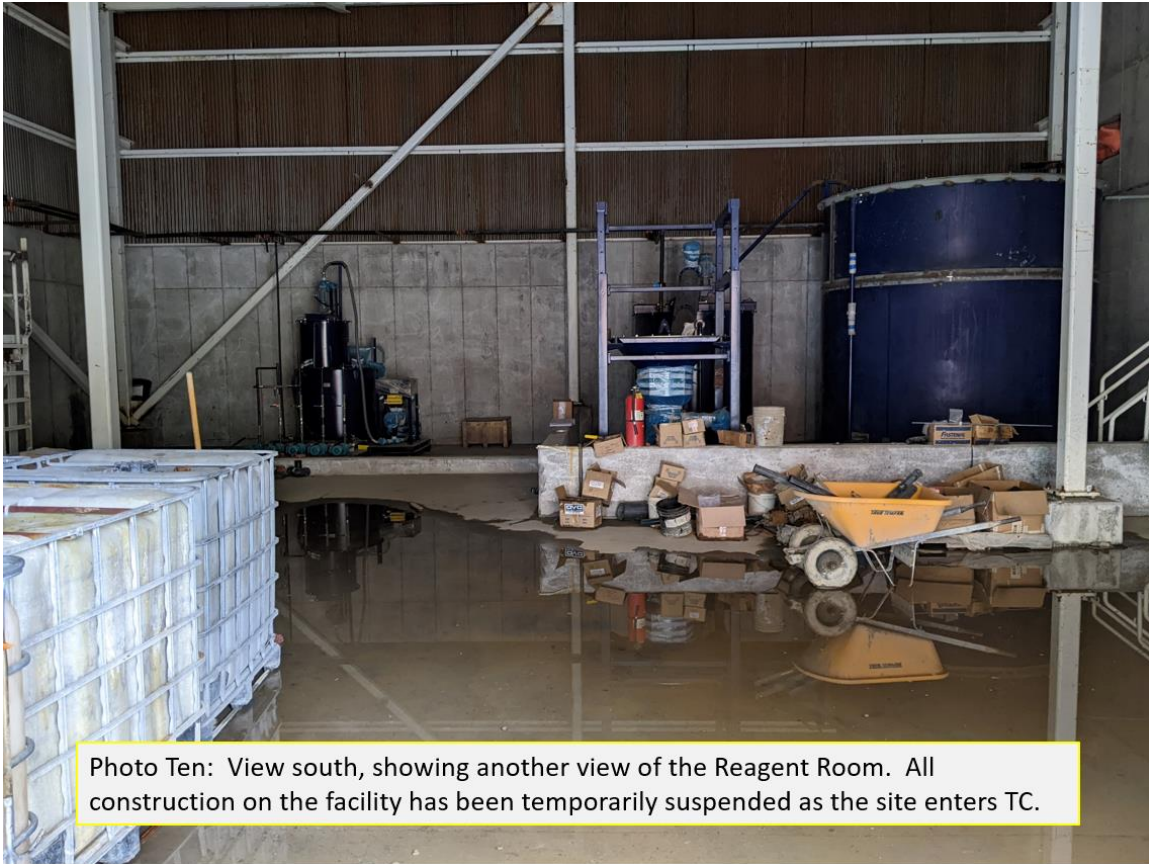
Adjacent to the mill building, the compressor room and reagent room, which is mid construction, were observed. The compressor room was neat and organized. The reagent room contained a good amount of standing water from snowmelt from the unsecured exterior of the structure. The interior of the room appeared to be in good condition despite the standing water and can be seen in Photos Nine through Eleven. All tanks that have been set and containment devices appeared to be in good condition, and the progress of the construction remains largely unchanged. The Operator has submitted a notice of suspension of construction of the facility due to the site entering into Temporary Cessation. This notice has been acknowledged by the Division. The exterior of the reagent room, mill building and area around the tailings thickener tank is neat and well kept.

Photo Ten: View south, showing another view of the Reagent Room. All construction on the facility has been temporarily suspended as the site enters TC.

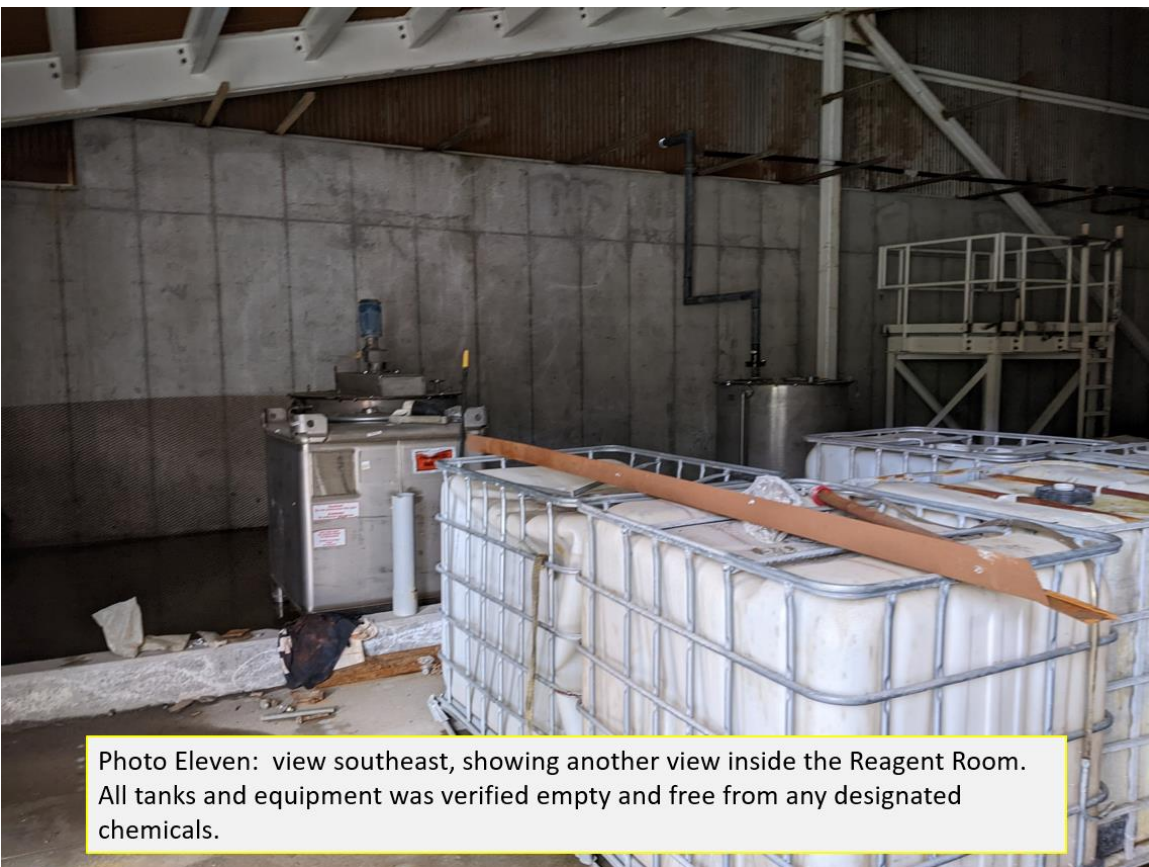
Photo Eleven: view southeast, showing another view inside the Reagent Room. All tanks and equipment was verified empty and free from any designated chemicals.

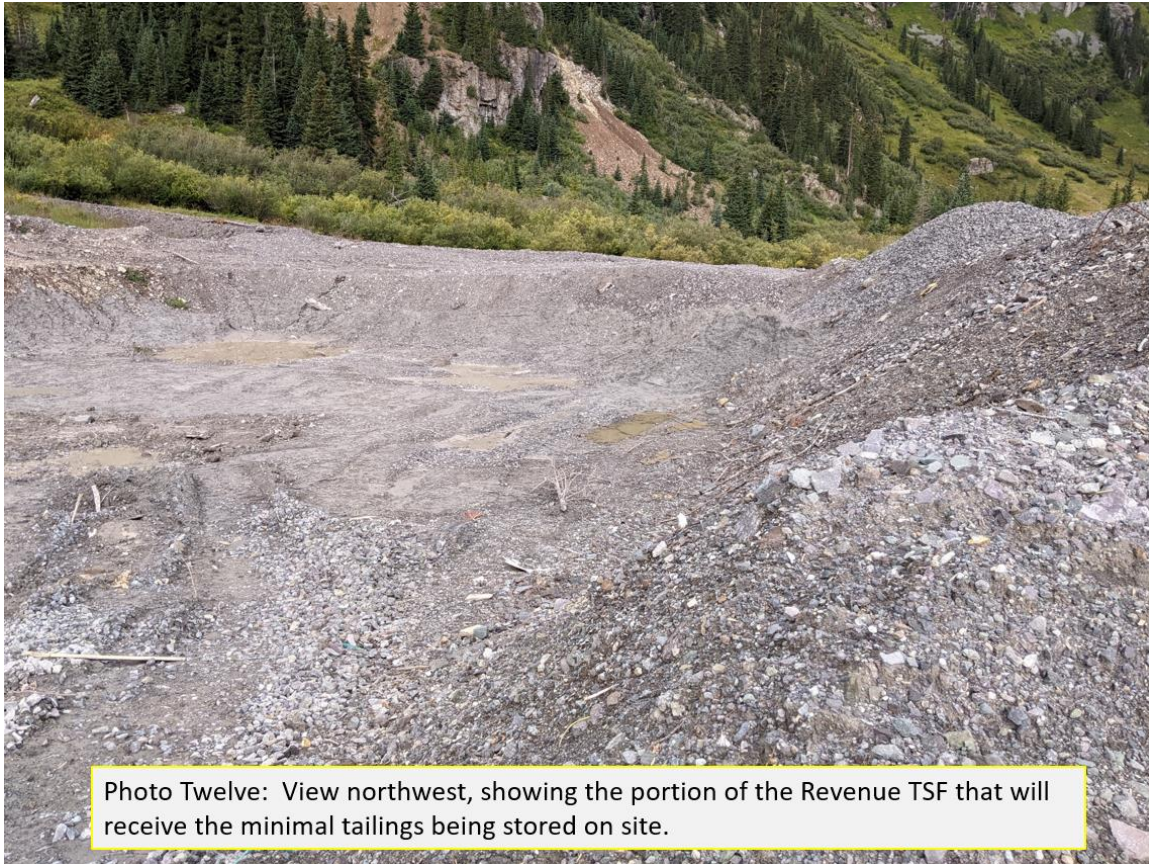
Adjacent to the admin building the Revenue Tailings Storage Facility was observed. Tailings are being placed and spread in the lower reaches of the facility and can be seen in Photo Twelve. The laydown yard near the Revenue TSF has undergone extensive cleanup and organization. All items stored in this area are neat, orderly and in excellent condition. The Passive Mine Water Treatment system was flowing and functioning as designed at the time of the inspection. The ponds were free from obstruction and can be seen in Photos Thirteen and Fourteen.
