MINERALS PROGRAM INSPECTION REPORT
PHONE: (303) 866-3567

MINE NAME: Gehrman Pit	MINE/PROSPECTING ID#: M-2009-078	MINERAL: Gravel and sand	COUNTY: Moffat
INSPECTION TYPE: Monitoring	INSPECTOR(S): Zach Trujillo	INSP. DATE: September 1, 2022	INSP. TIME: 08:30
OPERATOR: Elam Construction, Inc.	OPERATOR REPRESENTATIVE: None	TYPE OF OPERATION: 112c - Construction Regular Operation	
REASON FOR INSPECTION: Normal I&E Program	BOND CALCULATION TYPE: Complete Bond	BOND AMOUNT: \$88,975.00	
DATE OF COMPLAINT: NA	POST INSP. CONTACTS: None	JOINT INSP. AGENCY: None	
WEATHER: Clear	INSPECTOR'S SIGNATURE:

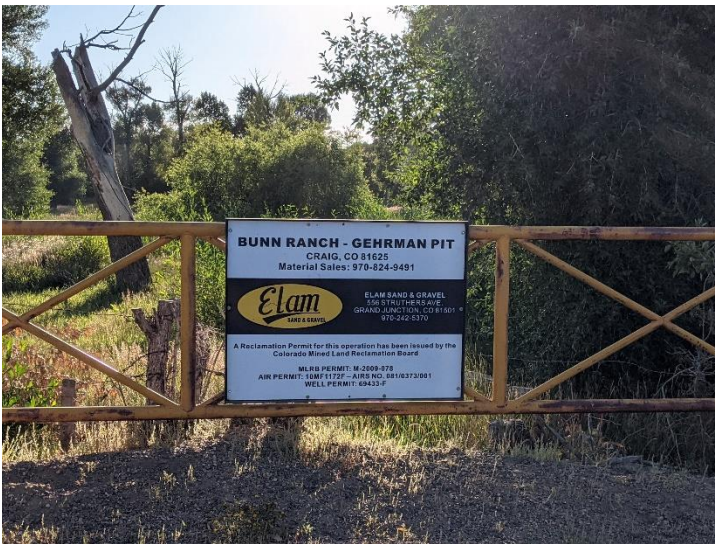
The mine identification sign was located at the entrance to the Bunn Ranch Pit with all required information for compliance.

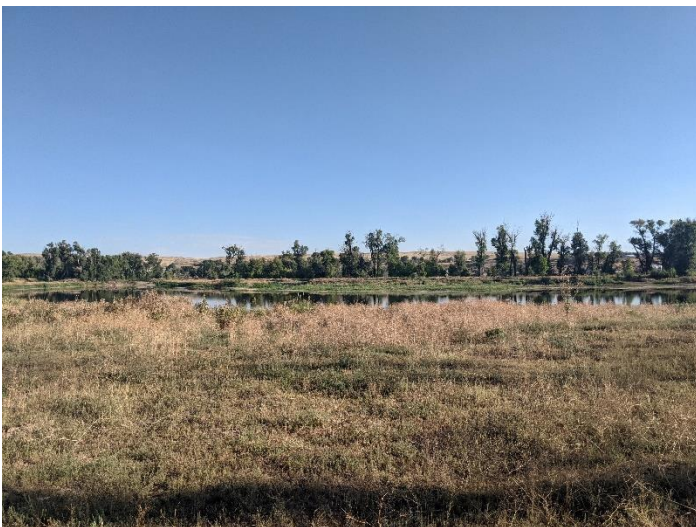
The pit was inactive at the time of the inspection and appeared fully mined through Phase 3 and reclaimed. Pit slopes appeared to have been scaled back to the approved 3:1. The entire pit area was filled with water and vegetation establishment was observed along the banks. The access road along the southern part of pit was roughened and vegetated.

Western extent of pit.

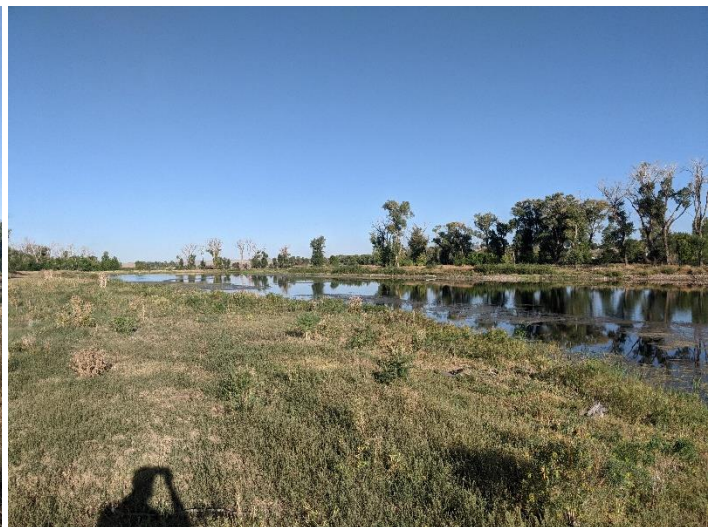
Eastern end of pit looking west.

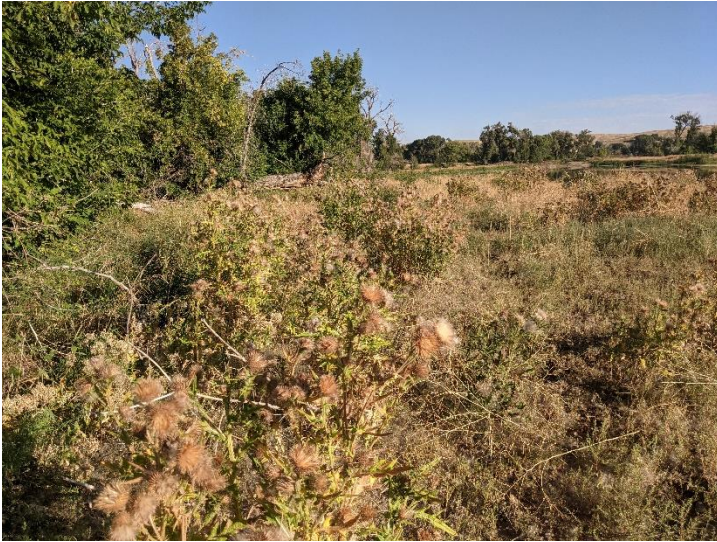
Several annual weeds were observed thought the pit. The operator is encouraged to more aggressively manage noxious weeds. Thistle and hounds tongue were observed throughout the site most predominantly near the western end of the pit near the mine entrance.

Thistle at western end of pit near entrance.
